1 **The street, an area exposed to earthquakes (the Lorca**
2 **case, Spain 2011)**

4 **M. B. Rojo, E. Beck, C. Lutoff.**

5 PACTE-Université de Grenoble-Alpes, PACTE UMR 5194 (CNRS, IEPG, UJF, UPMF),
6 Grenoble, 38041, France

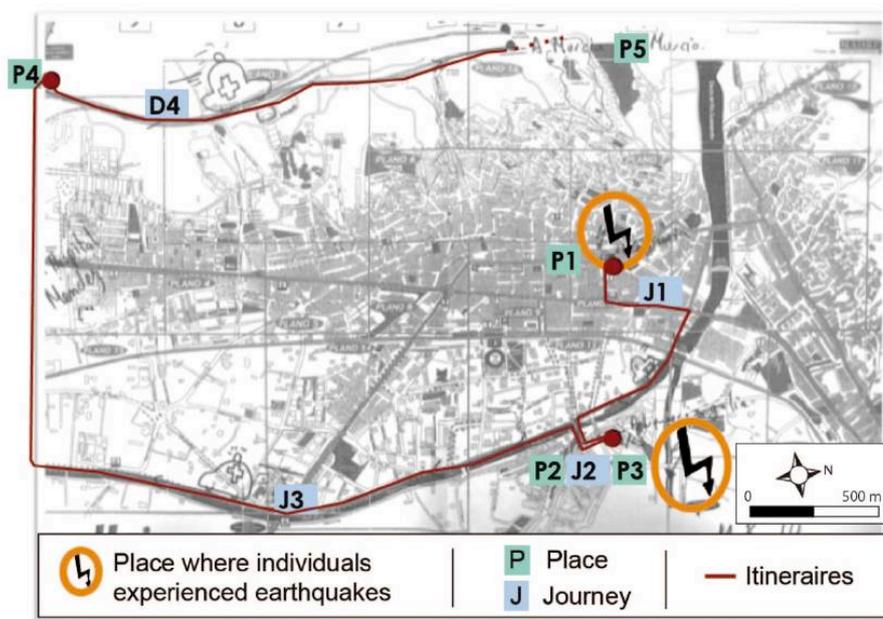
248 Figure 2 Example of the itinerary map drawn during one of the enquiries. Base map :
249 shopkeepers' book.

242 As we filled the grid with the interviewees we drew their itinerary, the places they usually go
243 to and the places where they had experienced the earthquake on a map (Figure 2). Using the
244 map during the interviews allowed people to better remember the details of their journey and
245 to be more precise with time schedules. This also allowed them to better remember the way
246 journeys were modified by the event (for example to avoid streets that were blocked or cut).

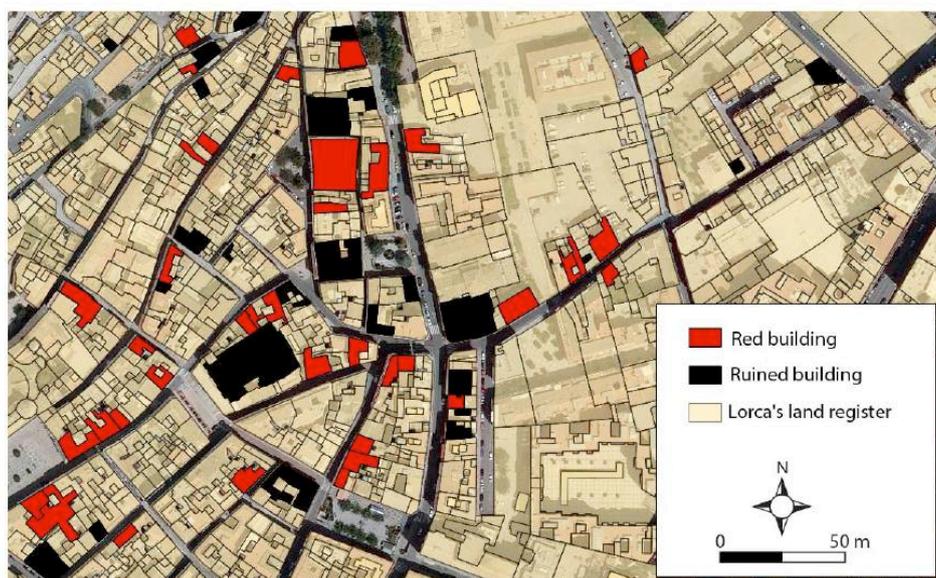
297
298 Figure 3 Extract from the maps of buildings classified in red or black (ruined). IGN land
299 register data. Map base : PNOA images *del Instituto Geografico Nacional*. Evaluation of
300 buildings : Source Servicio de Urbanismo de Planeamiento y Gestion. Production : Marc
301 Bertran Rojo 2014.

290 In our analysis of individual exposure we retained buildings classified red and ruined, defined
291 as « fragile » by the first evaluation (Figure 3). They were yet the ones that presented an
292 important danger for people approaching them. Information on buildings identified as fragile

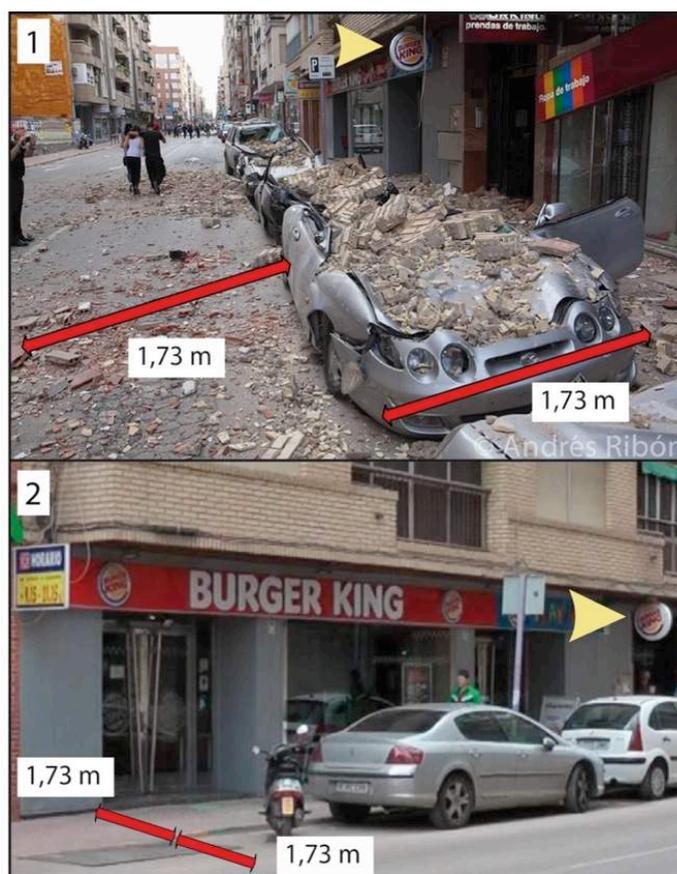
371
372 Figure 4 An example of the maximum impact distance evaluation. The yellow arrow provides
373 for a common point of reference for the three pictures (restaurant logo). Photographs by : 1
374 Andrés Ribón, 2 Marc Bertran Rojo.

348 The idea was to use these pictures to measure the maximum distance reached by the debris
349 which came off the buildings. This distance is defined as the furthest point from the facade
350 where debris approximately the size of a brick can be observed (110 x 70 x 230 mm). This
351 size was used to set a limit and not take small parts into account for they can result from the
352 fracturing of the debris impacting the ground. The point from which distance was calculated
353 was the facade of the building from which the debris came off. Two examples of how the
354 maximum impact distance was studied are given below.

369 these three distances we could conclude that the maximum impact distance was roughly 5
370 metres.

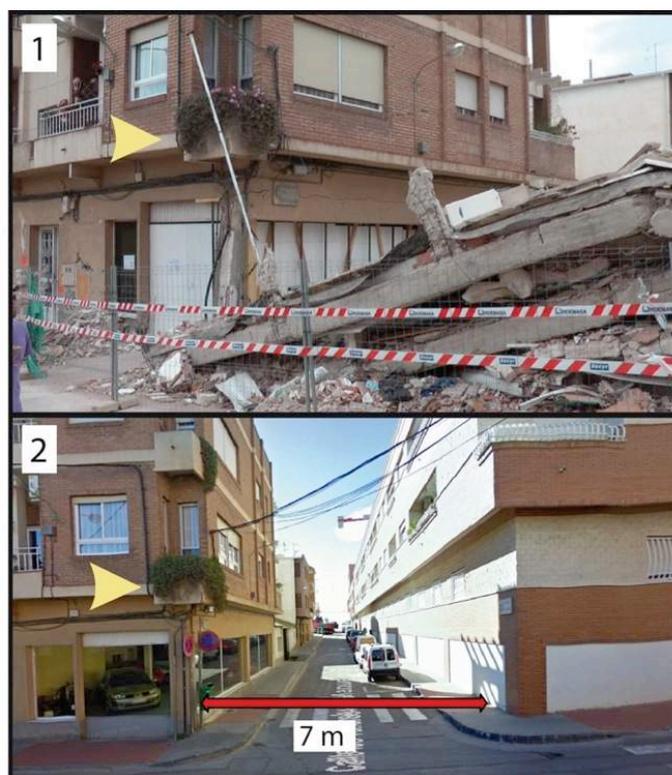
375 **Second example : Collapsed building (Figure 5)**

382 Figure 5 An example of the maximum impact distance evaluation. Photographs by : 1 Marc
383 Bertran Rojo, 2 (Google Street).

376 We wanted to calculate the maximum impact distance of a single collapsed building. This
377 case being rather spectacular photographs and movies were largely available. The impact area
378 covered the whole street width. It was then 7 metres wide or even a little more as the building
379 collapsed into the display window of the shop across the street (Figure 5). However we
380 preferred to round the estimation to 7 metres.

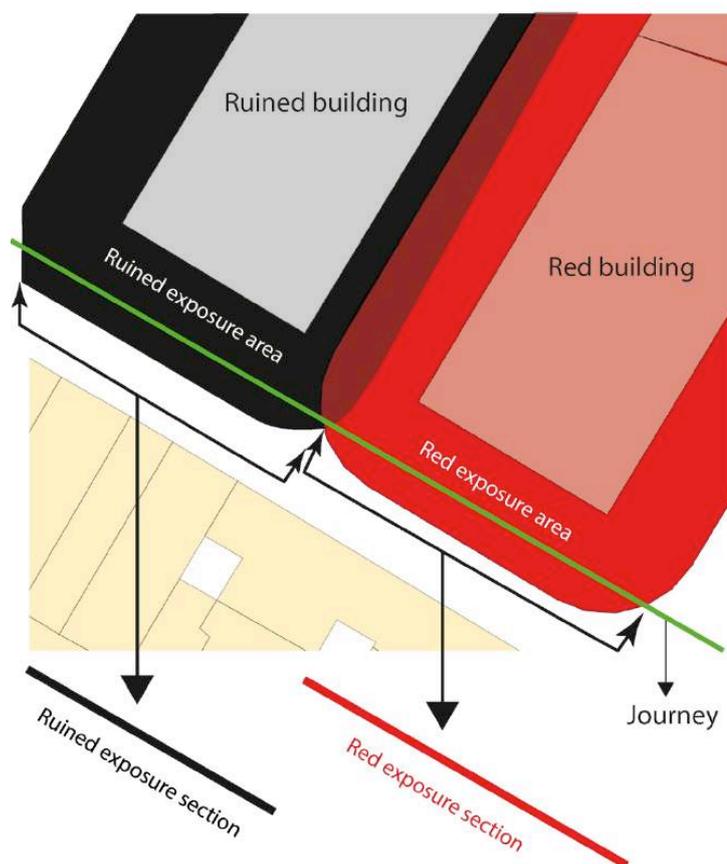
417 Figure 6 Production of exposure sections from an « intersection » geospatial tool between
418 the journeys (lines) and exposure areas around fragile buildings (ruined or red).

409 Among the 115 journeys listed in total 86 were retained to analyze their exposure : journeys
410 made between both tremors (and just before the strongest tremor) were not taken into account.
411 We chose to work only with journeys made after the second tremor because weakened
412 buildings were listed only after the second earthquake. Figure 6 shows the way a journey is
413 made across exposure areas to generate sections of exposure taken into consideration in the
414 following analyses. This operation was performed under the supervision of a GIS using a
415 geoprocessing tool (intersection).

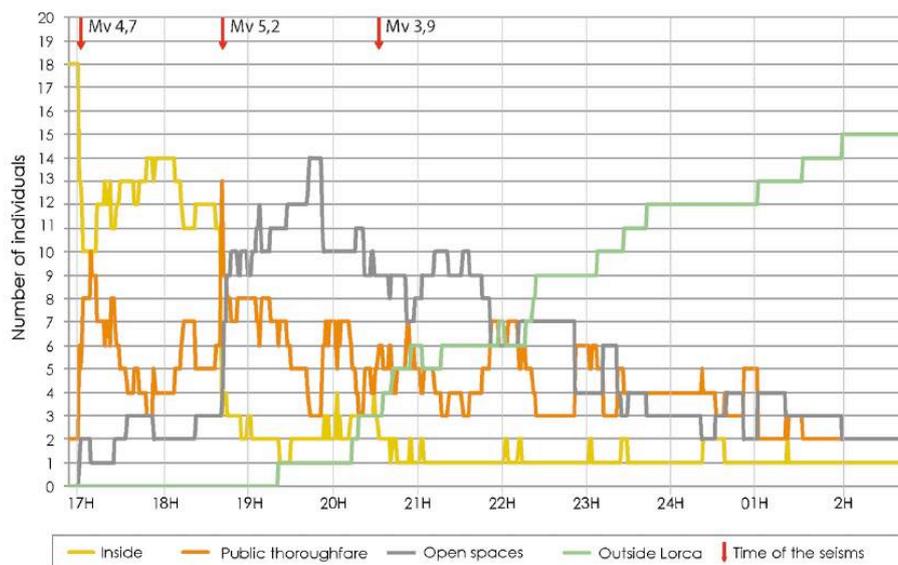
559 Figure 7 Evolution of the location of individuals in various categories of spaces during the
560 seismic crisis (inside, public thoroughfare, open spaces and outside Lorca).

551 Evacuation mainly started almost two hours after the main seism ; then the number of
552 evacuated individuals increased regularly until 7 hours after the tremor.

553 We can notice with this figure that the individuals did not feel the need to go to an open space
554 after the first seism and preferred to stay on the public thoroughfare. On the contrary,
555 following the main seism most of the witnesses decided to rapidly reach open spaces rather
556 than stay on the public thoroughfare. This difference in behaviour seems to be directly linked
557 to the intensity of the seisms.

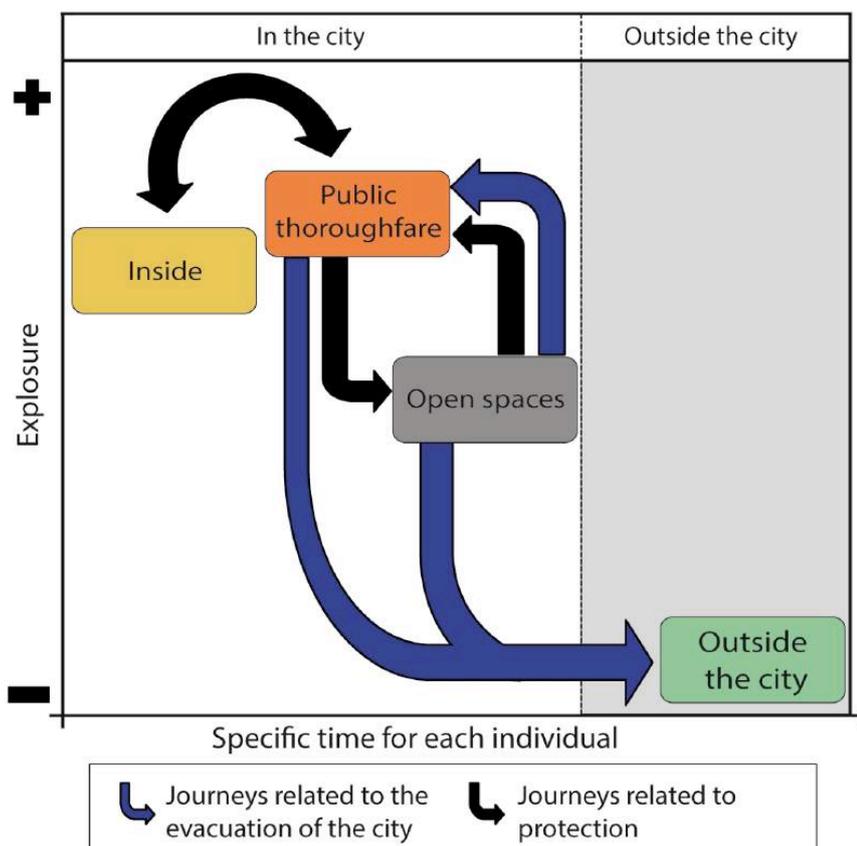
576 Figure 8 According to Géorisque (Rojo *et al.* 2013), a conceptual model of mobility in
577 connection with exposure in a seismic crisis period. A model built from the analysis of the
578 seismic event on May 11, 2011 in Lorca, Spain.
