# Factors influencing development of cracking-sliding failures of loess across the east Loess Plateau of China

Yanrong Li<sup>1</sup>, Jiarui Mao<sup>2</sup>, Xiqiong Xiang<sup>2</sup>, Ping Mo<sup>1</sup>

<sup>1</sup>Department of Earth Sciences and Engineering, Taiyuan University of Technology, Taiyuan, 030024, China

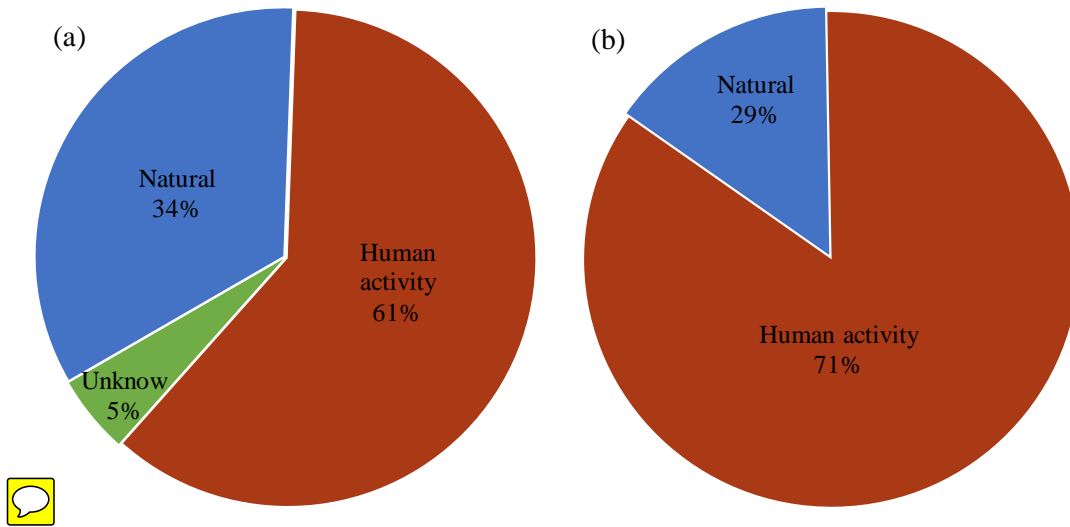
**Figure 11.** Role of engineering activities in loess failures: a) Shanxi Province; and b) Huangling County, Shaanxi Province.

214 More than half of the failures are attributed to human engineering activities (Fig. 11). In 2014,  
215 9 of 16 failure cases that occurred in Yan'an City were caused by extremely steep slopes for cave  
216 dwelling construction, and the 7 other cases were consequences of improper treatment of side  
217 slopes for road construction (Lei, 2001). These findings demonstrate that intense human  
218 activities likely result in a high probability of loess failures.
