1 **Factors influencing development of cracking-sliding failures of loess across the eastern** 2 **Loess Plateau of China**

22 **Keywords:** loess, cracking–sliding failure, influencing factors, development patterns

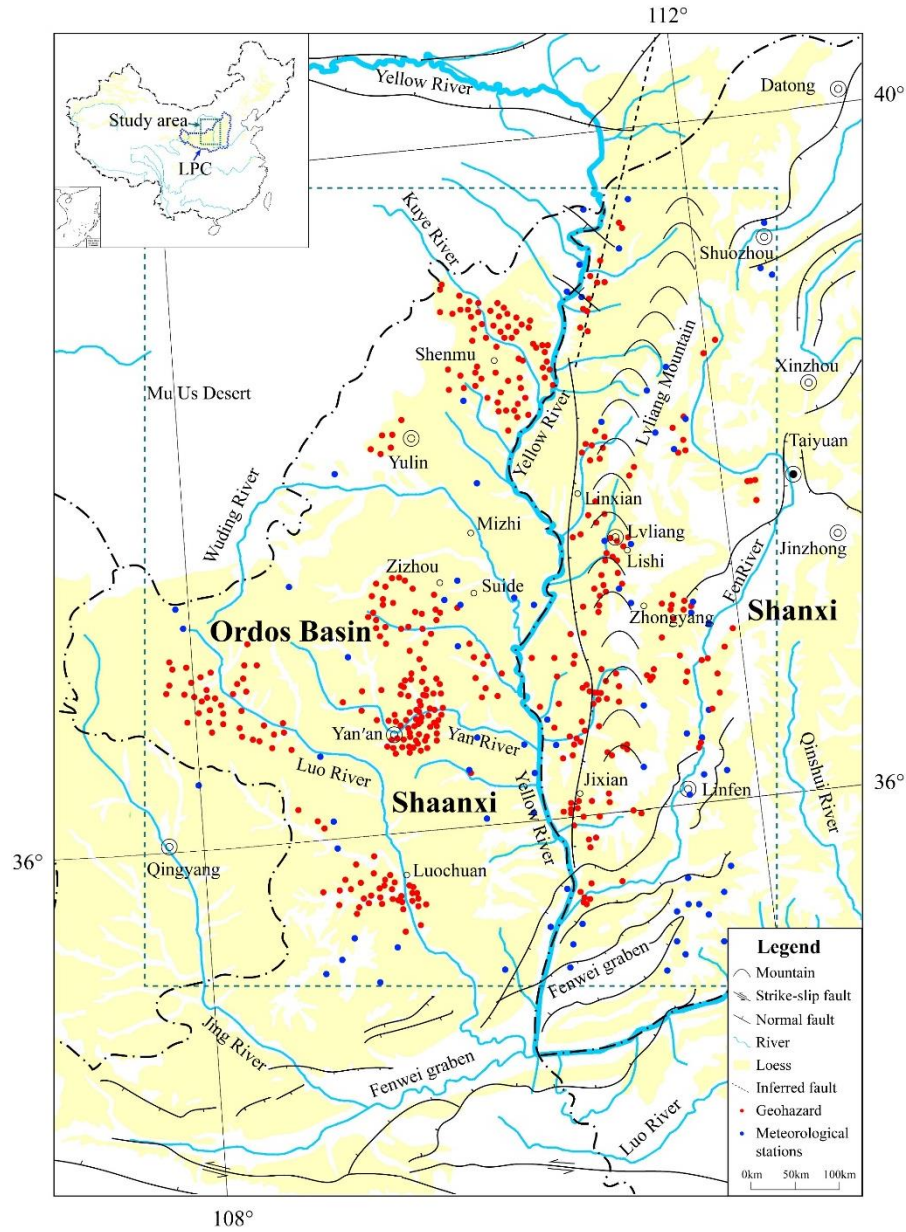
Figure 2. Geological map of the study area. The red dots denote the cracking–sliding failure cases, and the blue dots indicate the meteorological stations in the study area.

68 The study area is limited to the eastern LPC and covers Northern Shaanxi and Western
69 Shanxi provinces, considering the homogeneous background of climatic, morphologic, geologic,
70 and anthropic conditions in these regions (Fig. 2). Elevation of the study area ranges from 800 to
71 1300 m above sea level from southeast to northwest. The study area has a typical semiarid
72 continental monsoon climate with four distinct seasons. The average annual rainfall in this area
73 varies from 400 to 700 mm. Rainfall in summer (from July to September) accounts for
74 approximately 70% of the year (Hui, 2010; Qian, 2011; Zhu 2014). For instance, the maximum
75 precipitation in an hour in Yan'an City can accumulate to more than 60 mm in summer (Zhu,
76 2014). The total rainfall in Shilou County reached 412 mm in a month from early July to early
77 August in 2013 (Lv, 2011) and corresponded to 81% of rainfall in the same year. According to

110 Data pertaining to rainfall were obtained from the records of 75 meteorological stations (blue
111 dots in Fig. 2), which are almost uniformly distributed across the study area. Statistical analysis
112 shows that the variation in average annual rainfall in the past 15 years among these stations is
113 less than 80 mm, indicating a relatively homogeneous climatic condition over the study area.

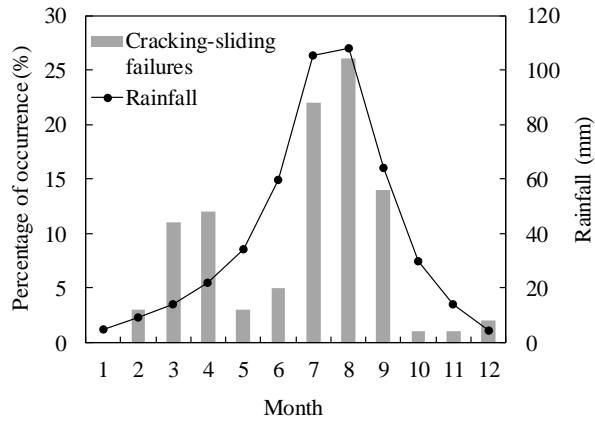
Figure 6. Occurrence of cracking–sliding failures mainly in July to September and consistent with the average monthly rainfall.

161 Rainfall remarkably influences the stability of loess slopes. In **Figure 6**, the number of loess
162 failures is closely and positively correlated with the average monthly rainfall of the past 15 years.
163 Summer rainfall (July to September) in the study area accounts for approximately 60% of the
164 annual precipitation, and the number of cracking–sliding failures in the same period corresponds
165 to 62% of the total failures. This finding is consistent with that of Gao et al. (2012), who
166 indicated that more than 60% of loess failures happen in Gansu Province in the rainy season.
167 Wei (1995) and Liu et al. (2012) presented a similar conclusion in Shanxi and Shaanxi **provinces**,
168 respectively.

178 **Figure 6** shows that cracking–sliding failures occur frequently not only in the rainy season
179 from July to September but also in the winter-to-spring transition from March to April. Soil
180 temperature increases rapidly from **values** below 0°C to **values** above 0°C. As shown in **Figure 7**,
181 soil temperature remains negative, and the frozen depth can reach approximately 1.0 m
182 underground from late November to February in the loess areas in China. At the end of March,
183 the ground temperature begins to increase, and the frozen layer gradually enters the thawing
184 stage. By mid-April, the soil is rapidly heated up to approximately 8 °C.

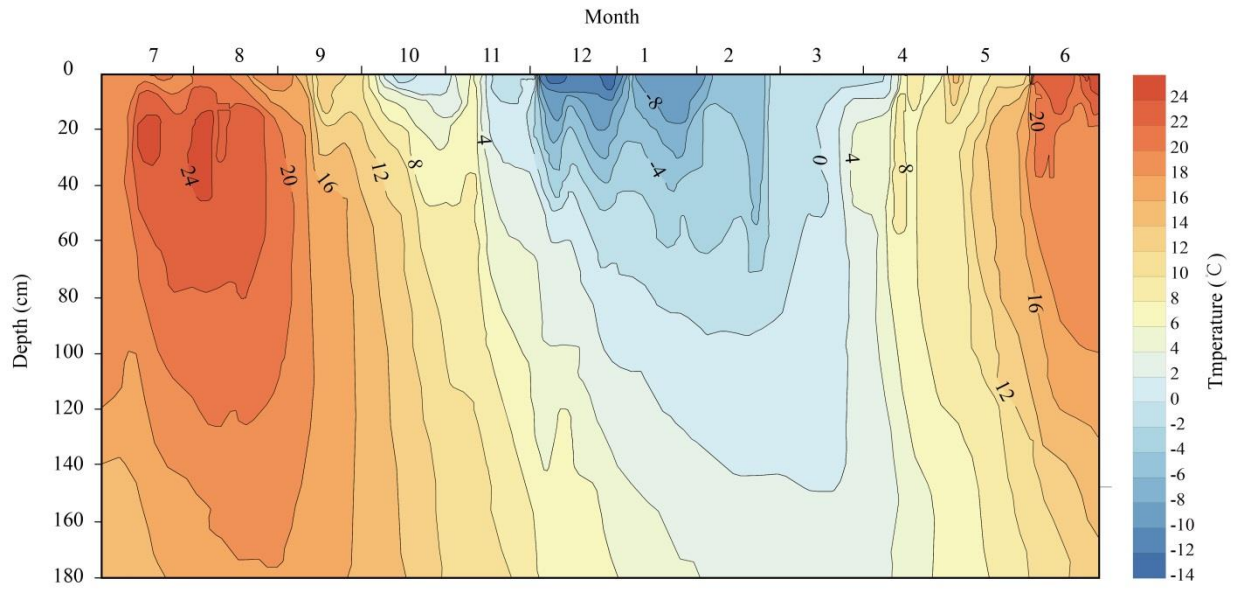
Figure 7. Annual variation of temperature ($^{\circ}\text{C}$) within a shallow zone of a typical loess slope (Yang and Shao, 1995).

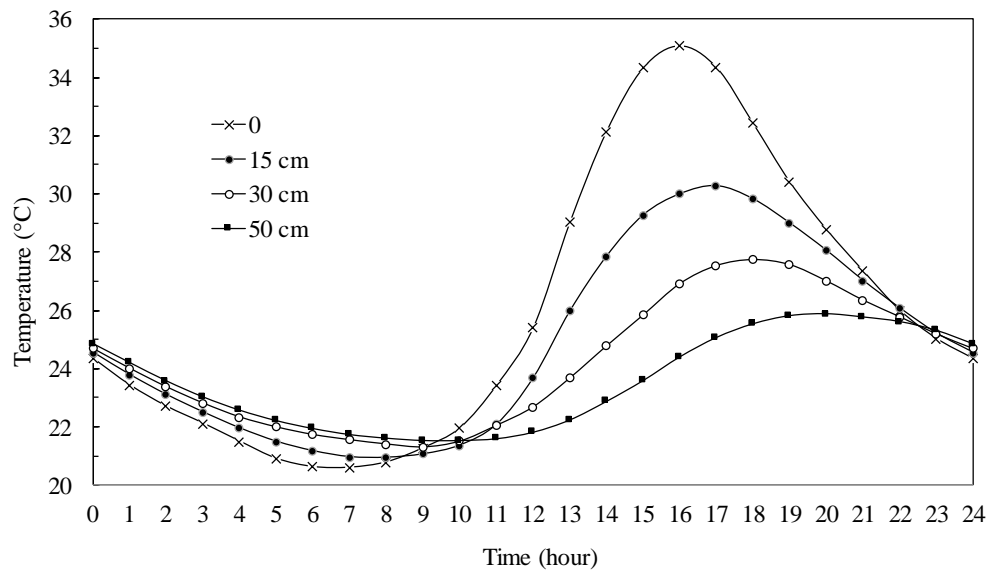
Figure 9. Daily soil temperature variation in loess areas of China in summer. Data are from the field monitoring during April 2014 to September 2017 in Linxian County, Shanxi, China.

194 Consistent with previous findings (Wei, 1995), our results indicate a relatively high
195 frequency of occurrence of cracking–sliding failures between 10 pm and 4 am (Fig. 8). The
196 difference in temperature between day and night in the loess area is more obvious than that in
197 other regions at the same latitude in China (Sun and Zhang, 2011), and variations in air
198 temperature in a day can occasionally reach 30 °C. **The soil at a 50 cm depth shows an average**
199 **daily temperature difference of approximately 5 °C in summer (Fig. 9).** Thermal expansion and
200 shrinkage occur during the rapid change in day and night temperatures. Under the cyclic
201 functioning of shrinkage and expansion stresses, a soil structure loosens.

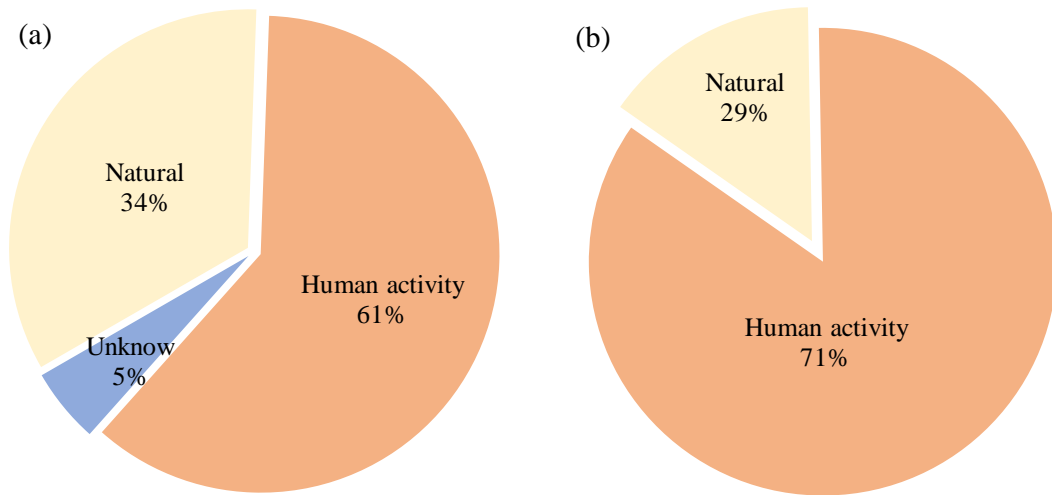
Figure 11. Role of engineering activities in loess failures: a) Shanxi Province; and b) Huangling County, Shaanxi Province.

216 More than half of the failures are attributed to human engineering activities (Fig. 11). In 2014,
217 9 of 16 failure cases that occurred in Yan'an City were caused by extremely steep slopes for cave
218 dwelling construction, and the 7 other cases were consequences of improper treatment of side
219 slopes for road construction (Lei, 2001). These findings demonstrate that intense human
220 activities likely result in a high probability of loess failures.
