Author comments to:

5 Author: Jonas Laudan¹
Co-authors: Viktor Rözer², Tobias Sieg^{1/2}, Kristin Vogel¹, Annegret H. Thieken¹

Damage assessment in Braunsbach 2016: A data collection and analysis for an improved understanding of damaging processes during flash floods

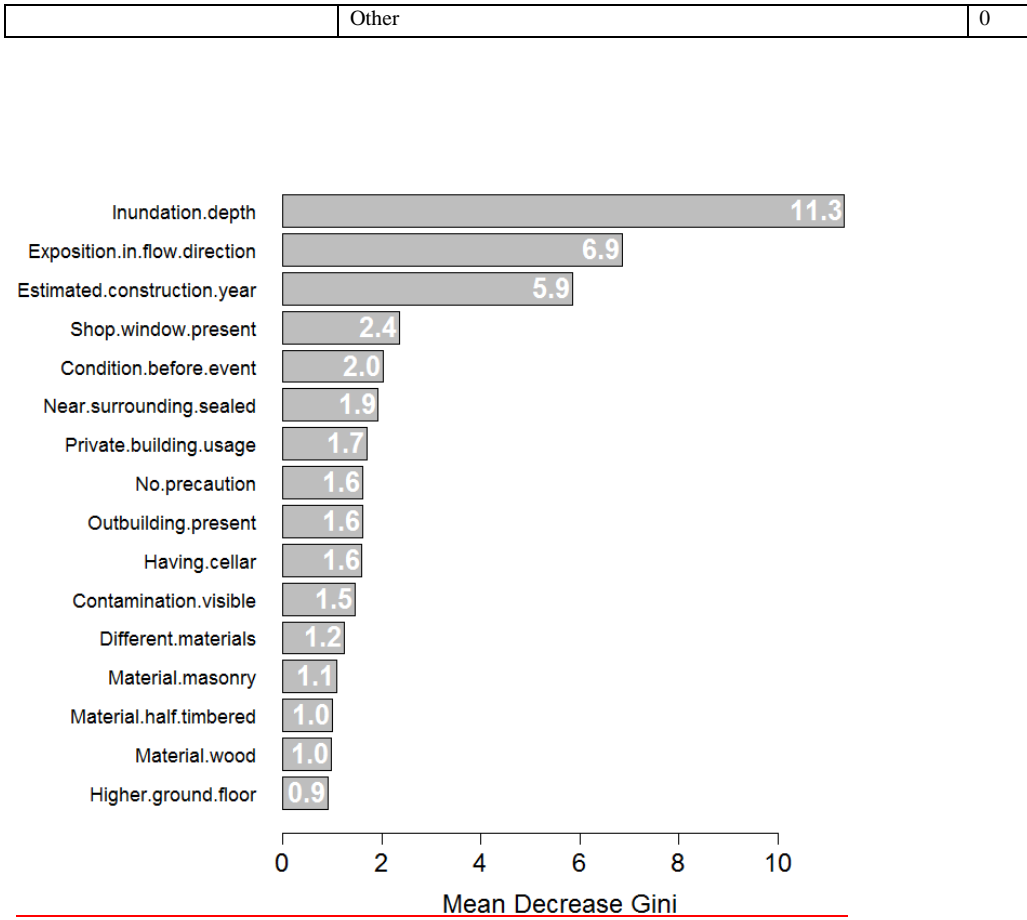
Figure 1: Random Forest feature importance (Mean Decrease Gini) for the response variable damage grade prediction.

The estimated construction year of a building displays a certain importance within the RF as well as the RGLM model with a Mean Decrease Gini of 5.9 and a feature selection count of ~~44~~52, respectively (see Figures 1 and 2). In this case, the correlation analysis does not reveal any significant monotonic relationships between the estimated construction year and the damage grade (Figure 3). Additionally, the building condition before the event displays only slight importance within the RF and slight, non-significant correlation with the damage grade. However, since the construction year is related to the overall preservation and the building's state of the art in terms of technology, it can still be assumed that newer buildings or buildings in a better condition have a higher resistance to structural damage. This which is in line with Maiwald and Schwarz (2015) who consider the building age and condition to have an influence on the expected structural damage.

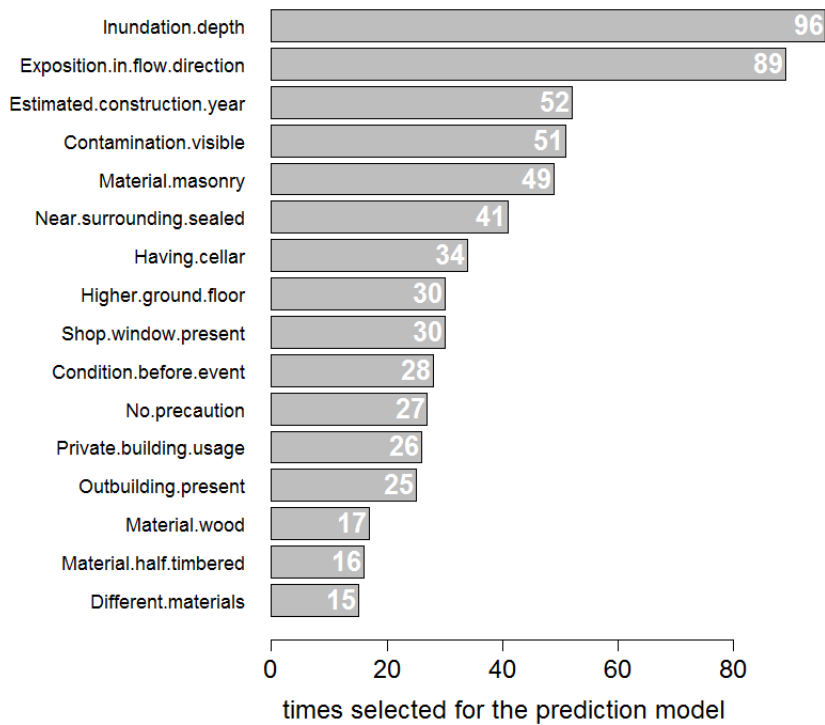
Figure 2: Random Generalized Linear Model feature importance (times selected) for the **response variable damage grade prediction.**

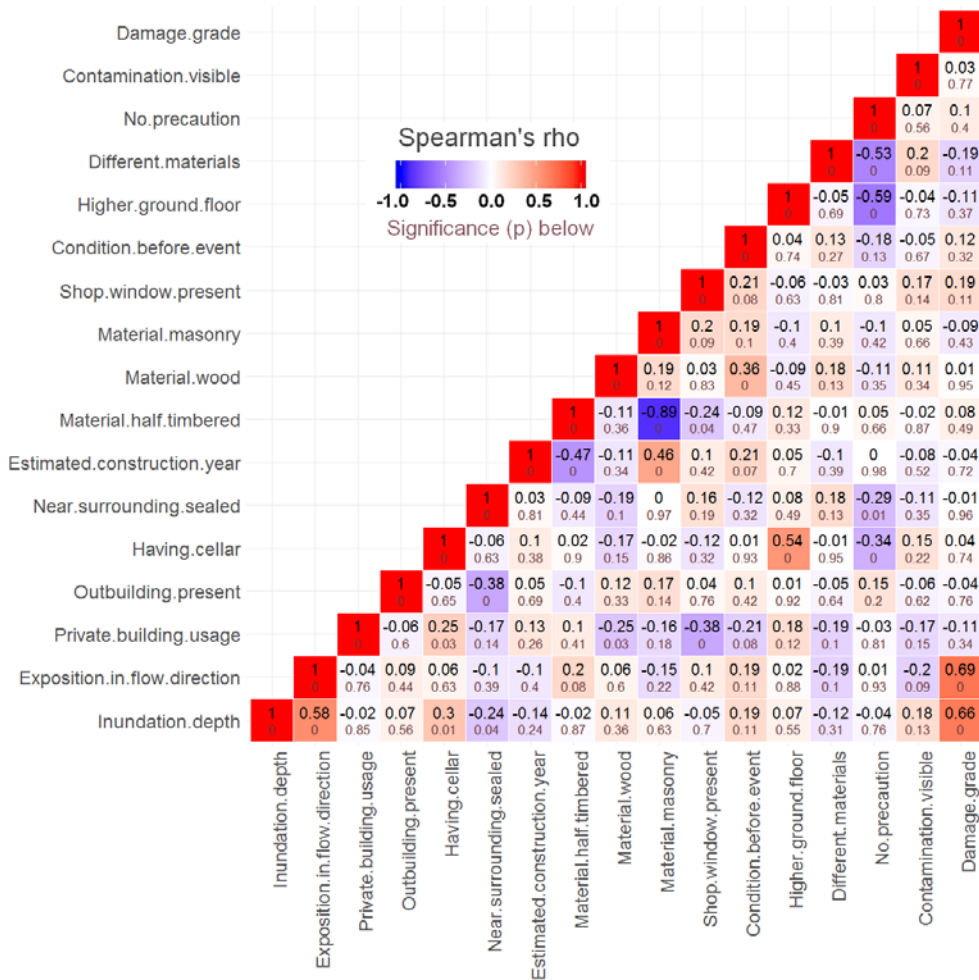
Figure 3: Spearman's rank correlation matrix and correlation significances of relevant variables (see Table 4-2 for a description of the variables). The count of complete cases for the analysis was 73.

Regarding the correlation tests, the highest positive (and significant) correlations can be seen between the damage class and the exposition of the building in flow direction as well as the damage class and inundation depth with a value of 0.650.69 and 0.690.66, respectively (Figure 3). Hence the correlation analysis, which strongly confirms the results of the RF and

Further, a positive correlation, but of low significance, can be observed between the damage grade and the existence of a shop window with a value of 0.19 and a p-value of 0.11 (Figure 3). Accordingly, the RF model shows a certain variable importance with a Mean Decrease Gini of 2.4 (Figure 1). Here, a trend towards higher damage grades caused by shop windows on ground level which - in case of breaking - open debris and water paths to the inside of the building can be assumed. Also Maiwald and Schwarz (2016) underline the fact that broken windows may allow water and debris to accumulate inside the building, causing damage to sustaining building structures. Yet, our results might also be affected by the fact that in this case study, buildings with shop windows mainly occur along the main street and city centre and are therefore located inside the main flow channels.

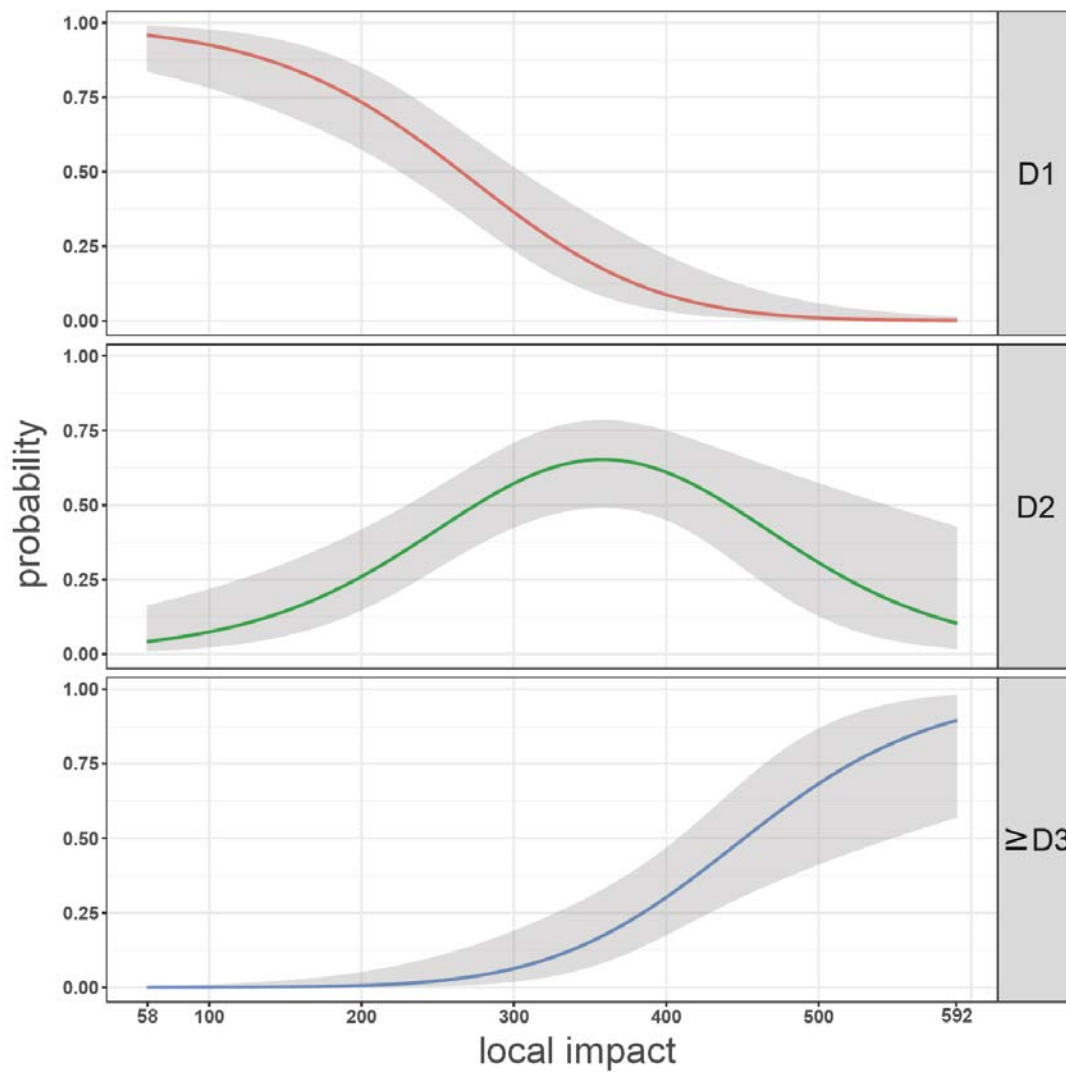
Figure 4: Probabilities of the damage grade predicted by the multinomial logistic regression model (see Table 2 and section 2.3.2 for details on the damage grades and the local impact indicator). It can be seen how the probability for a specific group affinity changes with an increasing local impact value and shifts towards higher damage grades.

Furthermore, a multinomial logistic regression was applied to test variable coherences between the damage grades and a local impact indicator (Figure 4), which describes a combination of inundation depth and the buildings' exposition in flow direction (the preparation-construction of the local impact indicator is explained in section 2.3.2). By treating the damage grade as a categorical variable, the multinomial logistic regression model gives probabilities of category affinity, given a specific local impact. In order to obtain more data points per category and to reduce modelling uncertainties, the damage grades 3, 4 and 5 were combined into a single class (compare Table 1). The inherent calculations are based on artificial neural networks (Ripley, 1996; Venables et al., 2002) which again do not require any model-specific assumptions such as linearity.

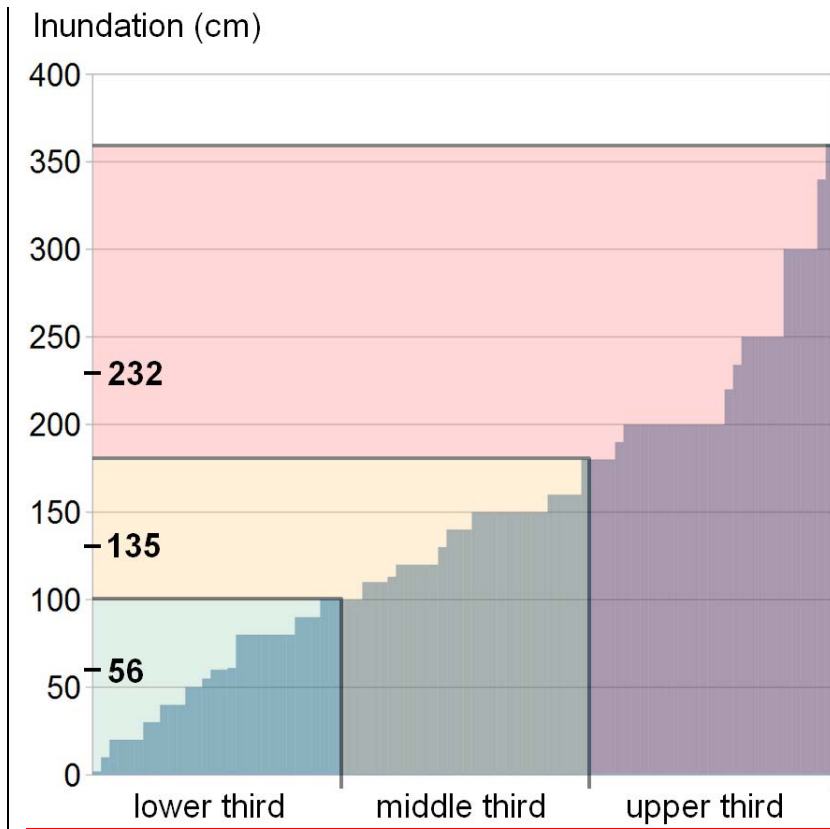
Figure 5: Step of deriving the local impact indicator. The recorded inundation depth is sorted in ascending order. By sorting, the relatively uniform distribution of the inundation values is shown, which allows the general procedure. On the left, the mean values of the lower, middle, and upper third of the sorted inundation depth (56, 135, 232) are given, which were used to replace the exposition classes “low” “medium” and “high”. This step enables a comparable variable range and the derivation of an interval-scaled indicator for further analysis.

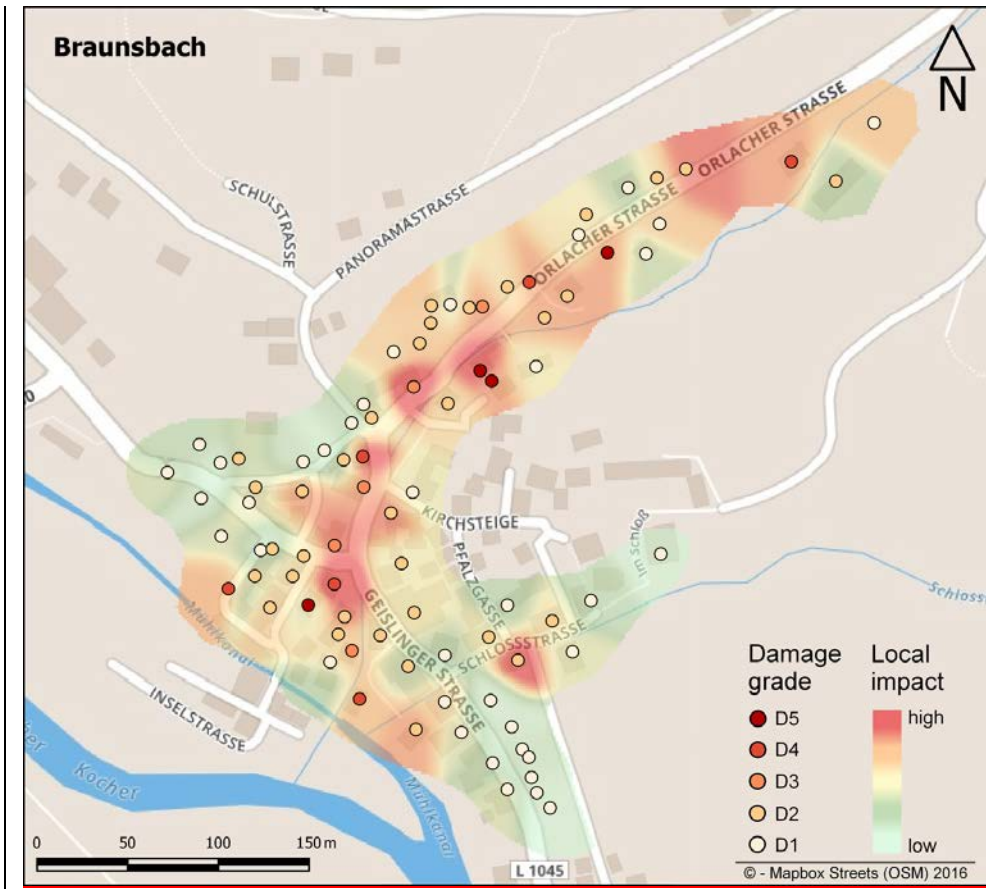
Figure 6: Map of the study area with the local impact, which is a combination of the inundation depth at the building and its exposition in flow direction (see text for further details). Further, the damage grades as recorded on site using the classification scheme of Schwarz and Maiwald (2007) are shown; see Table 1 for a verbal description of the damage grades.

Please note that the exposition values are not used to replace water levels, but are only transformed into a comparable range. Furthermore, a local impact map was created in QGIS (Figure 6) by calculating Voronoi diagrams for the geocoded data points and solely displaying the area with affected houses. For simpler visual appearance and better distinction of the displayed data, the Voronoi diagrams were smoothed by a Gaussian filter. The local impact map is used for visualization and comparison of the local impact indicator to the spatial distribution of the damage grades, since potential areas of similar local impact between and around the buildings are shown. However, it has to be noted that the local impact was measured directly at ~~on~~ the buildings ~~itself~~ and is therefore hypothetical for the areas around.

In Figure 6, the town of Braunsbach as well as the corresponding local impact during the event and recorded damage grades are illustrated. The ~~local impact~~ map reveals that highly damaged buildings and a strong local impact - which relates to hydrostatical and impact forces at the building (see section 2.3.2) - occurred along the main runoff channels of water and debris during the event -(Figure 6). Higher damage ~~classes~~ grades were also recorded in the lower-lying town regions, where

the tributaries “Orlacher Bach” and “Schlossbach” flow into the river “Kocher”, since debris and water accumulated in these areas and caused severe structural damage. Most of the higher damage ~~classes-grades~~ are located in high local impact areas. Yet, especially in those areas, the degree of damage differs strongly, highlighting the complexity of damage driving processes that cannot be explained by the local impact alone (~~section 3.3~~). The flow characteristics of debris and rubble during severe flash floods can be unforeseen and influenced by chaotic factors, changing sediment deposition as well as bedload processes (Totschnig et al., 2011; Hungr et al., 2013). Thus, it can be assumed that, during the flash flood in Braunsbach, chaotic factors and deposition of debris led to various damage patterns which remain inexplicable through quantitative analysis and modelling. This is strongly supported by the engineering report of Maiwald and Schwarz (2016), who claim that chaotic flow processes at the building caused by rubble and debris can greatly influence the inundation depth. However, it is revealed that buildings with a high exposition in flow direction are more susceptible to severe structural damage, since the probability of large debris colliding with building walls is much higher and erosion of the foundation is more likely to happen. Also Maiwald and Schwarz (2016) stated that the recorded damage patterns differ from damage patterns caused by riverine flooding and appear to be more severe due to higher hydrodynamic stress and collision of debris with the building. Conversely, some buildings can benefit from shadowing effects of neighbouring buildings, which retain debris and suspended material to a certain degree.
