Damage assessment in Braunsbach 2016: A data collection and analysis for an improved understanding of damaging processes during flash floods

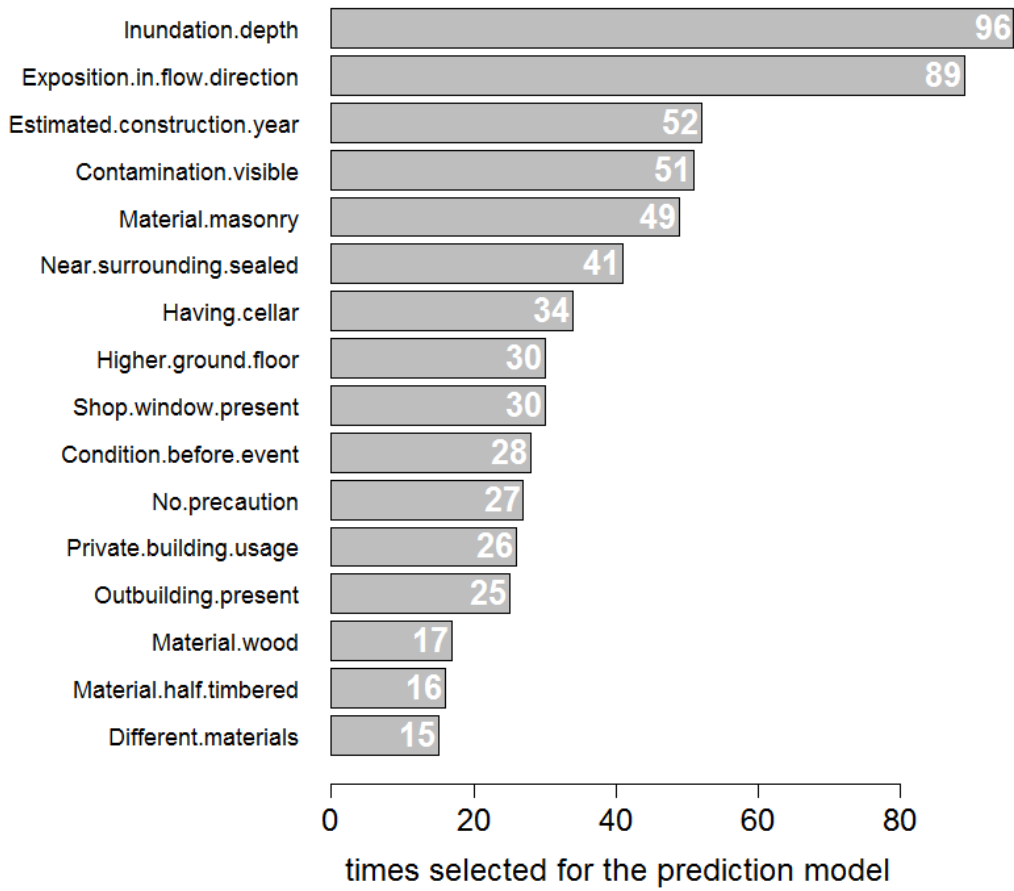
Figure 2: Random Generalized Linear Model feature importance (times selected) for the response variable damage grade..

15 The Random Generalized Linear Model (RGLM) (Song et al., 2013) was constructed as an alternative model to compare the results of the nonlinear RF to a method which implies linear variable coherences. Both models use the same predictor variables and the “damage grade” as dependent variable (excluding cases where no damage was recorded) in order to identify potential damage driving factors (Figure 1 and 2).

The estimated construction year of a building displays a certain importance within the RF as well as the RGLM model with a Mean Decrease Gini of 5.9 and a feature selection count of 52, respectively (see Figures 1 and 2). In this case, the correlation analysis does not reveal any significant monotonic relationships between the estimated construction year and the damage grade (Figure 3). Additionally, the building condition before the event displays only slight importance within the RF and slight, non-significant correlation with the damage grade. Since the construction year is related to the overall preservation and the building's state of the art in terms of technology, it can still be assumed that newer buildings or buildings in a better condition have a higher resistance to structural damage. This is in line with Maiwald and Schwarz (2015) who consider the building age and condition to have an influence on the expected structural damage.

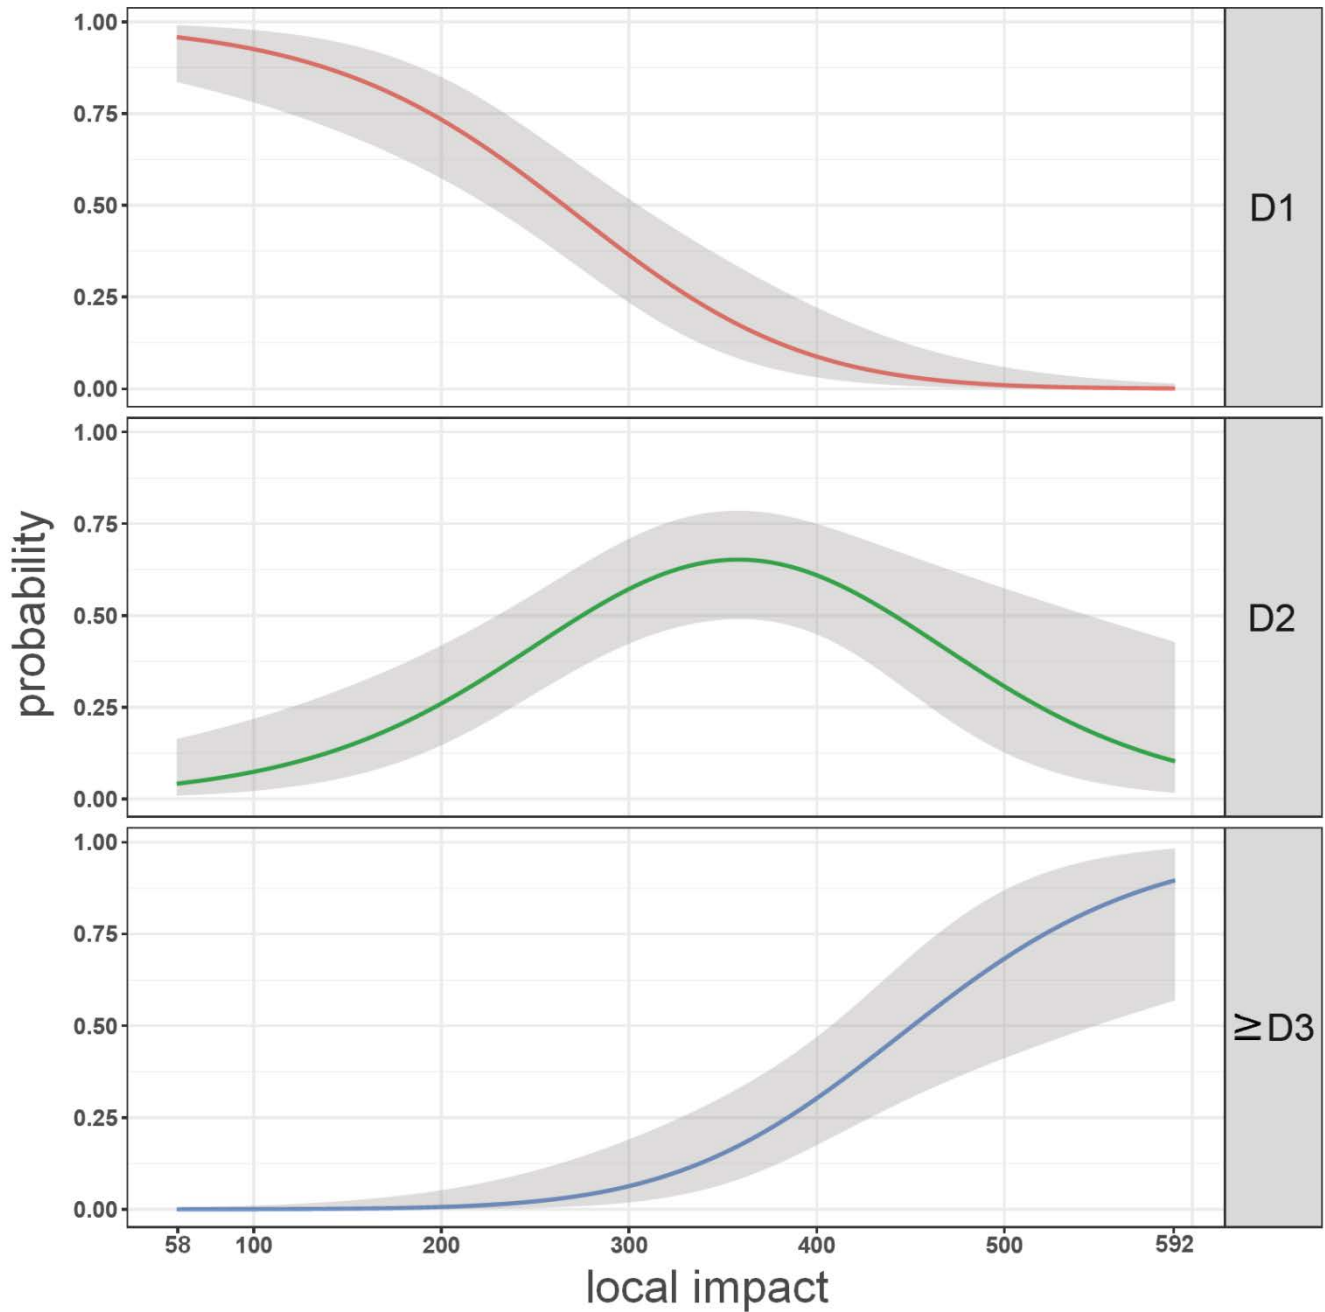
Figure 4: Probabilities of the damage grade predicted by the multinomial logistic regression model (see Table 2 and section 2.3.2 for details on the damage grades and the local impact indicator). It can be seen how the probability for a specific group affinity changes with an increasing local impact value and shifts towards higher damage grades.

Furthermore, a multinomial logistic regression was applied to test variable coherences between the damage grades and a local impact indicator (Figure 4), which describes a combination of inundation depth and the buildings' exposition in flow direction (the construction of the local impact indicator is explained in section 2.3.2). By treating the damage grade as a
10 categorical variable, the multinomial logistic regression model gives probabilities of category affinity, given a specific local impact. In order to obtain more data points per category and to reduce modelling uncertainties, the damage grades 3, 4 and 5 were combined into a single class (compare Table 1). The inherent calculations are based on artificial neural networks (Ripley, 1996; Venables et al., 2002) which again do not require any model-specific assumptions such as linearity.

To further evaluate the local impact indicator, a multinomial logistic regression was applied. By analysing the dependency between only the local impact indicator and the damage grade, the influence of external forces on the damage grade can be observed separately, since resistance parameters and building characteristics are neglected. As can be seen in figure 4, there is a clear coherence of an increasing local impact and an increasing probability to belong to higher damage grades. However, in accordance with figure 6, figure 4 reveals again that external forces are not enough to explain the complex damage pattern. Especially for moderate impact values (around 300 to 400) non-negligible probabilities are assigned to all damage grades. Further, if higher local impact values are considered, a large model uncertainty has to be taken into account, which is shown by the 95% confidence interval that covers a probability range of 45% for the corresponding damage grade affinity. This means that i.e. given a local impact of 550, the chance of belonging to class D2 ranges from 5% to 50% and for greater equal D3 from 50% to 95%. The large variability can be explained by the small number of observed data points with high local impact values. Additionally an increasing complexity of the damaging process for higher local impact values might contribute to the model uncertainty. Still, figure 4 shows that a local impact indicator can be suitable to evaluate the hydrostatical forces of this type of hazard, which, in addition to the characteristics of the element at risk, might allow vulnerability estimations such as performed by Papathoma-Köhle (2016).

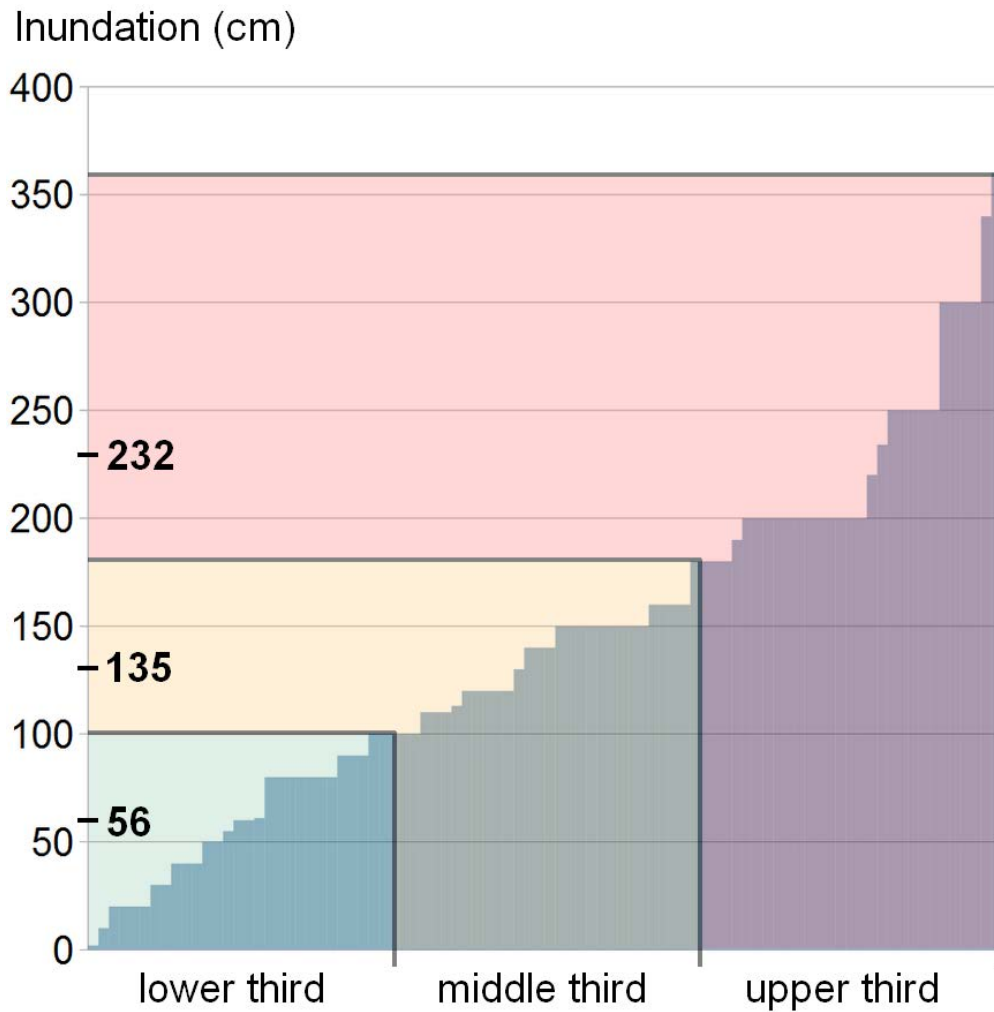
Figure 5: Step of deriving the local impact indicator. The recorded inundation depth is sorted in ascending order. By sorting, the relatively uniform distribution of the inundation values is shown, which allows the general procedure. On the left, the mean values of the lower, middle, and upper third of the sorted inundation depth (56, 135, 232) are given, which were used to replace the exposition classes “low” “medium” and “high”. This step enables a comparable variable range and the derivation of an interval-scaled indicator for further analysis.

25 achieve comparable variable ranges, the exposition classes "low", "medium" and "high" are transformed into the mean values of the lower (29 observations), middle (30 observations) and upper third (29 observations) of recorded water levels. The derived values 56, 135 and 232 fit into the range of observed water levels, enabling a combination of both attributes (Figure 5). The calculated local impact corresponds to the sum of water level and transformed exposition value. Please note that the exposition values are not used to replace water levels, but are only transformed into a comparable range.
