Damage assessment in Braunsbach 2016: A data collection and analysis for an improved understanding of damaging processes during flash floods

Jonas Laudan¹, Viktor Rözer², Tobias Sieg^{1/2}, Kristin Vogel¹, Annegret H. Thieken¹

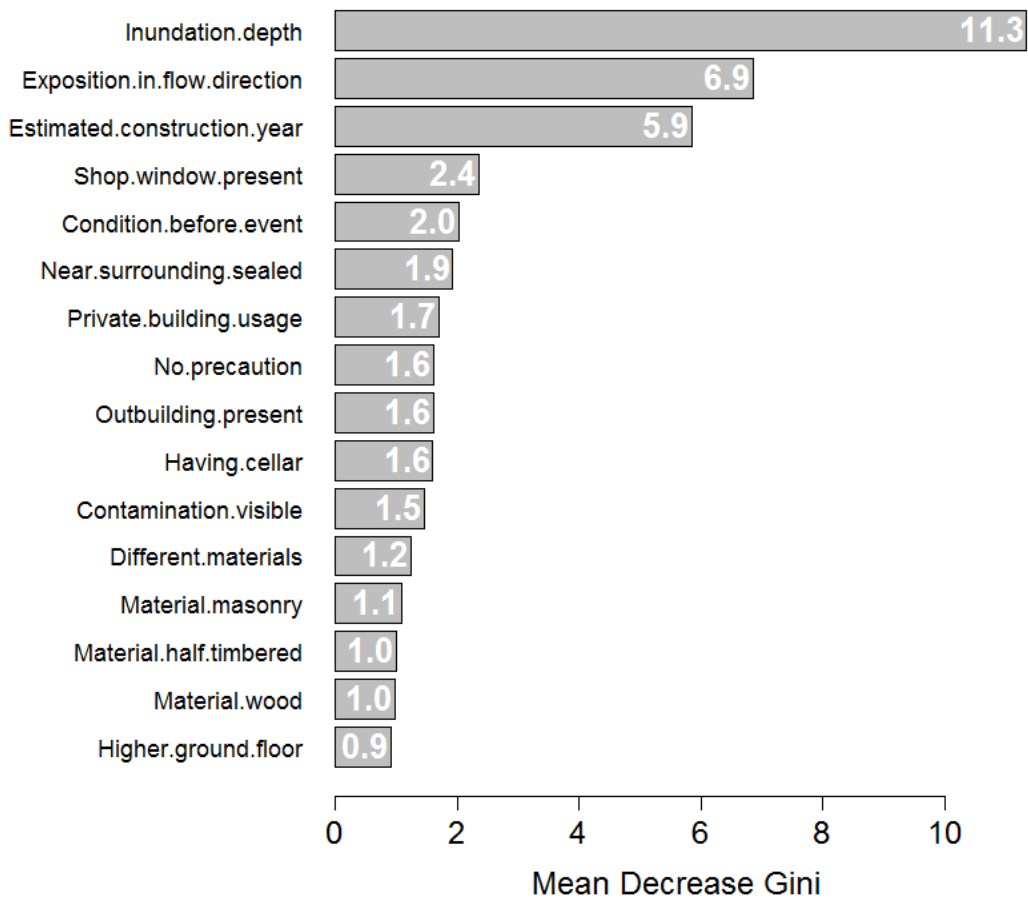
Figure 1: Random Forest feature importance (Mean Decrease Gini) for the response variable damage grade.

15 The Random Generalized Linear Model (RGLM) (Song et al., 2013) was constructed as an alternative model to compare the results of the nonlinear RF to a method which implies linear variable coherences. Both models use the same predictor variables and the “damage grade” as dependent variable (excluding cases where no damage was recorded) in order to identify potential damage driving factors (Figure 1 and 2).

The estimated construction year of a building displays a certain importance within the RF as well as the RGLM model with a Mean Decrease Gini of 5.9 and a feature selection count of 52, respectively (see Figures 1 and 2). In this case, the correlation analysis does not reveal any significant monotonic relationships between the estimated construction year and the damage grade (Figure 3). Additionally, the building condition before the event displays only slight importance within the RF and slight, non-significant correlation with the damage grade. Since the construction year is related to the overall preservation and the building's state of the art in terms of technology, it can still be assumed that newer buildings or buildings in a better condition have a higher resistance to structural damage. This is in line with Maiwald and Schwarz (2015) who consider the building age and condition to have an influence on the expected structural damage.

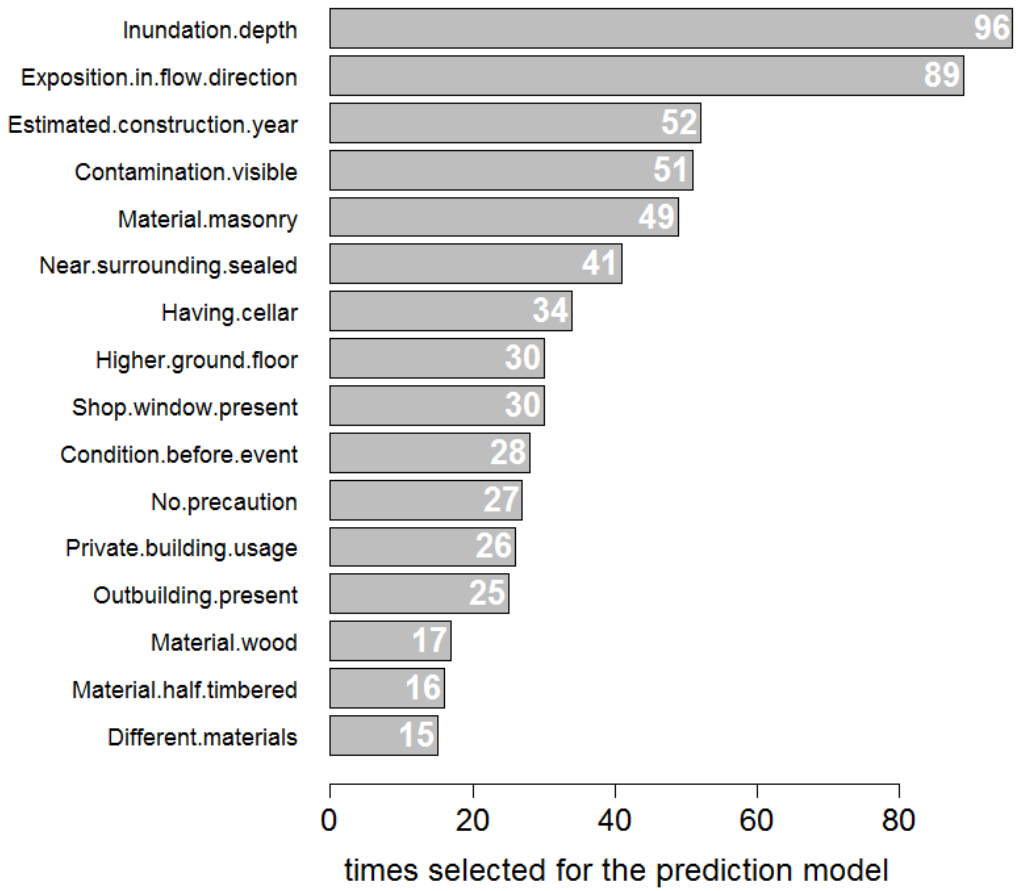
Figure 2: Random Generalized Linear Model feature importance (times selected) for the response variable damage grade..

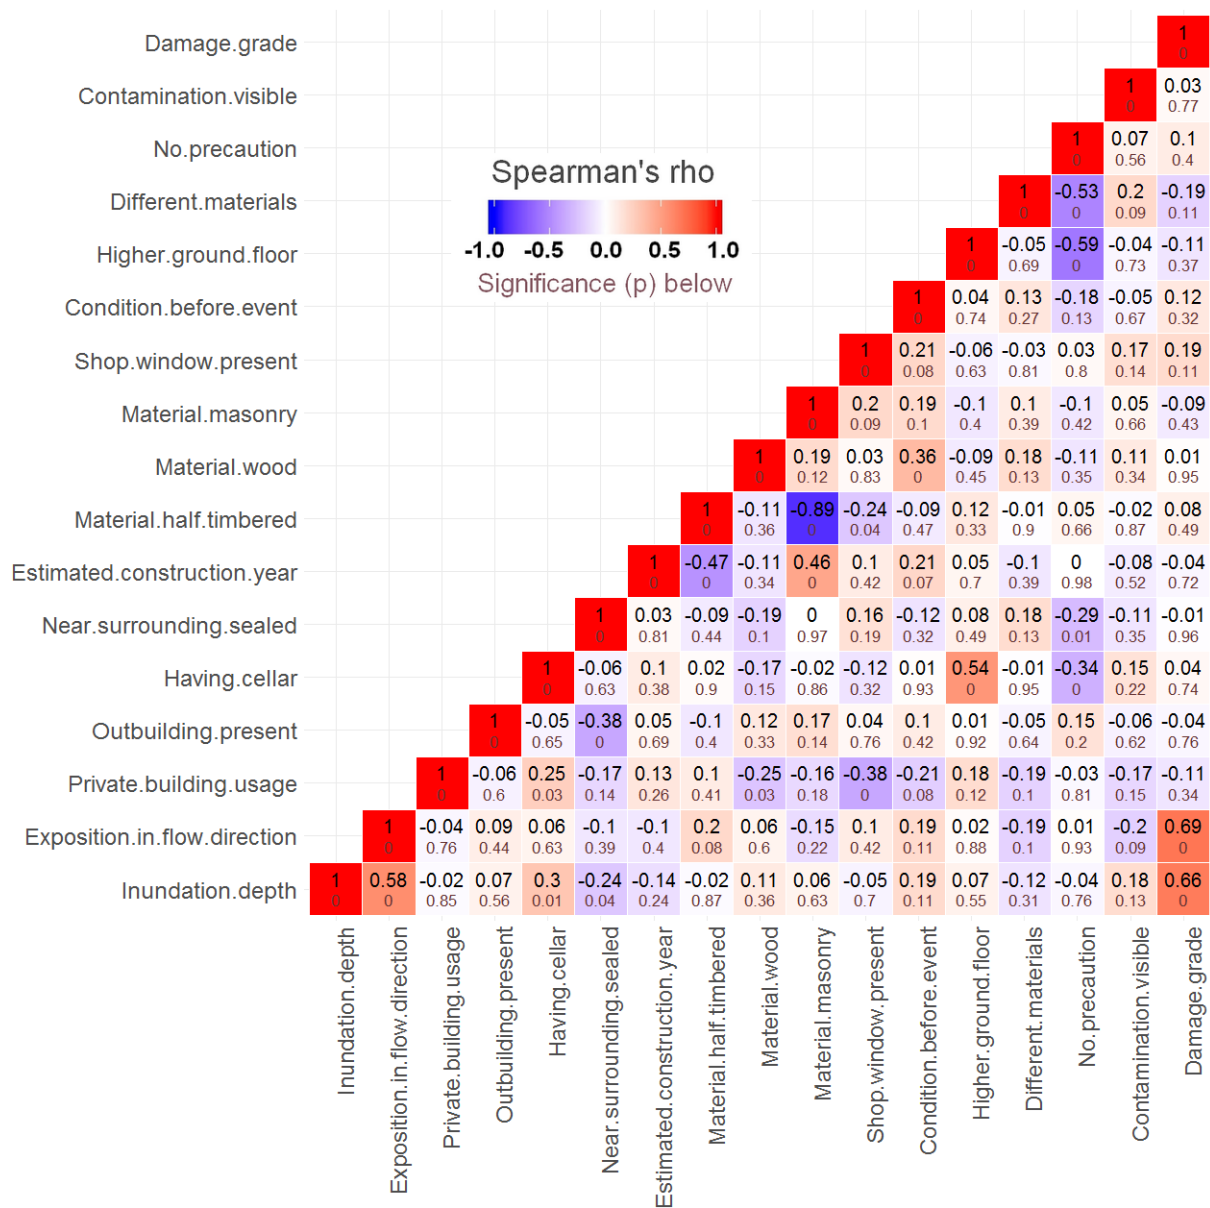
Figure 3: Spearman's rank correlation matrix and correlation significances of relevant variables (see Table 2 for a description of the variables). The count of complete cases for the analysis was 73.

Regarding the correlation tests, the highest positive (and significant) correlations can be seen between the damage class and the exposition of the building in flow direction as well as the damage class and inundation depth with a value of 0.69 and 0.66, respectively (Figure 3). Hence the correlation analysis strongly confirms the results of the RF and RGLM. The detected strong link of the exposition of the building in flow direction and the inundation depth to the caused damage makes sense, given the nature of the event and the mass of debris, water and mud flowing down the main channels within the village of Braunsbach. These results are confirmed by Maiwald and Schwarz (2016) as well, who identified the exposition of a building to the flow direction as an important parameter for potential structural damage. A high exposition in flow direction can be related to a higher flow force of water, higher flow velocities and intensities acting on a building. Investigations on these parameters regarding riverine floods by Kreibich et al. (2009) resulted in weak correlations with recorded damage grades of residential buildings. At this, it is revealed that especially the exposition in flow direction is a significant damage driving factor of flash floods, which does not show strong importance in riverine flooding.

Further, a positive correlation, but of low significance, can be observed between the damage grade and the existence of a shop window with a value of 0.19 and a p-value of 0.11 (Figure 3). Accordingly, the RF model shows a certain variable importance with a Mean Decrease Gini of 2.4 (Figure 1). Here, a trend towards higher damage grades caused by shop windows on ground level which - in case of breaking - open debris and water paths to the inside of the building can be assumed. Also Maiwald and Schwarz (2016) underline the fact that broken windows may allow water and debris to accumulate inside the building, causing damage to sustaining building structures. Yet, our results might also be affected by the fact that in this case study, buildings with shop windows mainly occur along the main street and city centre and are therefore located inside the main flow channels.

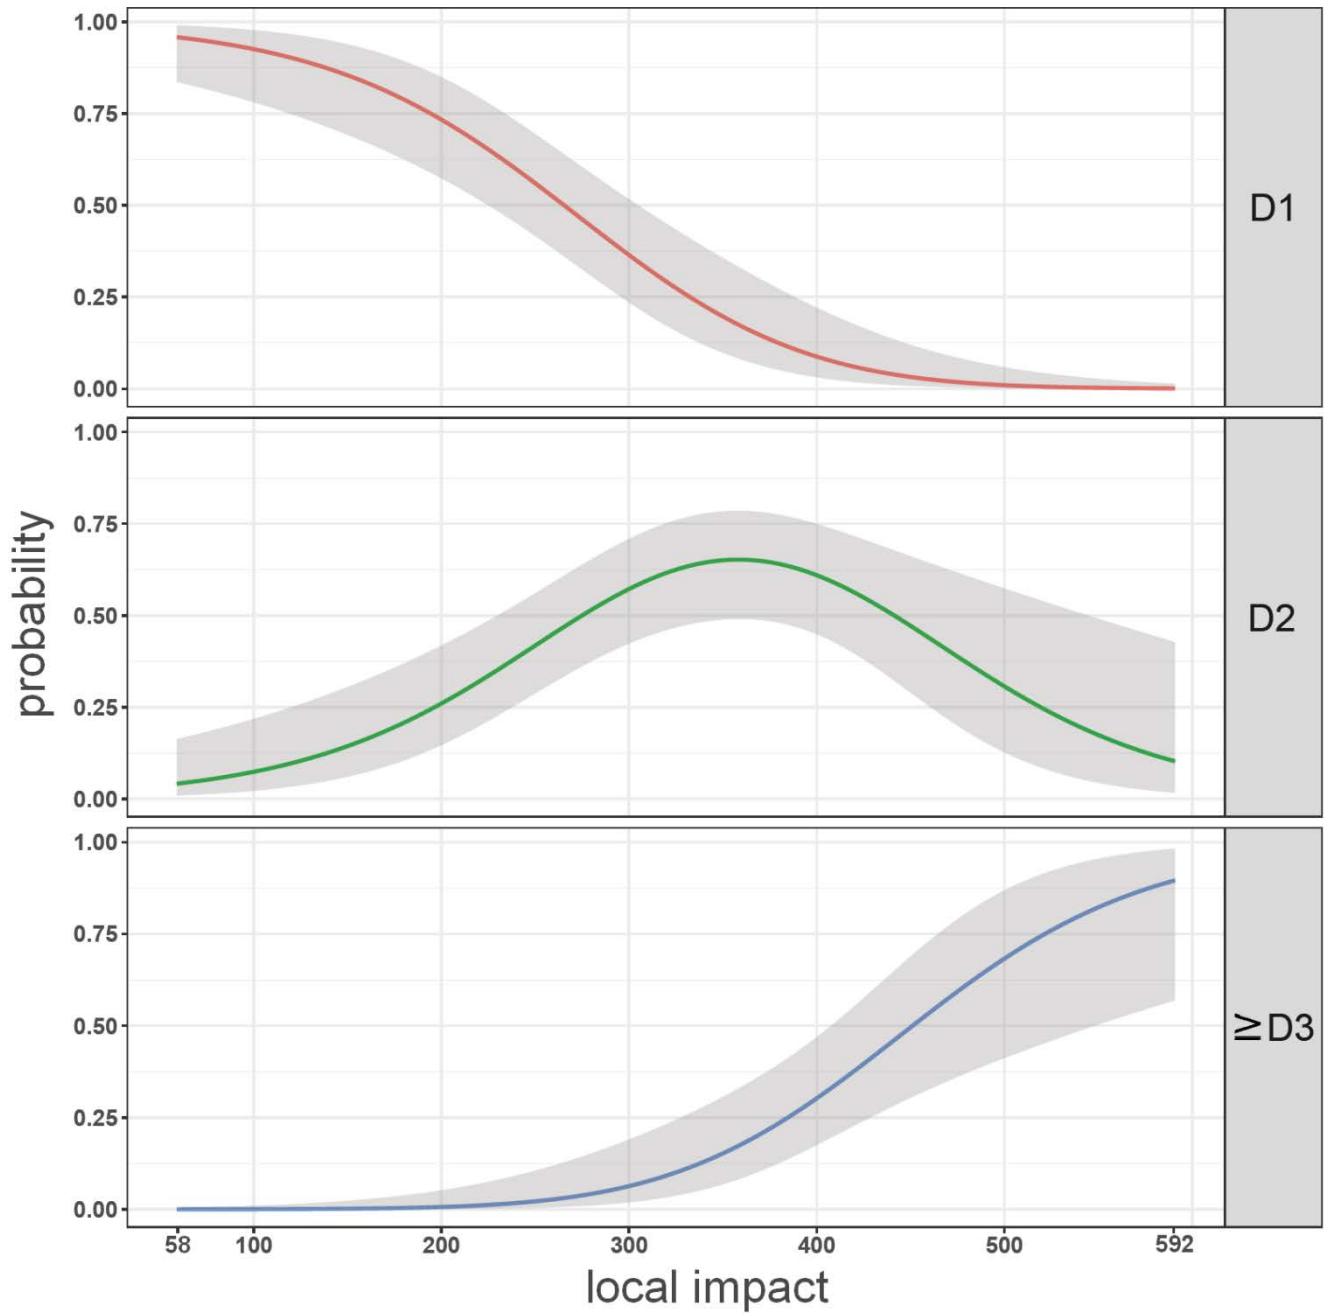
Figure 4: Probabilities of the damage grade predicted by the multinomial logistic regression model (see Table 2 and section 2.3.2 for details on the damage grades and the local impact indicator). It can be seen how the probability for a specific group affinity changes with an increasing local impact value and shifts towards higher damage grades.

Furthermore, a multinomial logistic regression was applied to test variable coherences between the damage grades and a local impact indicator (Figure 4), which describes a combination of inundation depth and the buildings' exposition in flow direction (the construction of the local impact indicator is explained in section 2.3.2). By treating the damage grade as a categorical variable, the multinomial logistic regression model gives probabilities of category affinity, given a specific local impact. In order to obtain more data points per category and to reduce modelling uncertainties, the damage grades 3, 4 and 5 were combined into a single class (compare Table 1). The inherent calculations are based on artificial neural networks (Ripley, 1996; Venables et al., 2002) which again do not require any model-specific assumptions such as linearity.

To further evaluate the local impact indicator, a multinomial logistic regression was applied. By analysing the dependency between only the local impact indicator and the damage grade, the influence of external forces on the damage grade can be observed separately, since resistance parameters and building characteristics are neglected. As can be seen in figure 4, there is a clear coherence of an increasing local impact and an increasing probability to belong to higher damage grades. However, in accordance with figure 6, figure 4 reveals again that external forces are not enough to explain the complex damage pattern. Especially for moderate impact values (around 300 to 400) non-negligible probabilities are assigned to all damage grades. Further, if higher local impact values are considered, a large model uncertainty has to be taken into account, which is shown by the 95% confidence interval that covers a probability range of 45% for the corresponding damage grade affinity. This means that i.e. given a local impact of 550, the chance of belonging to class D2 ranges from 5% to 50% and for greater equal D3 from 50% to 95%. The large variability can be explained by the small number of observed data points with high local impact values. Additionally an increasing complexity of the damaging process for higher local impact values might contribute to the model uncertainty. Still, figure 4 shows that a local impact indicator can be suitable to evaluate the hydrostatical forces of this type of hazard, which, in addition to the characteristics of the element at risk, might allow vulnerability estimations such as performed by Papathoma-Köhle (2016).

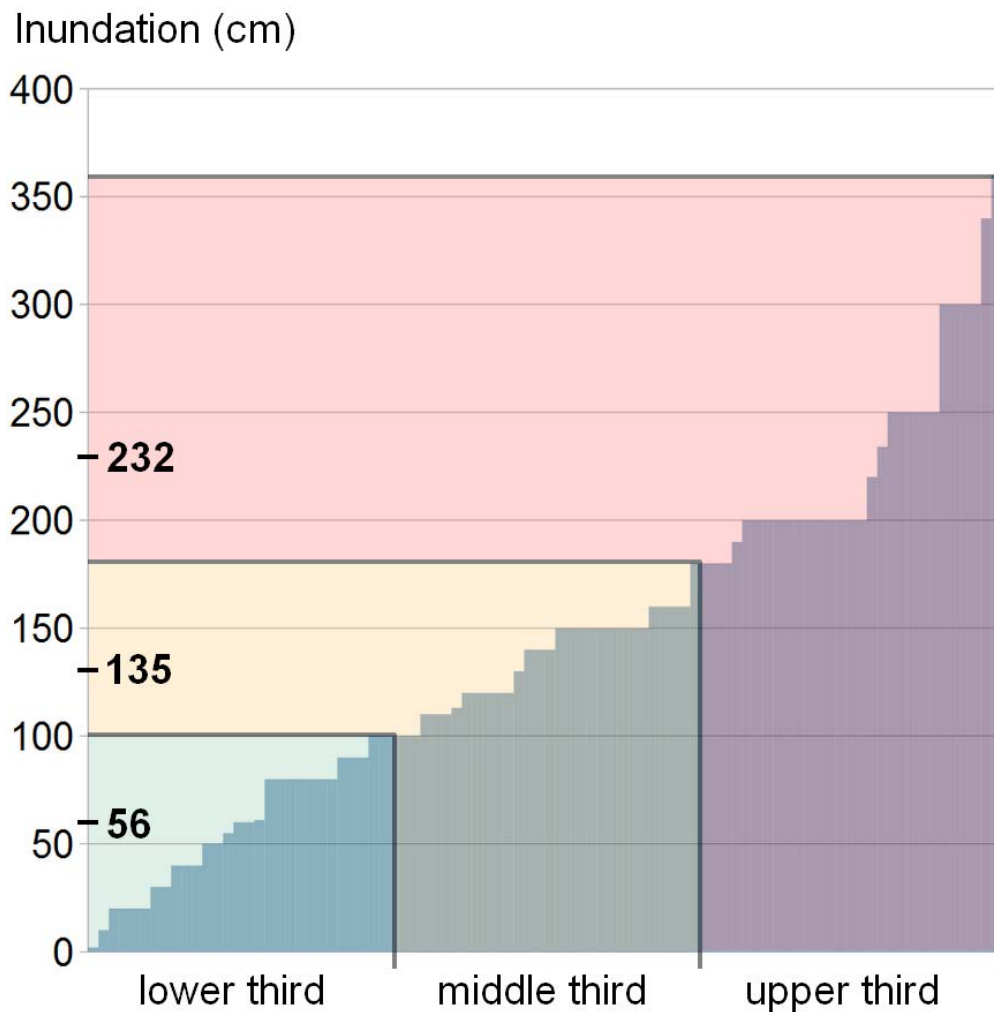
Figure 5: Step of deriving the local impact indicator. The recorded inundation depth is sorted in ascending order. By sorting, the relatively uniform distribution of the inundation values is shown, which allows the general procedure. On the left, the mean values of the lower, middle, and upper third of the sorted inundation depth (56, 135, 232) are given, which were used to replace the exposition classes “low” “medium” and “high”. This step enables a comparable variable range and the derivation of an interval-scaled indicator for further analysis.

Maiwald and Schwarz (2015) give an up to date overview of factors which influence structural damage on buildings in case of flooding. Especially the building material, condition (before the event) and the age are important factors related to a building's resistance potential. Factors such as inundation level, flow velocity, fluid density, specific energy and contamination relate to "action" parameters and describe external forces (Maiwald and Schwarz, 2015; Milanesi et al., 2015). Thus, in our study, the inundation depth measured at the building and the building's exposition in flow direction were combined to create a local impact, which can be seen as a proxy for local flood related impact and hydrostatic forces at the building. Consequently, we chose a combination of these factors where both contribute to equal extents. While the inundation depth has continuous values, which are roughly uniformly distributed between 2 and 360 cm for 88 recorded observations (see Table 2), the exposition in flow direction is recorded in three classes (low, medium, high, see Table 2). To achieve comparable variable ranges, the exposition classes "low", "medium" and "high" are transformed into the mean values of the lower (29 observations), middle (30 observations) and upper third (29 observations) of recorded water levels. The derived values 56, 135 and 232 fit into the range of observed water levels, enabling a combination of both attributes (Figure 5). The calculated local impact corresponds to the sum of water level and transformed exposition value. Please note that the exposition values are not used to replace water levels, but are only transformed into a comparable range.

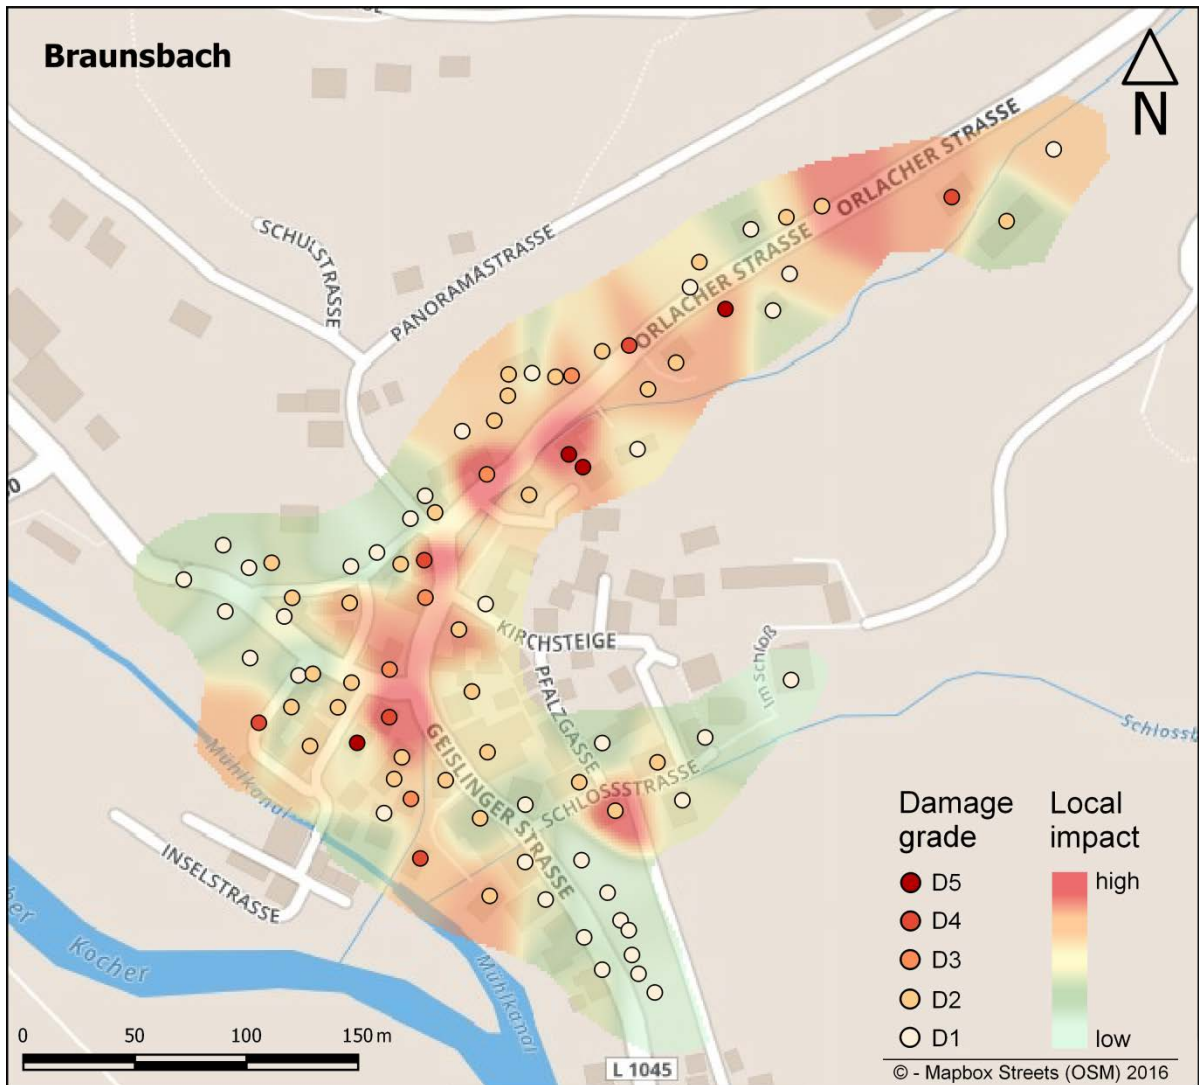
Figure 6: Map of the study area with the local impact, which is a combination of the inundation depth at the building and its exposition in flow direction (see text for further details). Further, the damage grades as recorded on site using the classification scheme of Schwarz and Maiwald (2007) are shown; see Table 1 for a verbal description of the damage grades.

Furthermore, a local impact map was created in QGIS (Figure 6) by calculating Voronoi diagrams for the geocoded data points and solely displaying the area with affected houses. For simpler visual appearance and better distinction of the displayed data, the Voronoi diagrams were smoothed by a Gaussian filter. The local impact map is used for visualization and comparison of the local impact indicator to the spatial distribution of the damage grades, since potential areas of similar local

impact between and around the buildings are shown. However, it has to be noted that the local impact was measured directly at the buildings and is therefore hypothetical for the areas around.

In Figure 6, the town of Braunsbach as well as the corresponding local impact during the event and recorded damage grades are illustrated. The map reveals that highly damaged buildings and a strong local impact - which relates to hydrostatical and impact forces at the building (see section 2.3.2) - occurred along the main runoff channels of water and debris during the event. Higher damage grades were also recorded in the lower-lying town regions, where the tributaries “Orlacher Bach” and “Schlossbach” flow into the river “Kocher”, since debris and water accumulated in these areas and caused severe structural damage. Most of the higher damage grades are located in high local impact areas. Yet, especially in those areas, the degree of damage differs strongly, highlighting the complexity of damage driving processes that cannot be explained by the local impact alone. The flow characteristics of debris and rubble during severe flash floods can be unforeseen and influenced by chaotic factors, changing sediment deposition as well as bedload processes (Totschnig et al., 2011; Hungr et al., 2013). Thus, it can be assumed that, during the flash flood in Braunsbach, chaotic factors and deposition of debris led to various damage patterns which remain inexplicable through quantitative analysis and modelling. This is strongly supported by the engineering report of Maiwald and Schwarz (2016), who claim that chaotic flow processes at the building caused by rubble and debris can greatly influence the inundation depth.
