# Earthquake Response of Heavily Damaged Historical Masonry Mosques after Restoration

Ahmet Can Altunışık<sup>1</sup>, Ali Fuat Genç<sup>1</sup>

<sup>1</sup>Department of Civil Engineering, Karadeniz Technical University, Trabzon, 61080, Turkey

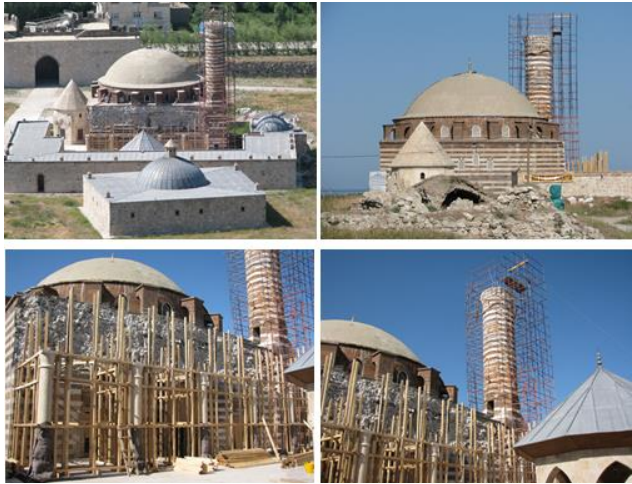
Today there are some cases which affect the structural performance of the mosque detrimentally. These cases are structural cracks, material deformations, destroyed parts of carrier system, environmental issues-algae and humidity. Some views of these cases and damaged views of the mosque are shown in Fig. 2.

**Figure 2: Damaged views of Hüseyin Pasha Mosque.**

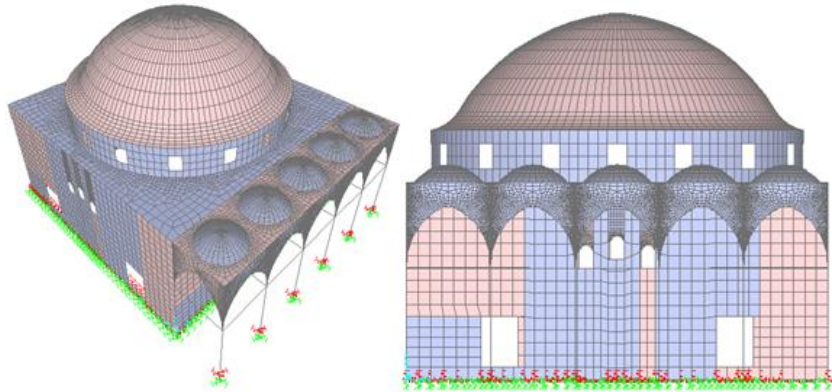
The mosque has 16 window openings before the restoration so finite element model of the mosque was constituted with 16 window openings. The model of the mosque has 27297 nodes, 127 bar elements, 25653 area elements and 102460 3D solid elements. Finite element model of the mosque with 16 window openings is shown in Fig. 3.

**Figure 3: Finite element model of the mosque with 16 window openings.**

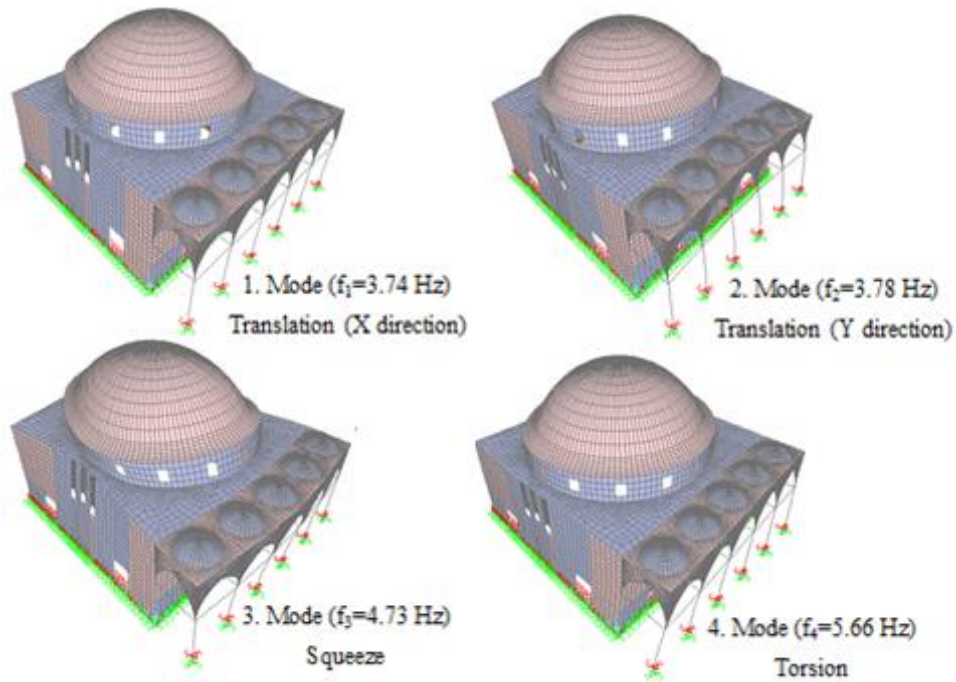
Dynamic characteristics were obtained with modal analysis. %5 damping ratio was used in the analysis. 20 mode shapes were obtained after analyses. First four mode shape and frequency are given with Fig. 4.

**Figure 4: First four mode shape and frequency.**

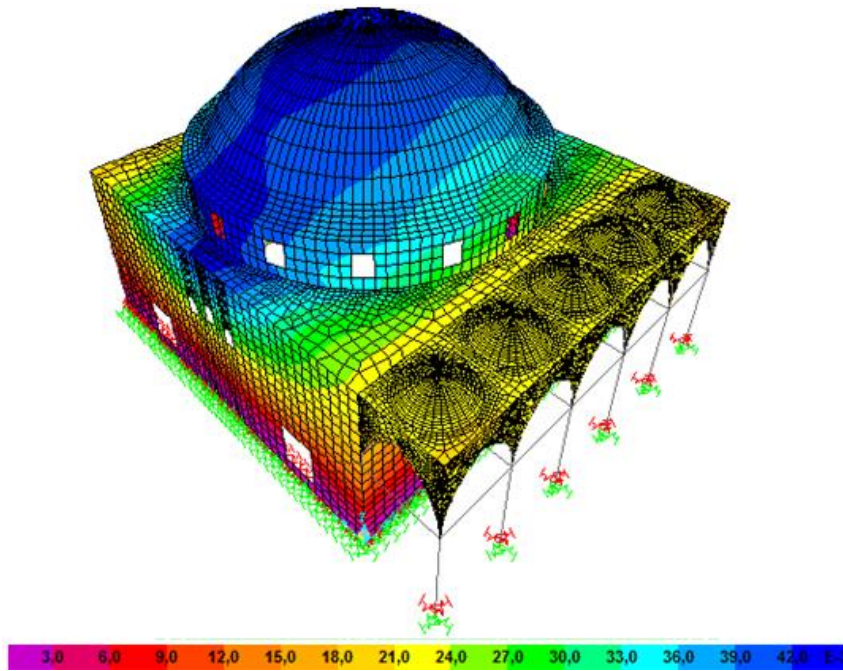
The maximum displacements contour diagram of Hüsrev Pasha Mosque with 16 window openings under dead load and earthquake load (G+EX) is shown in Fig. 5. It can be seen from the Figure 5 that the maximum displacement occurred at the middle point of the big dome as 42.0 mm. Beside this displacements have a decreasing trend from top of the dome to lower part of the mosque.

Figure 5: Maximum displacements contour diagram of the mosque with 16 window openings under dead load and earthquake load (G+EX).

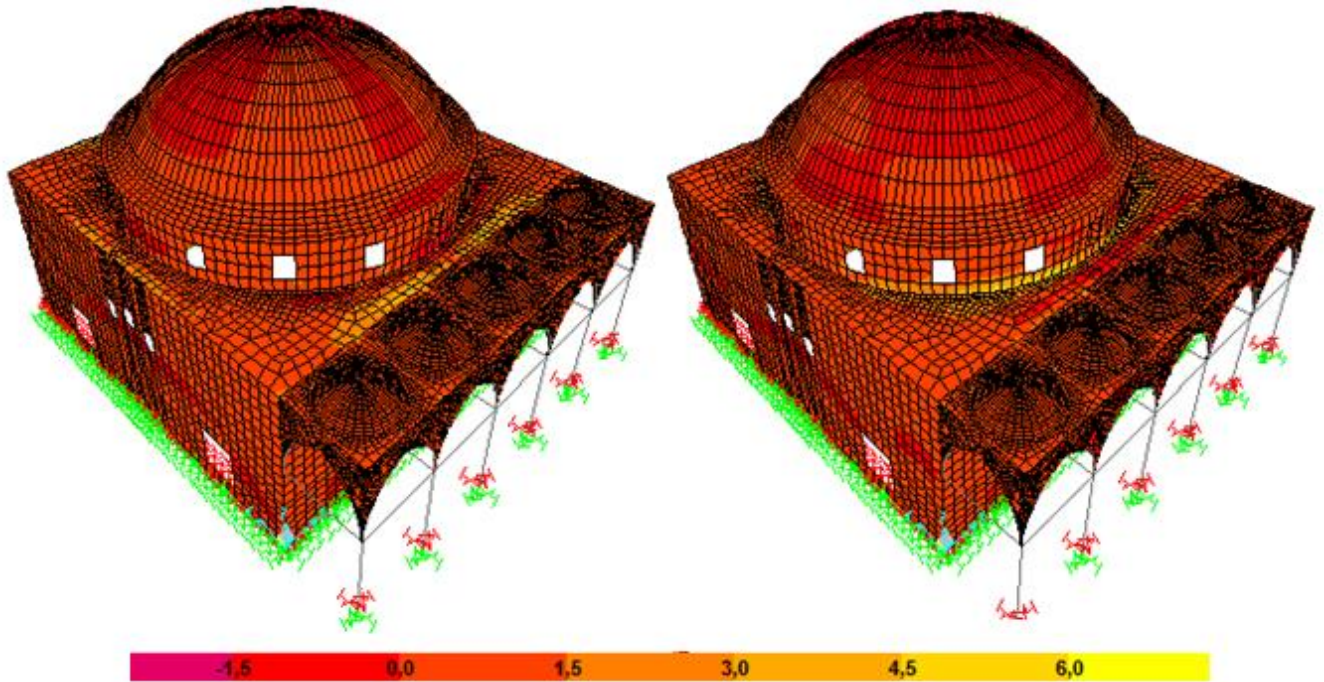
The maximum tensile stresses contour diagram is shown in Fig. 6. It is seen from the Figure 6 that maximum values of the tensile stresses for outer surface of the mosque occurred at side and lower part of big dome, near the window spaces and transition areas of between side walls as 1.05 MPa. Maximum tensile stresses for inner surface of the mosque occurred as 1.00 MPa.

5 Figure 6: Maximum tensile stresses contour diagram for outer and inner surfaces of the mosque with 16 window openings under dead load and earthquake load (G+EX).

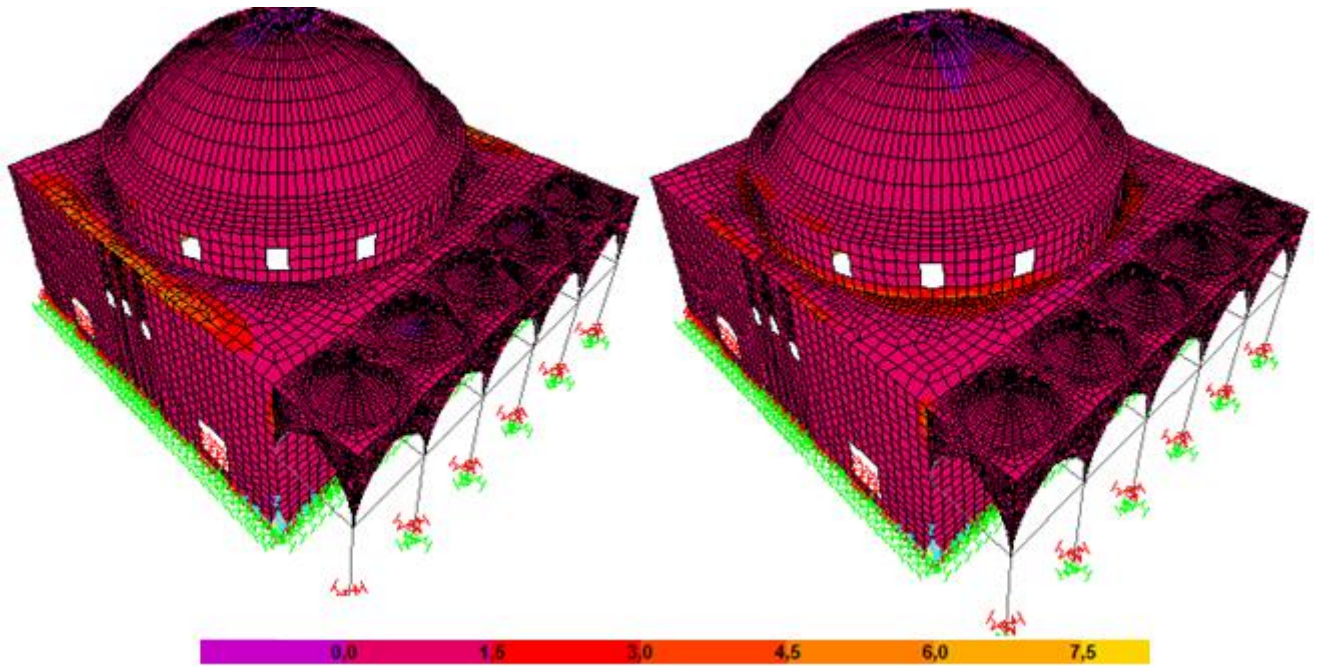
The maximum compression stresses contour diagram for outer and inner surfaces of Hüsrev Pasha Mosque with 16 window openings under dead load and earthquake load (G+EX) is shown in Fig. 7. It is seen from the Figure 7 that maximum values of the compression stresses for outer surface of mosque occurred at between the dome and side walls transition areas and near window spaces at dome as 2.05 MPa. Beside this maximum compression stresses for inner surface of the mosque, occurred as 1.85 MPa.

Figure 7: Maximum compression stresses contour diagram for outer and inner surfaces of the mosque with 16 window openings under dead load and earthquake load (G+EX).

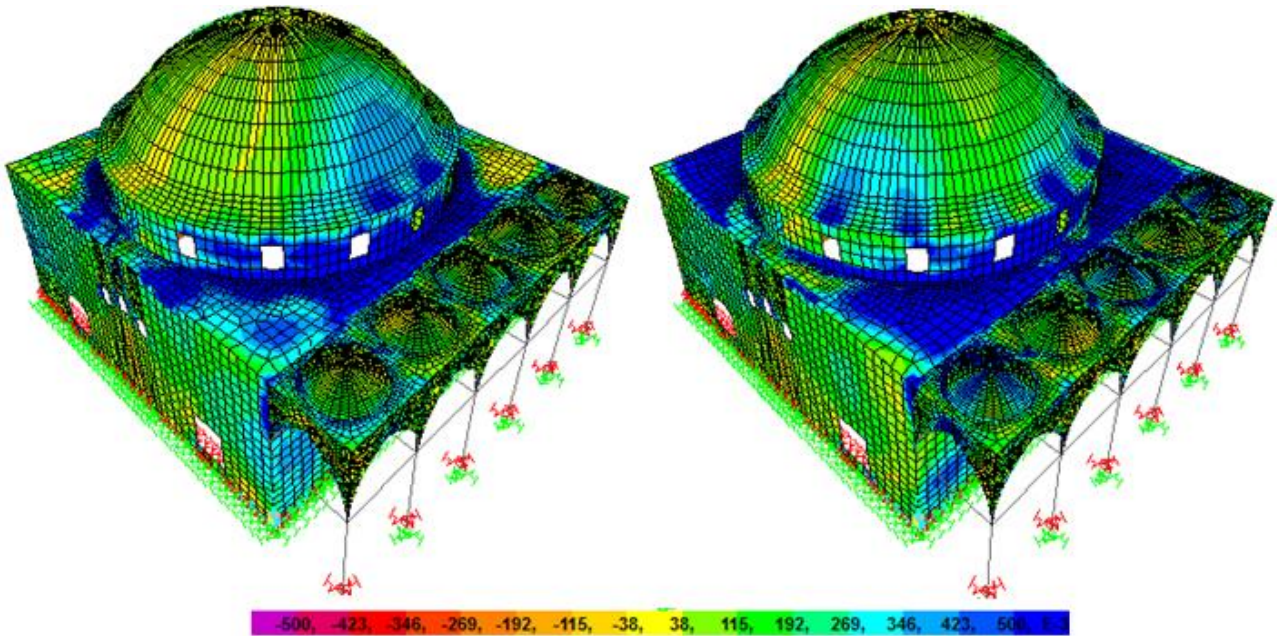
The maximum shear stresses contour diagram for outer and inner surfaces of Hüsrev Pasha Mosque under dead load and earthquake load (G+EX) is shown in Fig. 8. It is seen from the Figure 8 that maximum values of the shear stresses for outer and inner surfaces of the mosque are 0.65 MPa and 0.60 MPa respectively.

5 Figure 8: Maximum shear stresses contour diagram for outer and inner surfaces of the mosque with 16 window openings under dead load and earthquake load (G+EX).

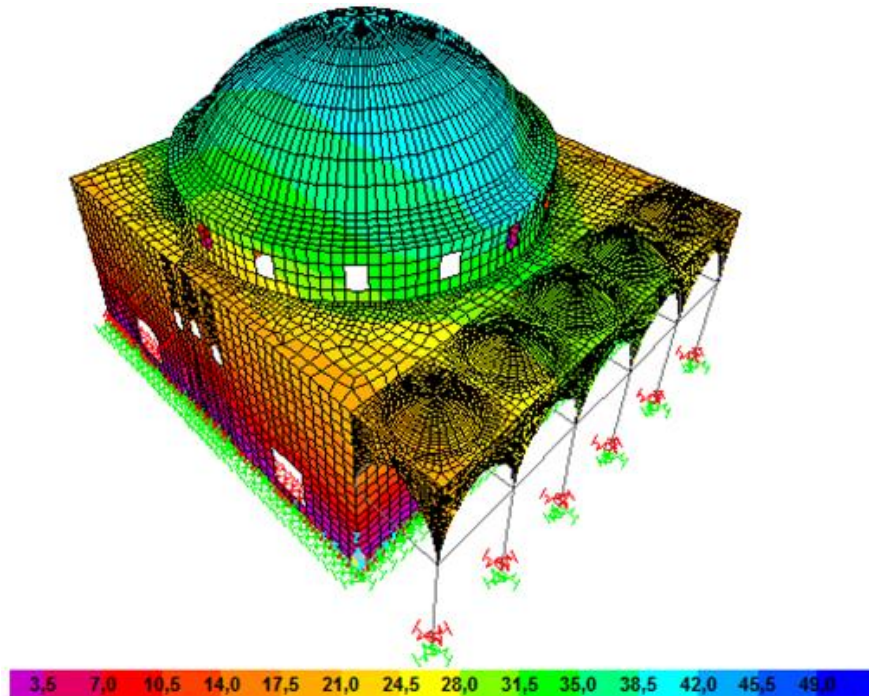
The maximum displacements contour diagram of Hüsrev Pasha Mosque with 16 window openings under dead load and earthquake load (G+EY) is shown in Fig. 9. It can be seen from the Figure 9 that the maximum displacement occurred at the middle point of the big dome as 44.0 mm. Beside this displacements have a decreasing trend from top of the dome to lower part of the mosque.

Figure 9: Maximum displacements contour diagram of the mosque with 16 window openings under dead load and earthquake load (G+EY).

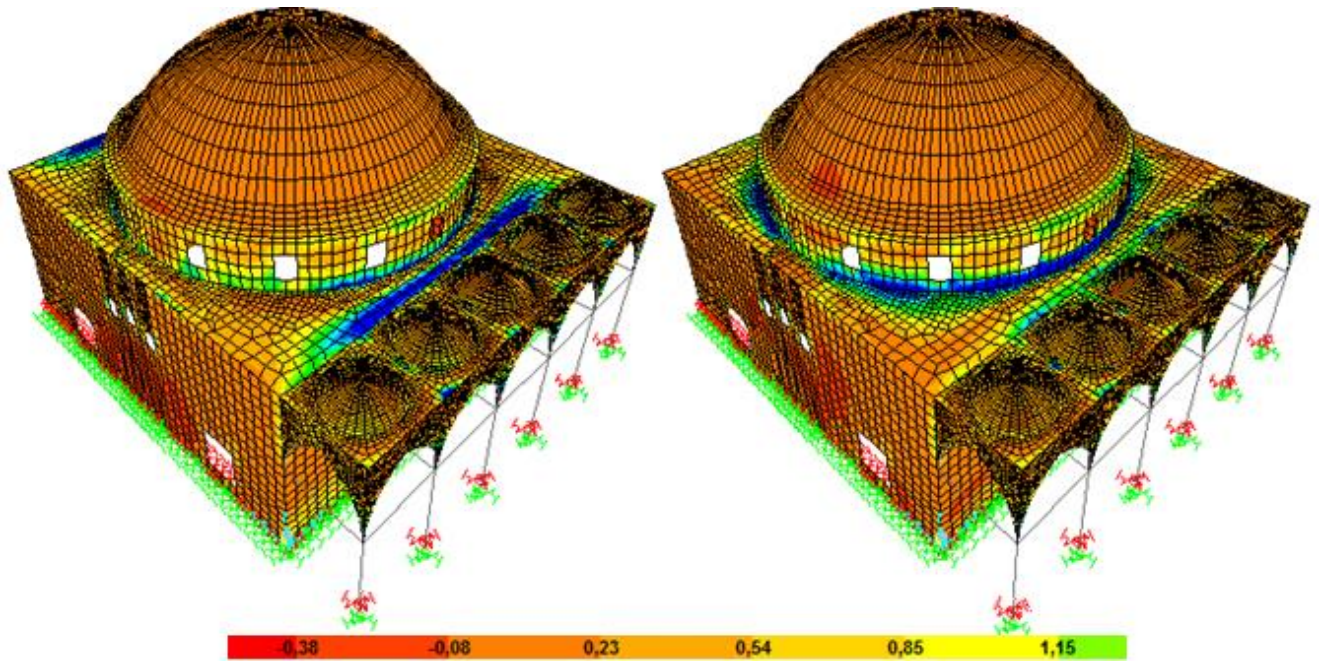
The maximum tensile stresses contour diagram is shown in Fig. 10. It is seen from the Figure 10 that maximum values of the tensile stresses for outer surface of the mosque occurred at side and lower part of big dome, near the window spaces and transition areas of between side walls as 0.95 MPa. Maximum tensile stresses for inner surface of the mosque occurred as 0.75 MPa.

Figure 10: Maximum tensile stresses contour diagram for outer and inner surfaces of the mosque with 16 window openings under dead load and earthquake load (G+EY).

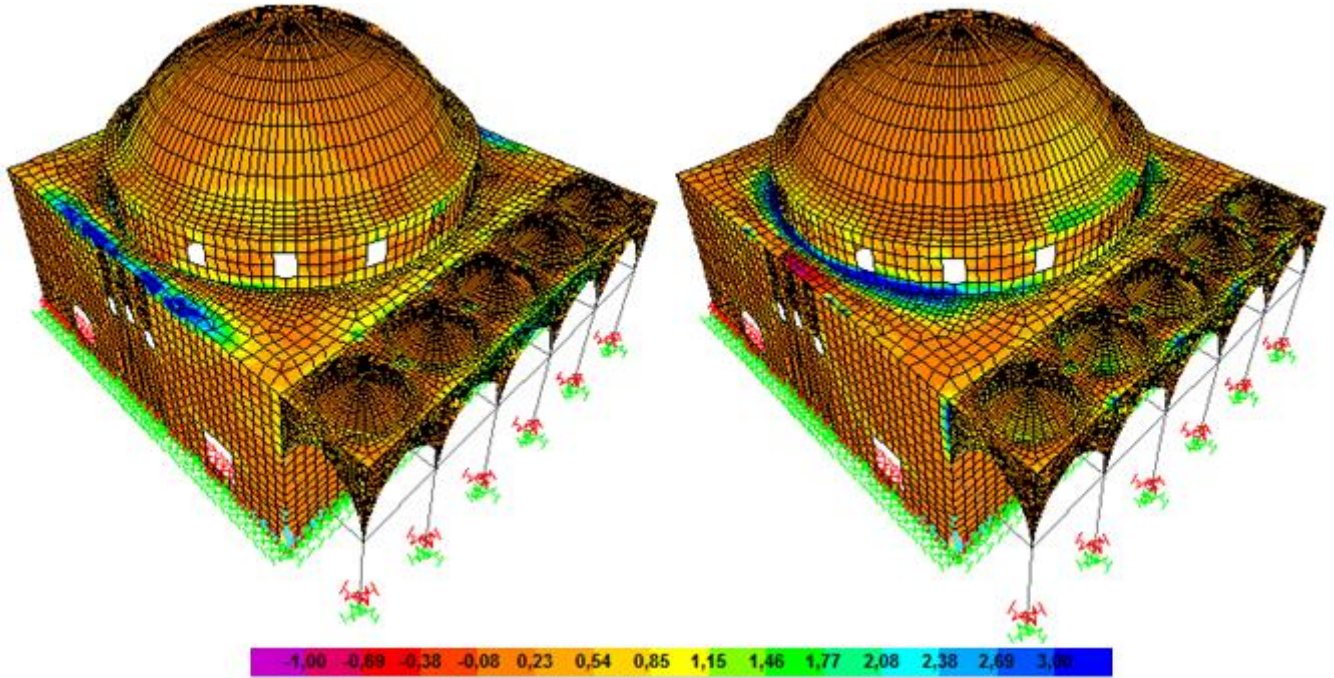
The maximum compression stresses contour diagram is shown in Fig. 11. It is seen from the Figure 11 that maximum values of the compression stresses for outer surface of mosque occurred at between the dome and side walls transition areas and near window spaces at dome as 1.15 MPa. Beside this maximum compression stresses for inner surface of the mosque, occurred as 1.10 MPa.

5 Figure 11: Maximum compression stresses contour diagram for outer and inner surfaces of the mosque with 16 window openings under dead load and earthquake load (G+EY).

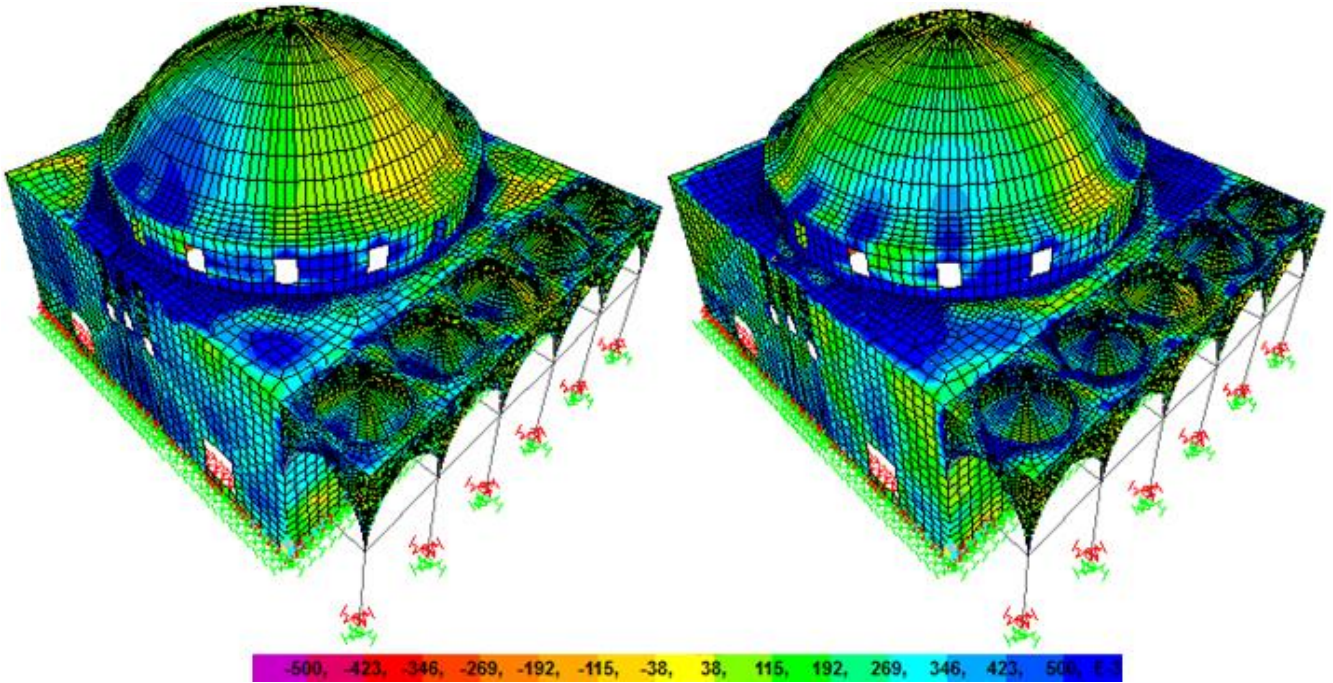
The maximum shear stresses contour diagram for outer and inner surfaces of Hüsrev Pasha Mosque under dead load and earthquake load (G+EY) is shown in Fig. 12. It is seen from the Figure 12 that maximum values of the shear stresses for outer and inner surfaces of the mosque are 0.60 MPa and 0.55 MPa respectively.

**Figure 12: Maximum shear stresses contour diagram for outer and inner surfaces of the mosque with 16 window openings under dead load and earthquake load (G+EY).**

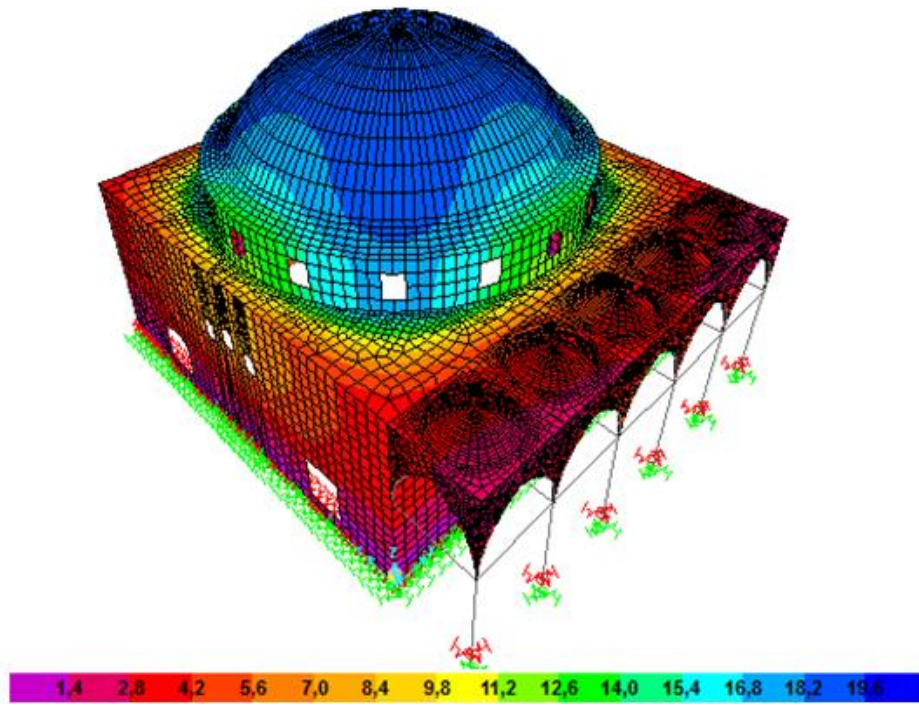
The maximum displacements contour diagram of Hüsrev Pasha Mosque with 16 window openings under dead load and earthquake load (G+EZ) is shown in Fig. 13. It can be seen from the Figure 13 that the maximum displacement occurred at the middle point of the big dome as 19.6 mm. Beside this displacements have a decreasing trend from top of the dome to lower part of the mosque.

Figure 13: Maximum displacements contour diagram of the mosque with 16 window openings under dead load and earthquake load (G+EZ).

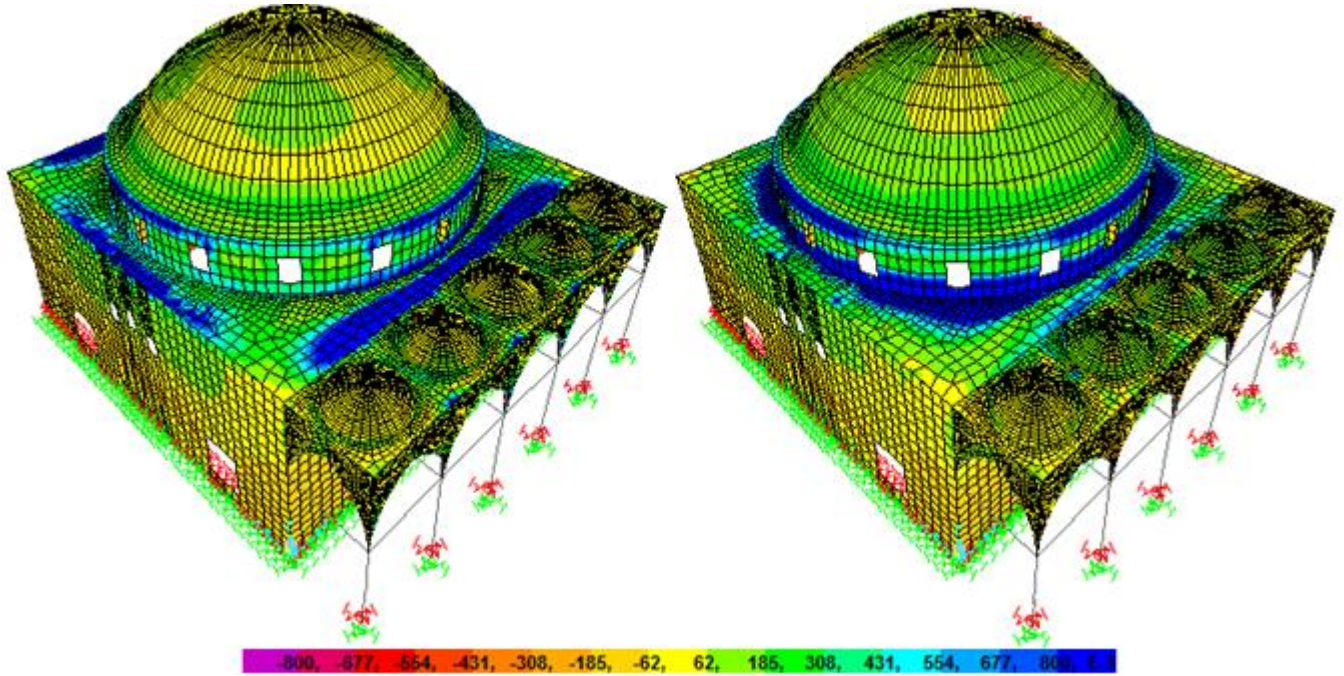
The maximum tensile stresses contour diagram is shown in Fig. 14. It is seen from the Figure 14 that maximum values of the tensile stresses for outer surface of the mosque occurred at side and lower part of big dome, near the window spaces and transition areas of between side walls as 0.85 MPa. Maximum tensile stresses for inner surface of the mosque occurred as 0.80 MPa.

5 Figure 14: Maximum tensile stresses contour diagram for outer and inner surfaces of the mosque with 16 window openings under dead load and earthquake load (G+EZ).

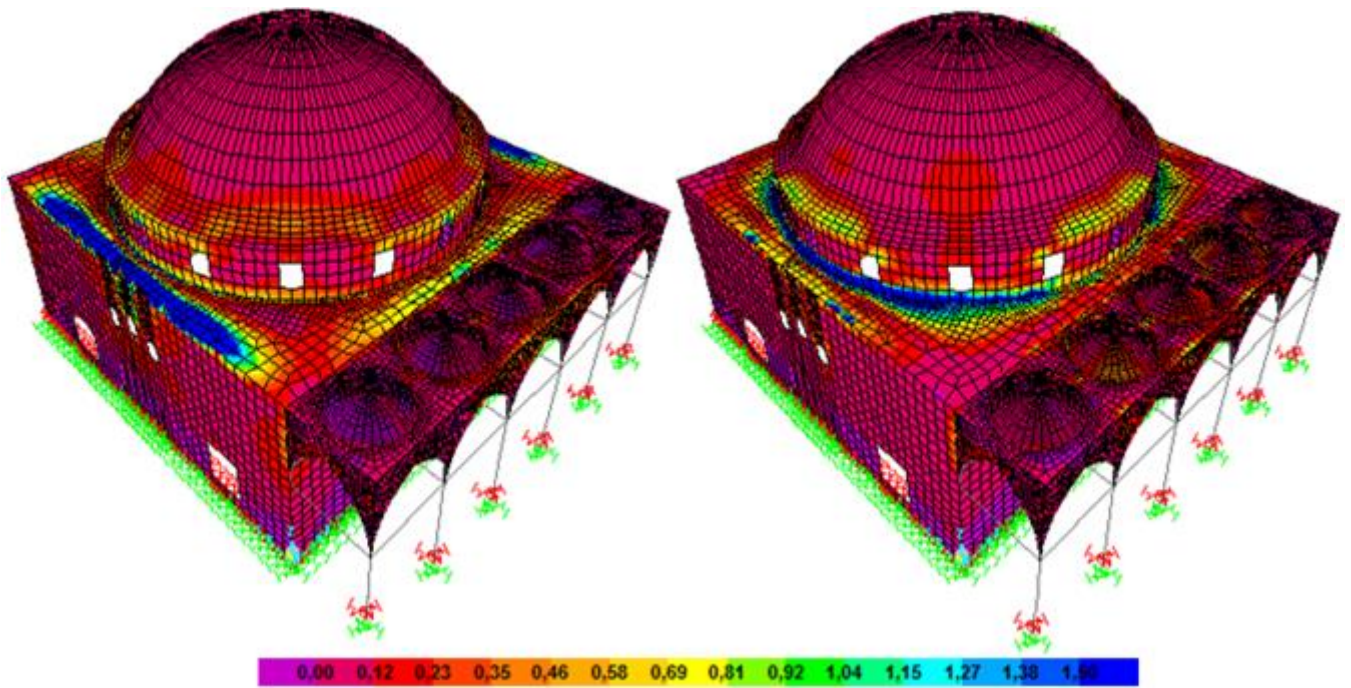
The maximum compression stresses contour diagram is shown in Fig. 15. It is seen from the Figure 15 that maximum values of the compression stresses for outer surface of mosque occurred at between the dome and side walls transition areas and near window spaces at dome as 1.35 MPa. Beside this maximum compression stresses for inner surface of the mosque, occurred as 1.25 MPa.

Figure 15: Maximum compression stresses contour diagram for outer and inner surfaces of the mosque with 16 window openings under dead load and earthquake load (G+EZ).

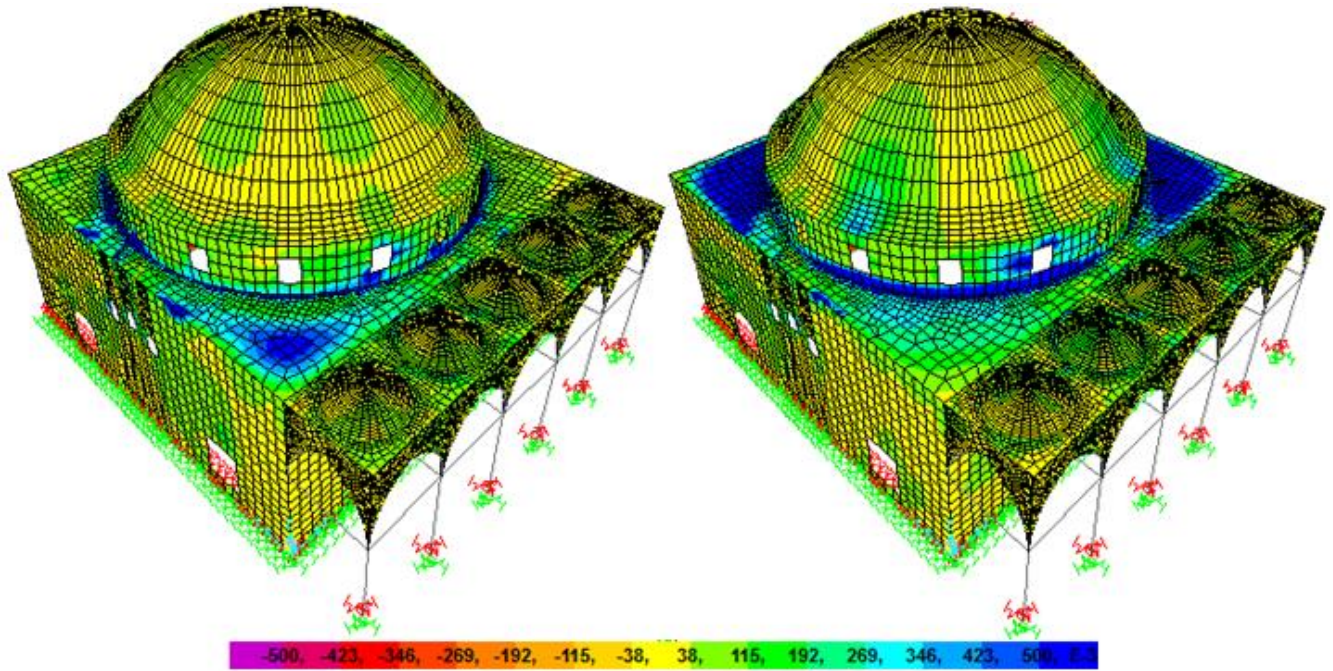
The maximum shear stresses contour diagram for outer and inner surfaces of Hüsrev Pasha Mosque under dead load and earthquake load (G+EZ) is shown in Fig. 16. It is seen from the Figure 16 that maximum values of the shear stresses for outer and inner surfaces of the mosque are 0.50 MPa and 0.45 MPa respectively.

5 Figure 16: Maximum shear stresses contour diagram for outer and inner surfaces of the mosque with 16 window openings under dead load and earthquake load (G+EZ).

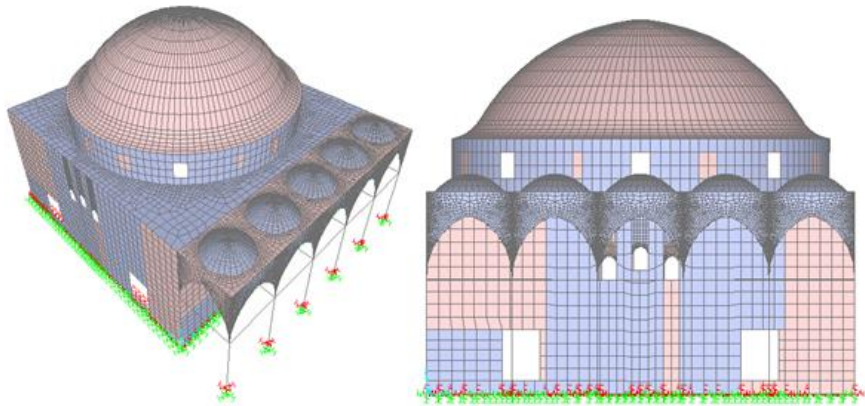
The mosque has 8 window openings before the restoration case so finite element model of the mosque was constituted with 8 window openings. Finite element model of the mosque with 8 window openings is shown in Fig. 17. According to the modal analysis first four natural frequencies were obtained as 3.81Hz, 3.87Hz, 4.81Hz and 5.78Hz respectively. Mode shapes were obtained as translation X direction, translation Y direction, squeeze and torsion respectively. Results of earthquake analyses are given in Table 3.

Figure 17: Finite element model of the mosque with 8 window openings.
