Detection of collapsed buildings due to the 2016 Kumamoto, Japan, earthquake from LiDAR data

Luis Moya¹, Fumio Yamazaki², Wen Liu², Masumi Yamada³

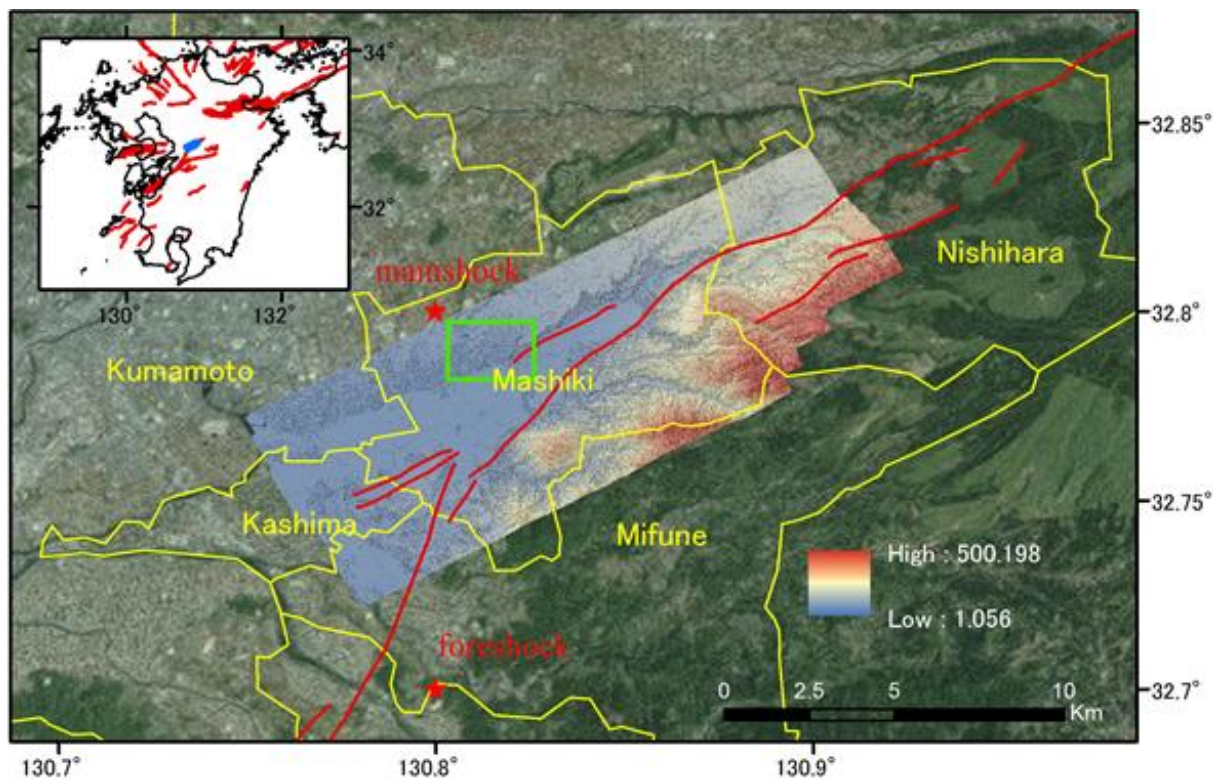
Figure 1: The post-event LiDAR data for the study area. Shaded colors represents the elevation. The green rectangle shows the locations of the area surveyed by Yamada et al. (2017). The inset shows Kyushu Island, and the blue polygon in the inset depicts the study area

10 After the foreshock, a LiDAR surveying flight was carried out during 15:00 – 17:00 (JST) on April 15, 2016, in order to record the effects of the earthquake (Asia Air Survey Co., Ltd., 2016). It produced point clouds with an average point density of 1.5-2 points/m². Subsequently, because the unexpected mainshock occurred, a second mission was set up during 10:00 – 12:00 (JST) on April 23, 2016, which produced point clouds with an average point density of 3-4 points/m². Both sets of LiDAR data were acquired using a Leica ALS50II instrument and the same pilot and airplane. After rasterization of the raw
15 point clouds, two digital surface models (DSMs) with a data spacing of 50 cm were created. The DSM collected before and after the mainshock will hereafter be referred to as the BDSM and ADSM, respectively. Figure 1 shows the extent of the ADSM, which represents the entire study area. It covers the main part of Mashiki town and some parts of Nishihara village, Mifune and Kashima towns, and Kumamoto city.

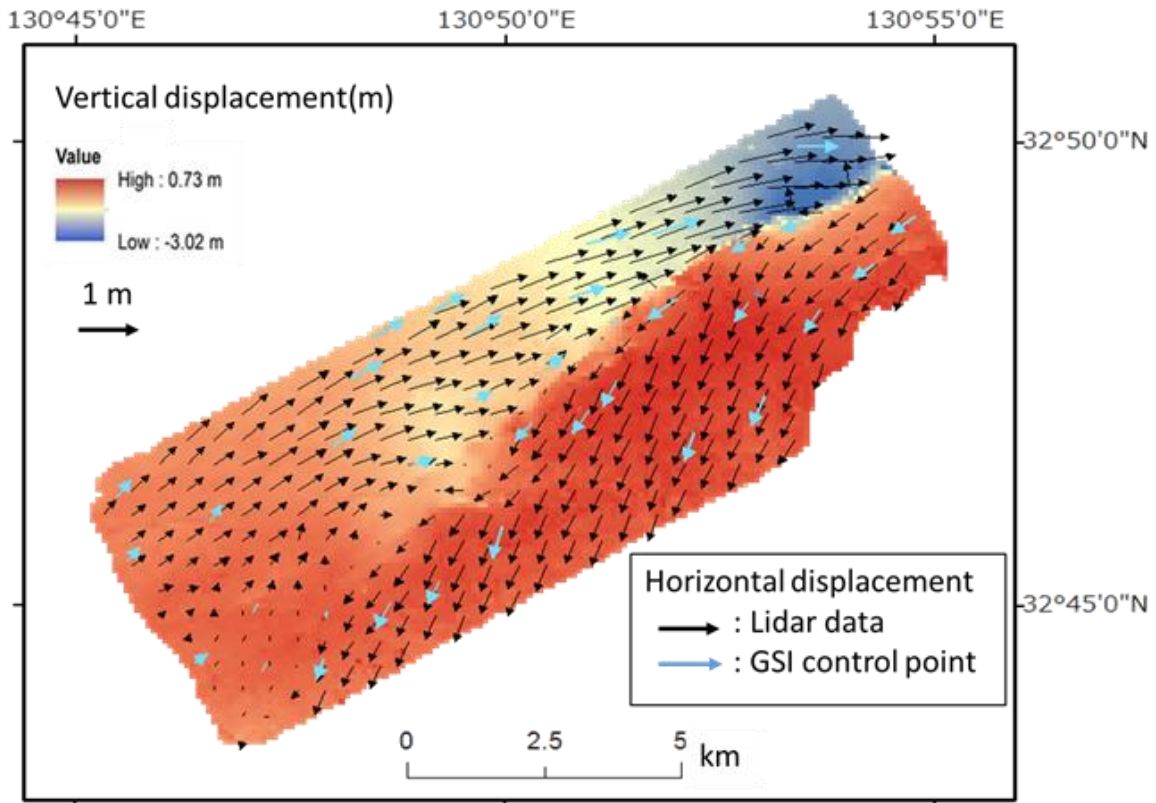
Figure 2: Estimated three-dimensional coseismic displacement after the mainshock of the 2016 Kumamoto earthquake. The black arrows and the shaded colors indicate the horizontal and vertical displacements obtained from **LiDAR**, respectively (Moya et al., 2017). The blue arrows indicate the horizontal displacements at the control points measured by the Geospatial Information Authority of Japan (2016).

The study area is located in the near field of the Kumamoto earthquake sequence where significant permanent ground
20 displacements were produced during the earthquake. A direct comparison of the BDSM and ADSM shows that the building coordinates do not match because the ADSM contains coseismic displacements. Therefore, the ADSM was shifted before detecting the damaged buildings based on the permanent crustal movement calculated by Moya et al. (2017). To do this, an automated procedure for calculating the permanent three-dimensional (3D) displacement was implemented. The permanent ground displacement was calculated by 100m-grid size, and then it is applied to the ADSM pixels within the grid-size.
25 Figure 2 illustrates the calculated permanent ground displacement of the common LiDAR data area. In the figure, the results of new field measurement carried out in August 2016 for surveying reference points after the Kumamoto earthquake are also shown (Geospatial Information Authority of Japan, 2017). The coseismic displacements estimated from the LiDAR data show good agreement with the survey results (Figure 3). In Figure 2, the causative fault is located in the areas where sudden changes in the direction of the permanent ground displacement are observed. Over the entire study area, a maximum

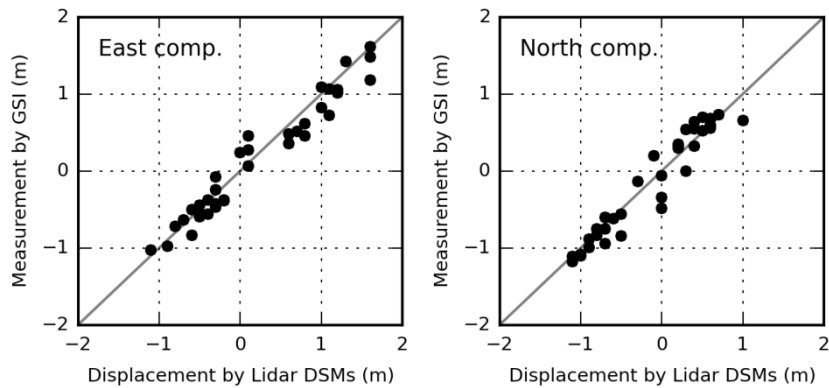
Figure 3: Comparison between the coseismic displacements estimated from the **LiDAR** data (Moya et al. 2017) and from field measurements (Geospatial Information Authority of Japan, 2016)

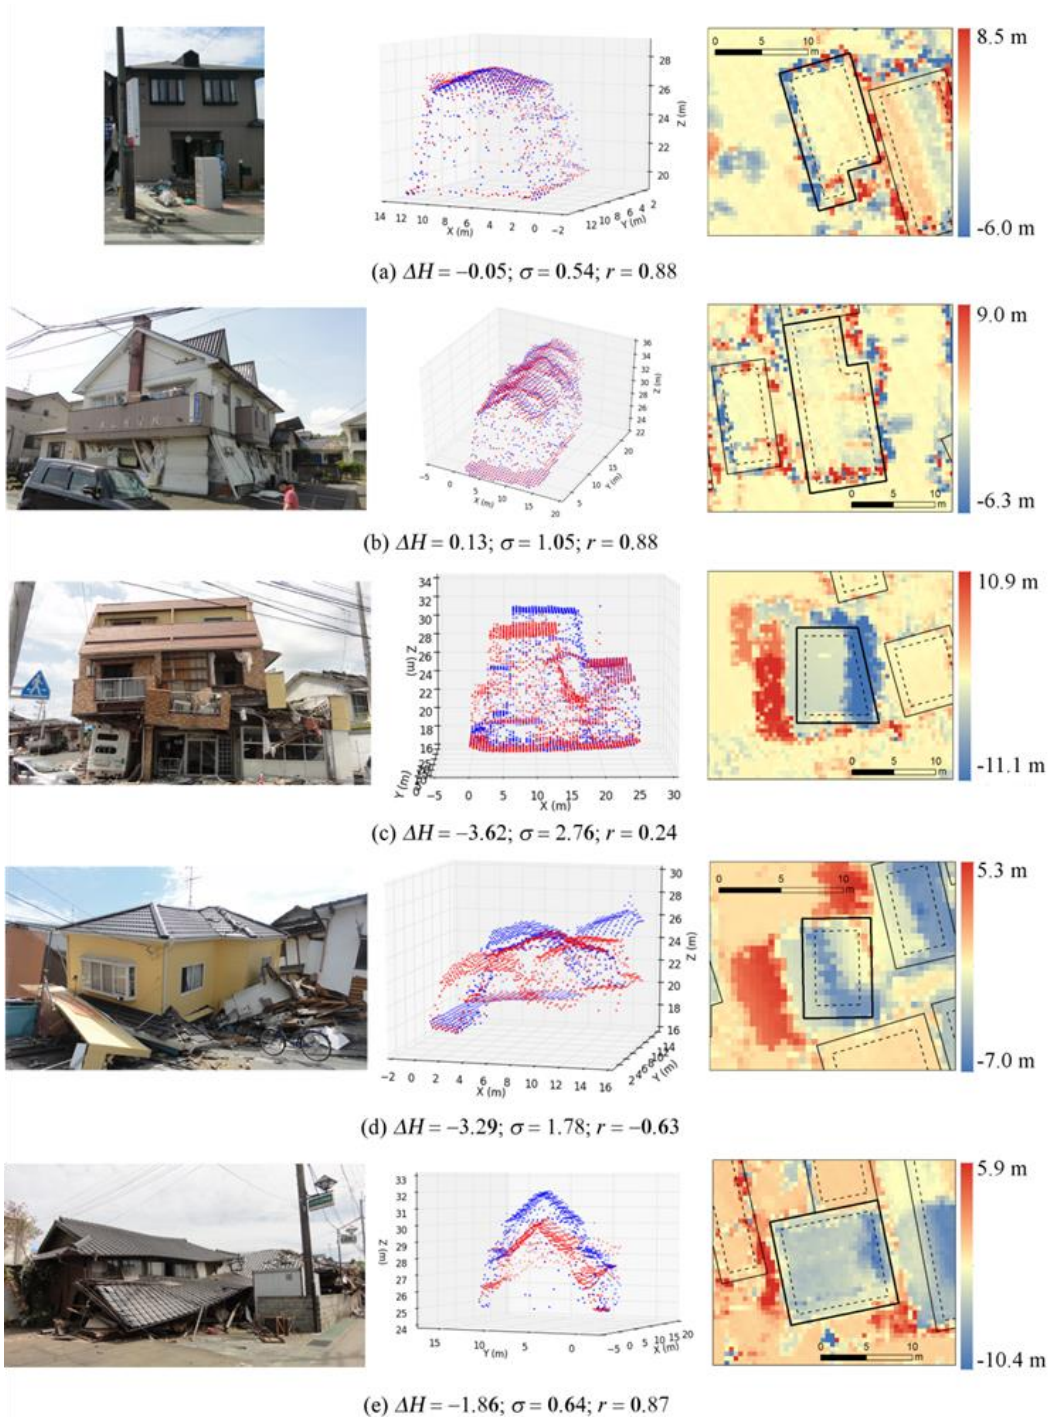
Figure 4: Examples of collapsed buildings extracted using the LiDAR data. The left column shows the photos taken after the mainshock by the authors. The middle column shows the LiDAR data, where the blue points depict the BDSM and the red points the ADSM. The right column shows the elevation differences between the two DSMs, where the solid lines depict the building footprints and the dashed lines depict the footprint reduced by 1m.

Figure 4 illustrates five buildings located in the study area. For each case, the BDSM (blue dots), the ADSM (red dots), and the difference of the two DSMs are depicted. These buildings were selected in order to demonstrate different damage patterns: non-damaged, tilted, and collapsed buildings. It is worth noting that the difference between the DSMs for a non-damaged building (Figure 4a) shows high values around the boundary of the building footprint, which was caused by the effect mentioned earlier. These errors are certainly present for tilted buildings as well and make damage detection very challenging (Figure 4b). Figure 4c shows a typical collapsed steel-frame building with a well-known damage pattern that occurs with a *soft story* or a *weak story*, that is, a significant difference of the stiffness/resistance between one story and the rest. They show a significant horizontal/vertical movement, which is easier to detect by LiDAR data. Figure 4d shows a collapsed wooden building that was shifted significantly in the horizontal direction; conversely, the collapsed wooden building shown in Figure 4e does not exhibit such horizontal movement, only a vertical shift. Lateral spread of debris is an important issue when the building is located along a main road. For almost all the collapsed buildings, a clear decrease in building elevation was observed from the LiDAR DSMs.

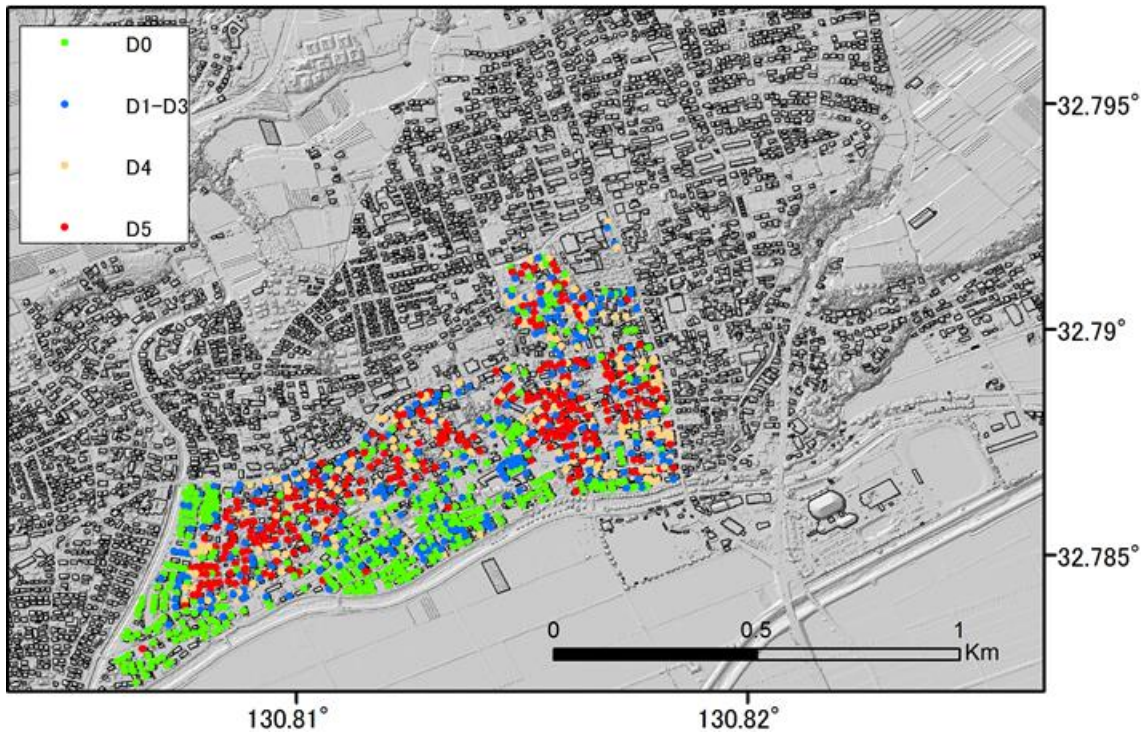
Figure 5: Building damage survey data from Yamada et al. (2017). The location of the survey area is shown in Figure 1.

5 Yamada et al. (2017) presented the distribution of building damage in the central part of Mashiki, where the damage was determined from aerial photos and field surveys. The damaged buildings were classified into four categories: no damage (D0), partially/moderately damaged (D1-D3), severely damaged/inclined (D4) and story collapse (D5). Here, D1-D5 represents the degree of damage according to Okada and Takai (2000), which is similar to G1-G5 of the European Macroseismic Scale (EMS-98). Figure 5 shows the damage distribution over the surveyed area, which is located along the
10 north side of the Akitsu River.

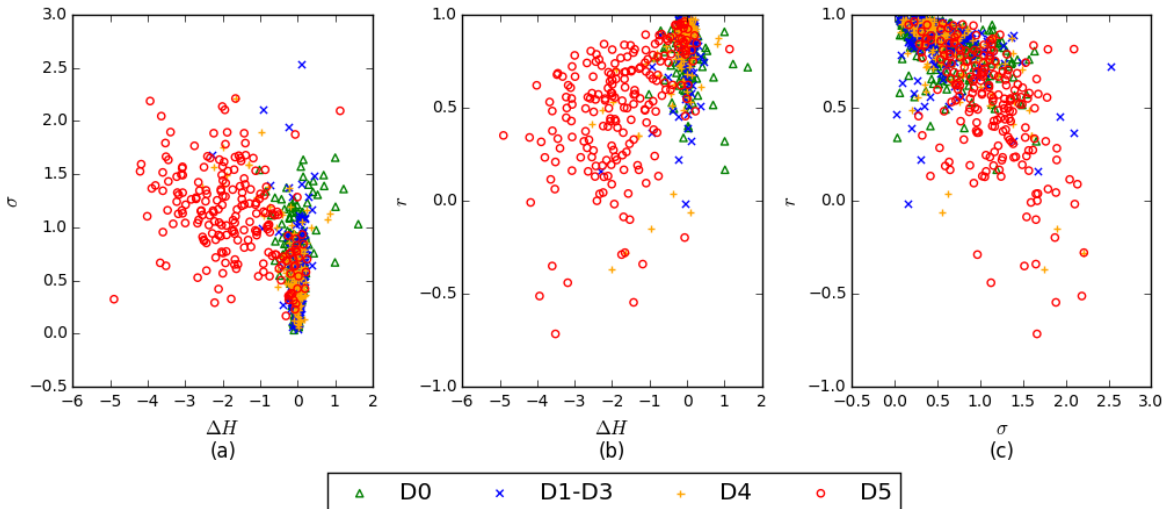
Figure 6: Scatter plots of the three parameters (ΔH , σ , r) calculated from the LiDAR DSMs for the buildings surveyed by Yamada et al. (2017).

Figure 6 shows the scatter plots of the parameters calculated for the surveyed buildings, and Figure 7 shows the histograms of the three parameters for the buildings with different damage levels, where the average (solid line) and the standard deviation (dashed line) are also included. Significant overlap of damage levels D0, D1-D3, and D4 was observed regardless of which parameter was chosen. On the other hand, collapsed buildings (D5) tend to have large negative values of
15 ΔH . Therefore, this paper focuses on the detection of collapsed buildings. It is important to note that few collapsed buildings show positive values of ΔH . A closer look showed that those buildings were covered by a neighboring building that had collapsed.

Although ΔH seems to be the dominant parameter for extracting collapsed buildings, the other two parameters (σ and r) can still provide additional information. For instance, if we observe the collapsed buildings from the scatter plot in Figure 6c
20 (red marks), a trend can be observed in which r trends to one when σ is close to zero. This trend is related to the collapse patterns and can be observed for the collapsed buildings shown in Figure 4. Figure 4d shows a completely collapsed building, where the debris has spread laterally. For those cases, the values of r are low and the values of σ are large. On the other hand, Figure 4e shows a collapsed building whose roof remained almost the same shape while it collapsed almost vertically. This means that all the elevations inside the footprint decreased by about the same amount, thus leading to a high value of r and a
25 low value of σ . This pattern is often difficult to detect from optical aerial and satellite optical images because the sensor measures the landscape vertically. The histograms for collapsed buildings (Figure 7) shows that several collapsed buildings have a value for r greater than 0.5, and it would be difficult to detect this from aerial or optical satellite imagery. Readers might notice that non-collapsed buildings also have a value of r close to 1 and σ close to zero; however, those can be first filtered using ΔH . Then, the pattern of collapse can be evaluated from the other two parameters (a process known as a

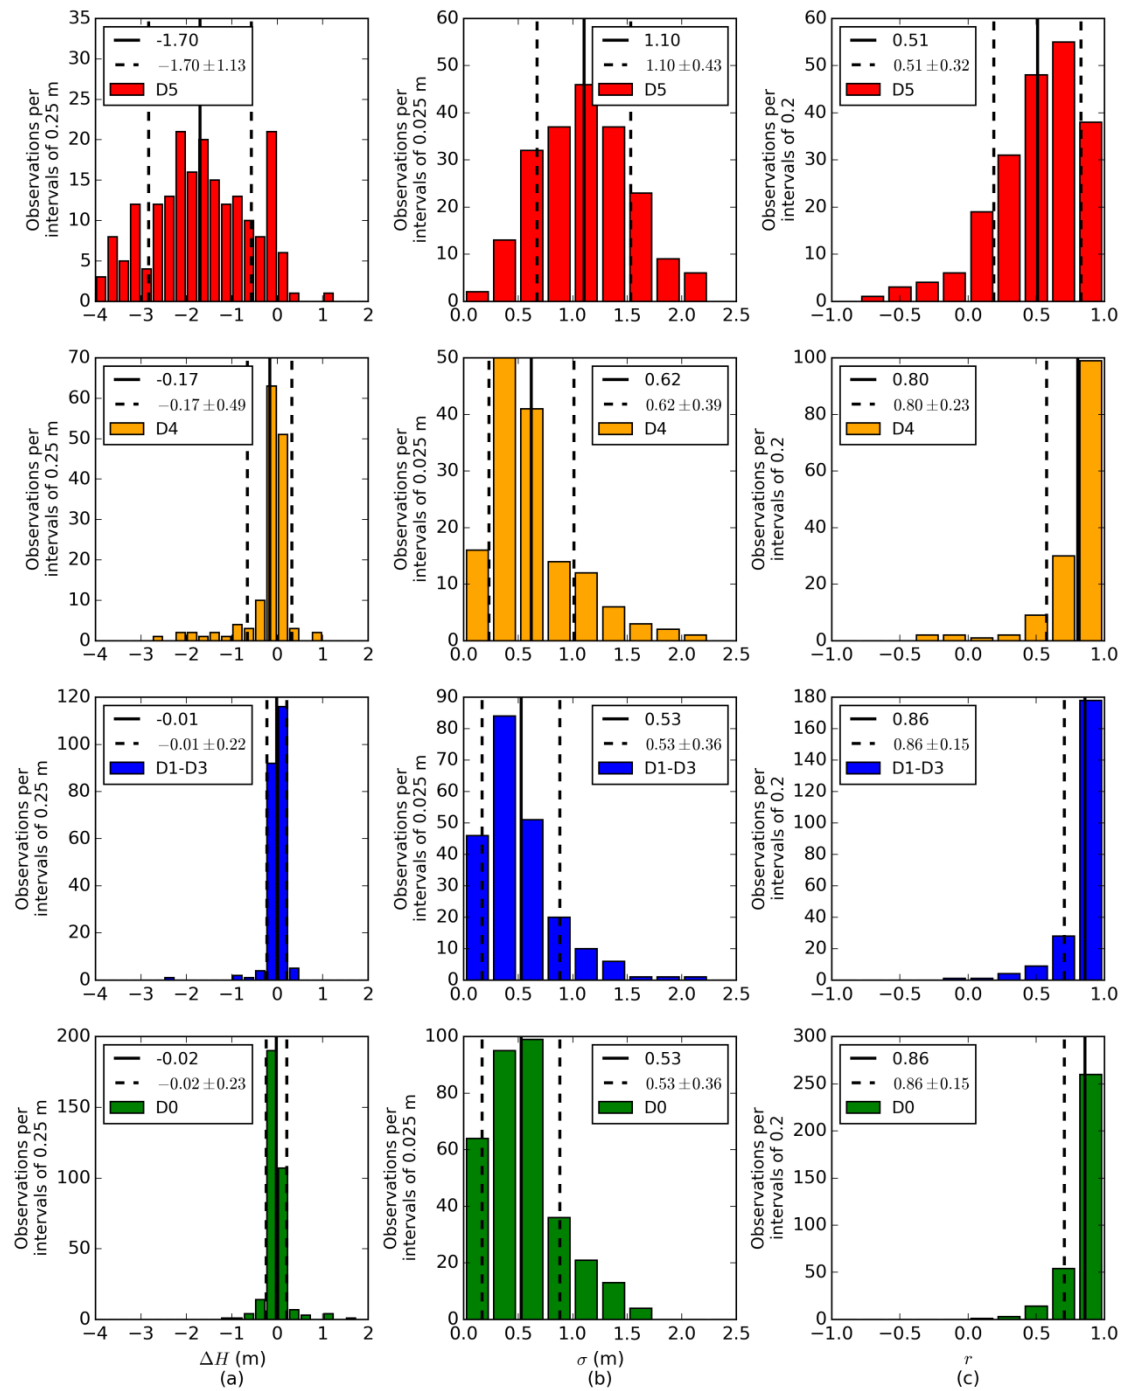
Figure 7: Histograms of the three parameters (ΔH , σ , r) calculated from the LiDAR DSMs for the buildings surveyed by Yamada et al. (2017), separated into four damage levels.

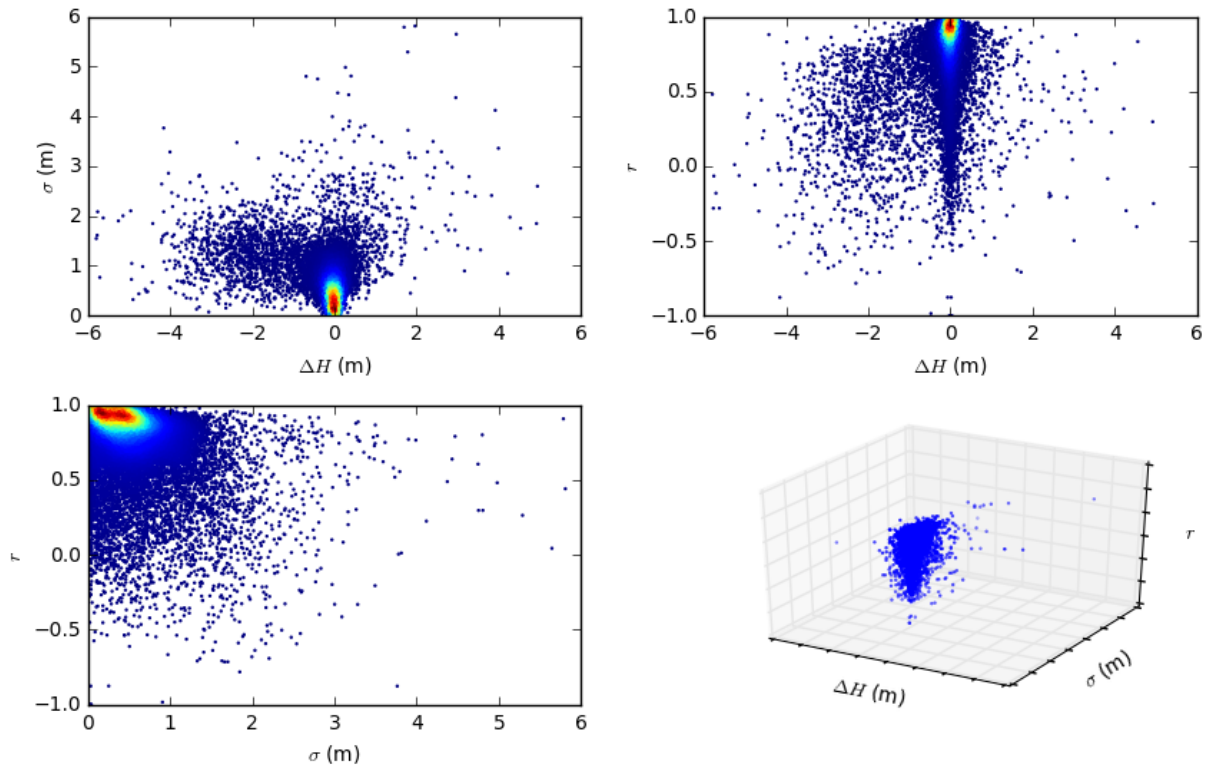
Figure 8: Scatter plots of the three parameters (ΔH , σ , r) calculated for all the buildings in the study area. The color represents the density of points, where red shows the area with the highest density.

Within the study area, 26,128 building footprints were extracted. It is worth mentioning that few buildings were not well registered in the GIS map. Figure 8 shows the parameters calculated for each building, where the shaded color depicts the density of the dots. As seen, most of the points are located at approximately $(\Delta H, \sigma, r) = (0 \text{ m}, 0.5 \text{ m}, 0.9)$, which indeed

represents non-collapsed buildings. Several buildings show positive values of ΔH . A closer look revealed two principle factors: (1) the collapse of a neighboring building and (2) plastic covers placed over the roof for protection from the rain.

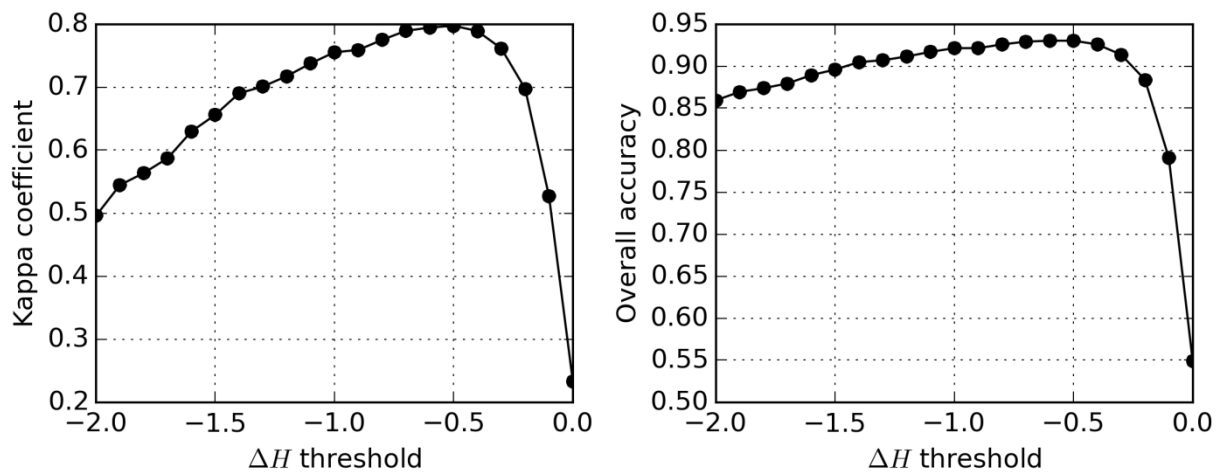
Figure 9: Kappa coefficient (left) and overall accuracy (right) obtained from the comparison between the data surveyed by Yamada et al. (2017) and the estimated collapsed buildings based on different ΔH threshold values.

where p_{11} and p_{12} are the ratio of non-collapsed buildings predicted as non-collapsed and collapsed buildings, respectively. p_{21} and p_{22} are the ratio of collapsed buildings predicted as non-collapsed and collapsed buildings, respectively. From Figure 9, it is observed that a threshold value of -0.5 m gave the highest values for both the Cohen's Kappa coefficient (0.80) and the overall accuracy (0.93).

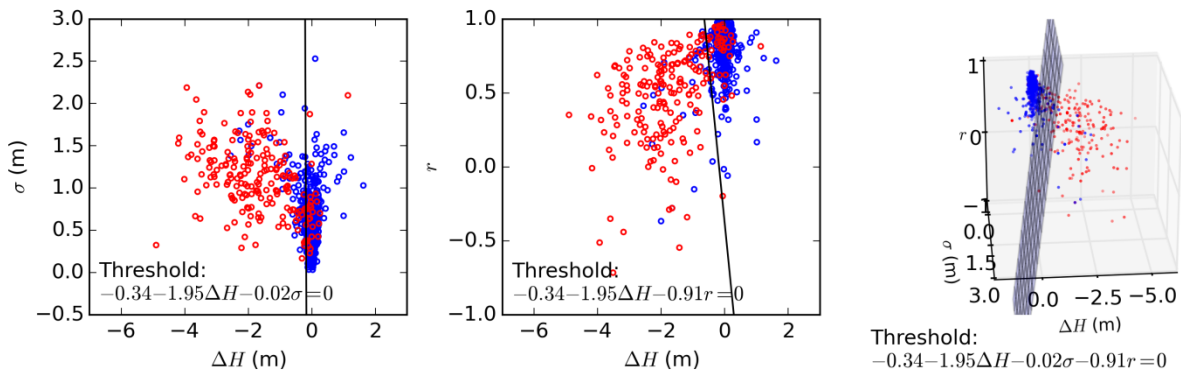
Figure 10: Classification of collapsed (red) and non-collapsed (blue) buildings using the three parameters based on SVM.

To determine if the use of all the parameters could produce better accuracy in detecting collapsed buildings, the Support Vector Machine (SVM) method was selected to construct a plane that separates collapsed and non-collapsed buildings in the three-dimensional database (ΔH , σ , r). The plane has the largest distance from the nearest training data (ground truth data). Using kernel functions, SVM can be used to construct a non-linear function as well; however, in this study we only evaluated linear functions (i.e., a plane or linear kernel function). Figure 10 shows the plane constructed using SVM, where the red and blue marks depict the collapsed and non-collapsed buildings based on the ground truth, respectively. The plane was constructed using the same amount of data for the two classes. Thus, 205 non-collapsed buildings were selected randomly from the surveyed data. The analysis was performed several times, and although the plane obtained showed small variations due to the random selection of the training data, the Cohen's Kappa coefficient produced in each analysis was almost constant with minor fluctuations around 0.80. The accuracy produced by SVM is very similar to the accuracy

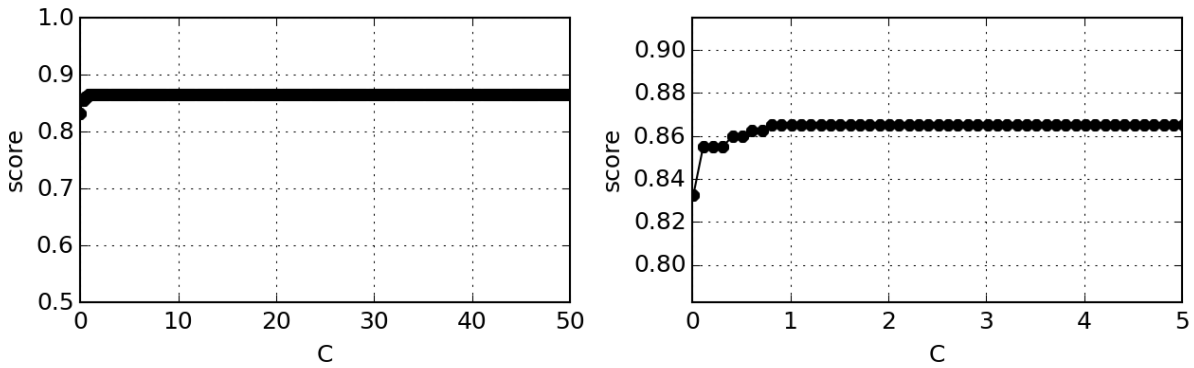
Figure 11: Classifier's cross-validation accuracy as a function of C . Left: Overall evaluated range of C . Right: A closer look of values lower than 5.

The parameter C trades off misclassification of training examples against simplicity of the decision surface. A low C value makes the decision surface smooth and a high C value aims at classifying all training examples correctly (Skit-learn, 2017a). In this study a value C equals to 1 was used. In order to evaluate its effects, a cross-validation procedure was performed. For each C value, 80% of the surveyed data were selected randomly and were used to calibrate the SVM classifier. The rest of
10 the surveyed data were used to calculate a score that represents the accuracy. The overall accuracy was chose as the score. The procedure was repeated 5 times and the average was stored. Figure 11 shows the cross-validation accuracy. It is observed the accuracy remains mainly constant with small fluctuations at lower values. However, a difference of approximately 3% is observed between the worst and the best accuracy. Therefore, it is concluded that the C value did not affect the SVM classifier in our study.

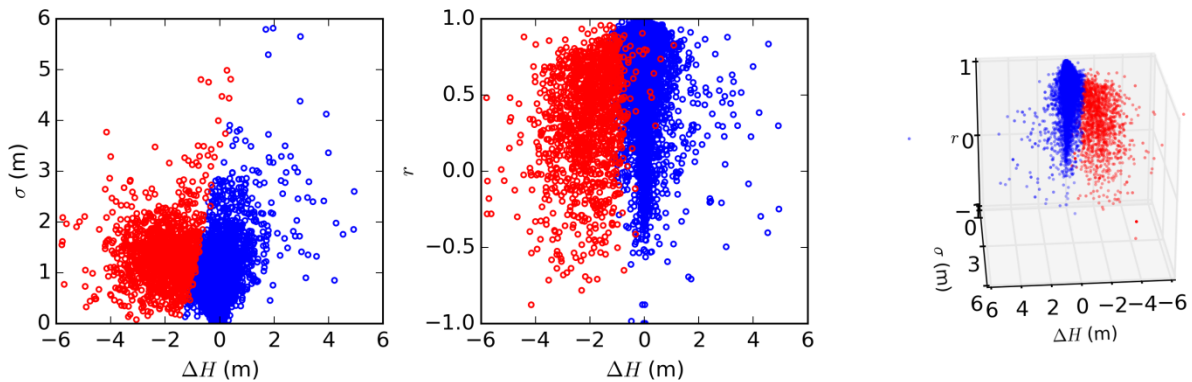
10 Figure 12: Classification of collapsed (red) and non-collapsed (blue) buildings using the three parameters based on the K-means clustering method

15 This study also evaluated the potential use of unsupervised classification to extract collapsed buildings. Specifically, K-means cluster analysis was applied to all the data in the study area. Unlike SVM, K-means clustering does not require training data. Therefore, the database of all the buildings in the study area (Figure 8) was used. The method clusters the data and separates them into two groups, which represent the collapsed and non-collapsed buildings. The objective of the method is to minimize the inertia of each group, that is, the summation of the squared distance between all the data points of a group
20 and its centroid. The result is highly dependent on the initialization of the centroids. Here, k-means++ initialization scheme was used. K-means++ initializes the centroids to be distant from each other (Scikit-learn, 2017b). Figure 12 represents the predicted collapsed and non-collapsed buildings using the K-means clustering method, for which the Cohen's Kappa coefficient obtained was 0.76. Figure 13 shows the confusion matrix calculated from the comparison between the ground truth data and the predicted results from the three methods explained above: applying a ΔH threshold, SVM, and K-means

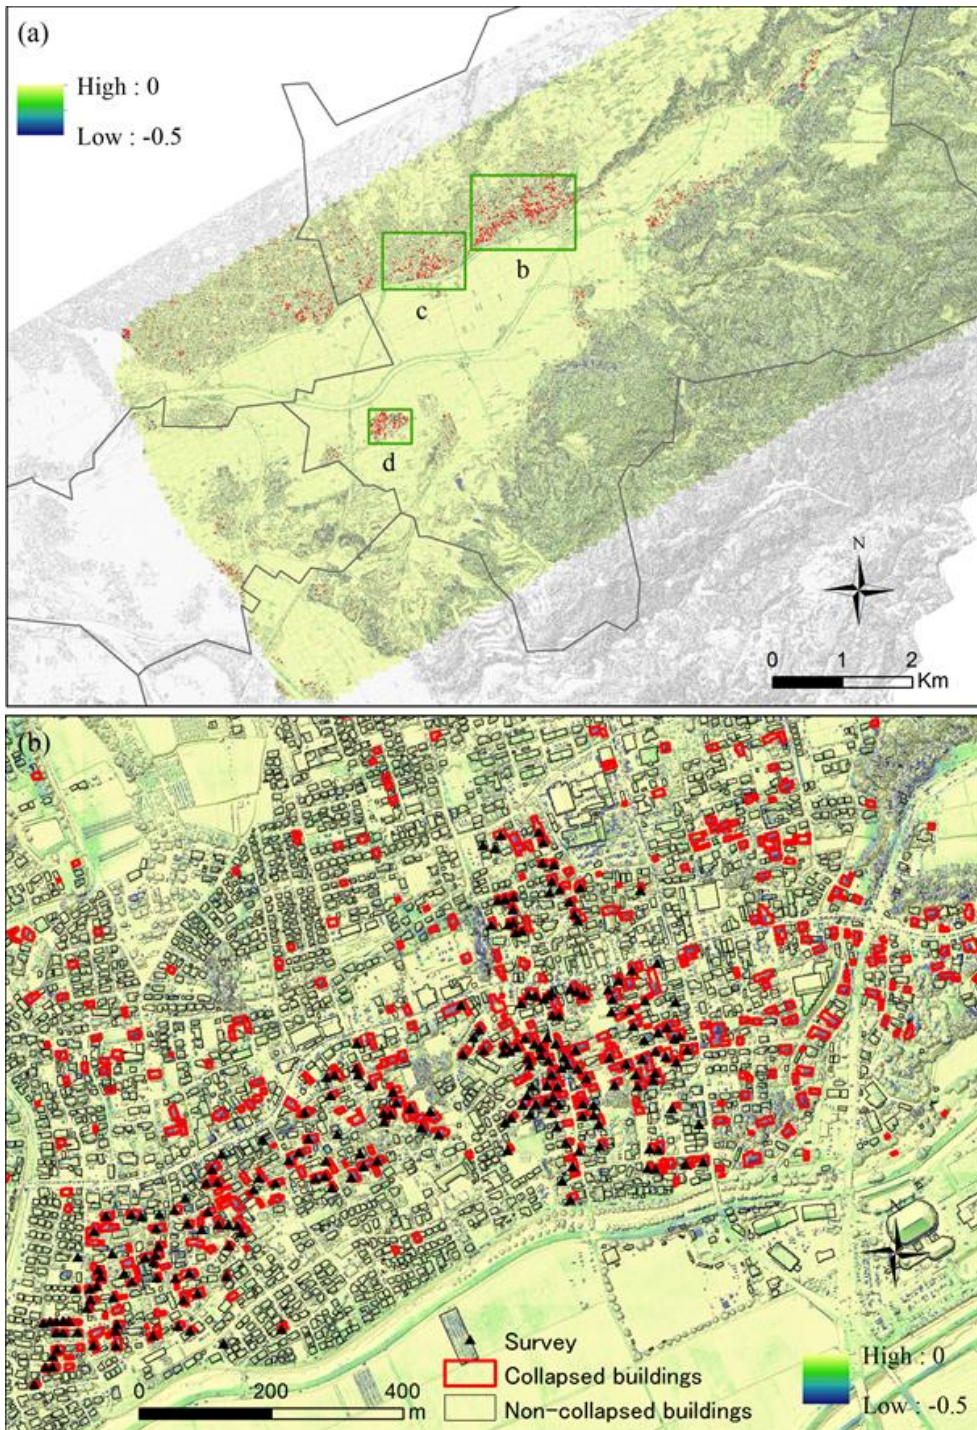
Figure 14: (a) A map showing the distribution of collapsed ($\Delta H \leq -0.5$ m) buildings, shown as red polygons, in the study area. The pixel color represents the difference in elevations between the BDSM and ADSM. The green squares show the locations of areas shown in Figure 13 (b) and Figure 14. (b) Close-up view of Area (b) where the collapsed buildings were concentrated. The black triangles show the D5 buildings from Yamada et al. (2017).

Figure 14 illustrates the spatial distribution of collapsed buildings estimated using a ΔH threshold of -0.5 m. A large number of collapsed buildings were observed in the study area (Figure 14a). The red and black polygons represent the collapsed (D5) and non-collapsed (D0-D4) buildings, respectively. The color of the pixels represents the difference in

elevations between the ADSM and BDSM. Blue pixels depict differences of elevations less than -0.5 m, and yellow pixels represent differences greater than 0 m. Figure 14b and Figure 15 provide a closer look of the areas where the collapsed buildings are concentrated. Figure 14b also depicts the location of the collapsed buildings surveyed by Yamada et al. (2017) as black triangles. Within the study area, a total of 26,128 buildings were evaluated, and 1,760 buildings were classified as collapsed (ΔH less than -0.5 m).

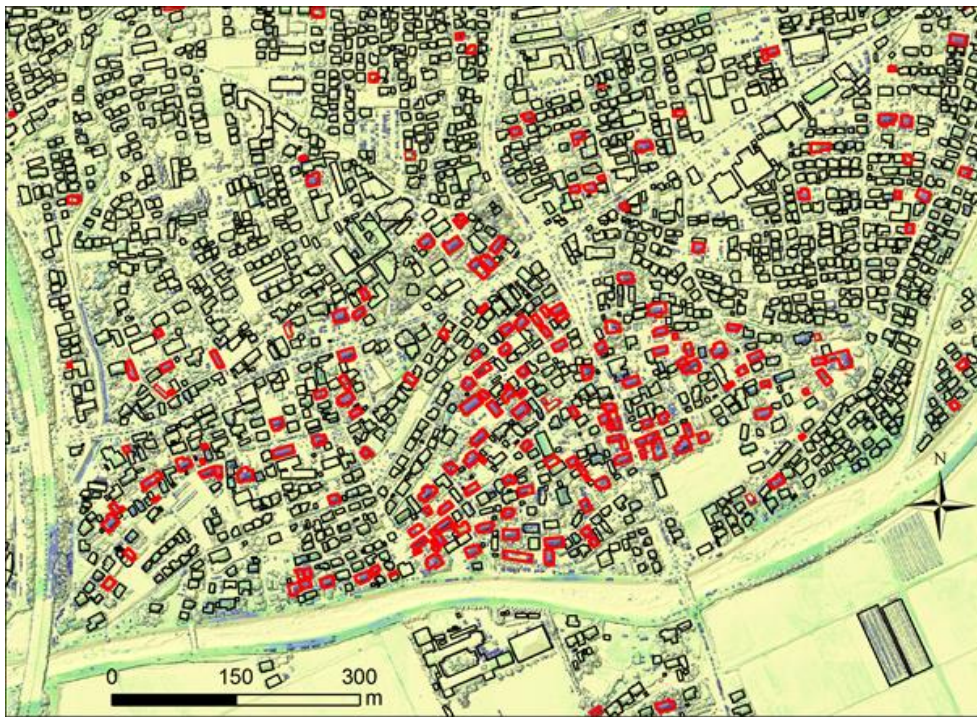
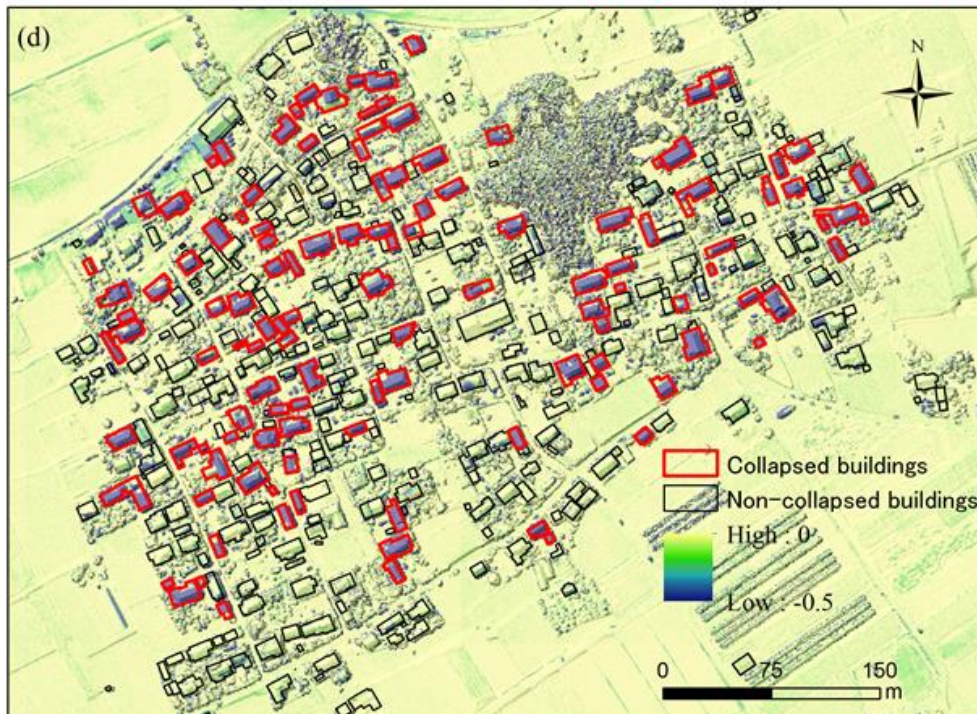
Figure 15: Close-up view of Areas (c) and (d) in Figure 13 (a) where collapsed buildings are concentrated. The red and green polygons are the collapsed and non-collapsed buildings estimated using the threshold ($\Delta H \leq -0.5$ m).
