# Detection of collapsed buildings due to the 2016 Kumamoto, Japan, earthquake from Lidar data

**Abstract.** The 2016 Kumamoto earthquake sequence was triggered by an Mw 6.2 event at 21:26 on April 14. Approximately 28 hours later, at 1:25 on April 16, an Mw 7.0 event (the mainshock) followed. The epicenters of both events were located near the residential area of Mashiki town and the region nearby. Due to very strong seismic ground motion, the earthquake produced extensive damage to buildings and infrastructure. In this paper, collapsed buildings were detected using a pair of digital surface models (DSMs), taken before and after the April 16 mainshock by airborne light detection and ranging (Lidar) flights. Different methods for extracting the collapsed buildings from the data were evaluated, and the change of average elevations within a building footprint was found to be the most important feature. Finally, the distribution of collapsed buildings in the study area was presented, and the result was consistent with that of a building damage survey performed after the earthquake.

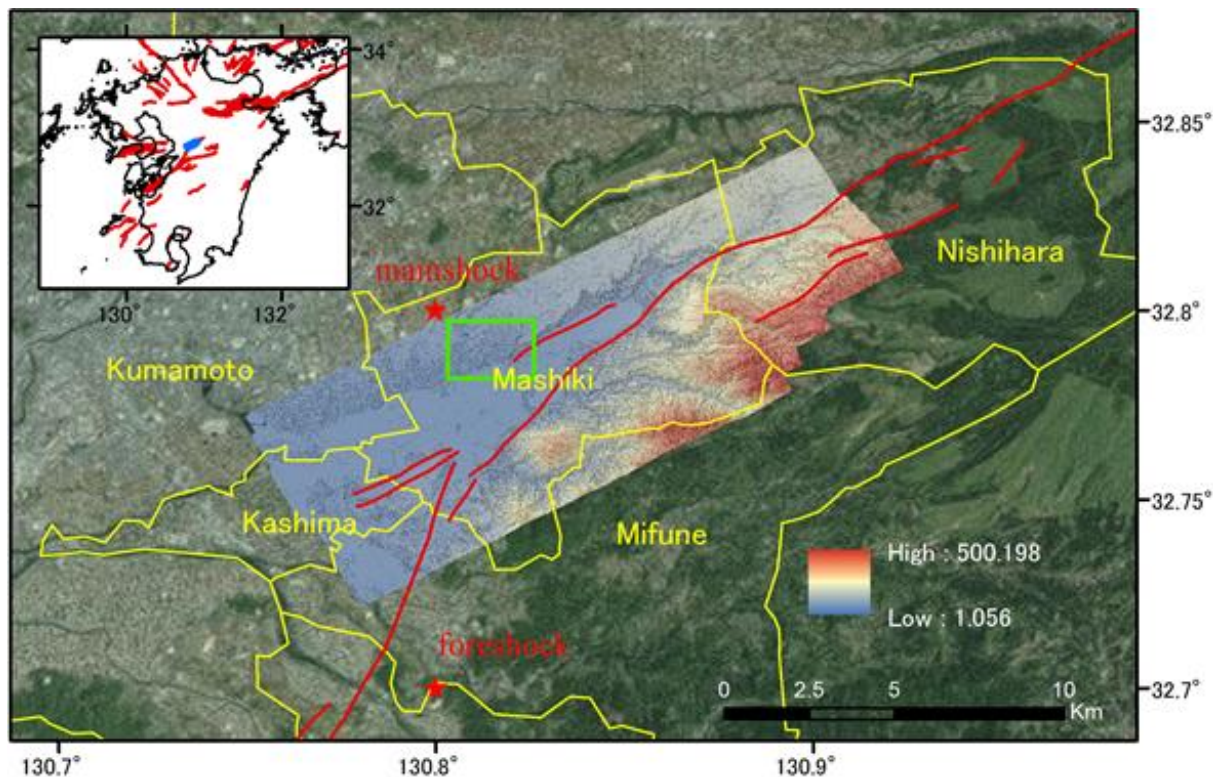
**Figure 1: The post-event Lidar data for the study area. Shaded colors represents the elevation. The green rectangle shows the locations of the area surveyed by Yamada et al. (2017). The inset shows Kyushu Island, and the blue polygon in the inset depicts the study area**

After the foreshock, a Lidar surveying flight was carried out during 15:00 – 17:00 (JST) on April 15, 2016, in order to record the effects of the earthquake (Asia Air Survey Co., Ltd., 2016). It produced point clouds with an average point density of 1.5-2 points/m<sup>2</sup>. Subsequently, because the unexpected mainshock occurred, a second mission was set up during 10:00 – 12:00 (JST) on April 23, 2016, which produced point clouds with an average point density of 3-4 points/m<sup>2</sup>. Both sets of Lidar data were acquired using a Leica ALS50II instrument and the same pilot and airplane. After rasterization of the raw point clouds, two digital surface models (DSMs) with a data spacing of 50 cm were created. The DSM collected before and after the mainshock will hereafter be referred to as the BDSM and ADSM, respectively. Figure 1 shows the extent of the ADSM, which represents the entire study area. It covers the main part of Mashiki town and some parts of Nishihara village, Mifune and Kashima towns, and Kumamoto city.

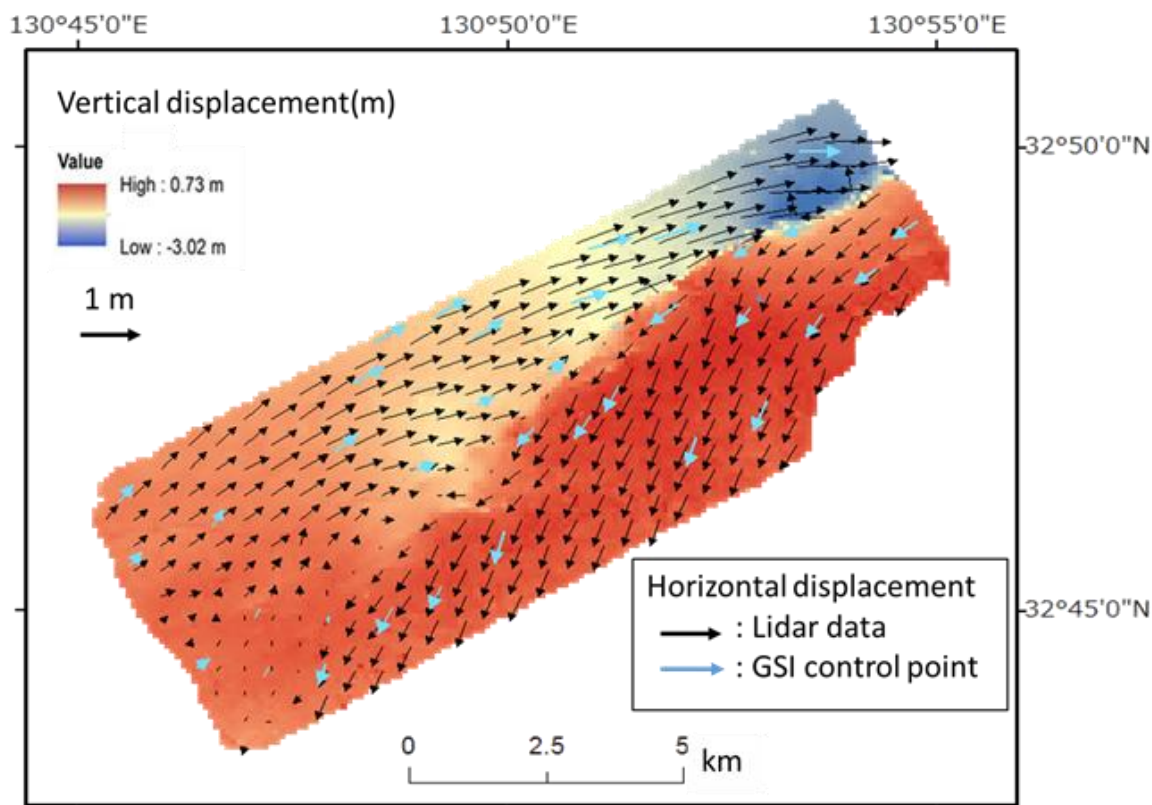
5 **Figure 2:** Estimated three-dimensional coseismic displacement after the mainshock of the 2016 Kumamoto earthquake. The black arrows and the shaded colors indicate the horizontal and vertical displacements obtained from Lidar, respectively (Moya et al., 2017). The blue arrows indicate the horizontal displacements at the control points measured by the Geospatial Information Authority of Japan (2016).

The study area is located in the near field of the Kumamoto earthquake sequence where significant permanent ground displacements were produced during the earthquake. A direct comparison of the BDSM and ADSM shows that the building coordinates do not match because the ADSM contains coseismic displacements. Therefore, the ADSM was shifted before detecting the damaged buildings based on the permanent crustal movement calculated by Moya et al. (2017). To do this, an automated procedure for calculating the permanent three-dimensional (3D) displacement was implemented. Figure 2 illustrates the calculated permanent ground displacement of the common Lidar data area. In the figure, the results of new field measurement carried out in August 2016 for surveying reference points after the Kumamoto earthquake are also shown (Geospatial Information Authority of Japan, 2017). The coseismic displacements estimated from the Lidar data show good agreement with the survey results (Figure 3). In Figure 2, the causative fault is located in the areas where sudden changes in the direction of the permanent ground displacement are observed. Over the entire study area, a maximum horizontal displacement of approximately 2 m was observed.

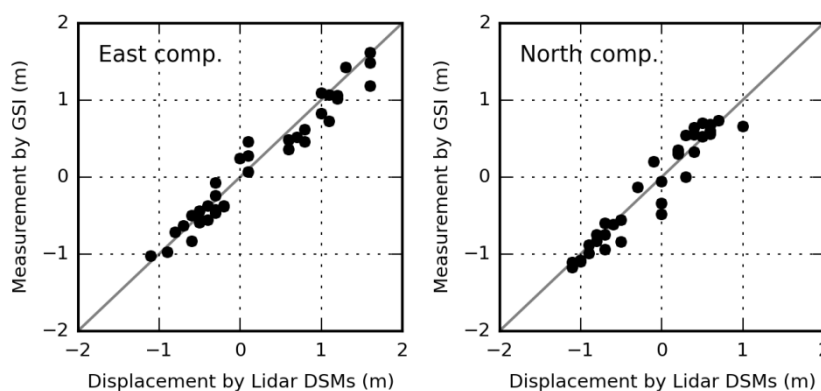
**Figure 3:** Comparison between the coseismic displacements estimated from the Lidar data (Moya et al. 2017) and from field measurements (Geospatial Information Authority of Japan, 2016)

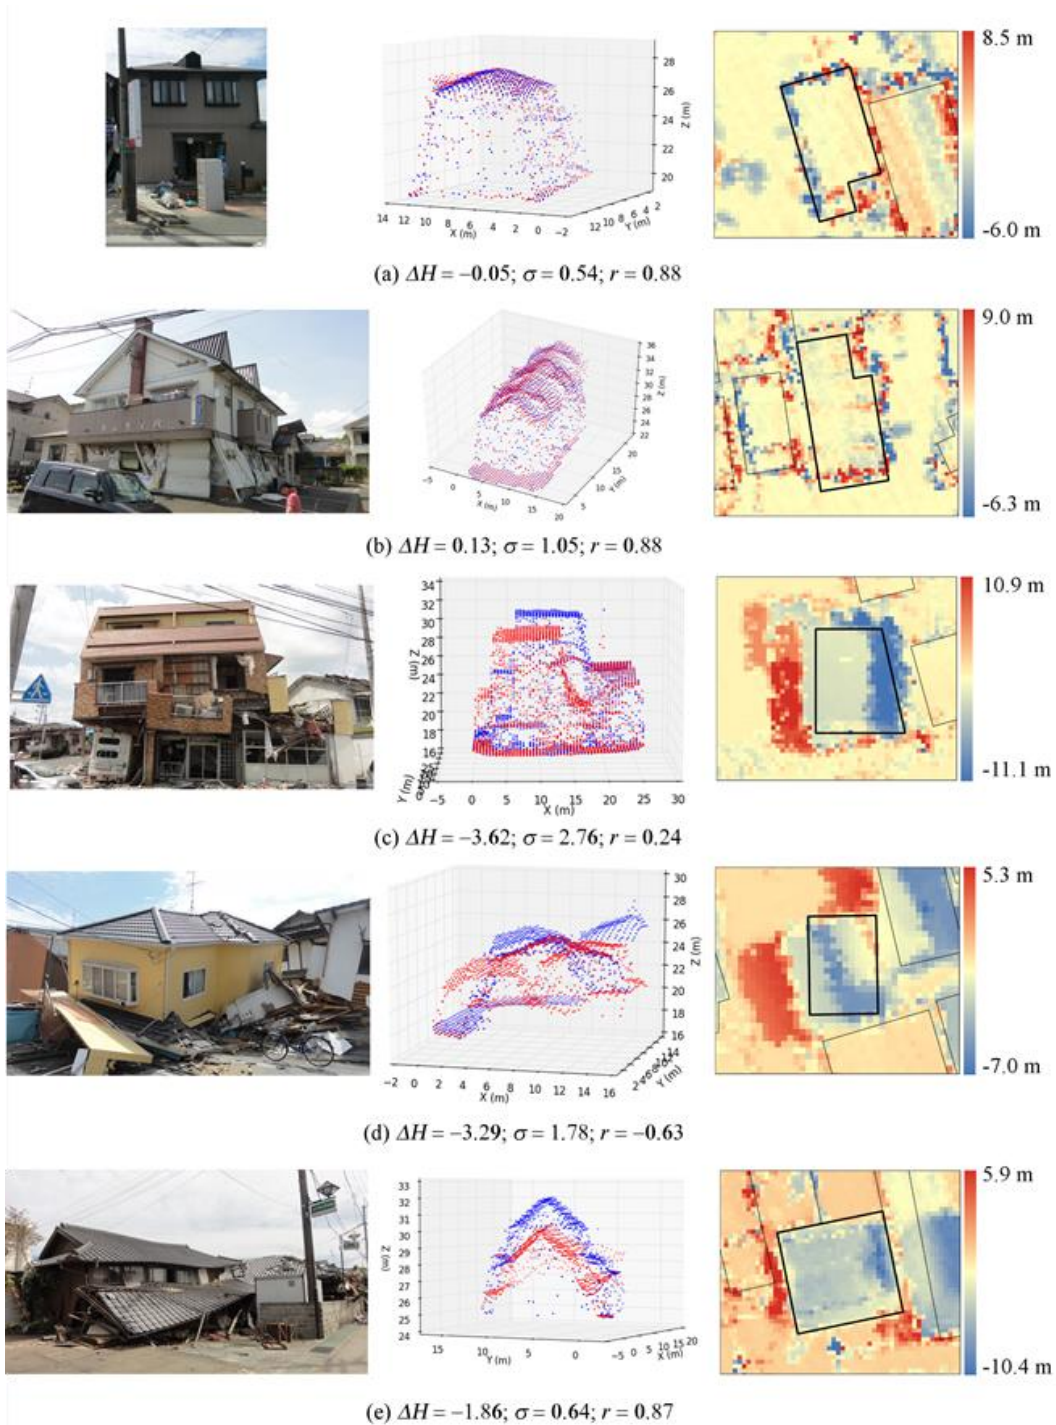
**Figure 4: Examples of collapsed buildings extracted using the Lidar data. The left column shows the photos taken after the mainshock by the authors. The middle column shows the Lidar data, where the blue points depict the BDSM and the red points the ADSM. The right column shows the elevation differences between the two DSMs.**

Figure 4 illustrates five buildings located in the study area. For each case, the BDSM (blue dots), the ADSM (red dots), and the difference of the two DSMs are depicted. These buildings were selected in order to demonstrate different damage patterns: non-damaged, tilted, and collapsed buildings. It is worth noting that the difference between the DSMs for a non-damaged building (Figure 4a) shows high values around the boundary of the building footprint, which was caused by the effect mentioned earlier. These errors are certainly present for tilted buildings as well and make damage detection very challenging (Figure 4b). Figure 4c shows a typical collapsed steel-frame building with a well-known damage pattern that occurs with a *soft story* or a *weak story*, that is, a significant difference of the stiffness/resistance between one story and the rest. They show a significant horizontal/vertical movement, which is easier to detect by Lidar data. Figure 4d shows a collapsed wooden building that was shifted significantly in the horizontal direction; conversely, the collapsed wooden building shown in Figure 4e does not exhibit such horizontal movement, only a vertical shift. Lateral spread of debris is an important issue when the building is located along a main road. For almost all the collapsed buildings, a clear decrease in building elevation was observed from the Lidar DSMs.

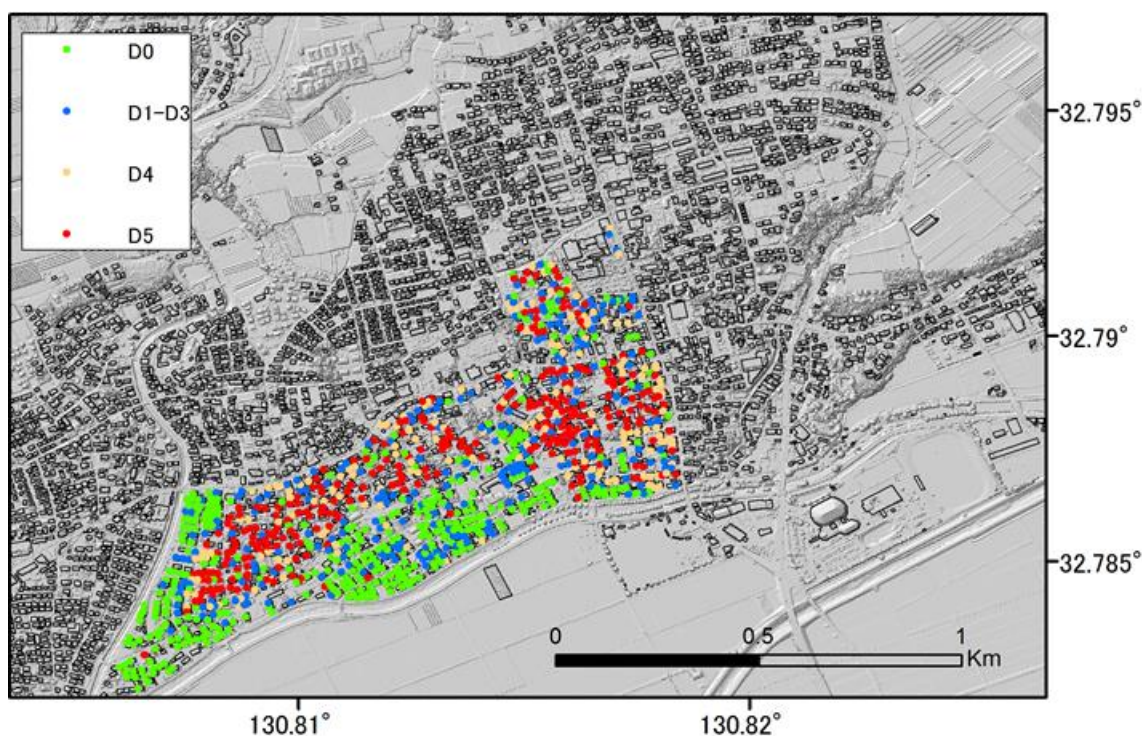
Figure 5: Building damage survey data from Yamada et al. (2017). The location of the survey area is shown in Figure 1.

Yamada et al. (2017) presented the distribution of building damage in the central part of Mashiki, where the damage was determined from aerial photos and field surveys. The damaged buildings were classified into four categories: no damage (D0), partially/moderately damaged (D1-D3), severely damaged/inclined (D4) and story collapse (D5). Here, D1-D5 represents the degree of damage according to Okada and Takai (2000), which is similar to G1-G5 of the European

Macroseismic Scale (EMS-98). Figure 5 shows the damage distribution over the surveyed area, which is located along the north side of the Akitsu River.

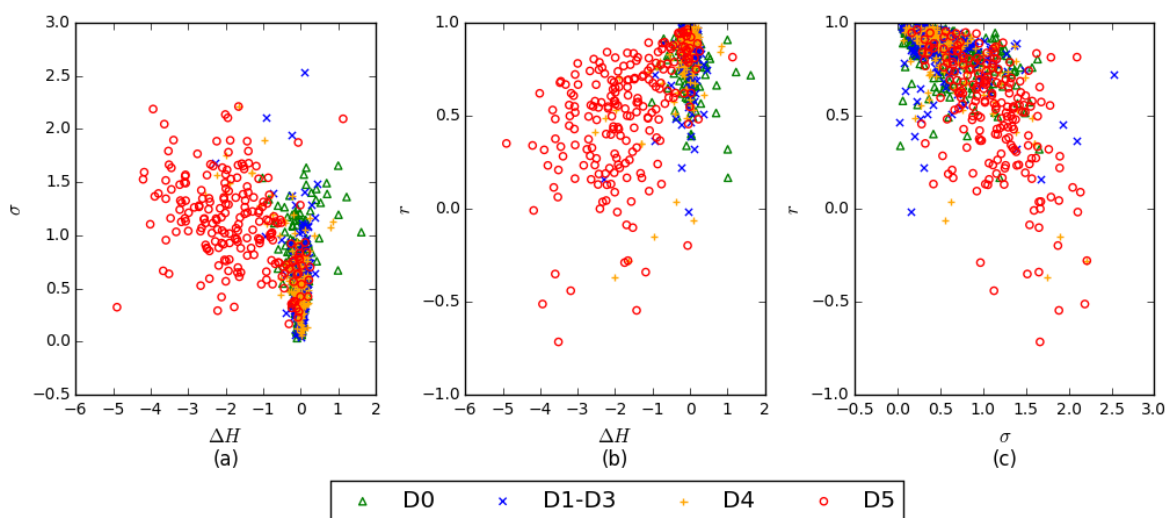
Figure 6: Scatter plots of the three parameters ( $\Delta H$ ,  $\sigma$ ,  $r$ ) calculated from the Lidar DSMs for the buildings surveyed by Yamada et al. (2017).

Figure 6 shows the scatter plots of the parameters calculated for the surveyed buildings, and Figure 7 shows the histograms of the three parameters for the buildings with different damage levels, where the average (solid line) and the standard deviation (dashed line) are also included. Significant overlap of damage levels D0, D1-D3, and D4 was observed regardless of which parameter was chosen. On the other hand, collapsed buildings (D5) tend to have large negative values of  $\Delta H$ . Therefore, this paper focuses on the detection of collapsed buildings. It is important to note that few collapsed buildings show positive values of  $\Delta H$ . A closer look showed that those buildings were covered by a neighboring building that had collapsed.

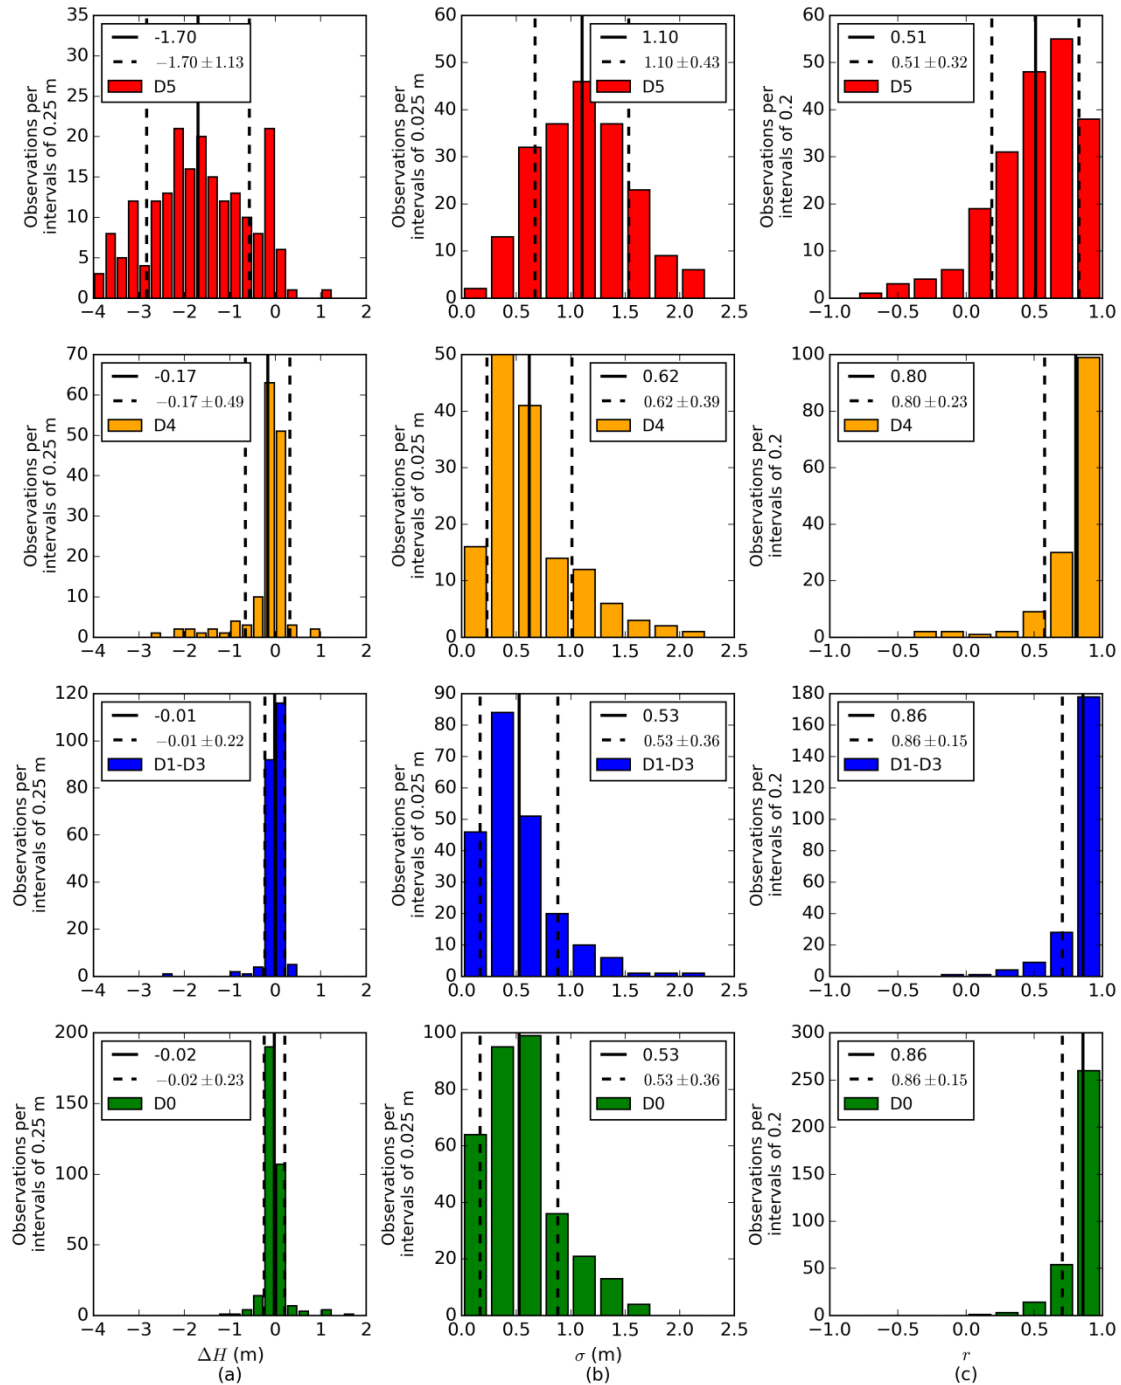
Figure 7: Histograms of the three parameters ( $\Delta H$ ,  $\sigma$ ,  $r$ ) calculated from the Lidar DSMs for the buildings surveyed by Yamada et al. (2017), separated into four damage levels.

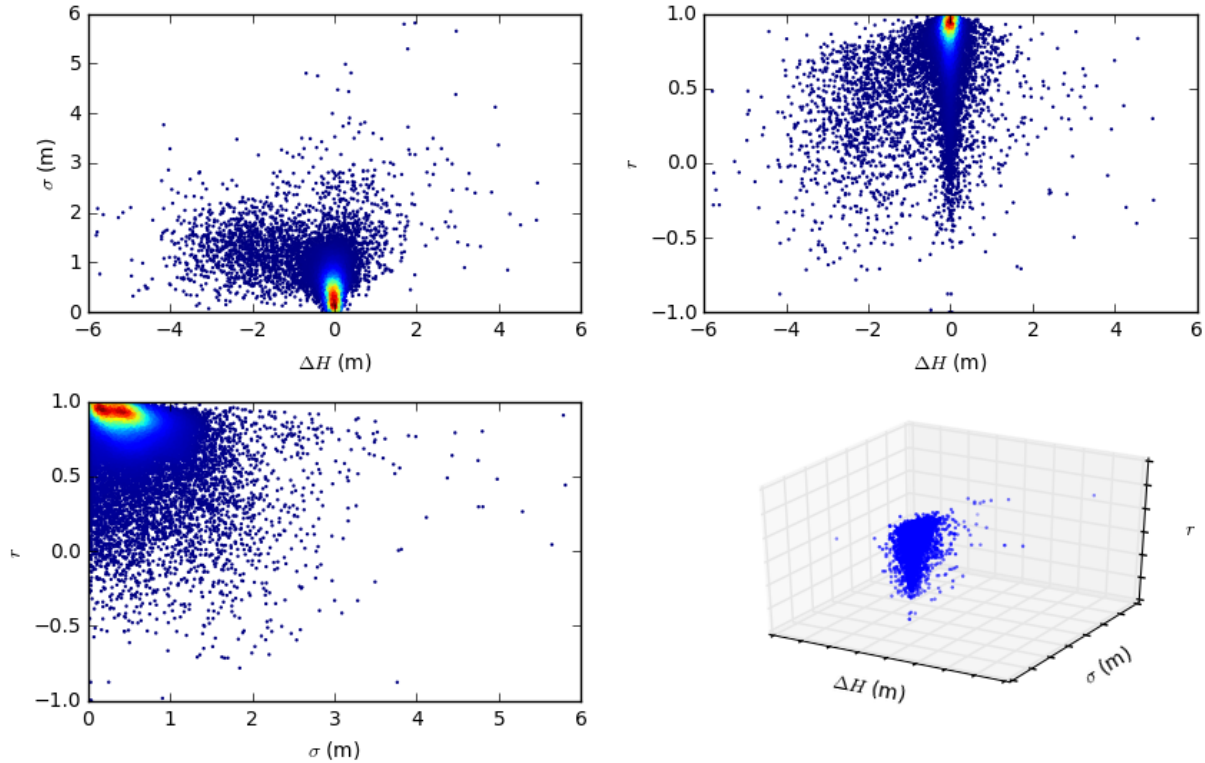
Figure 8: Scatter plots of the three parameters ( $\Delta H$ ,  $\sigma$ ,  $r$ ) calculated for all the buildings in the study area. The color represents the density of points, where red shows the area with the highest density.

Within the study area, 26,128 building footprints were extracted. It is worth mentioning that few buildings were not well registered in the GIS map. Figure 8 shows the parameters calculated for each building, where the shaded color depicts the density of the dots. As seen, most of the points are located at approximately  $(\Delta H, \sigma, r) = (0 \text{ m}, 0.5 \text{ m}, 0.9)$ , which indeed represents non-collapsed buildings. Several buildings show positive values of  $\Delta H$ . A closer look revealed two principle factors: (1) the collapse of a neighboring building and (2) plastic covers placed over the roof for protection from the rain.

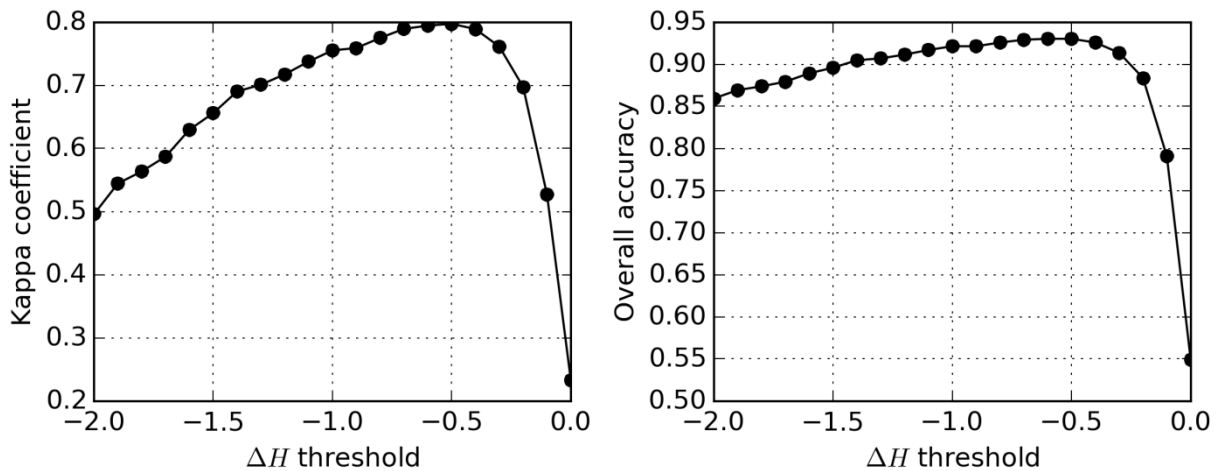
Figure 9: Kappa coefficient (left) and overall accuracy (right) obtained from the comparison between the data surveyed by Yamada et al. (2017) and the estimated collapsed buildings based on different  $\Delta H$  threshold values.

where  $p_{11}$  and  $p_{12}$  are the ratio of non-collapsed buildings predicted as non-collapsed and collapsed buildings, respectively.  $p_{21}$  and  $p_{22}$  are the ratio of collapsed buildings predicted as non-collapsed and collapsed buildings, respectively. From Figure 9, it is observed that a threshold value of -0.5 m gave the highest values for both the Cohen's Kappa coefficient (0.80) and the overall accuracy (0.93).

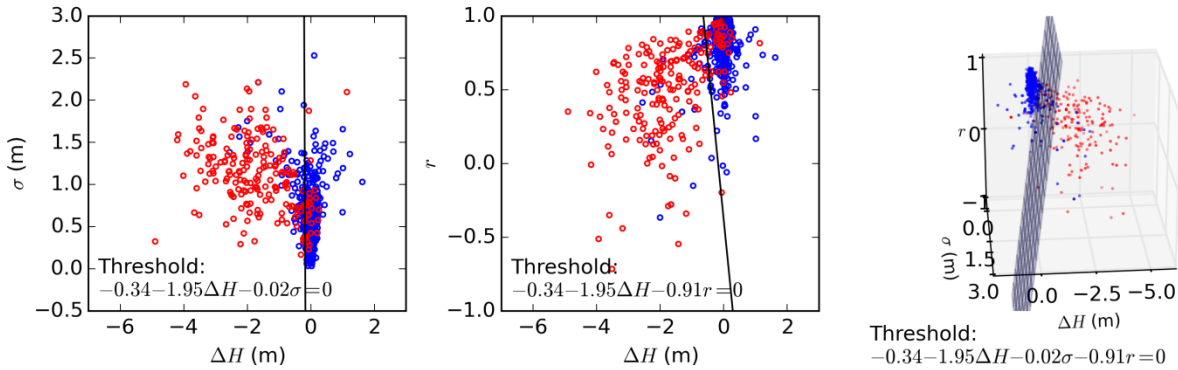
Figure 10: Classification of collapsed (red) and non-collapsed (blue) buildings using the three parameters based on SVM.

To determine if the use of all the parameters could produce better accuracy in detecting collapsed buildings, the Support Vector Machine (SVM) method was selected to construct a plane that separates collapsed and non-collapsed buildings in the three-dimensional database ( $\Delta H$ ,  $\sigma$ ,  $r$ ). The plane has the largest distance from the nearest training data (ground truth data). Using kernel functions, SVM can be used to construct a non-linear function as well; however, in this study we only evaluated linear functions (i.e., a plane). Figure 10 shows the plane constructed using SVM, where the red and blue marks depict the collapsed and non-collapsed buildings based on the ground truth, respectively. The plane was constructed using the same amount of data for the two classes. Thus, 205 non-collapsed buildings were selected randomly from the surveyed data. The analysis was performed several times, and although the plane obtained showed small variations due to the random selection of the training data, the Cohen's Kappa coefficient produced in each analysis was almost constant with minor fluctuations around 0.80. The accuracy produced by SVM is very similar to the accuracy obtained when only a  $\Delta H$  threshold is used.

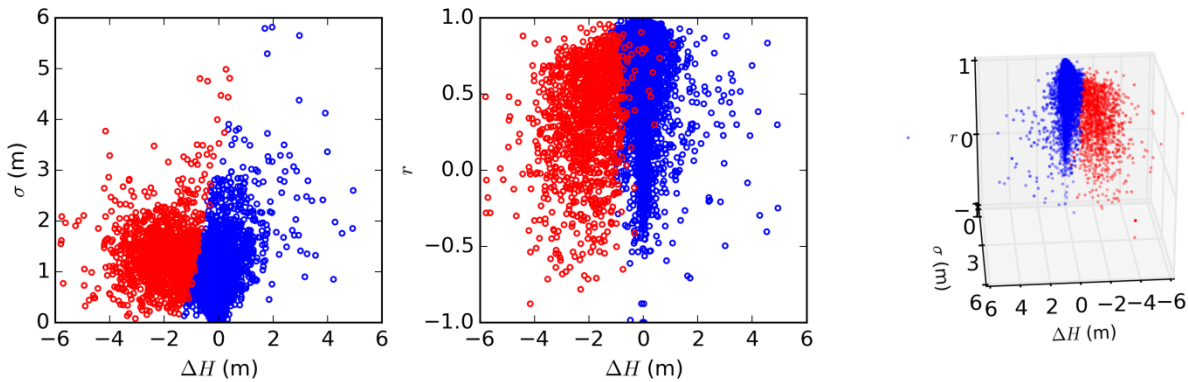
5 Figure 11: Classification of collapsed (red) and non-collapsed (blue) buildings using the three parameters based on the K-means clustering method

This study also evaluated the potential use of unsupervised classification to extract collapsed buildings. Specifically, K-means cluster analysis was applied to all the data in the study area. Unlike SVM, K-means clustering does not require training data. Therefore, the database of all the buildings in the study area (Figure 8) was used. The method clusters the data and separates them into two groups, which represent the collapsed and non-collapsed buildings. The objective of the method is to minimize the inertia of each group, that is, the summation of the squared distance between all the data points of a group and its centroid. Figure 11 represents the predicted collapsed and non-collapsed buildings using the K-means clustering method, for which the Cohen's Kappa coefficient obtained was 0.76. Figure 12 shows the confusion matrix calculated from

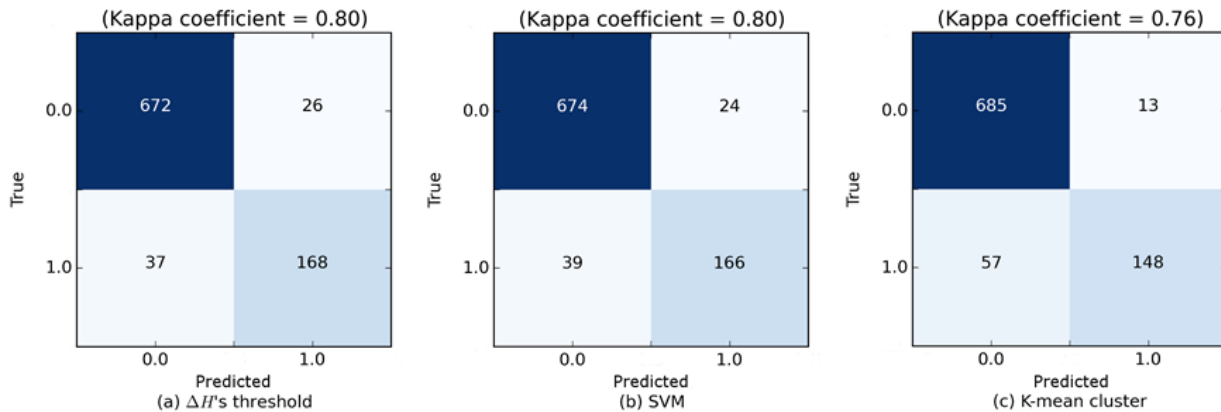
Figure 12: Confusion matrix calculated from the comparison of the ground truth data and the predicted damage levels based on the  $\Delta H$  threshold (a), SVM (b), and K-means clustering (c). Two damage levels, non-collapsed (0.0) and collapsed (1.0), were employed.

the comparison between the ground truth data and the predicted results from the three methods explained above: applying a  $\Delta H$  threshold, SVM, and K-means clustering. The first two methods show the same level of accuracy, while K-means clustering shows a lower accuracy.

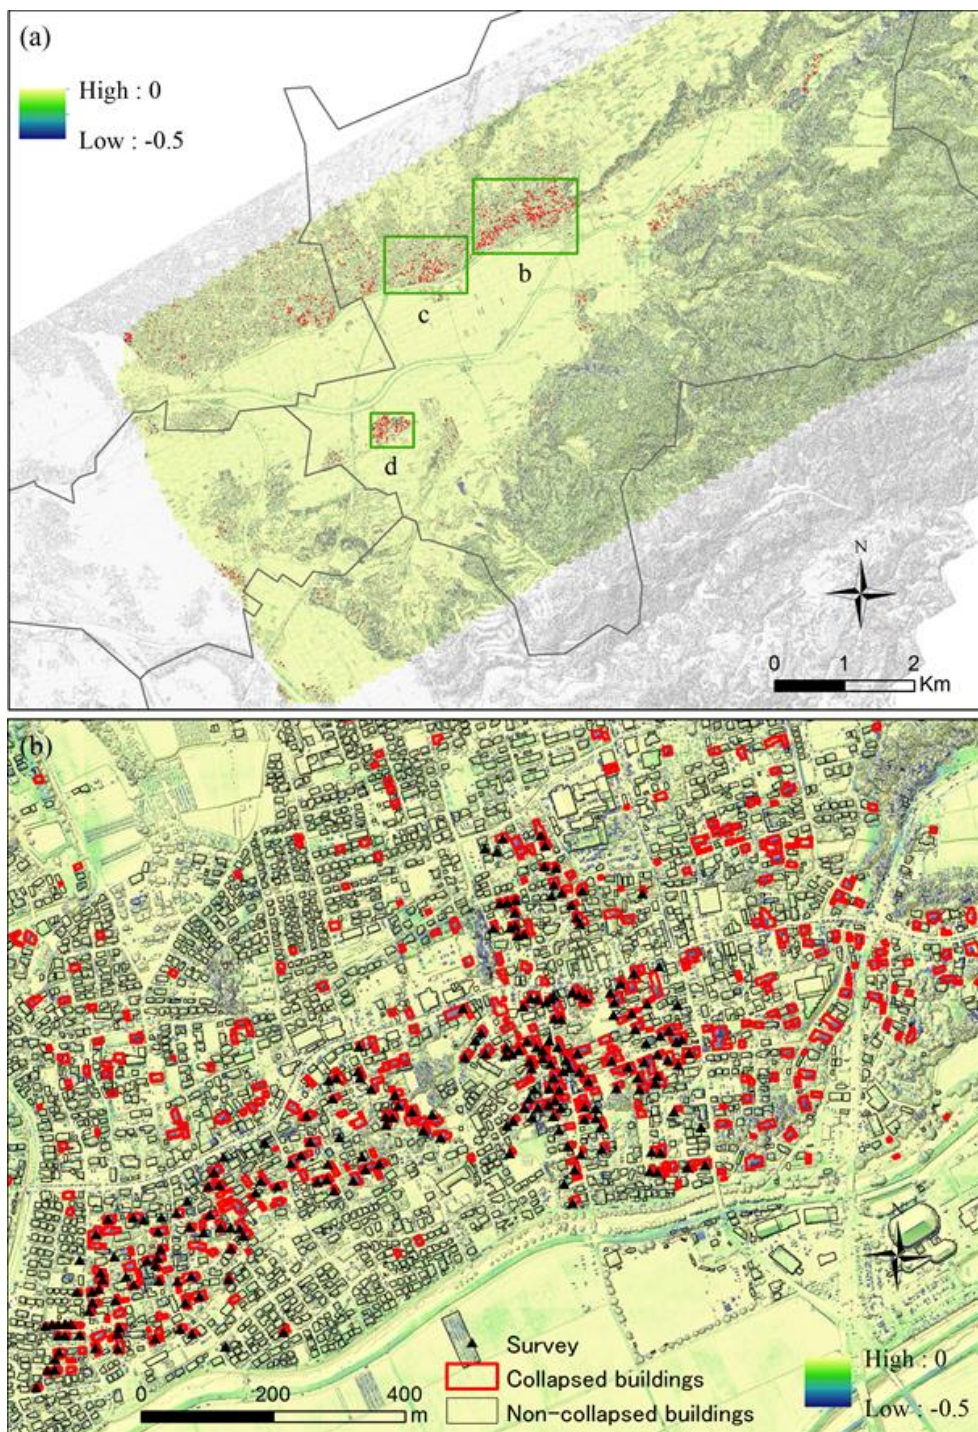
Figure 13: (a) A map showing the distribution of collapsed ( $\Delta H \leq -0.5$  m) buildings, shown as red polygons, in the study area. The pixel color represents the difference in elevations between the BDSM and ADSM. The green squares show the locations of areas shown in Figure 13 (b) and Figure 14. (b) Close-up view of Area (b) where the collapsed buildings were concentrated. The black triangles show the D5 buildings from Yamada et al. (2017).

Figure 13 illustrates the spatial distribution of collapsed buildings estimated using a  $\Delta H$  threshold of -0.5 m. A large number of collapsed buildings were observed in the study area (Figure 13a). The red and black polygons represent the collapsed (D5) and non-collapsed (D0-D4) buildings, respectively. The color of the pixels represents the difference in elevations between the ADSM and BDSM. Blue pixels depict differences of elevations less than -0.5 m, and yellow pixels represent differences greater than 0 m. Figure 13b and Figure 14 provide a closer look of the areas where the collapsed buildings are concentrated. Figure 13b also depicts the location of the collapsed buildings surveyed by Yamada et al. (2017) as black triangles. Within the study area, a total of 26,128 buildings were evaluated, and 1,760 buildings were classified as collapsed ( $\Delta H$  less than -0.5 m).

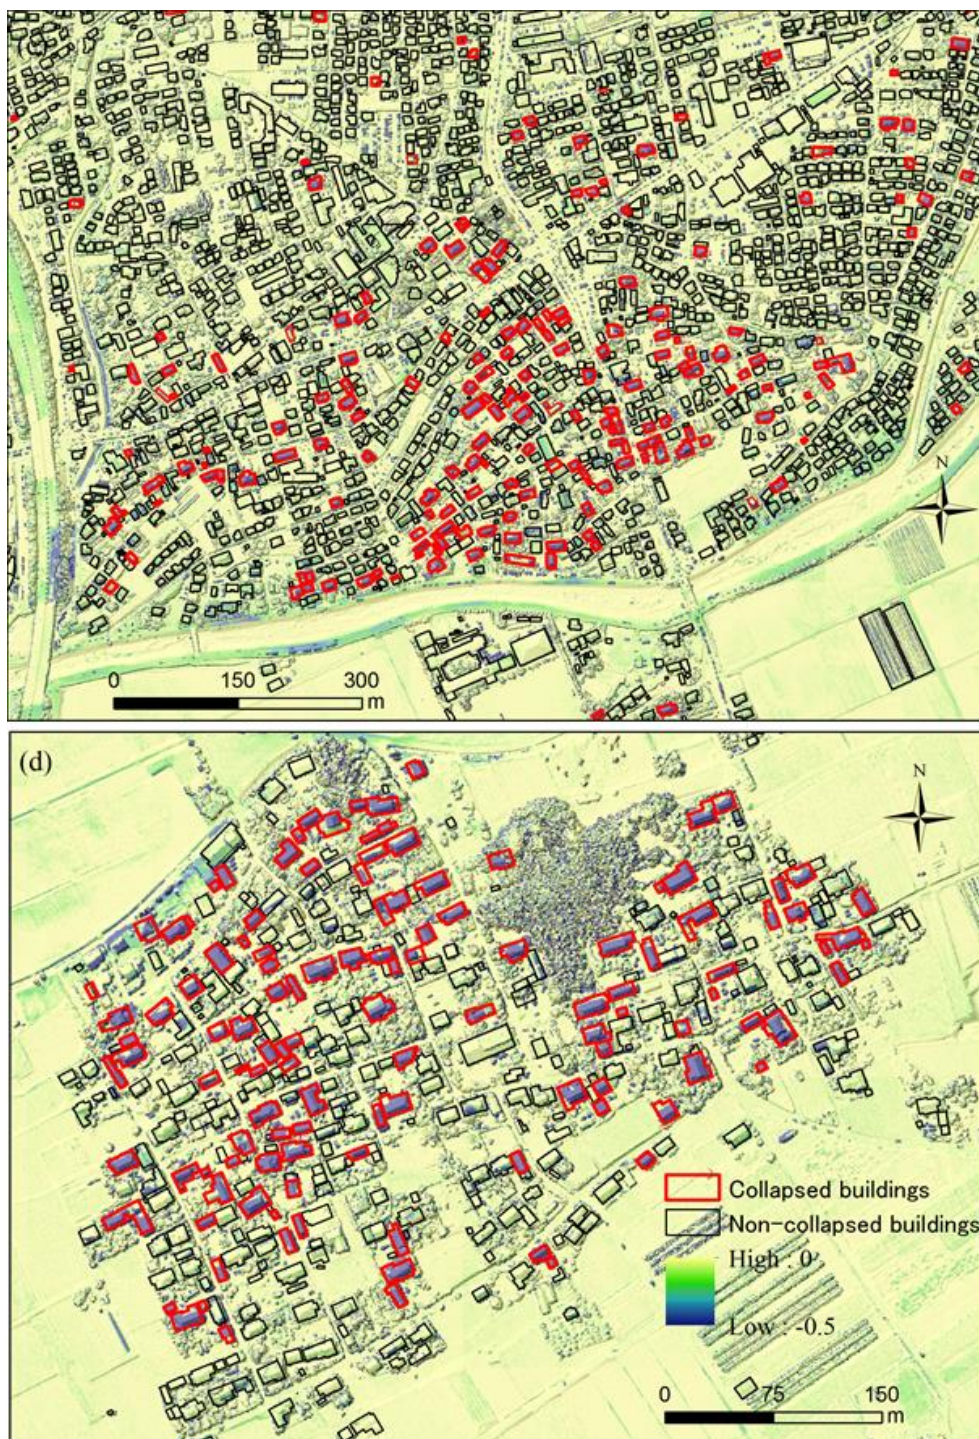
Figure 14: Close-up view of Areas (c) and (d) in Figure 13 (a) where collapsed buildings are concentrated. The red and green polygons are the collapsed and non-collapsed buildings estimated using the threshold ( $\Delta H \leq -0.5$  m).

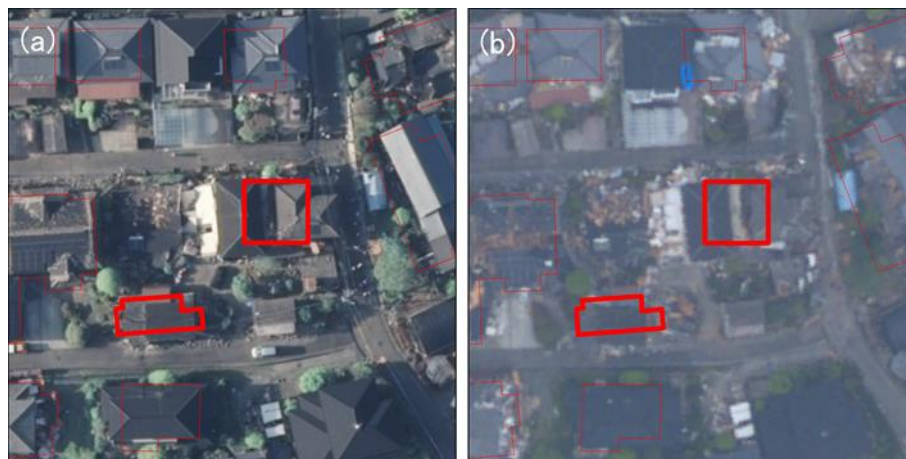
**Figure 15: (a) Aerial image taken on April 15; (b) Aerial image taken on April 23. The thick red polygons shows buildings that collapsed after the foreshock and were detected using the  $\Delta H$  threshold.**

It was observed that some buildings collapsed by the foreshock (April 14 event) were also detected by the Lidar methods. In order to be detected, the debris of those buildings should be either severely disturbed by the mainshock (April 16 event) or removed before the ADSM was recorded. For instance, Figure 15 shows two buildings collapsed during the foreshock (Figure 15a). However, because the mainshock produced significant reduction of their elevations (Figure 15b), it was also detected from the pair of Lidar.
