Use of a remotely piloted aircraft system for hazard assessment in a rocky mining area (Lucca, Italy)

5 Riccardo Salvini¹, Giovanni Mastrorocco¹, Giuseppe Esposito¹, Silvia Di Bartolo¹, John Coggan²,
Claudio Vanneschi²

Abstract. The use of remote sensing techniques is now common practice in different working environments, including
15 engineering geology. Moreover, in recent years the development of structure from motion (SfM) methods, together with rapid technological improvement, has allowed the widespread use of cost effective remotely piloted aircraft systems (RPAS) for acquiring detailed and accurate geometrical information even in evolving environments, such as mining contexts. Indeed, the acquisition of remotely sensed data from hazardous areas provides accurate 3D models and high resolution orthophotos minimizing the risk for operators. The quality and quantity of the data obtainable from RPAS surveys can then be used for
20 inspection of mining areas, audit of mining design, rock mass characterizations, stability analysis investigations and monitoring activities. Despite the widespread use of RPAS, its potential and limitations have still to be fully understood.

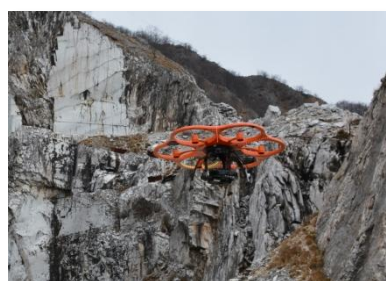
Table 1. Utilized RPAS and camera specifications.

RPAS Type	Dimensions (cm)	Engines	Rotor diameter (cm)	Empty weight (kg)	Max. takeoff weight (kg)
Aibotix Aibot X6 v1	Width 105 Height 45	Brushless motors	30.48 (12")	2.45	6.5
Camera	Sensor type	Sensor Size (mm)	Image size (pixel)	Pixel size (mm)	Focal length (mm)
Nikon CoolpixA	CMOS	23.6 x 15.6	4,928 x 3,264	0,121	18.5

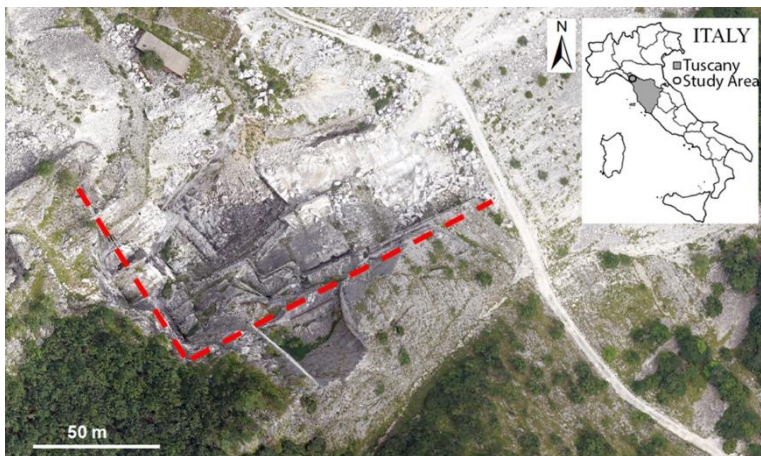
Figure 1. Plan view of the Piastrone open pit with indication of the two principal slope directions (dotted lines). Inset map shows the location of the study area.

- The study area is located in the Apuan Alps marble district, in the province of Lucca (Tuscany, Italy - Fig. 1). The open pit or quarry, named "Piastrone", is characterized by a V shape, with two principal slope directions oriented 50/90 and 323/90 (dip direction/dip). The bottom of the pit is located at 1,180 meters above sea level (m.a.s.l.) and the top of the excavated rock face is at 1,300 m.a.s.l.. The rock mass is characterized by different sets of discontinuities with persistence values that
- 15 can vary from a few meters up to decameters.

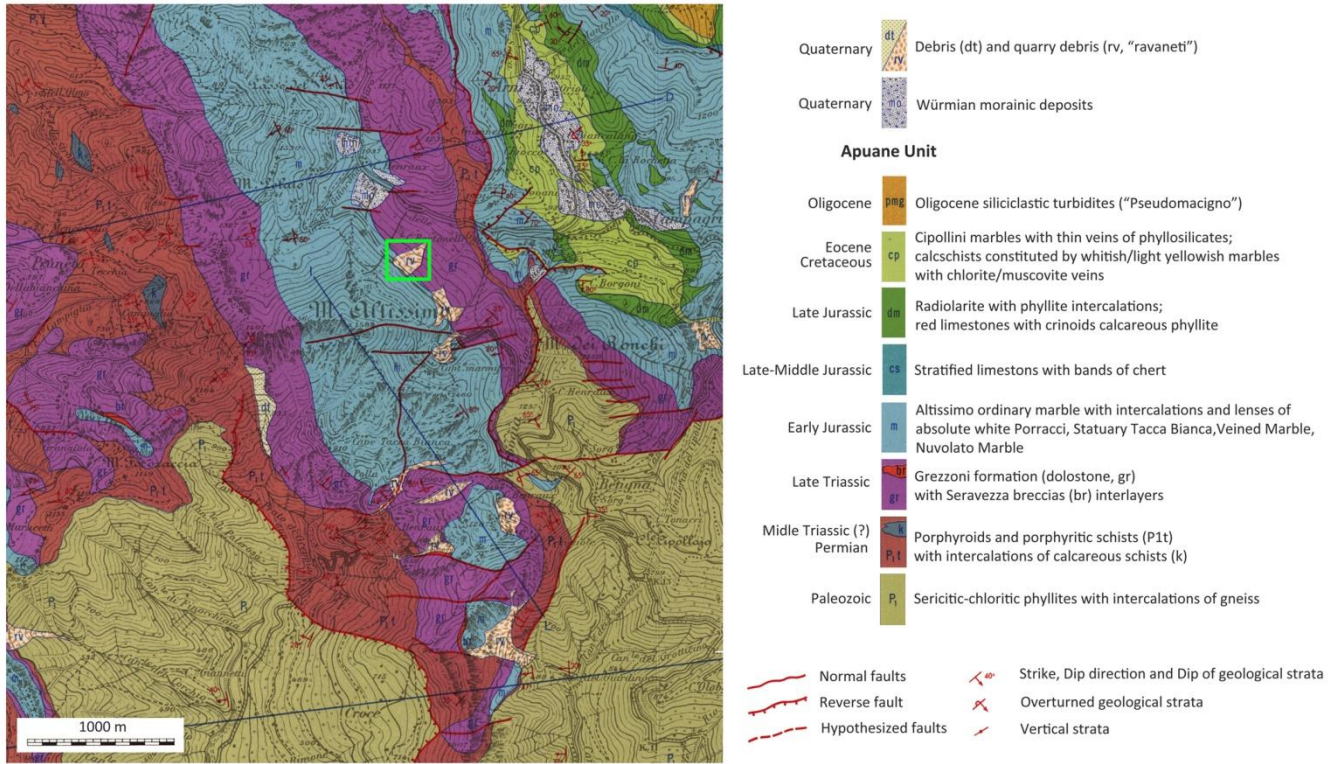
Figure 2. Geological map of the Mt. Altissimo area. The rectangle indicates the location of the quarry (modified from Giglia and Paiotti, 1963).

- From a geological point of view (Fig. 2) the Piastrone open pit is located in the Apuan Alps metamorphic complex, precisely in the Mt. Altissimo Syncline (AS), belonging to the Apuane Unit (Meccheri et al., 2007). According to classical interpretation (Carmignani and Kligfield, 1990) AS resulted from a compressive tectonic phase which originated during the Tertiary continental collision between the Sardinia-Corsica block and the Adria plate. Successively, during the Early

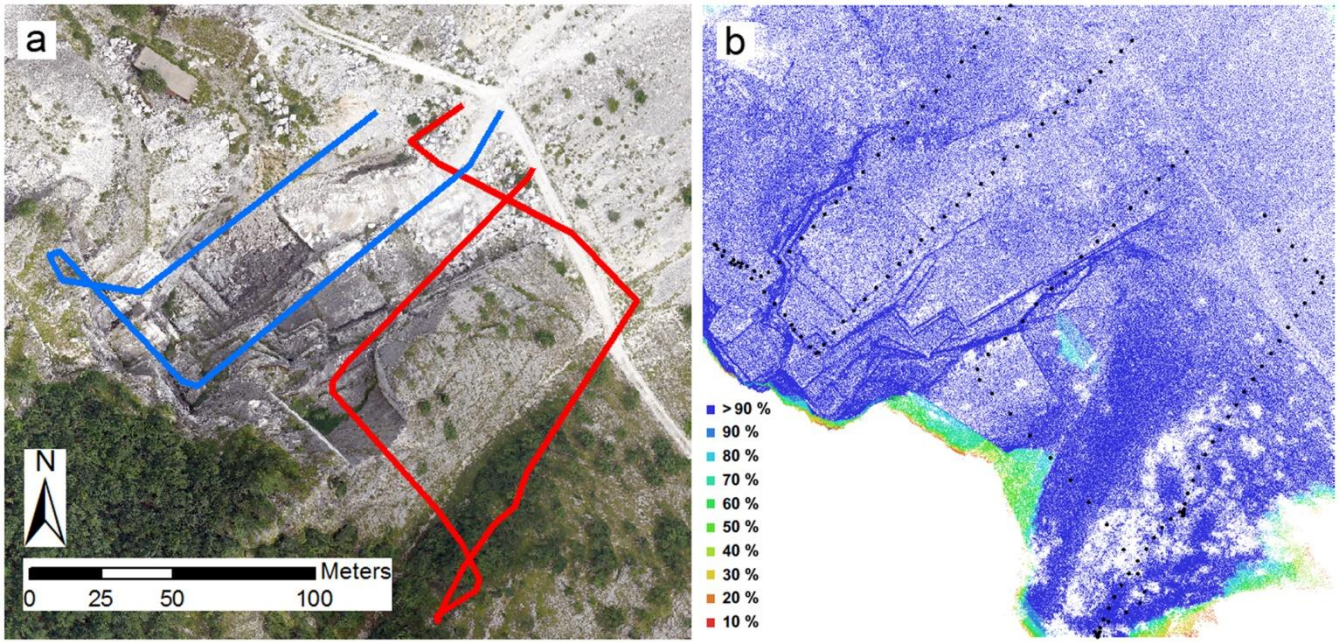
Figure 3. Flight paths of the RPAS zenithal surveys (a). Plan view of the area with indication of camera locations (black dots) and image overlap percentage (b).

The zenithal survey was preliminarily designed in the laboratory with the AibotixTM AiProflight planning software, and manually performed through single quasi-parallel flight lines. A total of 151 aerial images were acquired with a nominal overlap and sidelap of 80% and 60% respectively. Two flights were required to cover all sectors of the mining area (Fig. 3). An average estimated distance between pixel centers measured on the ground (i.e. ground sample distance - GSD) of 2.4 cm was calculated. During the flight, a global navigation satellite system (GNSS) field survey was also carried out in order to ensure the necessary spatial accuracy of the resultant images. Eight artificial targets, 50x50 cm large, were located with the purpose of obtaining an optimum spatial distribution on the accessible zones of the study area (Fig. 4) and used as ground control points (GCPs) and check points.

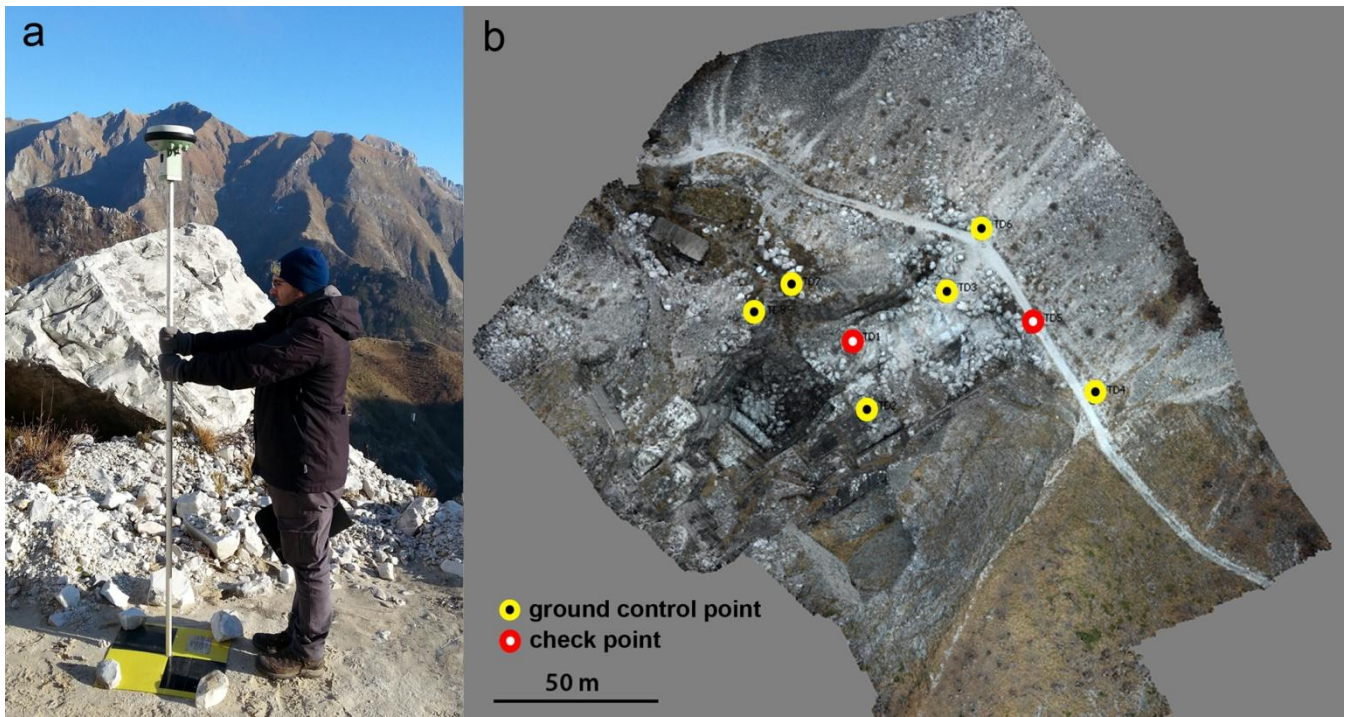
Figure 4. Example of a GCP measured during the RTK GNSS field survey (a) and spatial distribution of GCPs and check points for the RPAS zenithal flights (b).

The GNSS survey was carried out in real time kinematic (RTK), using geodetic receivers. A reference station was set up, recording continuous signals from the GNSS satellite constellation for more than 3 hours. The positional information obtained by the reference station was then sent to a mobile receiver, using radio modem communication. Each ground control point, GCP, was occupied for at least two minutes with a recording interval equal to 1 second. The coordinates of the points determined using this technique were corrected by post-processing procedures using contemporary data recorded by three permanent GNSS stations (La Spezia, Pieve Fosciana and Pisa) allowing centimetric accuracy. The orthometric heights were also calculated by using Convergo, an Italian code for full coordinate conversion. The coordinates of the GCPs were collected in ETRF2000 and then converted to the Italian National Gauss Boaga system for orientation of the images and subsequent determination of the inclination and position of slopes and orientation of discontinuities.

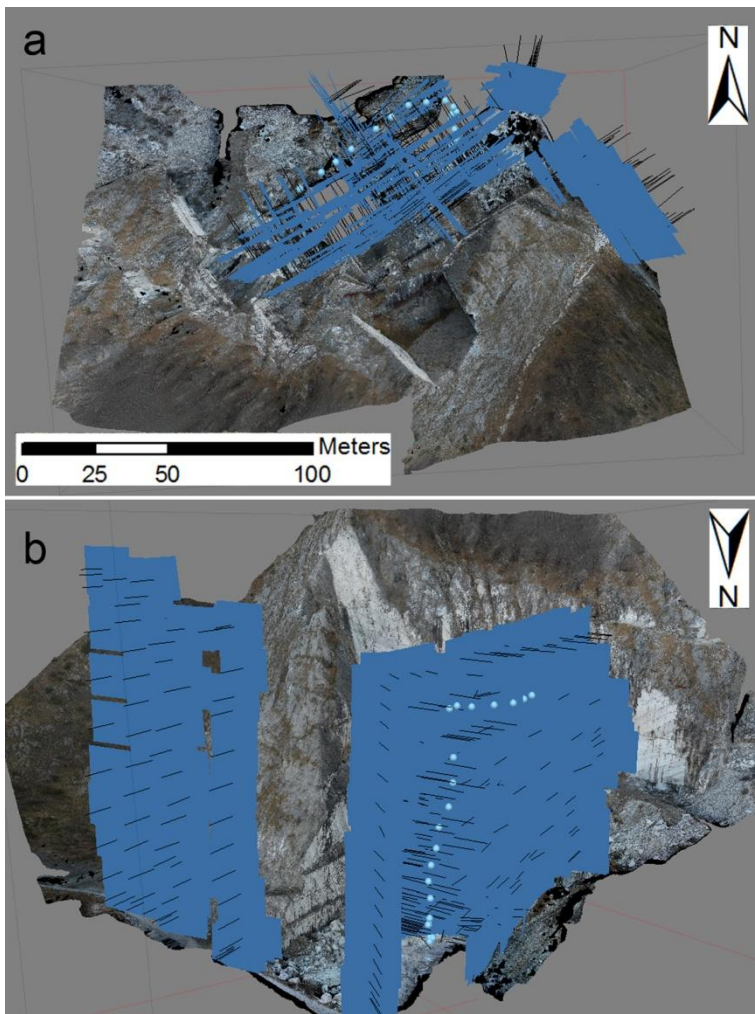
Figure 5. Plan view (a) and perspective view (b) of the RPAS frontal surveys (blue rectangles correspond to the photographs locations, black lines to normals). Corresponding 3D point cloud produced with photogrammetric processing of digital images is shown in background.

The frontal survey, with direction of acquisition parallel to the rock face, was carried out manually, without the use of the AibotixTM AiProflight planning software. Six flights were required in order to cover all sectors of the mining area, resulting in a total of 448 overlapping images. The flights were executed in sub-parallel straight lines approximately 60 meters distant from the rock face (Fig. 5), providing an average estimated GSD of 1.5 cm.

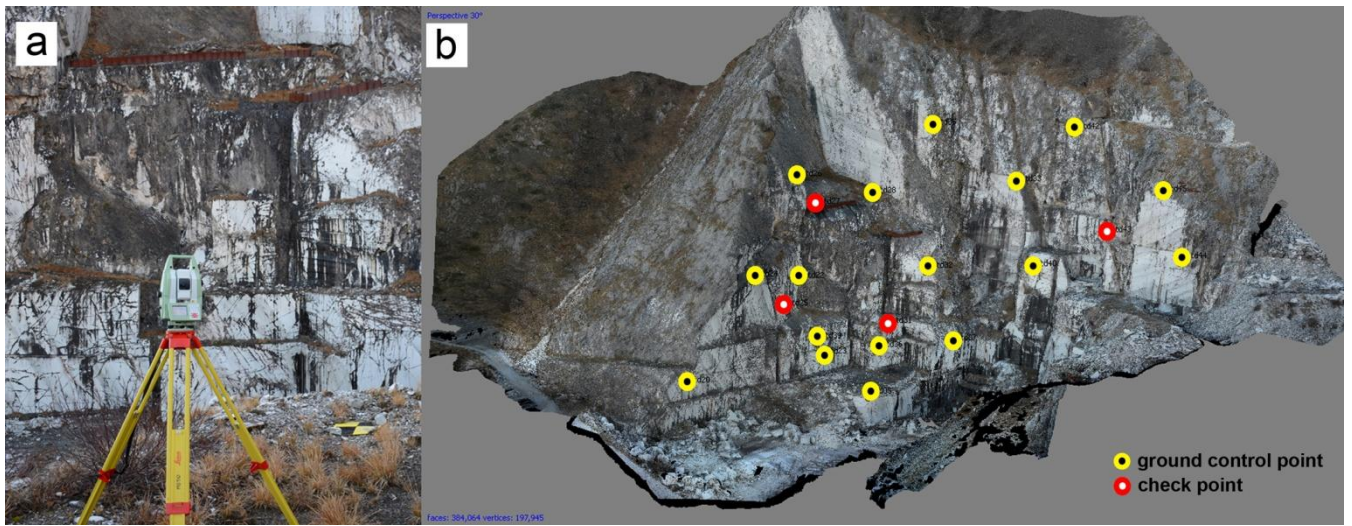
Figure 6. Topographic survey with TS (a) and spatial distribution of GCPs and check points for the RPAS frontal flights (b).

As for the zenithal flight, a series of GCPs and check points (21 targets in total - Fig. 6) were measured using a reflectorless total station (TS). Their location was decided considering a balance between an optimum spatial distribution (Fig. 6), both in space and elevation from the open pit floor, and easy identification of points on the images. Due to the complex morphology of the slopes and the extent of the mining area, a large number of GCPs were used to orient the photogrammetric model.

Differently, the frontal flights, on the perpendicular to the rock faces, have been executed ad hoc and the related photos used to build a separate frontal model as shown in Fig. 6. In that case the GCPs were collected at different heights using a TS, obtaining a very good model of the cliff. It should be underlined that GCPs for both zenithal and frontal flights are projected in the same reference system. In the end, analysis of the results confirms the good accuracy level of the final model, widely adequate for the purpose of the work.

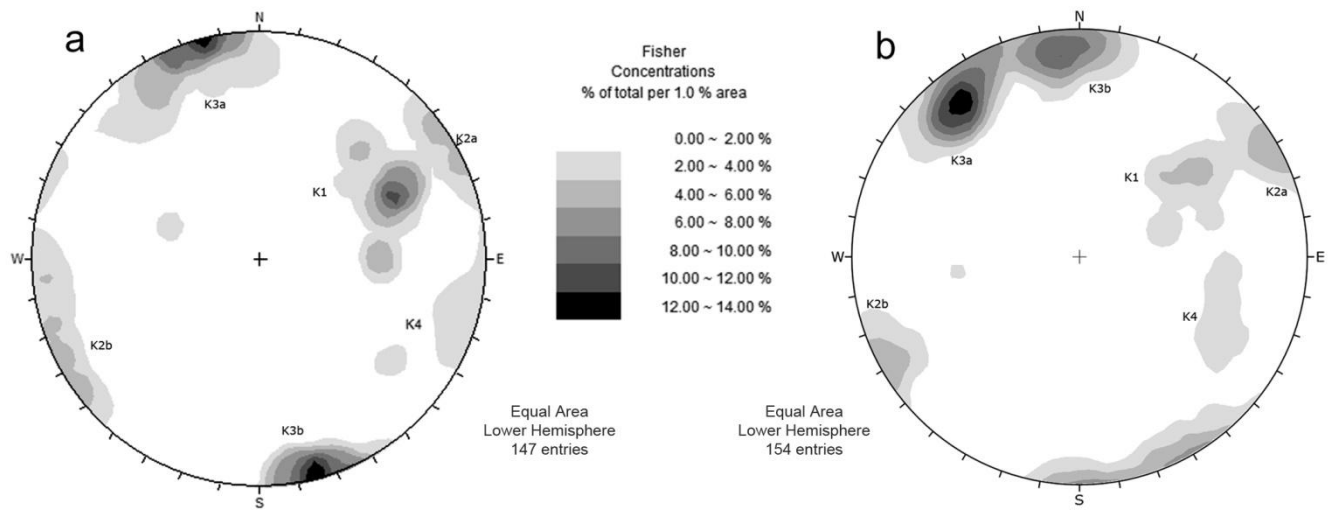
Figure 7. Stereonet plot of poles (Schmidt, equal area, lower hemisphere) of the discontinuities manually collected through classical engineering geological survey (a) and remotely collected by using photogrammetric data from RPAS surveys (b).

The orientation of 154 discontinuity planes manually selected on the point cloud was calculated through stereographic projection. The final stereonet allowed identification of four discontinuity sets, whose properties listed in table 3 were obtained from traditional engineering geological survey carried out in accessible areas of the mine. By comparing the discontinuity planes obtained through traditional manual engineering geological survey (a in Fig. 7) and that identified on the point cloud (b in Fig. 7) a good level of congruence has been highlighted, confirming the quality of the approach taken.

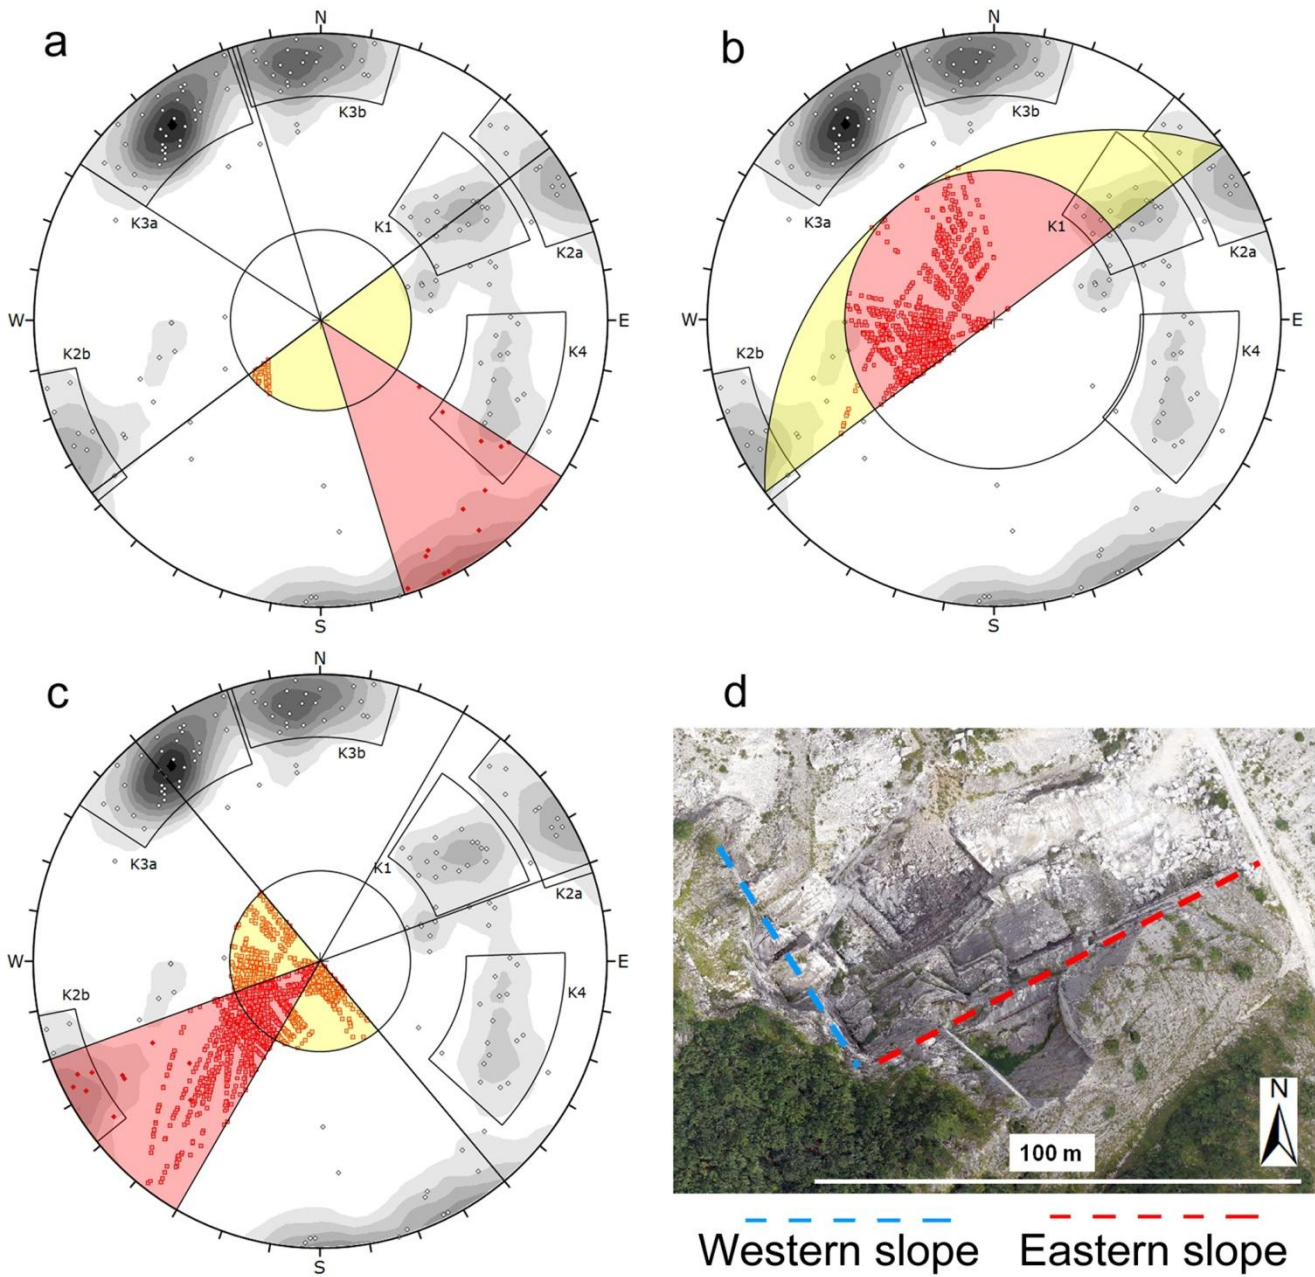
Figure 8. Examples of kinematic stability analysis carried out using Rocscience™ Dips 6.0 stereographic projection through the Wulff equal-angle method (lower hemisphere); a) Planar sliding on the eastern slope; b) Wedge sliding on the eastern slope; c) Direct toppling on the western slope; d) Aerial photo showing the two principal slope orientations.

Based on the discontinuity characteristics derived from RPAS and traditional engineering geological surveys, the basic RMR (RMRb) and GSI index were calculated. The RMRb was found to be 67 (table 4), while the GSI was estimated to be between 60 and 65 using the modified chart proposed by Hoek et al. (2013). In addition, application of Hoek et al. (2013) equation for GSI quantification ($GSI=1.5 JCond_{80} + RQD/2$) confirmed the results of the qualitative chart interpretation with a value of 65. Both classifications indicate a rock mass of 'good' quality. These results agree with the authors' field observations and what is described in the actual quarry excavation plan (Lorenzoni, 2012). In view of the rock competency, potential instability is not related to the strength properties of the rock mass, but the intersection of discontinuity planes can locally form rock blocks with the potential for sliding or toppling. For this reason, a kinematic stability analysis was performed. A discontinuity friction angle of 35° was used in the analysis: this agrees with data from previous studies carried out by the quarry's advisors (Lorenzoni, 2012; Dumas, 1999), by the Geomechanical laboratory of the Centre of GeoTechnologies of Siena University, and literature (Chang et al., 1996; Perazzelli et al., 2009; Mastrorocco, 2013). Table 5 shows the potential failures identified through kinematic stability analysis (examples are shown in Fig. 8) for both principal slope orientations. Three different possible kinematic modes were identified, with K2b and K4 systems having the most influence on potential instability. The majority of the potential failures identified relate to planar sliding or wedge sliding, in agreement with field and SfM-based observations. The results highlight the potential for blocks to form that may be subject to gravity induced instability but, as previously stated, traditional kinematic analyses do not identify the location of these unstable blocks.

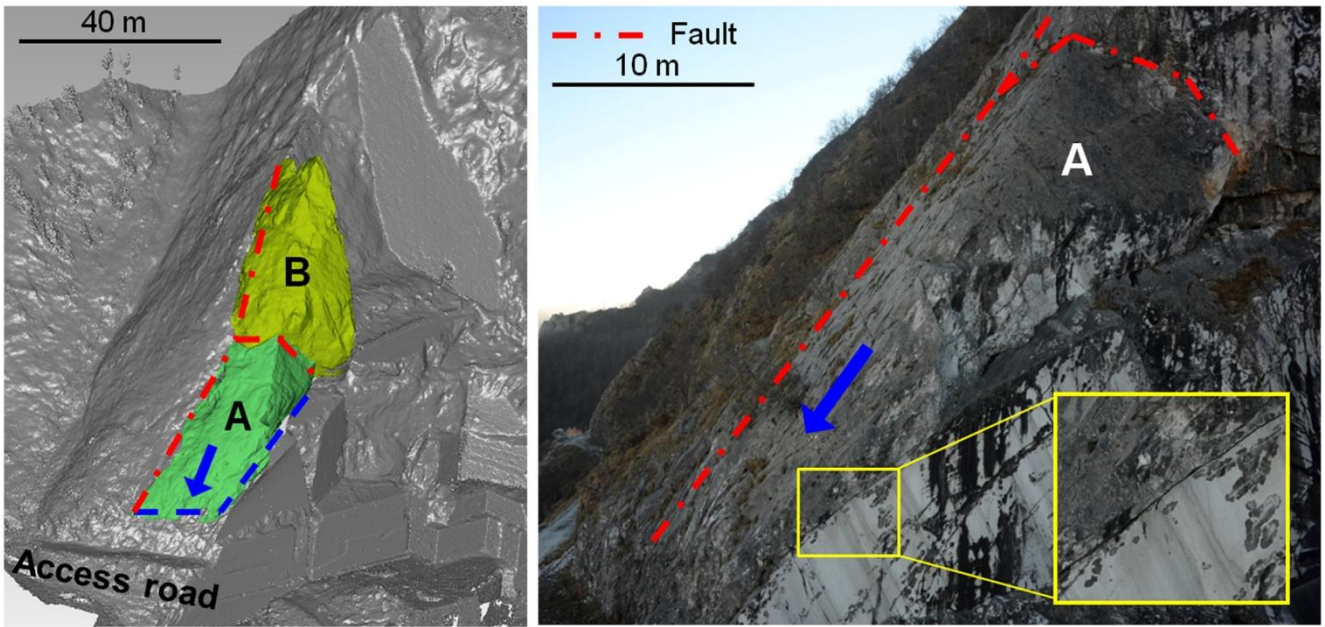
Figure 9. Identification of two large blocks with potential for sliding; inset photo highlights the visible aperture of the basal plane.

Therefore, further analysis of the high resolution images and the dense point cloud was performed in order to locate possible block source areas. More than 20 blocks were deterministically characterized in terms of size, shape and barycentric coordinates, varying from about a cubic meter to a few hundred cubic meters. In addition, the analysis identified two large blocks (Fig. 9), a few thousand cubic meters in size, with potential for sliding. These are formed by the intersection of two different faults and a discontinuity basal plane with 5 cm aperture, no infill, smooth surface and high persistence. The basal plane appears not to correspond with any of the identified discontinuity sets, but is probably connected to planes of weakness of the marble in correspondence with a particular orientation of minerals crystallographic axes. The lateral and rear faults, however, may be associated with the K3a and K3b systems respectively. The rear fault may also be associated with the East-West fault system that characterizes the geology of this area of the Apuan Alps complex (Fig. 2).

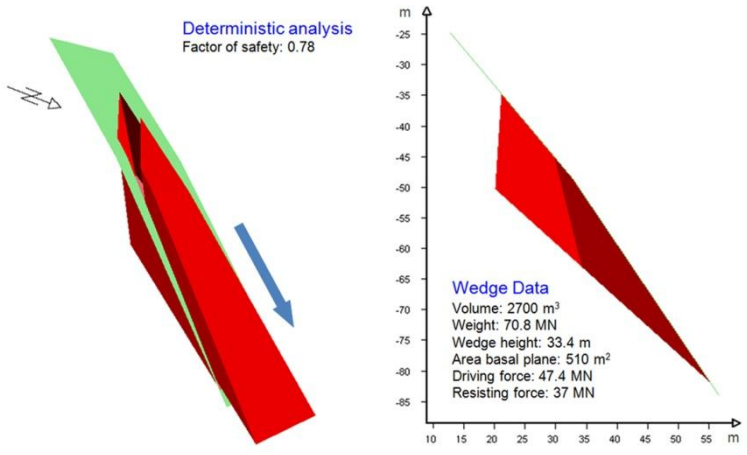
5 **Figure 10.** Result of Swedge 3D preliminary slope stability analysis.

20 The adopted limit equilibrium solution for the slope stability analysis was based on the Mohr-Coulomb shear strength model with a friction angle of 35° and a unit weight of 0.026 MN/m³ (Ertag, 1980; Dumas, 1999). It should be noted that the western lateral surface observable in the model was also necessary to re-create the block geometry in the software. It was assigned 0° friction angle so as not to induce a resisting force in the simulation. Water forces were also initially ignored within the preliminary analysis (Fig. 10).

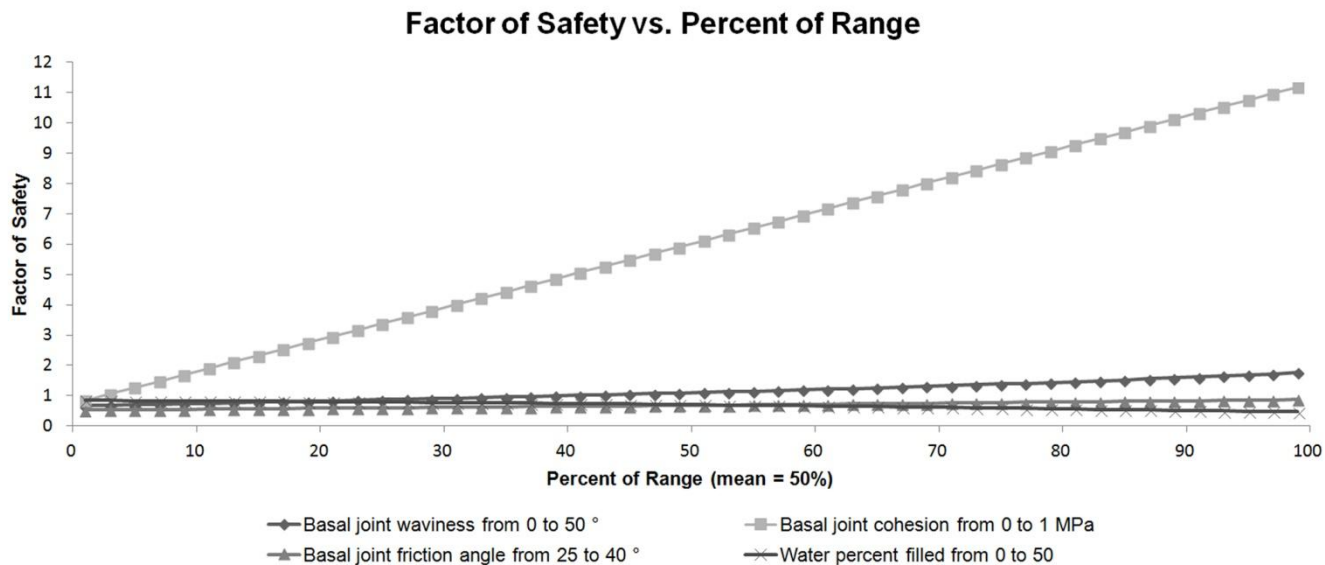
5 **Figure 11.** Result of sensitivity analysis relative to basal joint waviness, friction angle, cohesion and water percent filled parameters.

25 The result highlights a possible condition of instability for Block A which does not match with field observations, since the block under study has remained stable in this position for tens of years. In order to investigate the effect of uncertainty or variability of the input parameters, a sensitivity analysis was performed. In a sensitivity analysis (Fig. 11) specific parameters are varied across a range of values and the effect on the Factor of Safety is observed. This helps to identify the parameters that have the most effect on block stability. Since the geometrical inputs are well defined through the accurate 3D model, the subsequent analysis focused on waviness angle (it accounts for the undulations of the joint surface, observed over distances on the order of 1 m to 10 m; Miller, 1988), cohesion and friction angle of the basal plane and water pressure. These are also the parameters with the higher input uncertainty.

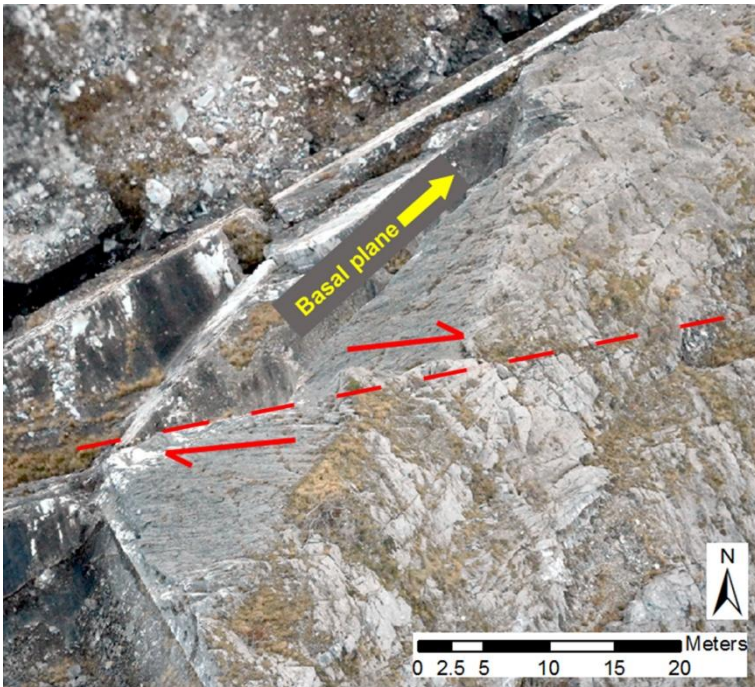
Figure 12. Detail of the zenithal orthophoto with indication of apparent motion of a major fault acting as back release surface for block A of figure 9.

In this stability analysis the major uncertainty is on the basal plane (Fig. 12). Despite the presence of a continuous trace line
30 on the rock exposure, its full persistence in the rock mass is not clear. In general, the presence of rock bridges plays an important role in stabilizing the removable rock blocks. In particular, a rock block cannot fall or slide from a slope until the rock bridges have failed. The rock bridge failure involves the collapse or failure of the intact rock, which can be an order of magnitude stronger than the rock mass (Kemeny and Donovan, 2005). From the sensitivity analysis undertaken, cohesion of the basal plane was the parameter that had the most significant influence on the block factor of safety. This suggests that it

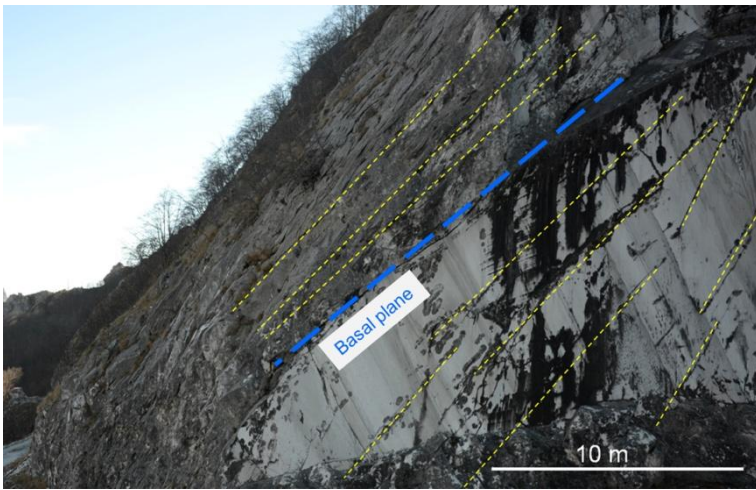
Figure 13. Details of a series of high discontinuities over and below the basal plane under study.
