# Use of a remotely piloted aircraft system for hazard assessment in a rocky mining area (Lucca, Italy)

**Abstract.** The use of remote sensing techniques is now common practice in different working environments, including  
15 engineering geology. Moreover, in recent years the development of structure from motion (SfM) methods, together with rapid technological improvement, has allowed the widespread use of cost effective remotely piloted aircraft systems (RPAS) for acquiring detailed and accurate geometrical information even in evolving environments, such as mining contexts. Indeed, the acquisition of remotely sensed data from hazardous areas provides accurate 3D models and high resolution orthophotos minimizing the risk for operators. The quality and quantity of the data obtainable from RPAS surveys can then be used for  
20 inspection of mining areas, audit of mining design, rock mass characterizations, stability analysis investigations and monitoring activities. Despite the widespread use of RPAS, its potential and limitations have still to be fully understood.

In this paper a case study is shown where a RPAS was used for the engineering geological investigation of a closed

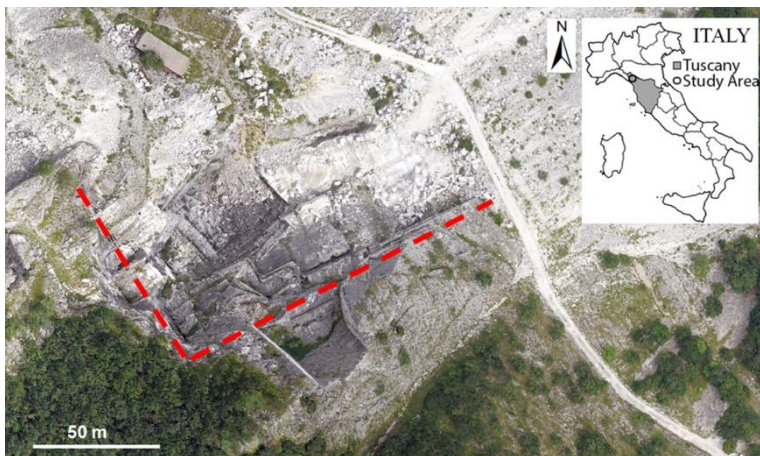
**Figure 1.** Plan view of the Piastrone open pit with indication of the two principal slope directions (dotted lines). Inset map shows the location of the study area.

The study area is located in the Apuan Alps marble district, in the province of Lucca (Tuscany, Italy - Fig. 1). The open pit or quarry, named "Piastrone", is characterized by a V shape, with two principal slope directions oriented 50/90 and 323/90 (dip direction/dip). The bottom of the pit is located at 1,180 meters above sea level (m.a.s.l.) and the top of the excavated rock face is at 1,300 m.a.s.l.. The rock mass is characterized by different sets of discontinuities with persistence values that can vary from a few meters up to decameters.

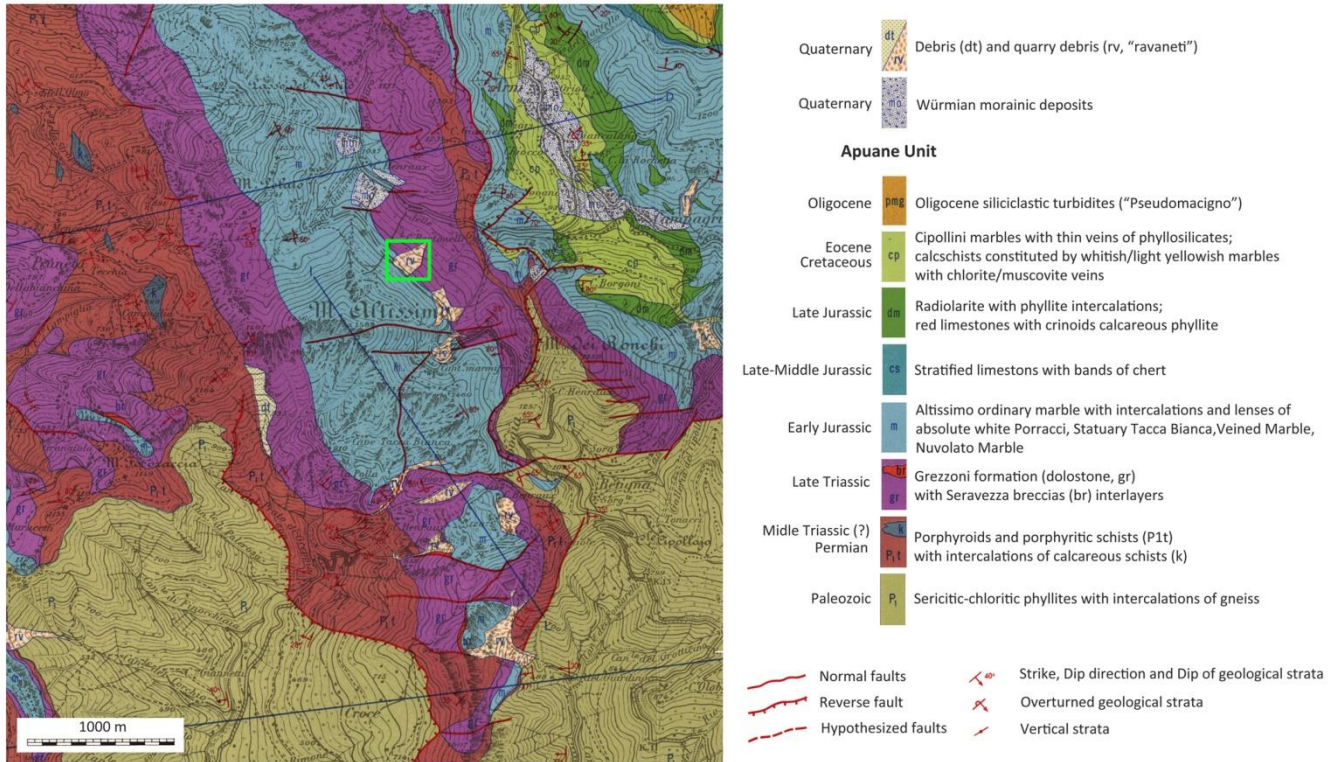
# Mt. Altissimo Geological map

**Figure 2.** Geological map of the Mt. Altissimo area. The green rectangle indicates the location of the quarry (modified from Giglia and Paiotti, 1963).

From a geological point of view (Fig. 2) the Piastrone open pit is located in the Apuan Alps metamorphic complex, precisely in the Mt. Altissimo Syncline (AS), belonging to the Apuane Unit (Meccheri et al., 2007). According to classical interpretation (Carmignani and Kligfield, 1990) AS resulted from a compressive tectonic phase which originated during the Tertiary continental collision between the Sardinia-Corsica block and the Adria plate. Successively, during the Early Miocene, a new ductile to brittle-ductile deformation caused by a post-compression tectonic uplift overprinted the earlier structures and generated a widespread network of joints and faults. In the Mt. Altissimo area, the main set of brittle deformation strikes SW-NE to W-E with sub-vertical dip, generally with negligible displacement except for a few cases where offsets of some ten meters have been observed (Meccheri et al., 2007).

of the marble in correspondence with a particular orientation of minerals crystallographic axes. The lateral and rear faults, however, may be associated with the K3a and K3b systems respectively. The rear fault may also be associated with the E-W fault system that characterizes the geology of this area of the Apuan Alps complex (Fig. 2).

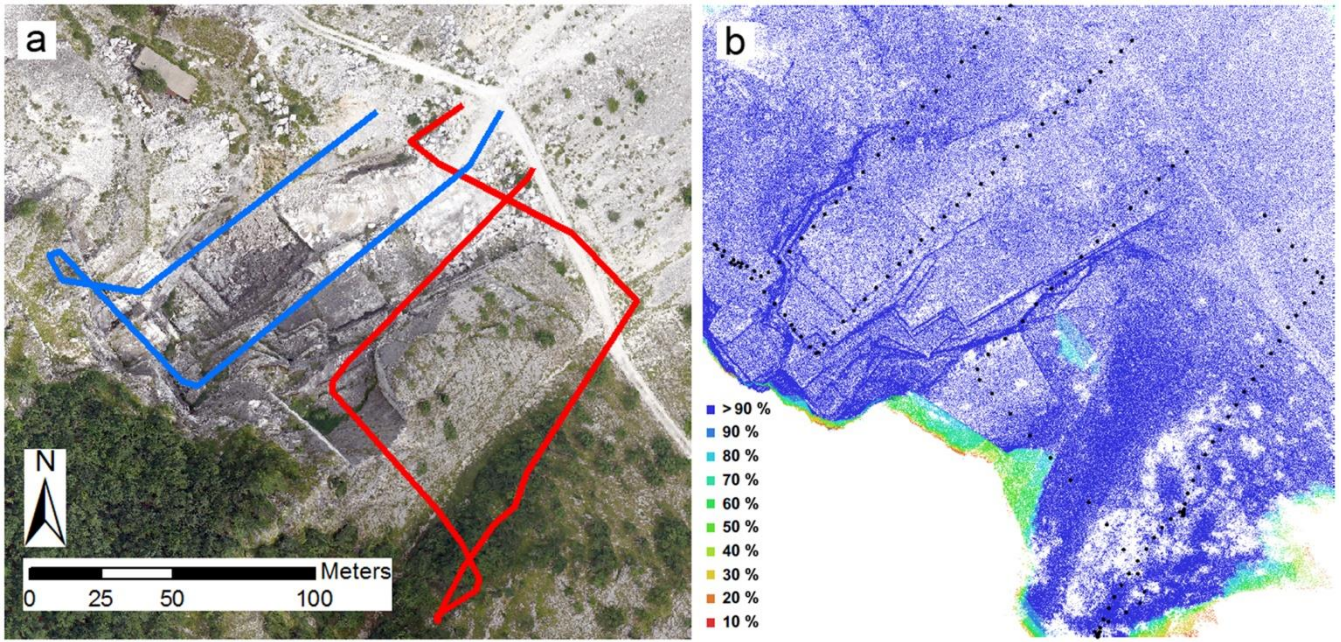
**Figure 3.** Flight paths of the RPAS zenithal surveys (a). Plan view of the area with indication of camera locations (black dots) and image overlap percentage (b).

The zenithal survey was preliminarily designed in the laboratory with the Aibotix™ AiProfFlight planning software, and manually performed through single quasi-parallel flight lines. A total of 151 aerial images were acquired with a nominal overlap and sidelap of 80% and 60%, respectively. Two flights were required to cover all sectors of the mining area (Fig. 3). An average estimated distance between pixel centers measured on the ground (i.e. ground sample distance - GSD) of 2.4 cm was calculated. During the flight, a GNSS field survey was also carried out in order to ensure the necessary spatial accuracy of the resultant images. Eight artificial targets, 50x50 cm large, were placed on the ground with the purpose of obtaining an optimum spatial distribution on the accessible zones of the study area (Fig. 4) and used as GCPs and check points.

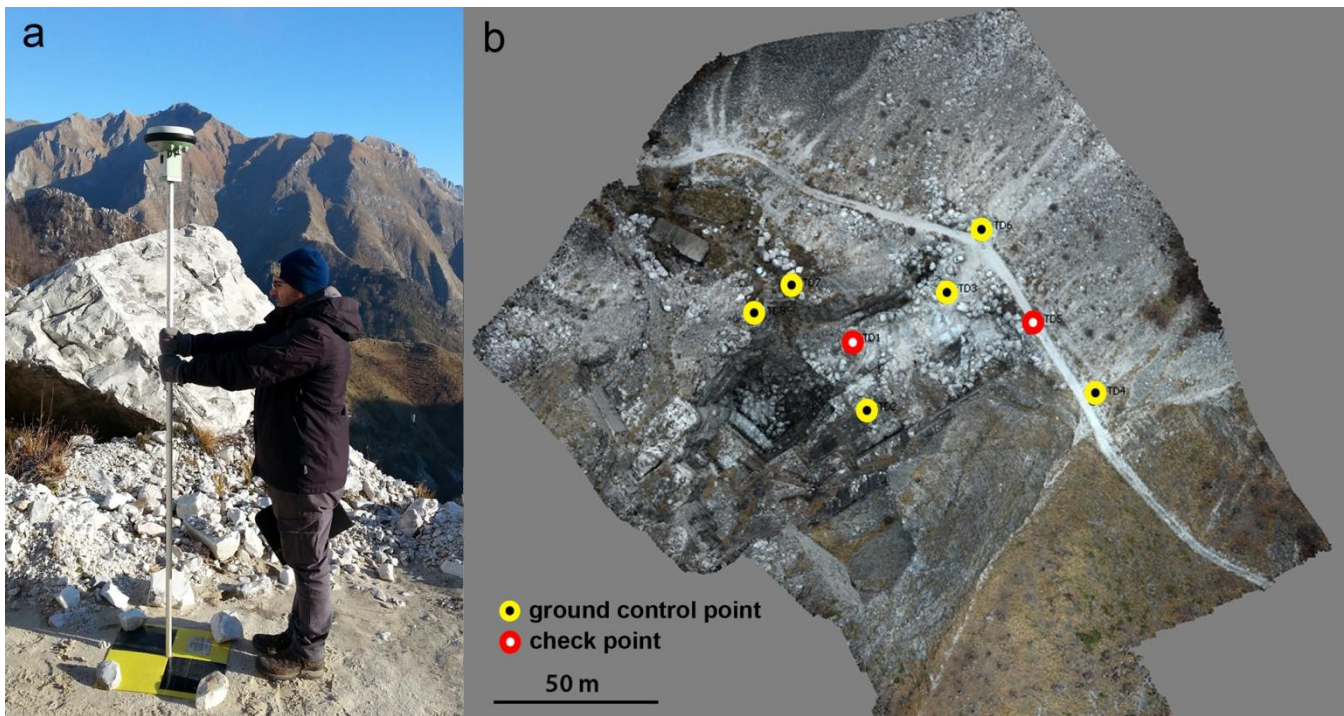
**Figure 4.** Example of a GCP measured during the RTK GNSS field survey (a) and spatial distribution of GCPs and check points for the RPAS zenithal flights (b).

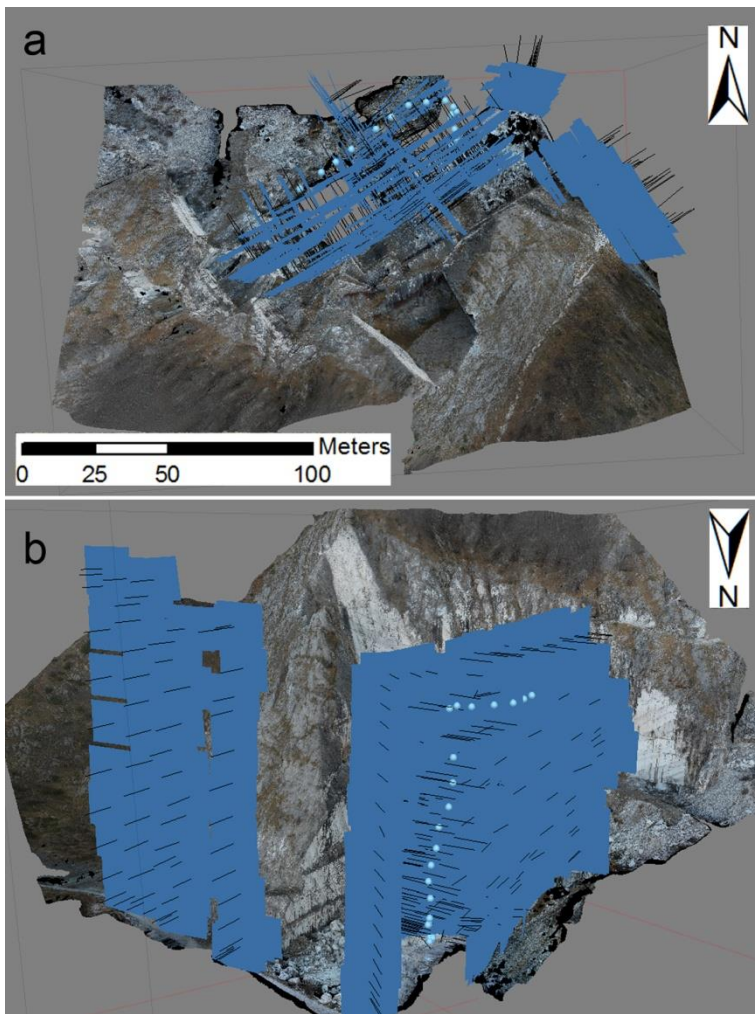
**Figure 5.** Plan view (a) and perspective view (b) of the RPAS frontal surveys (blue rectangles correspond to the photographs locations, black lines to normals). Corresponding 3D point clouds produced by the photogrammetric processing of natural colour digital images is shown in background.

The frontal survey, with direction of acquisition parallel to the rock face, was carried out manually, without the use of the Aibotix™ AiProfFlight planning software. Six flights were needed in order to cover all sectors of the mining area, resulting in a total of 448 overlapping images. The flights were executed in sub-parallel straight lines approximately 60 meters distant from the rock face (Fig. 5), providing an average estimated GSD of 1.5 cm.

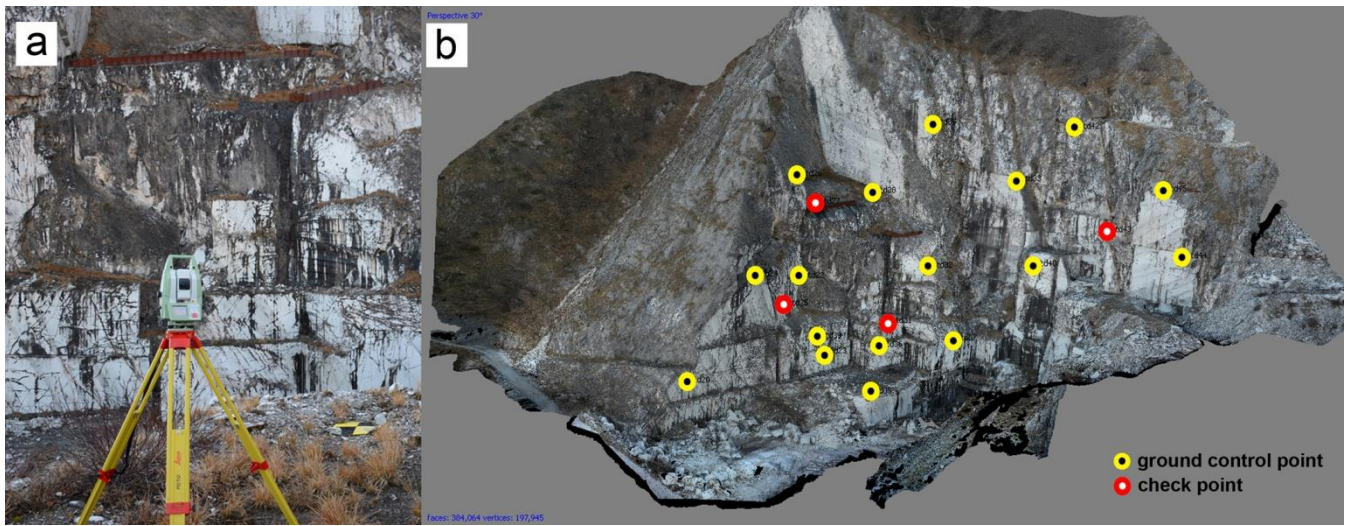
**Figure 6.** Topographic survey with TS (a) and spatial distribution of GCPs and check points for the RPAS frontal flights (b).

As for the zenithal flight, a series of GCPs and check points (21 targets in total - Fig. 6) were measured using a reflectorless TS. Their location was decided considering a balance between an optimum spatial distribution (Fig. 6), both in space and elevation from the open pit floor, and easy identification of points on the images. Due to the complex morphology of the slopes and the extent of the mining area, a large number of GCPs were used to orient the photogrammetric model. Two GNSS receivers, operating in static modality, were used to obtain the geographic coordinates of two points: the origin of the

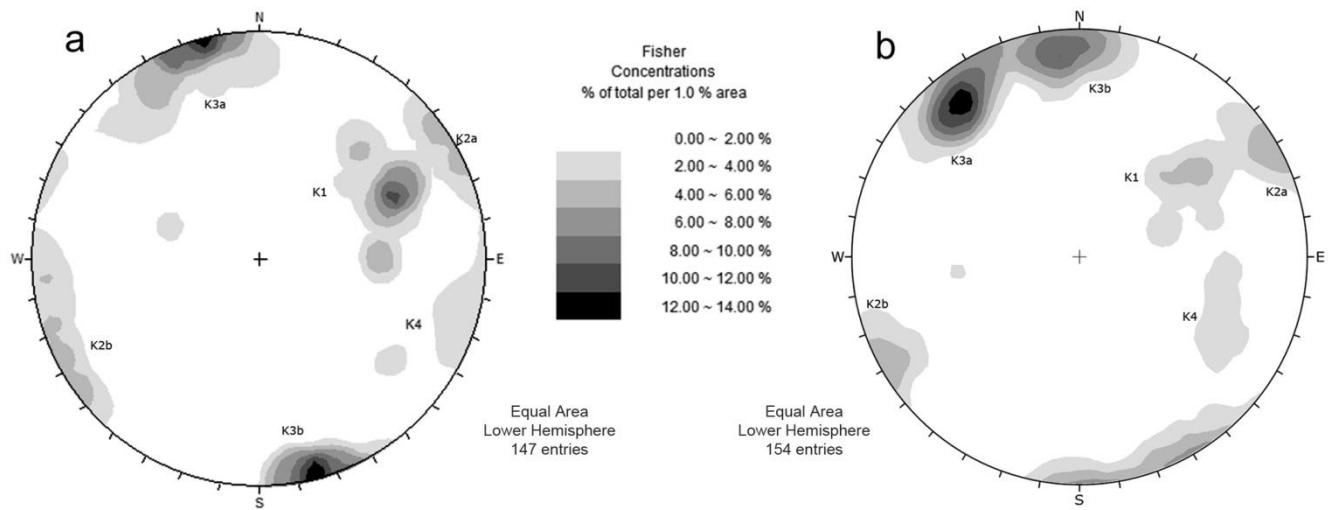
**Figure 7.** Stereonet plot of poles (Schmidt, equal area, lower hemisphere) of the discontinuities manually collected through classical engineering geological survey (a) and remotely collected by using photogrammetric data from RPAS surveys (b).

By comparing the discontinuity planes obtained through traditional manual engineering geological survey (a in Fig. 7) and that identified on the point cloud (b in Fig. 7) a good level of congruence has been highlighted, confirming the quality of the  
10 taken approach.

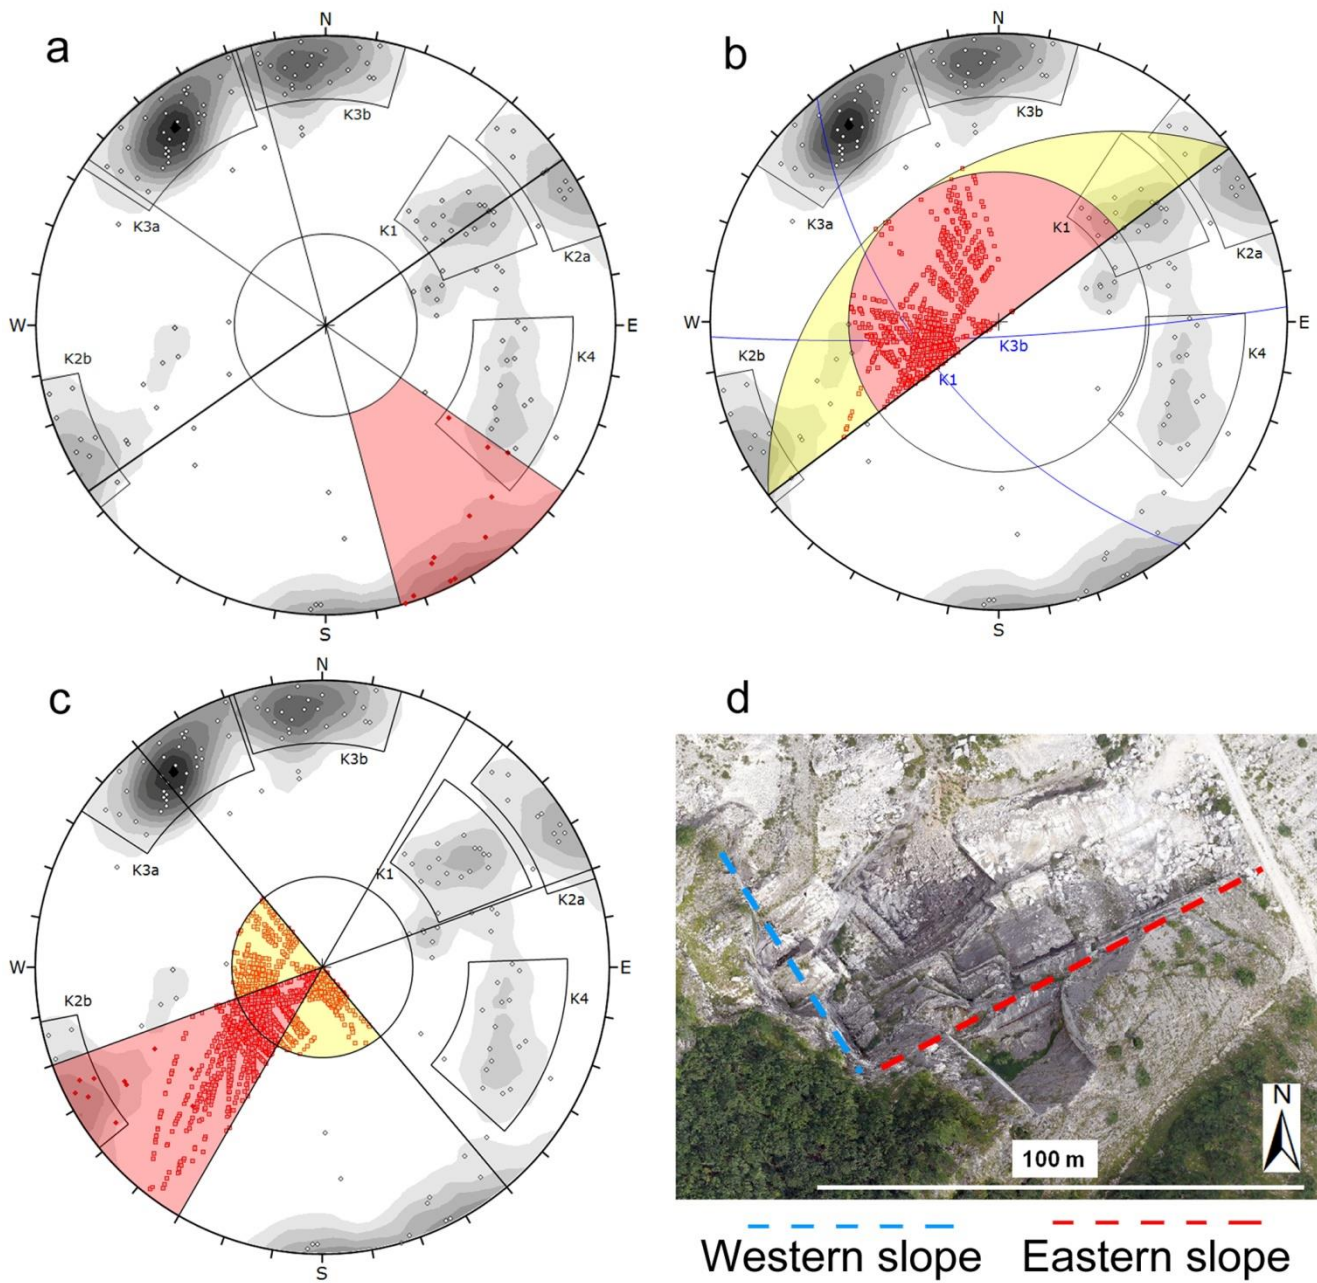
5 **Figure 8.** Examples of kinematic stability analysis carried out using Rocsience™ Dips 6.0 stereographic projection through the Wulff equal-angle method (lower hemisphere); a) Planar sliding on the eastern slope; b) Wedge sliding on the eastern slope (with highlighted great circles of intersection K1/K3b as example); c) Direct toppling on the western slope; d) Aerial photo showing the two principal slope orientations.

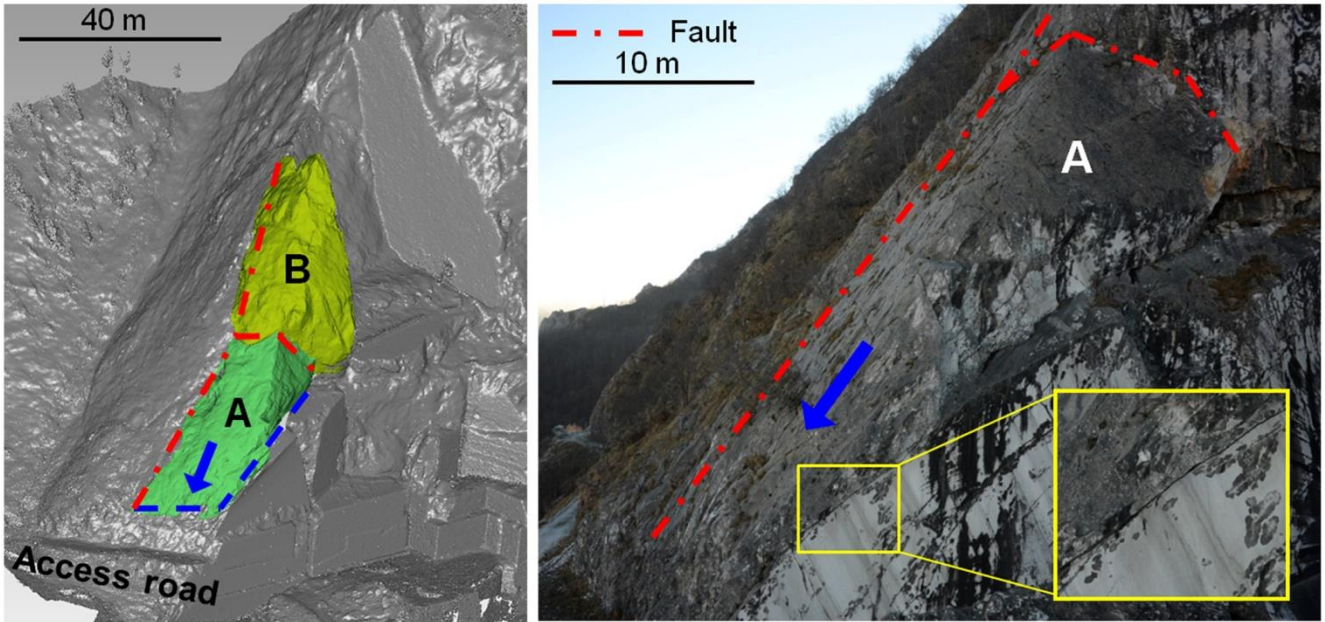
**Figure 9.** Identification of two large blocks with potential for sliding; inset photo highlights the visible aperture of the basal plane.

30 coordinates, varying from about a cubic meter to a few hundred cubic meters. In addition, the analysis identified two large blocks (Fig. 9), a few thousand cubic meters in size, with potential for sliding. These are formed by the intersection of two different faults and a discontinuity basal plane with 5 cm aperture, no infill, smooth surface and high persistence. The basal plane appears not to correspond with any of the identified discontinuity sets, but is probably connected to planes of weakness

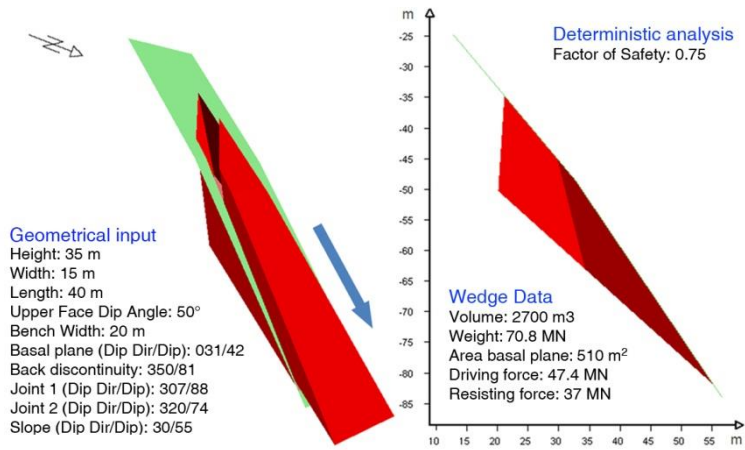
**Figure 10.** Result of Rocscience™ Swedge 3D preliminary slope stability analysis.

The geometry of Block A was deterministically re-created in Swedge using the geometrical information shown in Fig. 10. Initially the discontinuities were assumed to be fully persistent. This is a common approach in engineering geology, since reliable values of persistence are almost impossible to obtain from field mapping and most rock slope stability analysis assume that the 100% persistent joint exists on failure surface (Park, 2005). The basal plane is a joint and the possible presence of rock bridges should be carefully considered. In this case the basal plane did not show the presence of segments of intact rock along its trace on the rock exposure, consequently application of Eq. (2) confirms a 100% persistence of the basal plane, that was used in the first analysis. In addition, the lateral and rear or back surfaces correspond to geological faults and can be therefore considered fully persistent. In this regard, the western lateral surface has been included in the Swedge model has a discontinuity (Joint 1 in Fig.10; Dip Dir/Dip 307/88), while the back surface has been included as a tension crack (Back discontinuity in Fig.10; Dip Dir/Dip 350/81). It should be also noted that the eastern lateral surface observable in the model (Joint 2 in Fig.10; Dip Dir/Dip 320/74) was also necessary to re-create the block geometry in the software. A friction angle of 0° was assigned to the latter so as not to induce a resisting force in the simulation. Water forces were also initially ignored within the preliminary analysis.

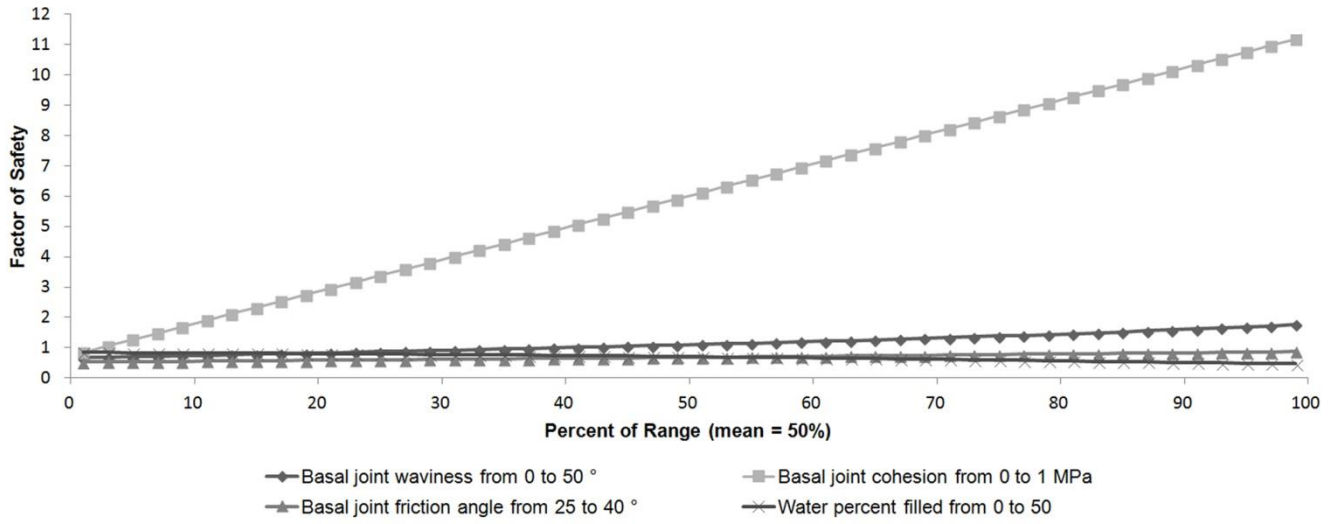
### Factor of Safety vs. Percent of Range

**Figure 11.** Result of sensitivity analysis relative to the parameters basal joint waviness, friction angle, cohesion and water percent filled.

Results of the sensitivity analysis (Fig. 11) show that the cohesion is clearly the parameter that has the most effect on block stability. For this reason, the effect of this parameter was investigated in more detail in the following analyses. Application of Eq. (3) makes it possible to determine an effective cohesion dependent on the continuity of jointing. From this the contribution of eventual rock bridges on the block stability can be investigated starting from intact rock cohesion material value, that has been determined to be approximately 16 MPa (Lorenzoni, 2012; Dumas, 1999; data from Geomechanical Laboratory of the Centre of GeoTechnologies of Siena University). Table 7 shows the results in terms of Factor of Safety obtained from a parametric stability analysis performed with increased values of effective cohesion, corresponding to 0, 0.5, 1, 2, 5, and 10% of rock bridges on the basal plane (total area of 510 m<sup>2</sup>), and a 20% of water filled fissures (considered reliable after field observation and high-resolution images analysis).

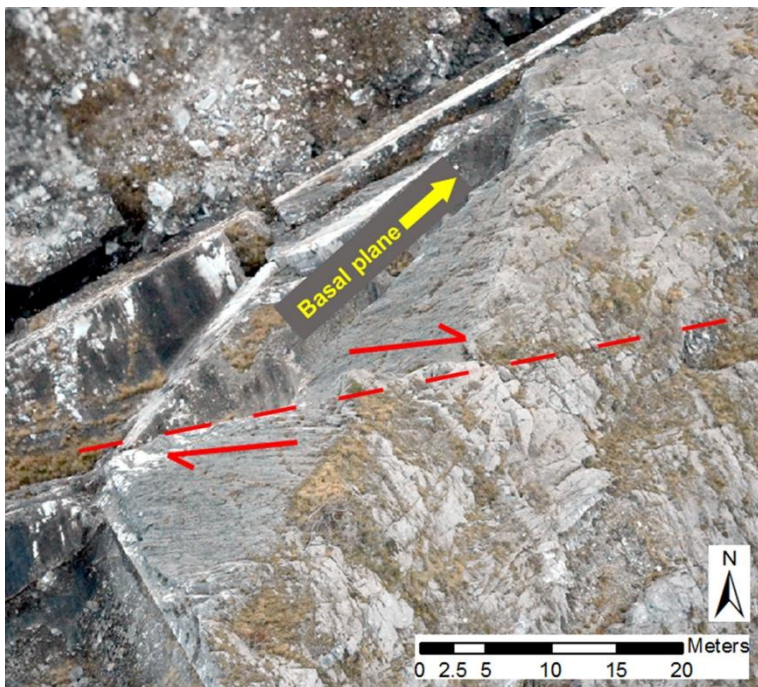
**Figure 12.** Detail of the zenithal orthophoto with indication of apparent offset of a major fault acting as back release surface for block A of figure 9.

In the preliminary limit equilibrium analysis, the major uncertainty is on the basal plane (Fig. 12). Despite the presence of a continuous trace line on the rock exposure, its full persistence in the rock mass is not clear. In general, the presence of rock 30 bridges plays an important role in stabilizing removable rock blocks. Indeed, a rock block cannot fall or slide from a slope until the rock bridges have failed. Rock bridge failure involves fracturing of intact rock, which can be an order of magnitude stronger than the rock mass (Kemeny and Donovan, 2005). From the undertaken sensitivity analysis, cohesion of the basal plane was the parameter that had the most significant influence on the block Factor of Safety. This suggests that it may not be completely persistent in this case, since the block has remained stable over time. In this regard, the parametric analysis

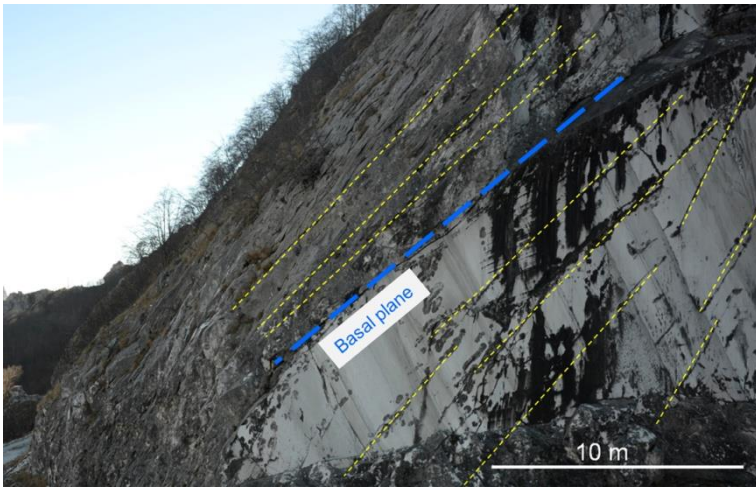
**Figure 13.** Details of a series of tight discontinuities above and below the basal plane under study.
