Use of a remotely piloted aircraft system for hazard assessment in a rocky mining area (Lucca, Italy)

Abstract. The use of remote sensing techniques is now common practice in different working environments, including
15 engineering geology. Moreover, in recent years the development of structure from motion (SfM) methods, together with rapid technological improvement, has allowed the widespread use of cost effective remotely piloted aircraft systems (RPAS) for acquiring detailed and accurate geometrical information even in evolving environments, such as mining contexts. Indeed, the acquisition of remotely sensed data from hazardous areas provides accurate 3D models and high resolution orthophotos minimizing the risk for operators. The quality and quantity of the data obtainable from RPAS surveys can then be used for
20 inspection of mining areas, audit of mining design, rock mass characterizations, stability analysis investigations and monitoring activities. Despite the widespread use of RPAS, its potential and limitations have still to be fully understood.

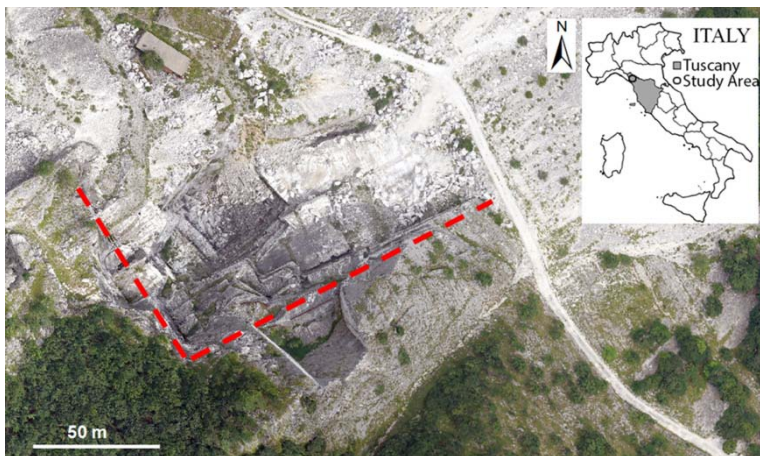
Figure 1. Plan view of the Piastrone open pit with indication of the two principal slope directions (dotted lines). Inset map shows the location of the study area.

The study area is located in the Apuan Alps marble district, in the province of Lucca (Tuscany, Italy - Fig. 1). The open pit or quarry, named "Piastrone", is characterized by a V shape, with two principal slope directions oriented 50/90 and 323/90 (dip direction/dip). The bottom of the pit is located at 1,180 meters above sea level (m.a.s.l.) and the top of the excavated rock face is at 1,300 m.a.s.l.. The rock mass is characterized by different sets of discontinuities with persistence values that can vary from a few meters up to decameters.

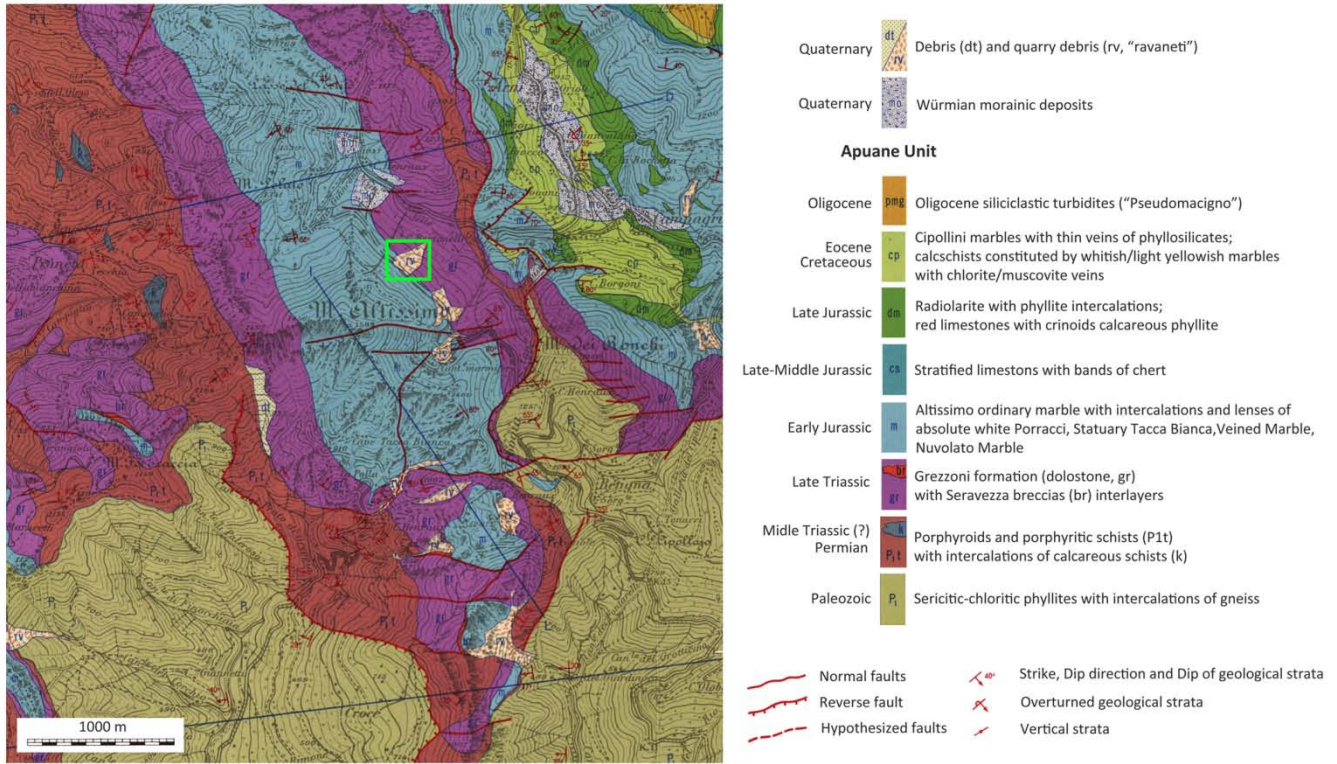
Mt. Altissimo Geological map

Figure 2. Geological map of the Mt. Altissimo area. The green rectangle indicates the location of the quarry (modified from Giglia and Paiotti, 1963).

From a geological point of view (Fig. 2) the Piastrone open pit is located in the Apuan Alps metamorphic complex, precisely in the Mt. Altissimo Syncline (AS), belonging to the Apuane Unit (Meccheri et al., 2007). According to classical interpretation (Carmignani and Kligfield, 1990) AS resulted from a compressive tectonic phase which originated during the continental collision between the Sardinia-Corsica block and the Adria plate (Upper Oligocene-Lower Miocene). Successively, during the Early Miocene, a new ductile to brittle-ductile deformation caused by a post-compression tectonic uplift overprinted the earlier structures and generated a widespread network of joints and faults. In the Mt. Altissimo area, the main set of brittle deformation strikes SW-NE to W-E with sub-vertical dip, generally with negligible displacement except for a few cases where offsets of some ten meters have been observed (Meccheri et al., 2007).

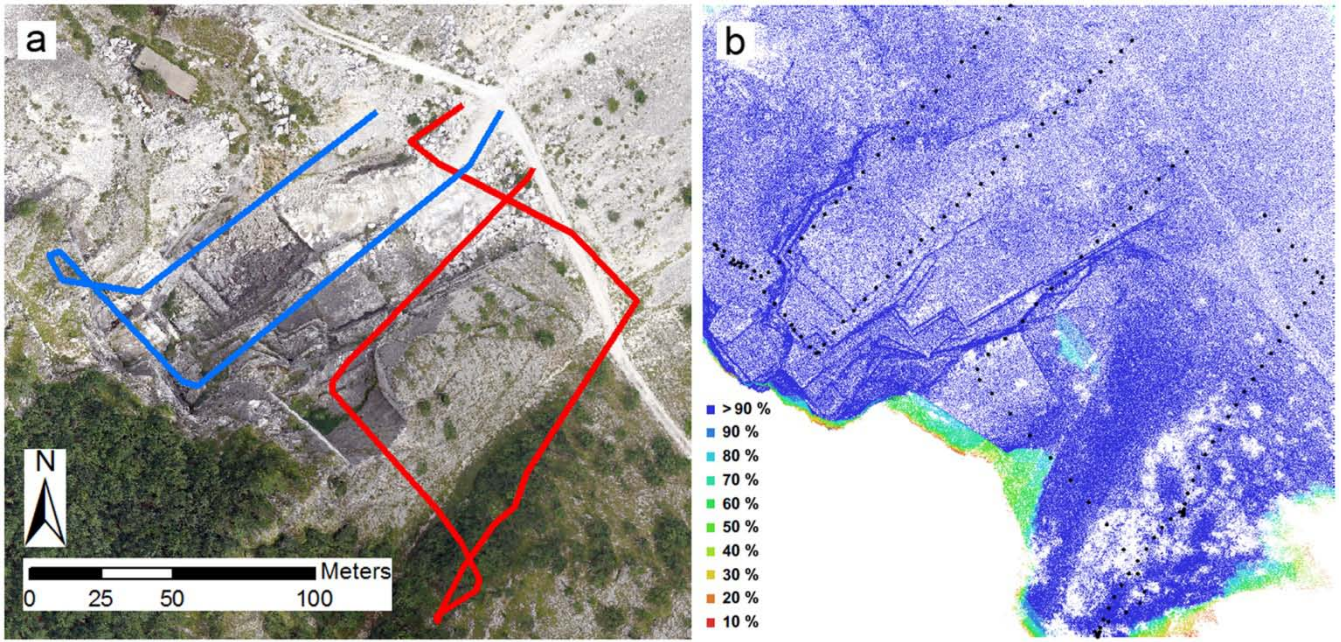
Figure 3. Flight paths of the RPAS zenithal surveys (a). Plan view of the area with indication of camera locations (black dots) and image overlap percentage (b).

The zenithal survey was preliminarily designed in the laboratory with the AibotixTM AiProfliight planning software, and manually performed through single quasi-parallel flight lines. A total of 151 aerial images were acquired with a nominal overlap and sidelap of 80% and 60%, respectively. Two flights were required to cover all sectors of the mining area (Fig. 3). An average estimated distance between pixel centers measured on the ground (i.e. ground sample distance - GSD) of 2.4 cm was calculated. During the flight, a GNSS field survey was also carried out in order to ensure the necessary spatial accuracy of the resultant images. Eight artificial targets, 50x50 cm large, were placed on the ground with the purpose of obtaining an optimum spatial distribution on the accessible zones of the study area (Fig. 4) and used as GCPs and check points.

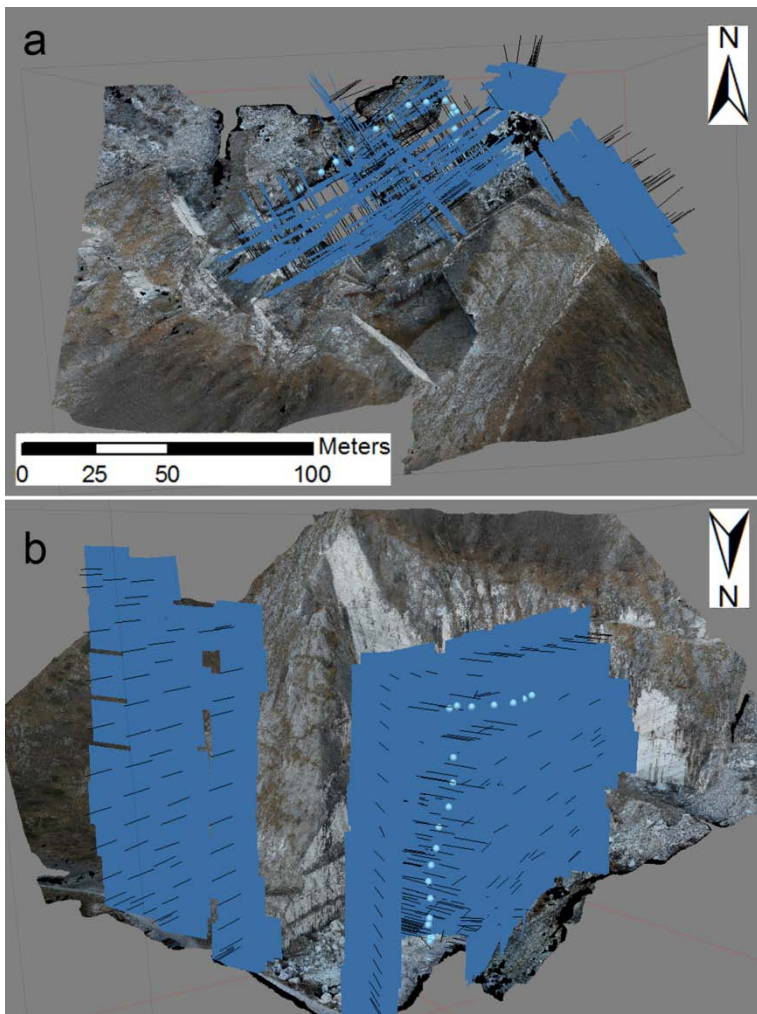
Figure 5. Plan view (a) and perspective view (b) of the RPAS frontal surveys (blue rectangles correspond to the photographs locations, black lines to normals). Corresponding 3D point clouds produced by the photogrammetric processing of natural colour digital images is shown in background.

The frontal survey, with direction of acquisition parallel to the rock face, was carried out manually, without the use of the AibotixTM AiProfliight planning software. Six flights were needed in order to cover all sectors of the mining area, resulting in a total of 448 overlapping images. The flights were executed in sub-parallel straight lines approximately 60 meters distant from the rock face (Fig. 5), providing an average estimated GSD of 1.5 cm.

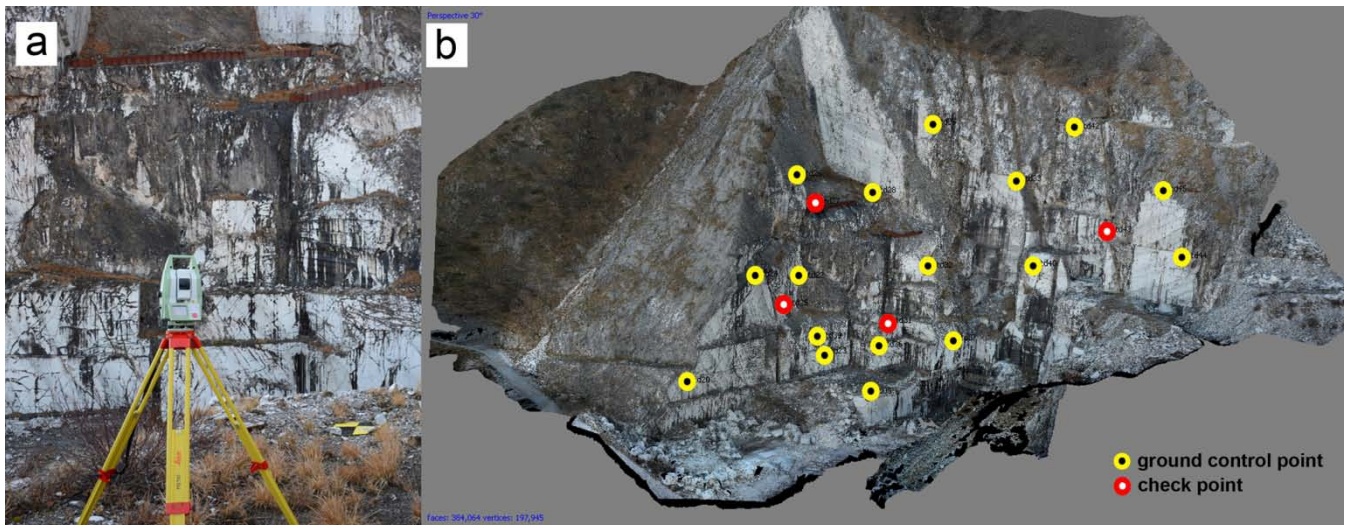
Figure 6. Topographic survey with TS (a) and spatial distribution of GCPs and check points for the RPAS frontal flights (b).

As for the zenithal flight, a series of GCPs and check points (21 targets in total - Fig. 6) were measured using a reflectorless TS. Their location was decided considering a balance between an optimum spatial distribution (Fig. 6), both in space and elevation from the open pit floor, and easy identification of points on the images. Due to the complex morphology of the slopes and the extent of the mining area, a large number of GCPs were used to orient the photogrammetric model. Two GNSS receivers, operating in static modality, were used to obtain the geographic coordinates of two points: the origin of the

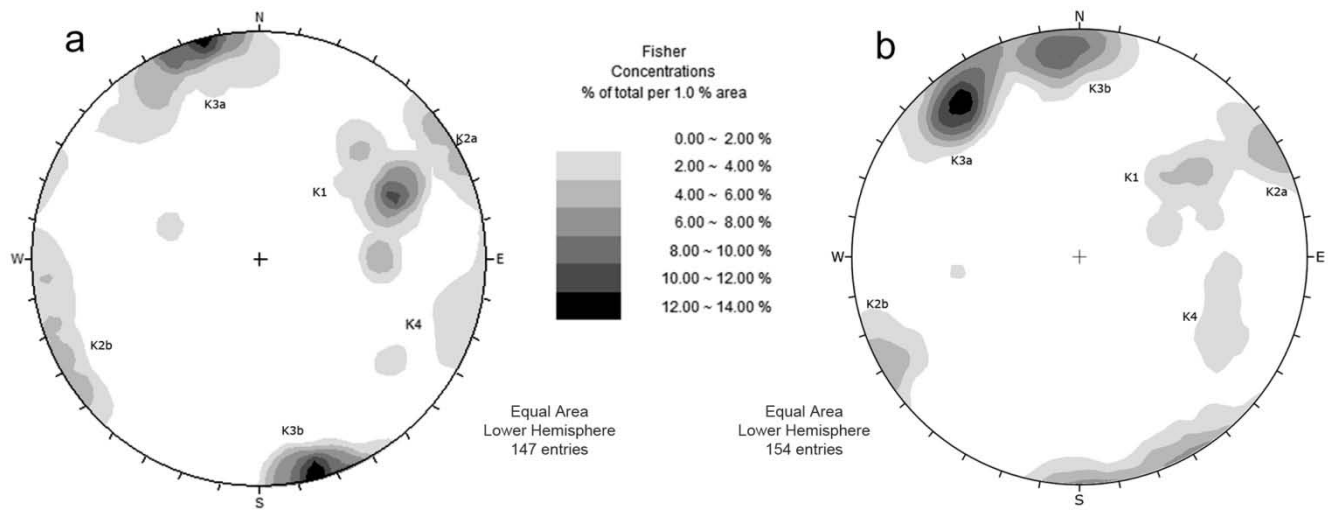
Figure 7. Stereonet plot of poles (Schmidt, equal area, lower hemisphere) of the discontinuities manually collected through classical engineering geological survey (a) and remotely collected by using photogrammetric data from RPAS surveys (b).

By comparing the discontinuity planes obtained through traditional manual engineering geological survey (a in Fig. 7) and that identified on the point cloud (b in Fig. 7) a good level of congruence has been highlighted, confirming the quality of the
10 taken approach.

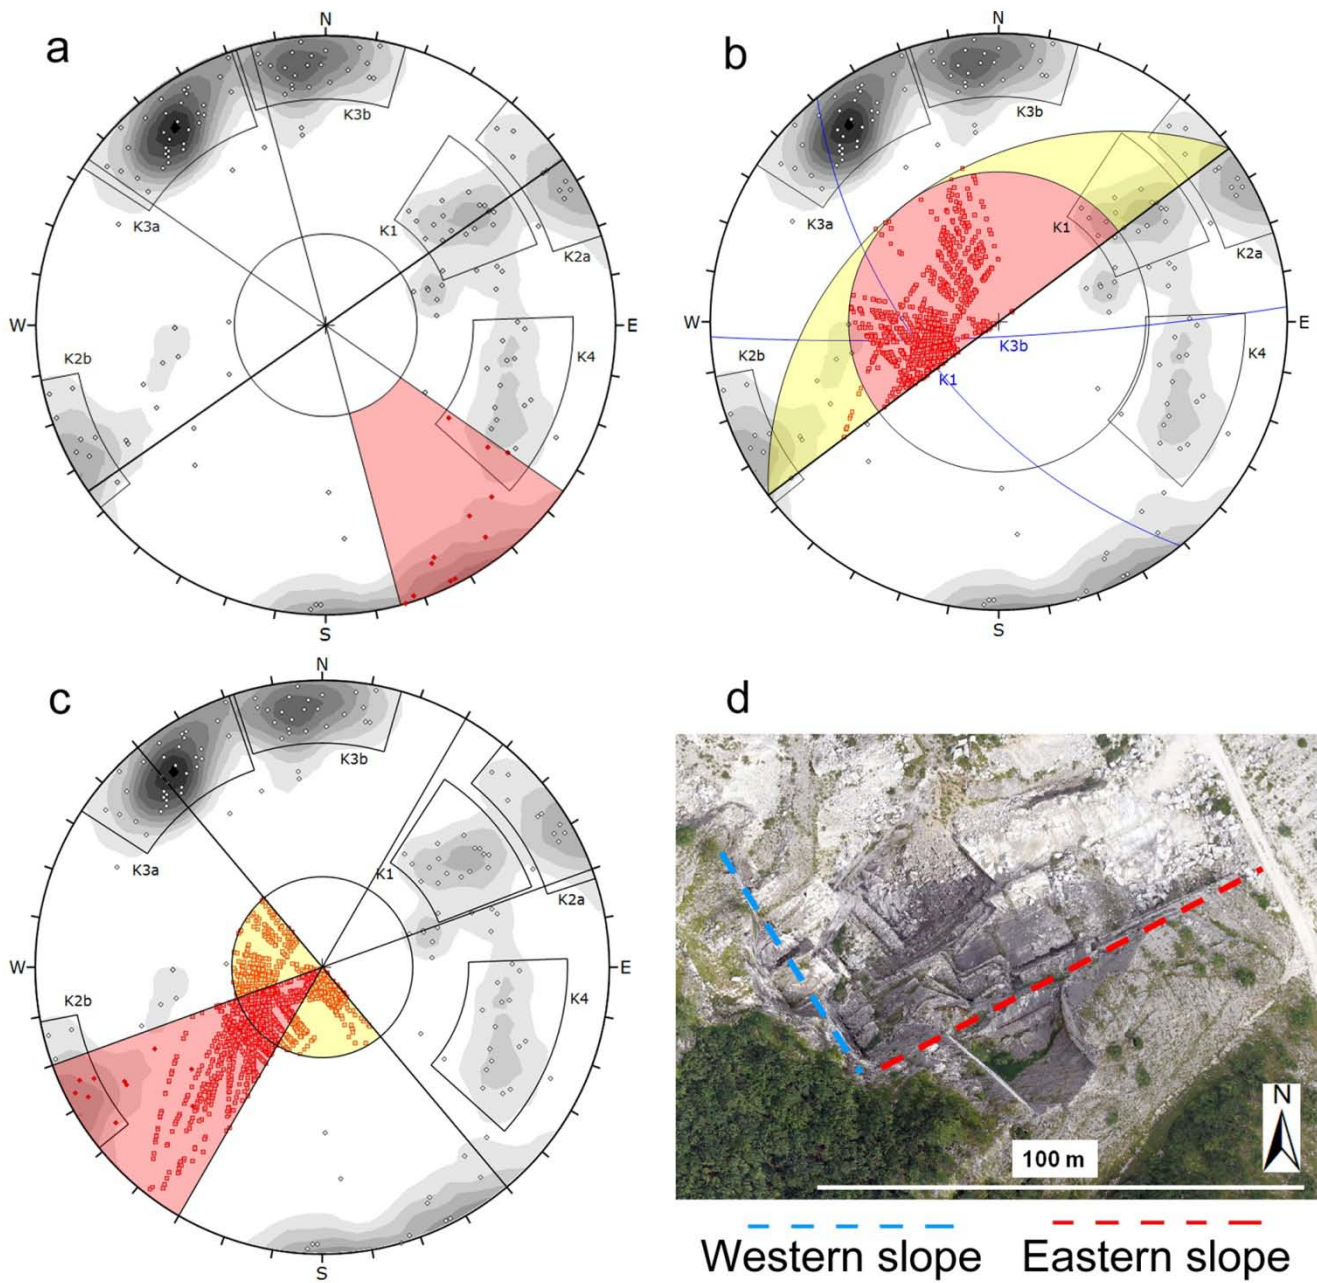
5 **Figure 8.** Examples of kinematic stability analysis carried out using Rocsience™ Dips 6.0 stereographic projection through the Wulff equal-angle method (lower hemisphere); a) Planar sliding on the eastern slope; b) Wedge sliding on the eastern slope (with highlighted great circles of intersection K1/K3b as example); c) Direct toppling on the western slope; d) Aerial photo showing the two principal slope orientations.

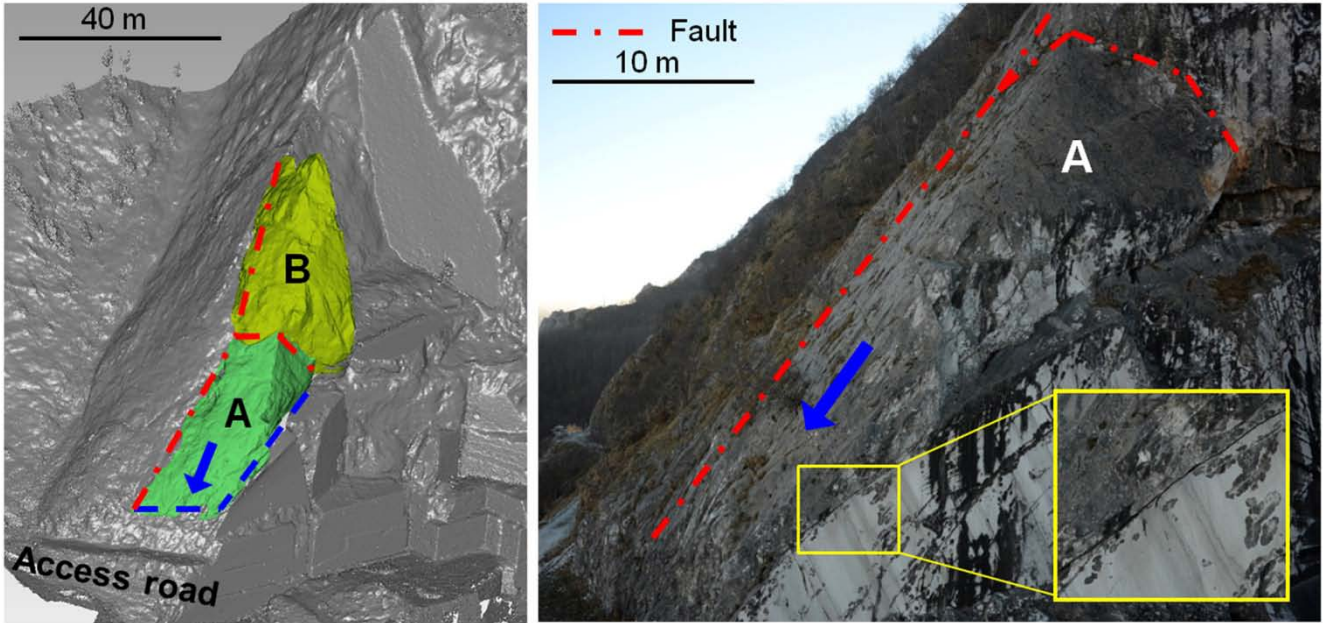
Figure 9. Identification of two large blocks with potential for sliding; inset photo highlights the visible aperture of the basal plane.

plane appears not to correspond with any of the identified discontinuity sets, but is probably connected to planes of weakness of the marble in correspondence with a particular orientation of minerals crystallographic axes. The lateral and rear faults, however, may be associated with the K3a and K3b systems respectively. The rear fault may also be associated with the E-W fault system that characterizes the geology of this area of the Apuan Alps complex (Fig. 2).

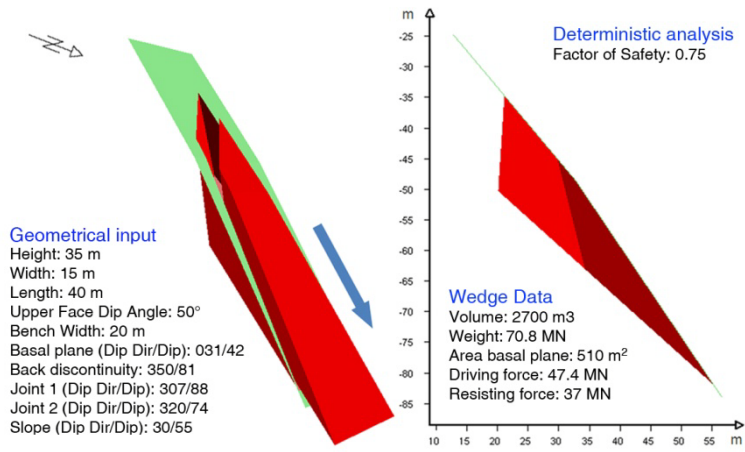
Figure 10. Result of Rocscience™ Swedge 3D preliminary slope stability analysis.

15 The geometry of Block A was deterministically re-created in Swedge using the geometrical information shown in Fig. 10. Initially the discontinuities were assumed to be fully persistent. This is a common approach in engineering geology, since reliable values of persistence are almost impossible to obtain from field mapping and most rock slope stability analysis assume that the 100% persistent joint exists on failure surface (Park, 2005). The basal plane is a joint and the possible presence of rock bridges should be carefully considered. In this case the basal plane did not show the presence of segments
20 of intact rock along its trace on the rock exposure, consequently application of Eq. (2) confirms a 100% persistence of the basal plane, that was used in the first analysis. In addition, the lateral and rear or back surfaces correspond to geological faults and can be therefore considered fully persistent. In this regard, the western lateral surface has been included in the Swedge model has a discontinuity (Joint 1 in Fig.10; Dip Dir/Dip 307/88), while the back surface has been included as a tension crack (Back discontinuity in Fig.10; Dip Dir/Dip 350/81). It should be also noted that the eastern lateral surface

25 observable in the model (Joint 2 in Fig.10; Dip Dir/Dip 320/74) was also necessary to re-create the block geometry in the software. A friction angle of 0° was assigned to the latter so as not to induce a resisting force in the simulation. Water forces were also initially ignored within the preliminary analysis.

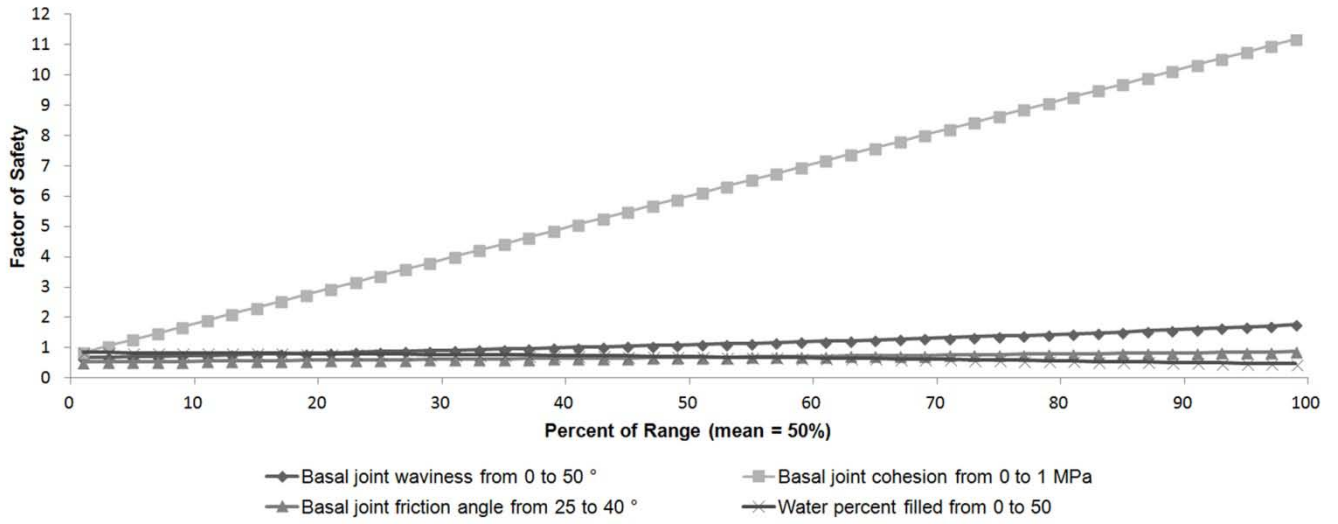
Factor of Safety vs. Percent of Range

Figure 11. Result of sensitivity analysis relative to the parameters basal joint waviness, friction angle, cohesion and water percent filled.

5 Results of the sensitivity analysis (Fig. 11) show that the cohesion is clearly the parameter that has the most effect on block stability. For this reason, the effect of this parameter was investigated in more detail in the following analyses. Application of Eq. (3) makes it possible to determine an effective cohesion dependent on the continuity of jointing. From this the contribution of eventual rock bridges on the block stability can be investigated starting from intact rock cohesion material value, that has been determined to be approximately 16 MPa (Lorenzoni, 2012; Dumas, 1999; data from Geomechanical
10 Laboratory of the Centre of GeoTechnologies of Siena University). Table 7 shows the results in terms of Factor of Safety obtained from a parametric stability analysis performed with increased values of effective cohesion, corresponding to 0, 0.5, 1, 2, 5, and 10% of rock bridges on the basal plane (total area of 510 m²), and a 20% of water filled fissures (considered reliable after field observation and high-resolution images analysis).

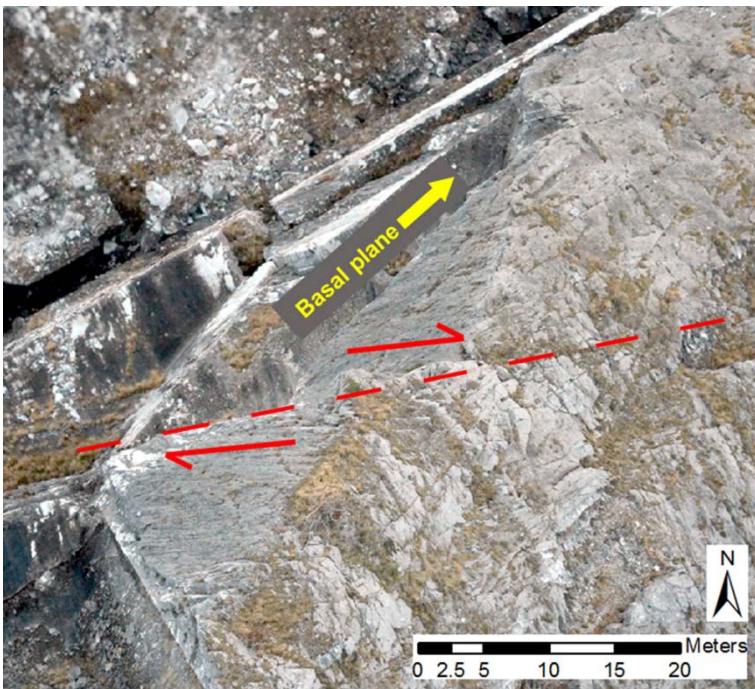
Figure 12. Detail of the zenithal orthophoto with indication of apparent offset of a major fault acting as back release surface for block A of figure 9.

In the preliminary limit equilibrium analysis, the major uncertainty is on the basal plane (Fig. 12). Despite the presence of a
30 continuous trace line on the rock exposure, its full persistence in the rock mass is not clear. In general, the presence of rock bridges plays an important role in stabilizing removable rock blocks. Indeed, a rock block cannot fall or slide from a slope until the rock bridges have failed. Rock bridge failure involves fracturing of intact rock, which can be an order of magnitude stronger than the rock mass (Kemeny and Donovan, 2005). From the undertaken sensitivity analysis, cohesion of the basal plane was the parameter that had the most significant influence on the block Factor of Safety. This suggests that it may not

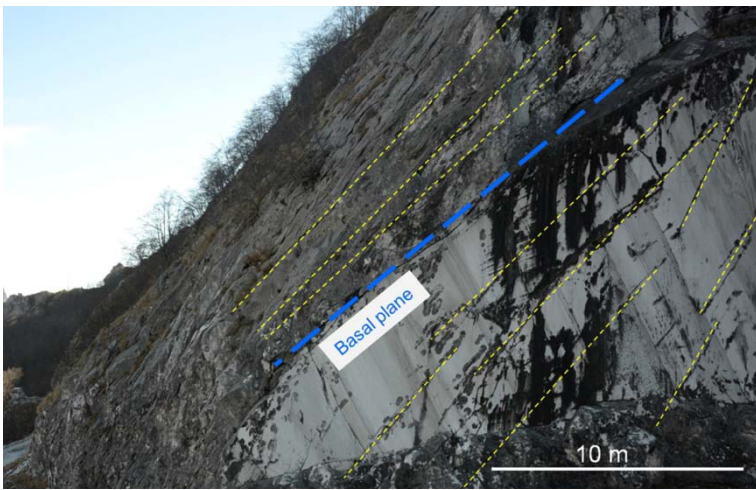
Figure 13. Details of a series of tight discontinuities above and below the basal plane under study.
