Developing fragility functions for aquaculture rafts and eelgrass in the case of the 2011 Great East Japan tsunami

Anawat SUPPASRI¹, Kentaro FUKUI², Kei YAMASHITA³, Natt LEELAWAT⁴, Hiroyuki OHIRA⁵, and Fumihiko IMAMURA⁶

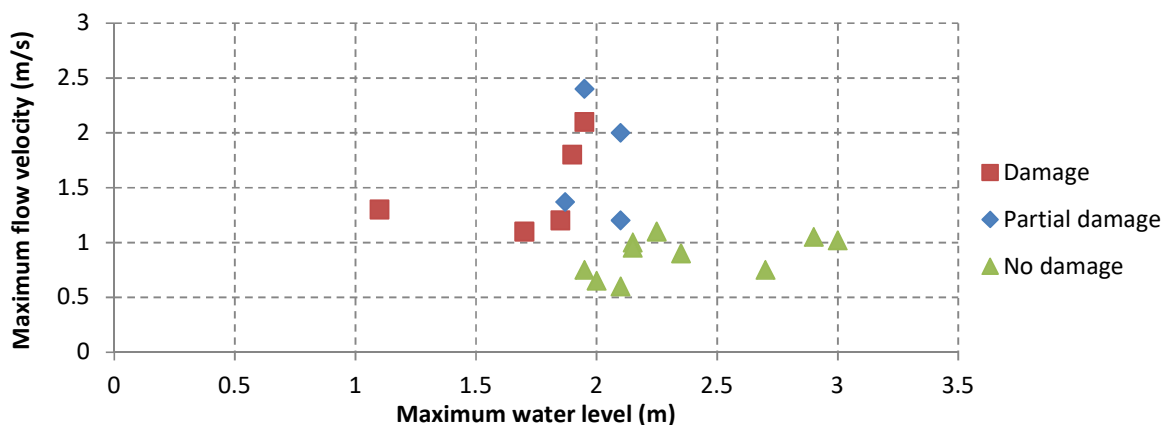
Fig. 1 Damage criteria of the aquaculture raft based on the damage data from Kii Peninsula, western Japan, from the 1960 Chilean tsunami (Adapted from Nagano et al., 1991)

This section reviews selected previous studies related to the damage characteristics of offshore facilities and marine plants against tsunamis. The first attempt was based on the 1960 Chilean tsunami that struck the west of Japan. The damaged aquaculture rafts were plotted against the simulated maximum water level and flow velocity (Nagano et al., 1991). As shown in Fig. 1, the damage to the aquaculture raft (pearl) begins to occur when the tsunami flow velocity is higher than 1 m/s regardless of the water level. Similarly, Kato et al., (2010) applied identical criteria to quantify the damage to aquaculture rafts in areas along the east coast of Japan, which were struck by the 2010 Chilean tsunami. They found that the damage on the east coast of Japan caused by the 2010 Chilean tsunami was accurately modeled by the proposed damage criteria developed from the data of the 1960 Chilean tsunami in the west of Japan.

A comparison of the aquaculture raft data in the cases of the 1960 Chilean tsunami (Fig. 1) and the 2011 Japan tsunami is shown in Fig. 11. Most of the aquaculture rafts that were not completely damaged in the 2011 tsunami were limited to a maximum flow velocity of less than 1.5 m/s. For both target areas, the damage probabilities for each range of the simulated water level and maximum flow velocity of both aquaculture rafts and eelgrass were calculated and are shown against a median value in a specific range of the grids. In Fig. 12, the preliminary scatter plot does not show any significant trend between the simulated maximum water level and the damage to the aquaculture rafts (Fig. 12a) and eelgrass (Fig. 12b) in Mangokuura Lake or between the simulated maximum flow velocity and the damage to eelgrass in Matsushima Bay (Fig. 12c). Thus, another expected parameter was used to develop the fragility functions: the simulated maximum flow velocity in Mangokuura Lake. To verify that our regression model is better than the predicted average value, an analysis of variance (ANOVA) was performed. The ANOVA is a statistical test to verify whether the regression model is significantly satisfactory in terms of predicting the variable's value. The analysis can test whether the proposed regression model provides a better estimation than that obtained using the average value of the predicted variables. The result shows that the calculated models significantly predict the damage ratio ($F_{\text{aquaculture raft}} = 74.73$; $p_{\text{aquaculture raft}} < 0.001$; $F_{\text{eelgrass}} = 89.70$; $p_{\text{eelgrass}} < 0.001$) in the model.

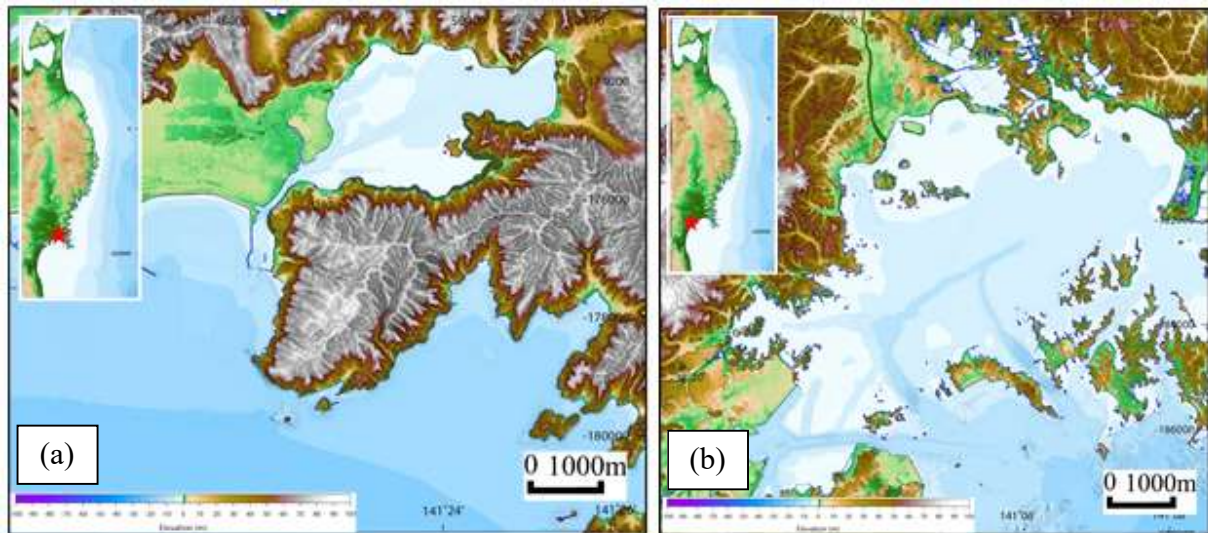
Fig. 2 Study areas: (a) Mangokuura Lake and (b) Matsushima Bay

Because the size of the 2011 tsunami was extremely large, most aquaculture rafts and other marine plants were completely destroyed. There are only two well-suited locations with specific coastal geography, namely, Mangokuura Lake and Matsushima Bay in Miyagi Prefecture (Fig.

2), where the effects of the tsunami were comparatively small (Suppasri et al., 2012) and the aquaculture rafts were undamaged and the eelgrass survived (University of Tokyo, 2016). Mangokuura Lake has a notably narrow entrance from the Pacific Ocean through Ishinomaki Bay, and the average sea depth is as shallow as 5 m or less. Matsushima Bay is protected by almost 300 small islands around the bay front. Thus, the 2011 tsunami inundation and run-up heights in both areas were less than 1-2 m, whereas they were as high as 10 m in other nearby areas (Suppasri et al., 2012). As a result, some aquaculture rafts and other marine plants survived in these two locations, which enabled the development of fragility functions.

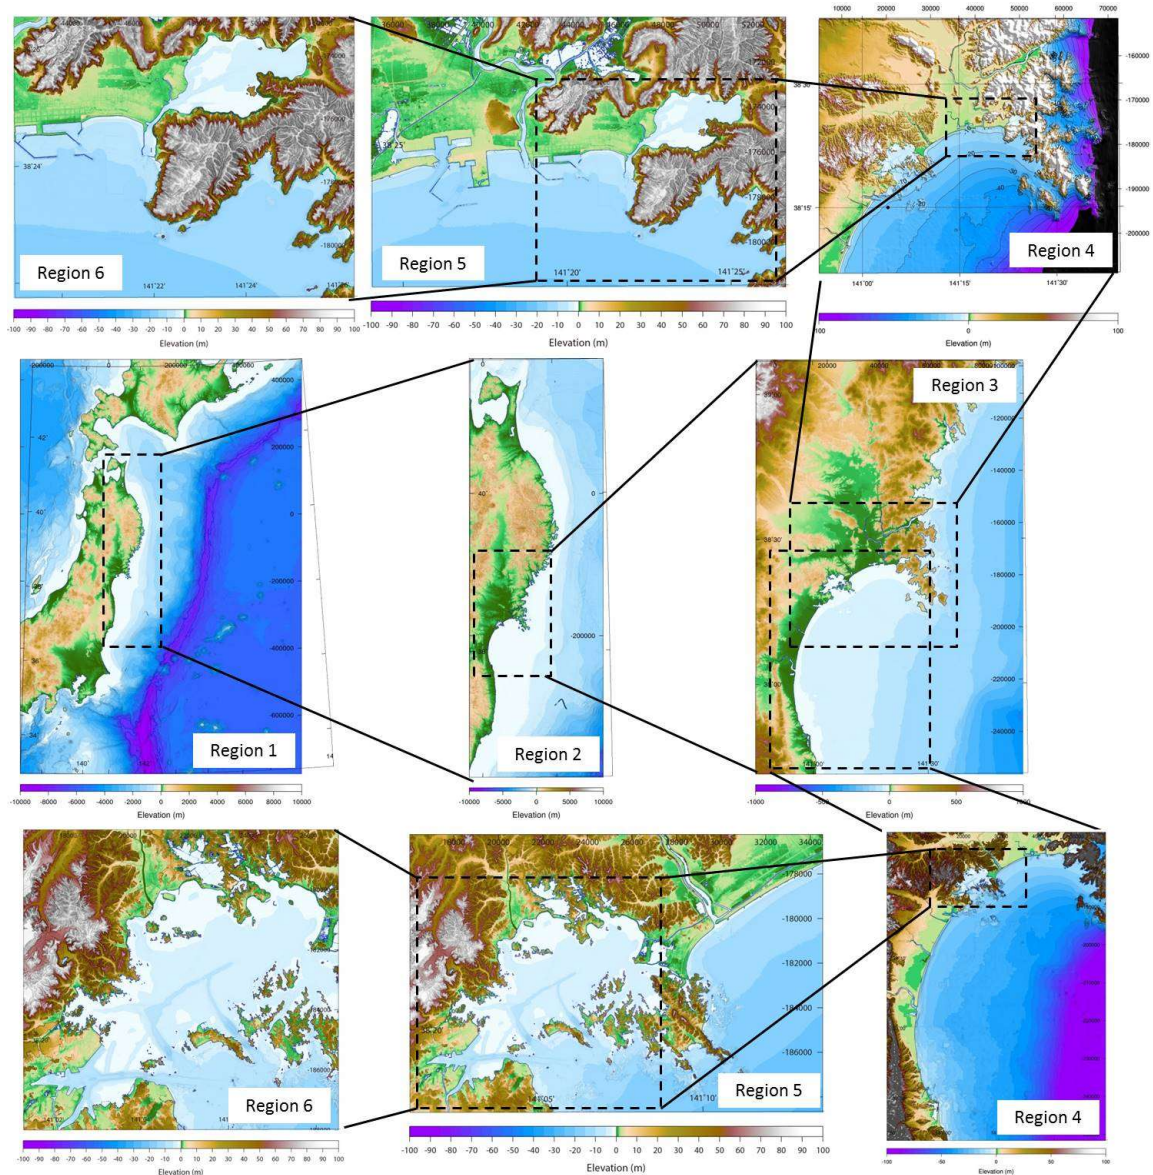
Fig. 3 Six computational areas for Mangokuura Lake (up) and Matsushima Bay (down)

To obtain tsunami-related parameters, including the water level and flow velocity, the 2011 tsunami was reproduced using a numerical analysis. The 2011 tsunami was numerically simulated using a set of nonlinear shallow water equations, which were discretized using the staggered leap-frog finite difference scheme (TUNAMI model) with bottom friction in the form of Manning's formula, similar to previous studies (Suppasri et al., 2010, Charvet et al., 2015 and Macabuag et al., 2016). Six computational domains were used as a nesting grid system of 1,215 m (Region 1), 405 m (Region 2), 135 m (Region 3), 45 m (Region 4), 15 m (Region 5) and 5 m (Region 6). The tidal level of -0.42 m was set at the time of the tsunami occurrence, and the simulation time was set to three hours to maximize the water level and flow velocity.

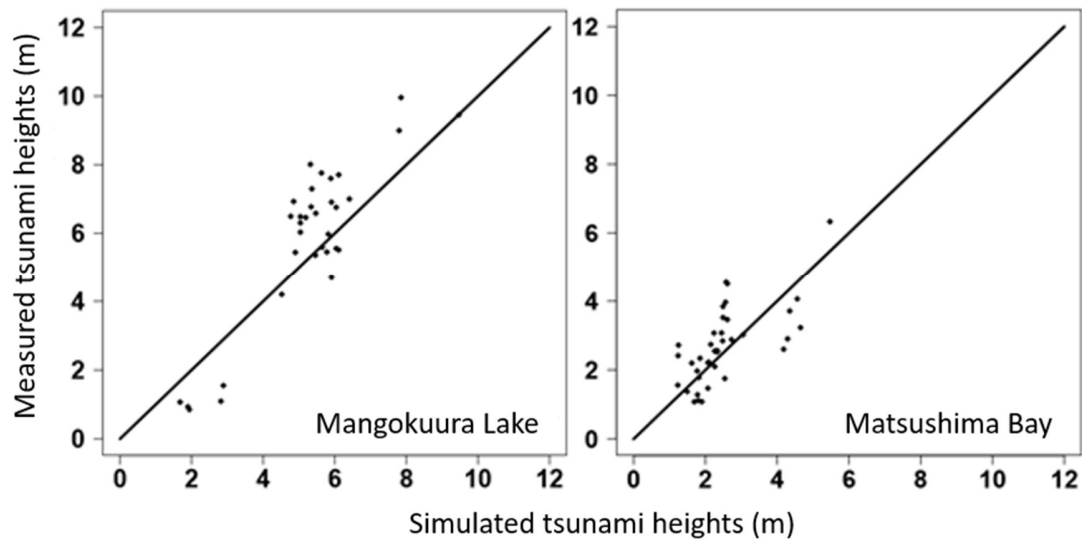
Fig. 4 Comparison of the simulated and measured tsunami heights in Mangokuura Lake and Matsushima Bay

For Mangokuura Lake, Model 3 produced the optimal values of Aida's K and κ . Because K is slightly less than 1.0, the simulated tsunami heights are slightly larger than the measurement. Similarly, for Matsushima Bay, Model 2 produced the best Aida's K and κ . Because K is larger than 1.0, the simulated tsunami heights are smaller than the measurement. To better obtain the tsunami parameters, the fault slip was scaled by the K values of 0.96 and 1.29 for Mangokuura Lake and Matsushima Bay, respectively, so that the reproduced tsunami closely matched the measured tsunami trace heights and satisfied the guideline of the Japan Society of Civil Engineers; $0.95 < K < 1.05$ and $\kappa < 1.45$ (Suppasri et al., 2010). As a result, the accuracy of the simulated tsunami parameters in both study areas was improved, as shown in Fig. 4.

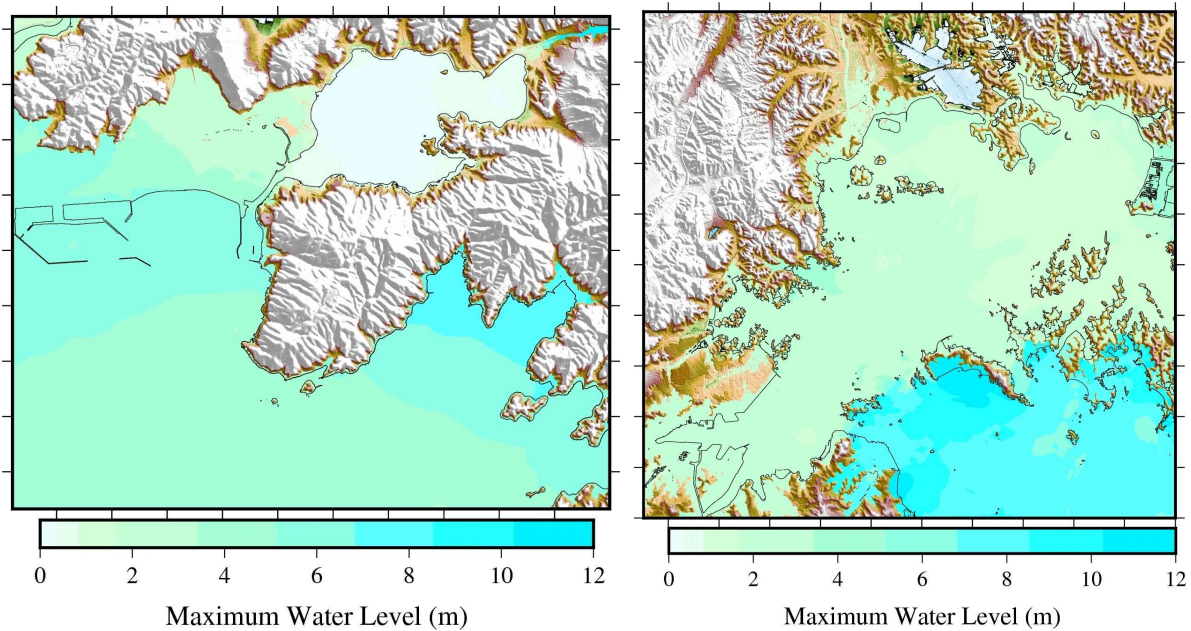
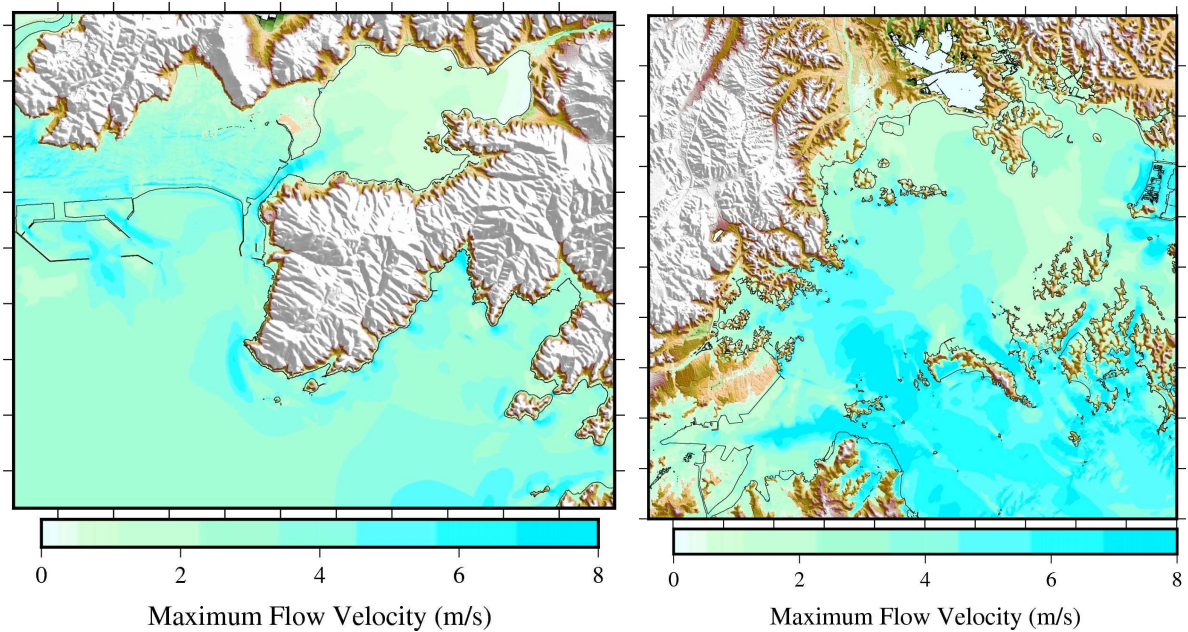
Fig. 5 Simulated maximum water level and flow velocity in Mangokuura Lake and Matsushima Bay

The hydrodynamic properties of the 2011 tsunami were reproduced based on the model calibration and verification as mentioned above. Fig. 5 shows that the average maximum water level and flow velocity in the bay of Mangokuura Lake are approximately 0.5 m and 1-2 m/s, those of Matsushima Bay are approximately 2 m and 3-5 m/s, and the average offshore maximum water level and flow velocity in the other 2011 tsunami affected areas were much higher than these values (Suppasri et al., 2014).

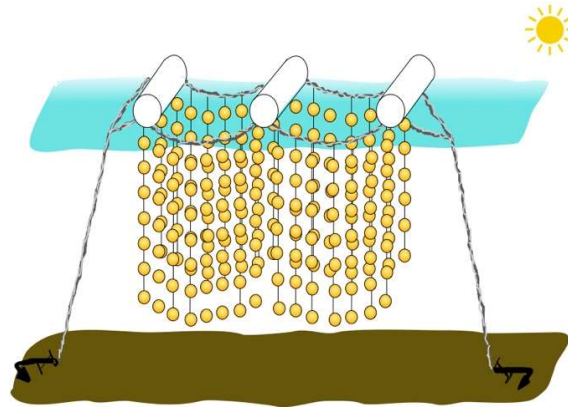
Fig. 6 Aquaculture raft (long-line type)

Based on criteria for the recovery process developed by the Japan Fisheries Agency (2010), aquaculture raft damage can be classified into four types: 1) complete damage (washed away), 2) major damage (70-100% physical damage), 3) moderate damage (30-70% physical damage) and 4) small damage (less than 30% physical damage). Because of the limitations encountered when using satellite images, only the complete damage (washed away) level could be investigated using the satellite images taken before and after the tsunami, similar to other previous studies related to buildings (Koshimura et al., 2009 and Suppasri et al., 2011). In this study, only the long-line type of aquaculture raft (Fig. 6) had sufficient quantities to develop the fragility function. This type of aquaculture raft is common in the study area and is used for oyster and seaweed farming. Examples of the visual inspection of the aquaculture rafts in the lake before (Fig. 7a) and after the tsunami (Fig. 7b) are shown. Approximately half of the rafts remained after the tsunami; the others were completely washed away. The aquaculture rafts that completely disappeared were classified as completely damage (washed away), whereas the damage levels of the remaining aquaculture rafts ranged from no damage to major damage. This classification is used to calculate the damage probability of complete damage in section 4. Fig. 7 also shows the visual inspection results (presented as polygons) of complete damage versus no damage and other damage levels for the aquaculture rafts (long-line type) in Mangokuura Lake. Many completely damaged aquaculture rafts were found near the entrance to and in the middle of the lake. Then, the created polygons were gridded into $5 \times 5 \text{ m}^2$ regions corresponding to the

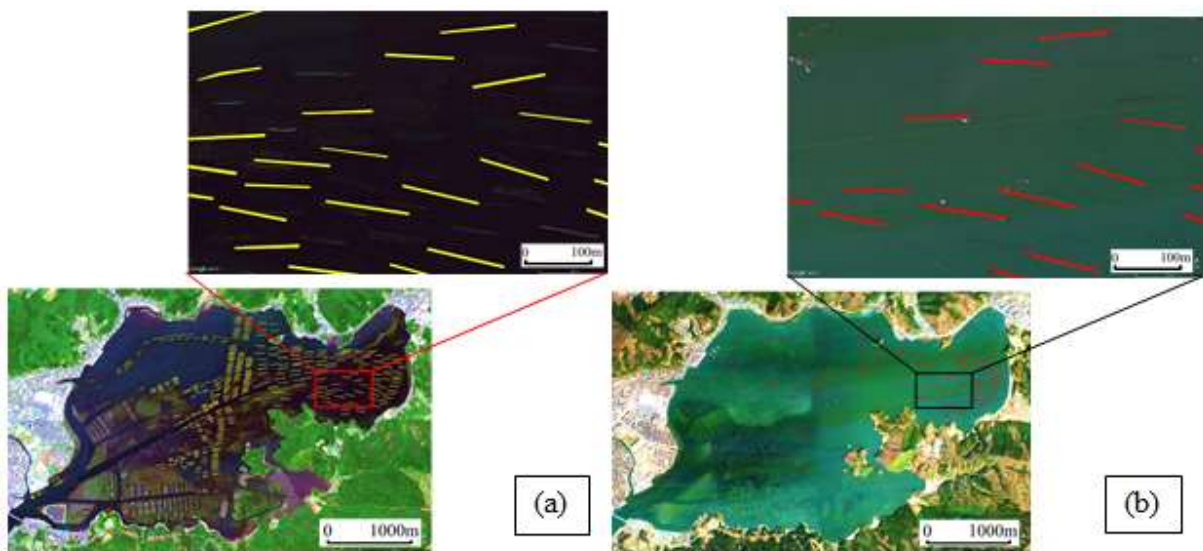
Fig. 7 Visual damage interpretation of aquaculture rafts (long-line type) (a) before and (b) after the 2011 tsunami

finest tsunami simulation grid (Region 6). The simulated maximum water level and flow velocity were assigned to each grid. For Matsushima Bay, there was an insufficient number of long-line-type aquaculture rafts, and many rafts could not be classified into types. Therefore, only those aquaculture rafts in Mangokuura Lake that were completely damaged were used to develop the fragility functions.

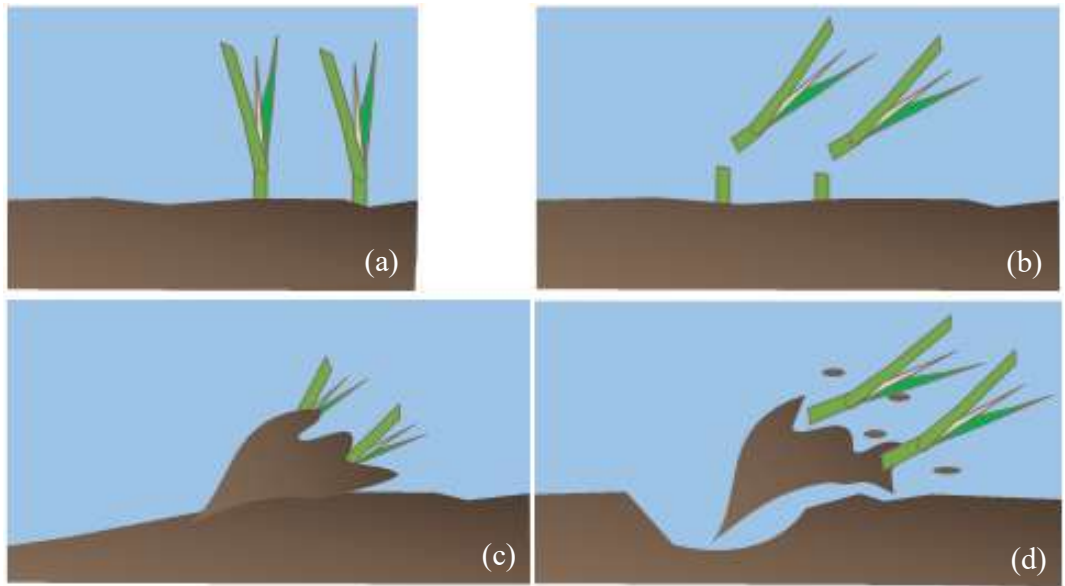
Fig. 8 Eelgrass (a) and its damage pattern: (b) cut-off, (c) sand deposition and (d) erosion

Damage to eelgrass occurs in one of three modes: cut-off, deposition or erosion, as shown in Fig. 8. Although the deposition and erosion can be estimated using a sediment transport model, more detailed data and surveys are required to obtain the necessary data for the model input. This pilot study considered only the tsunami itself. In addition, the erosion was controlled primarily by the flow velocity. Therefore, the cut-off and erosion were considered damage from the horizontal force of the tsunami.

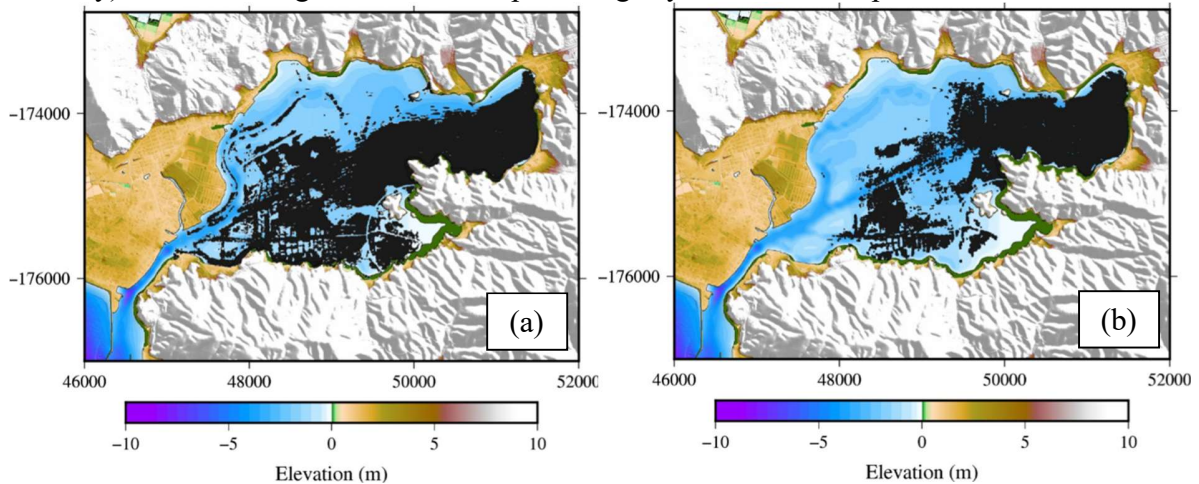
Fig. 9 Areas of the eelgrass before (a) and after (b) the 2011 tsunami in Mangokuura Lake

Color images from an actual satellite image taken before the 2011 tsunami and after the 2011 tsunami were analyzed (University of Tokyo, 2016 and Tsujimoto et al., 2016). At this stage, the areas for land, sea, aquaculture raft, eelgrass and mudflat were first identified. To identify only the eelgrass area, the colored images were binarized to binary (black and white) images using the ImageJ image analysis software, which is being developed at the National Institutes of Health, the United States (ImageJ, 2016). This binarization helps distinguish eelgrass and non-eelgrass areas. Figs. 9 and 10 show the eelgrass areas before and after the 2011 tsunami in Mangokuura Lake and Matsushima Bay, respectively. **Similar to the aquaculture rafts, the eelgrass that was completely damaged could be investigated by comparing the images taken before and after the tsunami.** The identified damage and undamaged areas for both aquaculture rafts and eelgrass were gridded into $5 \times 5 \text{ m}^2$ regions. Then, the damage ratio of each grid was calculated, and the maximum simulated water level and flow velocity were assigned to each grid. Finally, another process was performed to create a list of the simulated tsunami characteristics (water level and velocity) and the damage ratio to develop the fragility function, as explained in the next section.

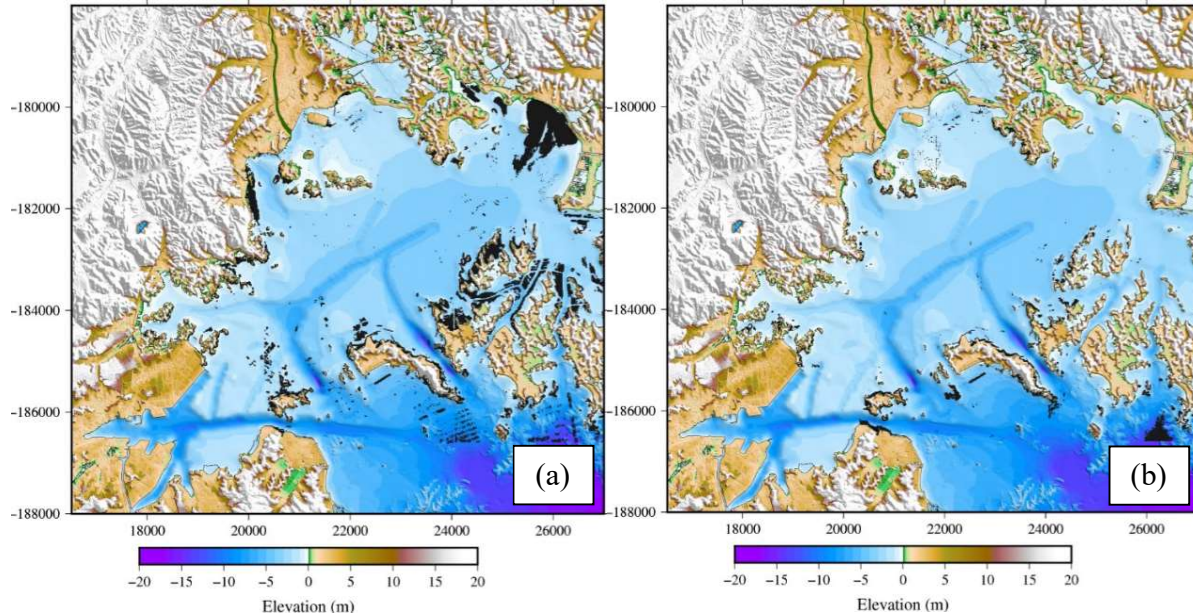
Fig. 10 Areas of the eelgrass before (a) and after (b) the 2011 tsunami in Matsushima Bay

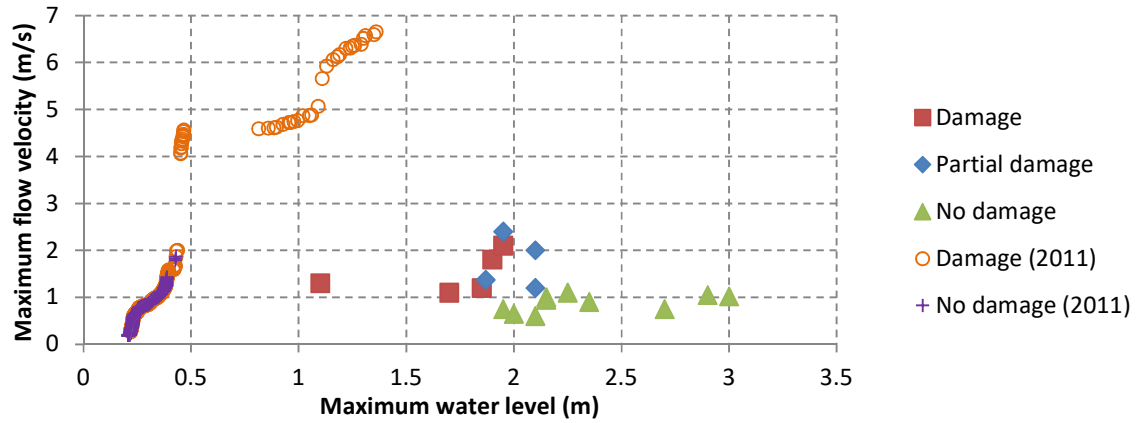
Fig. 11 Comparison of the aquaculture raft data from the 1960 Chilean tsunami (Fig. 1) and the present study on the 2011 Japan tsunami

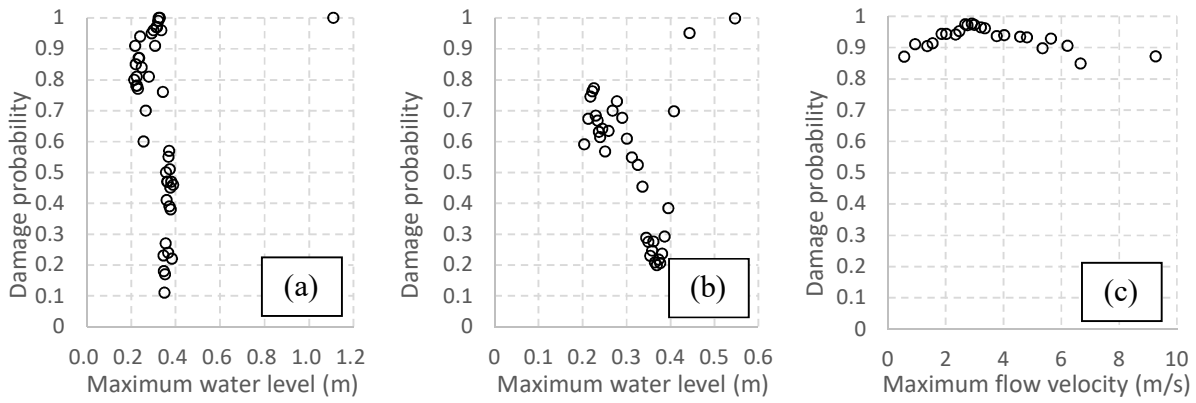
Fig. 12 Maximum water level and complete damage probability for the (a) aquaculture rafts and (b) eelgrass in Mangokuura Lake and (c) eelgrass in Matsushima Bay

- Based on the reproduced hydrodynamic characteristics of the 2011 tsunami, Matsushima Bay was hit by a stronger tsunami than Mangokuura Bay (Fig. 5).
- The maximum water level is not related to the damage to aquaculture rafts and eelgrass (Fig. 12).
- The threshold value (at 90% damage probability) of the maximum flow velocity for **completely** damaged aquaculture rafts and eelgrass is 1.3 m/s and 3.0 m/s, respectively (Fig. 15).
- The proposed fragility function for the aquaculture rafts is consistent with the previously proposed damage criteria and can further provide the values of the damage ratio at other flow velocities in addition to the threshold value.

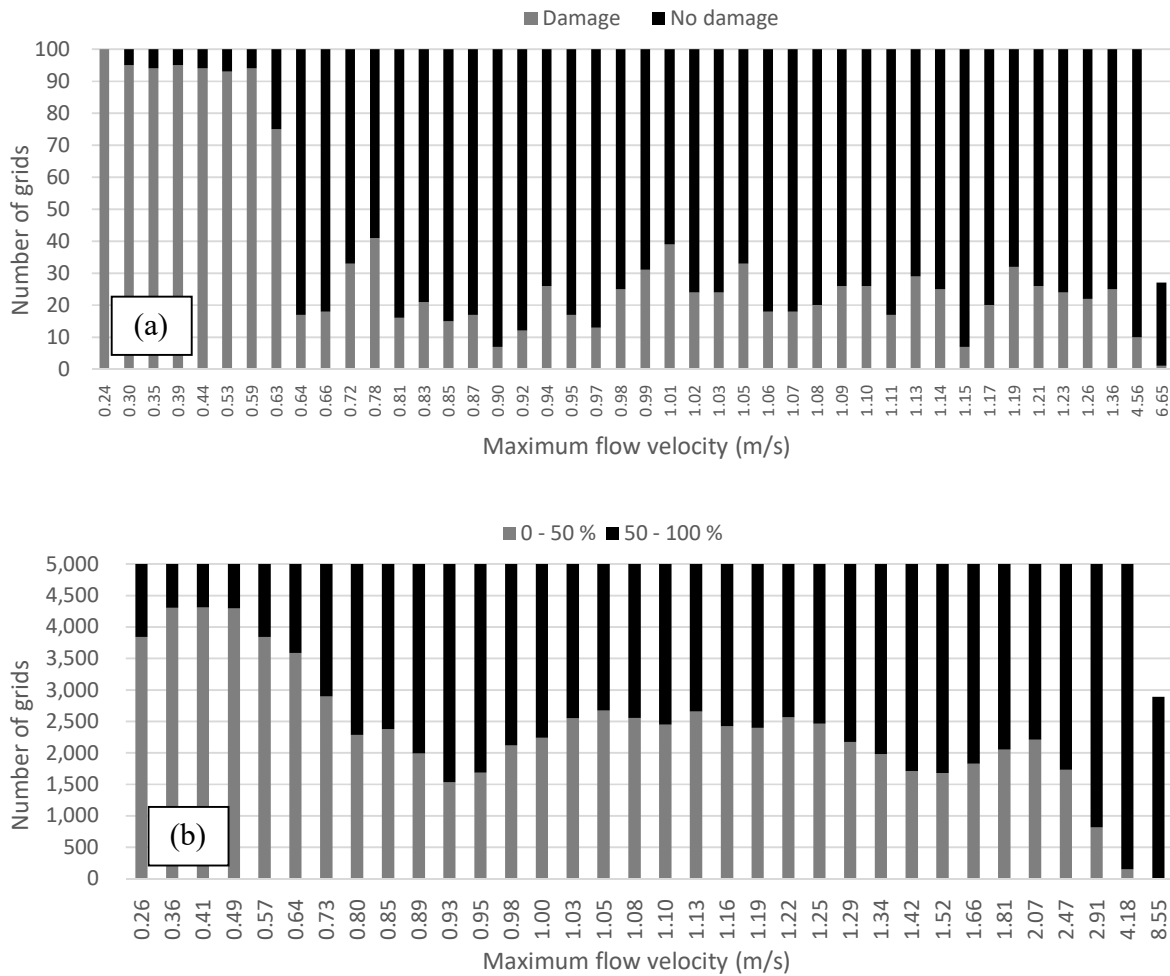
Fig. 13 Histogram of the numbers of (a) damaged and undamaged aquaculture rafts and (b) 0-50% damaged and 50-100% damaged eelgrass in terms of the simulated flow velocity range in Mangokuura Lake.

Only the simulated maximum flow velocity and damaged-eelgrass data in Mangokuura Lake could be used to develop the fragility functions. The tsunami fragility functions were developed by applying the classical standardized lognormal distribution function throughout the linear regression analysis for both aquaculture rafts and eelgrass. For Mangokuura Lake, Fig. 12 shows the histograms of the numbers of damaged and undamaged aquaculture rafts in every 100 grids (Fig. 13a) and 0-50% damaged and 50-100% damaged eelgrass in every 5,000 grids (Fig. 13b) in terms of the simulated maximum flow velocity range. Both histograms show that the damage data increase when the flow velocity increases. A linear regression analysis was performed to develop the fragility function. The cumulative probability P of occurrence of the damage is given in Eq. (4).

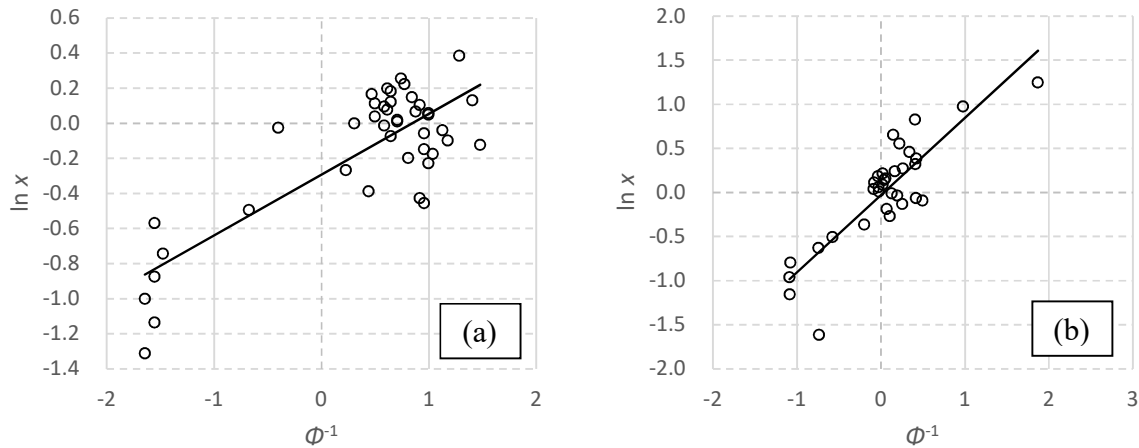
Fig. 14 Least-squares fit on lognormal probability paper for the aquaculture rafts (a) and eelgrass (b) in Mangokuura Lake

where Φ is the standardized lognormal distribution function, x is the hydrodynamic feature of the tsunami (simulated maximum velocity), and μ' and σ' are the mean and standard deviation of $\ln x$, respectively. The statistical parameters μ' and σ' of the fragility function were obtained by plotting $\ln x$ against the inverse of Φ^{-1} on lognormal probability papers and performing least-squares fitting of this plot (Figs. 14a and 14b). Consequently, two parameters are obtained as the intercept ($=\mu'$) and angular coefficient ($=\sigma'$) in Eq. (5).

$$\ln x = \sigma' \Phi^{-1} + \mu' \quad (5)$$

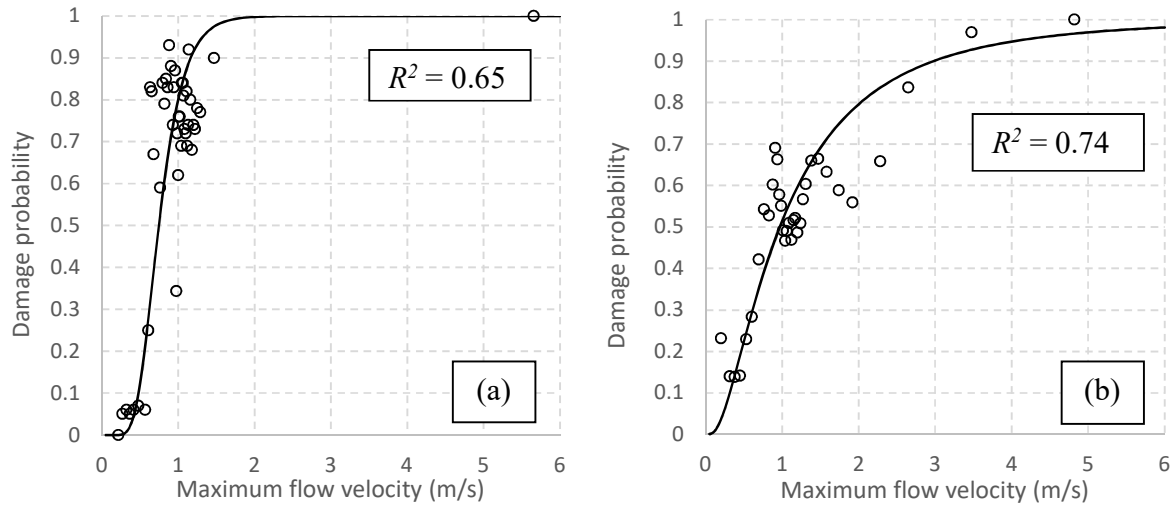
Fig. 15 Tsunami fragility functions for **completely damaged** aquaculture rafts (a) and eelgrass (b) based on data from Mangokuura Lake

With the regression analysis, the parameters that best fit the fragility functions with respect to the maximum flow velocity are shown in Table 2. The tsunami fragility curves for the aquaculture rafts and eelgrass were developed as shown in Figs. 15a and 15b, respectively. The proposed fragility functions show that a **complete** damage ratio above 0.5 corresponds to maximum flow velocities of 0.8 m/s (aquaculture raft) and 1.0 m/s (eelgrass). A **complete** damage ratio above 0.9 corresponds to maximum flow velocities of 1.3 m/s (aquaculture raft) and 3.0 m/s (eelgrass). The results for the aquaculture rafts are consistent with the previously proposed criteria (Nagano et al., 1991): at 1 m/s flow velocity, the damage ratio is almost 0.8.

Item	μ'	σ'	R^2
Aquaculture raft	-0.2917	0.3464	0.65
Eelgrass	-0.0314	0.8750	0.74
