RESPONSE TO COMMENTS

Title: UAV-enabled reconnaissance and trajectory modeling of a co-seismic rockfall in Lefkada

Journal: NHESS

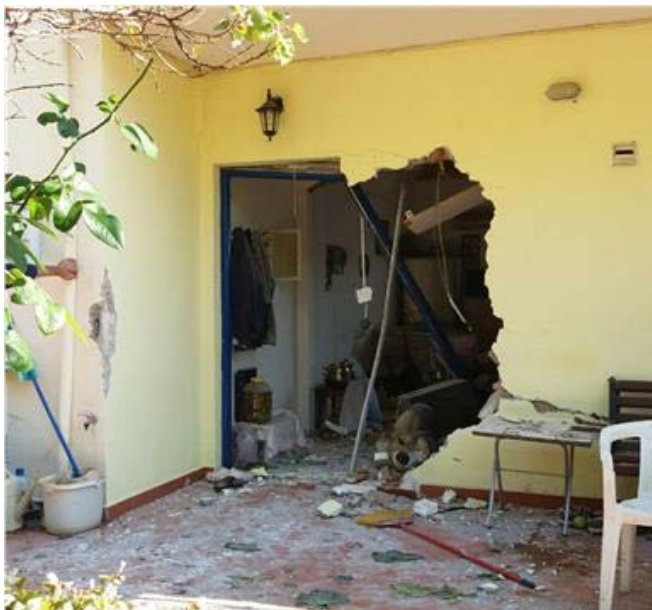
Figure 3. Impact of rock on house in Ponti, Lefkada, Greece.

416 [On the southeast side of Lefkada near the Gulf of Vassiliki, a seismically-triggered A](#)
417 [rockfall in Ponti village, which lies in the southeast side of Lefkada near the Gulf of](#)
418 [Vassiliki, was triggered during this earthquake and](#) was responsible for one of two
419 deaths caused by the earthquake (Figure 1). Of particular interest, is the very long
420 travel path of the rock block, which was about 800 m in plan view from the point of
421 detachment to the end of its path. Near the end of the rock fall path, the block impacted
422 a family residence, penetrated two brick walls and killed a person in the house. The
423 block exited through the back of the house and came to rest in the property's backyard.

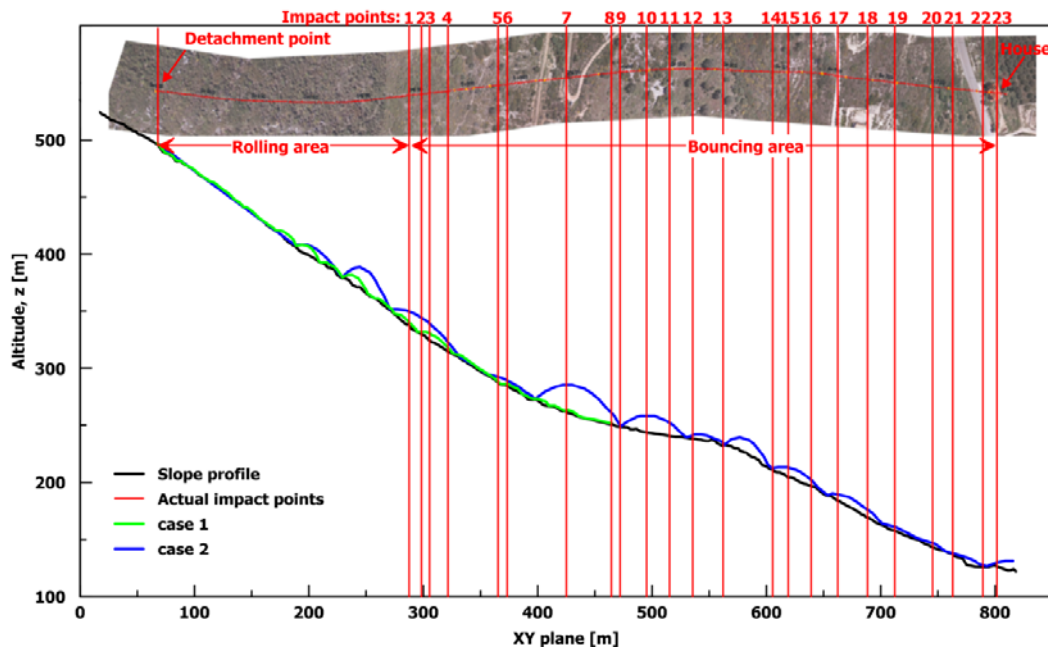
Figure 98. Plan view and cross section along block's path (units in m); 2D rockfall trajectory analysis results are plotted with green and blue line

663 23 impact points were identified on the slope surface (Figure 98). Their coordinates
664 are presented in Table 2, along block's path starting from the detachment point (where
665 ~~x=0). No trees were observed along the block's path. impact on trees was recorded.~~
