# A forensic re-analysis of one of the deadliest tornadoes in European history

Alois M. Holzer<sup>1</sup>, Thomas M. E. Schreiner<sup>1, 2</sup> and Tomáš Púčik<sup>1</sup>

<sup>1</sup>ESSL, European Severe Storms Laboratory, Wiener Neustadt, 2700, Austria  
<sup>2</sup>Skywarn Austria, Steyr, 4400, Austria

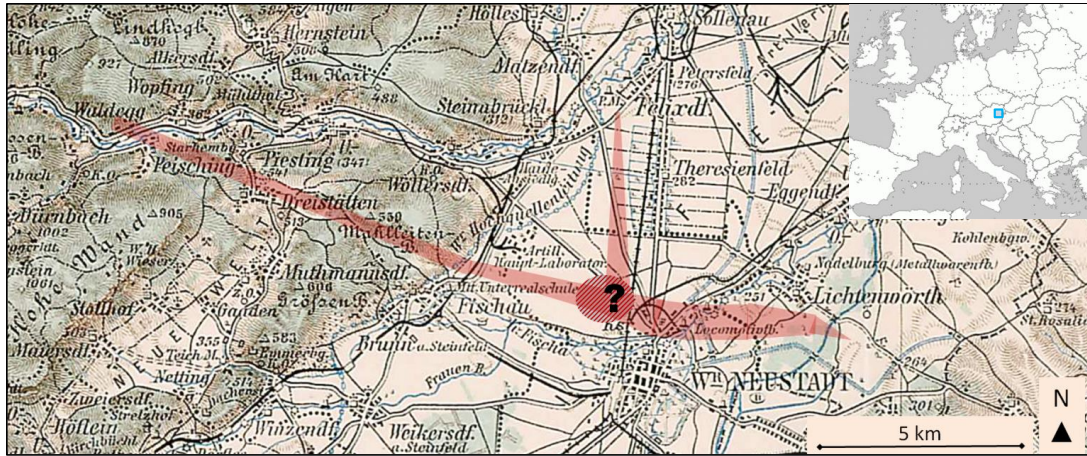
Fig. 2: Map of tornado damage tracks (red shadings) in the Wiener Neustadt area. The hatched area with the question mark denotes the airfield west of town, where the exact genesis of the main tornado is unknown. Basis map: „Generalkarte von Mitteleuropa des k.u.k. Militärgeographischen Instituts Wien, Blatt 34° 48° Wien“ of 1893.

The first damages were documented in the village of Peisching (Dörr, 1917), located in the Piesting valley, 15 km west-north-west of Wiener Neustadt (Fig. 2). The tornado was reported to have formed on a slope to the west of the village, while in Peisching roofs were damaged, and beyond Peisching, a continuous visible damage track extended to the Leitha River east of Wiener Neustadt. In the northern part of the following village Dreistetten a few houses were severely damaged, and the first severe injury is evident (Karl, 2017; Schramböck, 2017). A young farmer, who was at home on furlough from World War I, sustained a severe leg injury after being picked up by the tornado a few metres in height and thrown back to the ground.

The existence of two predecessor tornadoes is a plausible deduction based on the analyses of different trustworthy sources, and offers a new hypothesis in contrast to the contemporary scientific study (Dörr, 1917). It is not possible to conclude whether the eyewitness report about a northern predecessor tornado was unknown to Dörr or if it was intentionally omitted. The professional background of the eyewitness in question, Professor Leopold Schmidt, adds to the credibility. Schmidt was an aviation pioneer (ÖBL, 1992) and familiar with the landscape around the airfield. He was also interested in meteorology. For unknown reasons, none of the different eyewitnesses were able to see both predecessor tornadoes in the minutes before the main tornado struck Wiener Neustadt. An idea of how complex tracks of different tornadoes in one close area can be we can get from a track map that was made after the 3 July 1980 Grand Island, Nebraska, tornadoes (p. 44, Fujita and Merriam, 1992), showing between the tornadoes no. 5 and no. 6 a similar angle as can be seen from our Fig. 2.

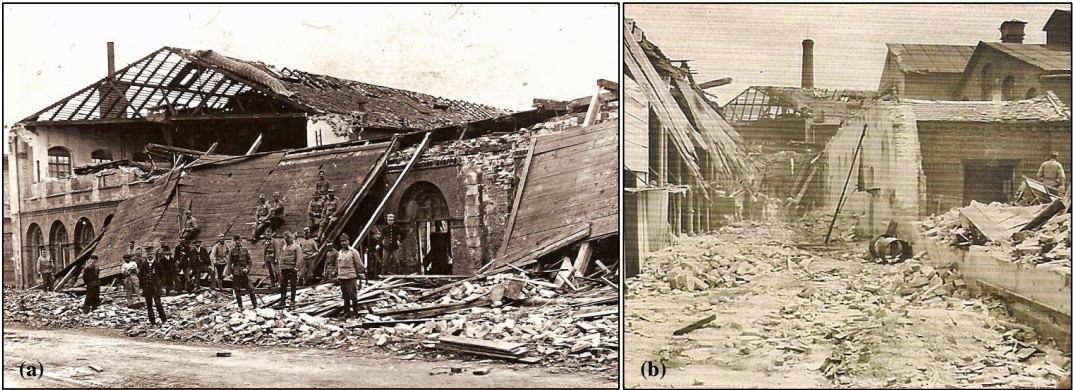
Fig. 3: Details of the old locomotive factory. Left (a): inner ceiling flipped outside, in foreground whole upper floor with massive brick walls collapsed (similar as the building parts that are still visible in the background). Right (b): Former indoor part of the same building with destruction of up to 1 m thick walls down to the ground level. Source of photos: Industrieviertelmuseum Wiener Neustadt.

- 25
- An example for a DI-DoD pair from the region of highest interest is the old locomotive factory, located at 47.82861 N, 16.251412 E (Fig. 3b): The photographer documented in the foreground the (pre-event) indoor part of the factory. Remaining foundations of a largely destroyed massive brick wall are visible on the right side. The remaining building parts on the left can also be seen in Fig. 3a, with a viewing angle from further left. The chosen DI for this building was “E”

- 30 (“strong brick structure”), while the determined DoD was “f3” (“walls partly collapsed”) for the left section and “f4” (“largely blown down”) for the right section. A DoD “f3” leads to F4-, whereas a DoD “f4” leads to F5 category. Because of the unknown preservation stage, the final combined rating for this building leans towards the lower F4 rating (Building “z”

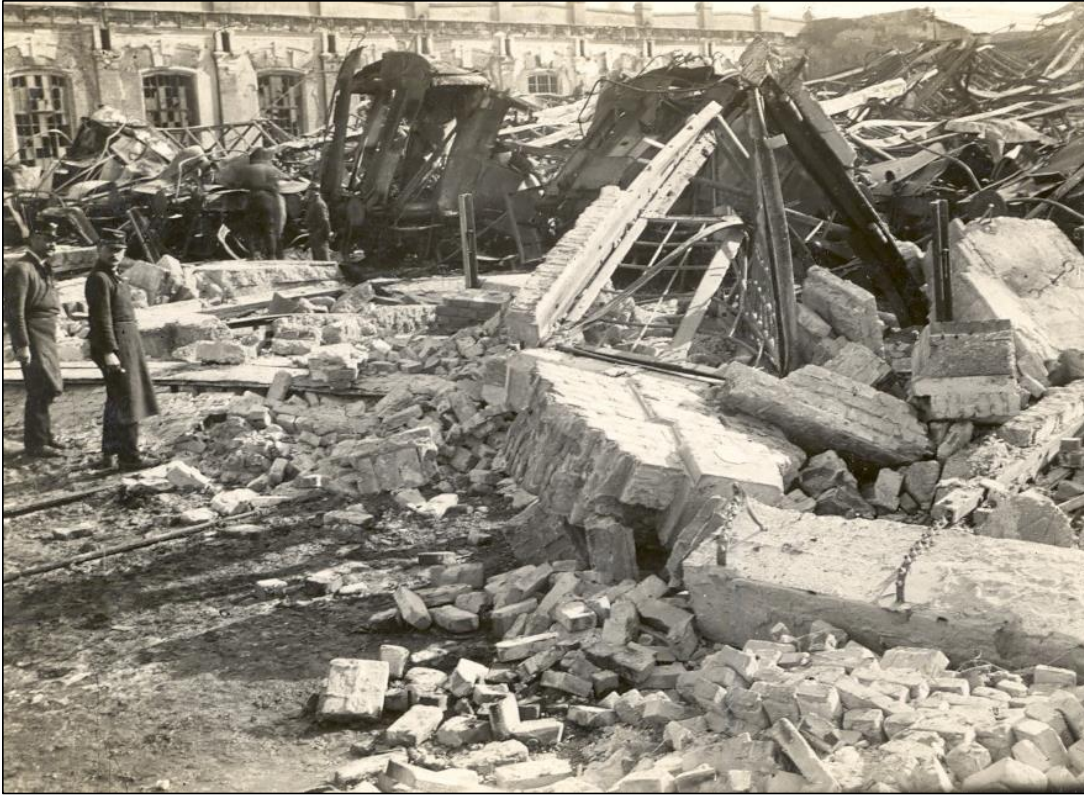
Fig. 4: F4 destruction on the plot of the old locomotive factory. Photo committed from a private archive in Wiener Neustadt.

- 5 The main justification for the F4 rating in the most devastated area is the fact that several brick walls of about 1-m thickness belonging to the old locomotive factory collapsed. The ceiling between the ground floor and the first upper floor of this building was supported by steel beams, leading to an even more robust sturdiness. A large piece of this floor was flipped outside the exterior walls. An aggressive rating could have classified the DoD as “largely blown down” for important parts of the factory in an area of about 50 m of diameter, which would have resulted in a final F5 rating. Given the uncertainties in

- 10 the state of conservation of the building and the unknown building structure before the event, the more conservative “walls partly collapsed” DoD was chosen, resulting in the final F4 rating. A neighbouring building also experienced the collapse of very thick brick walls, resulting in another F4 rating.

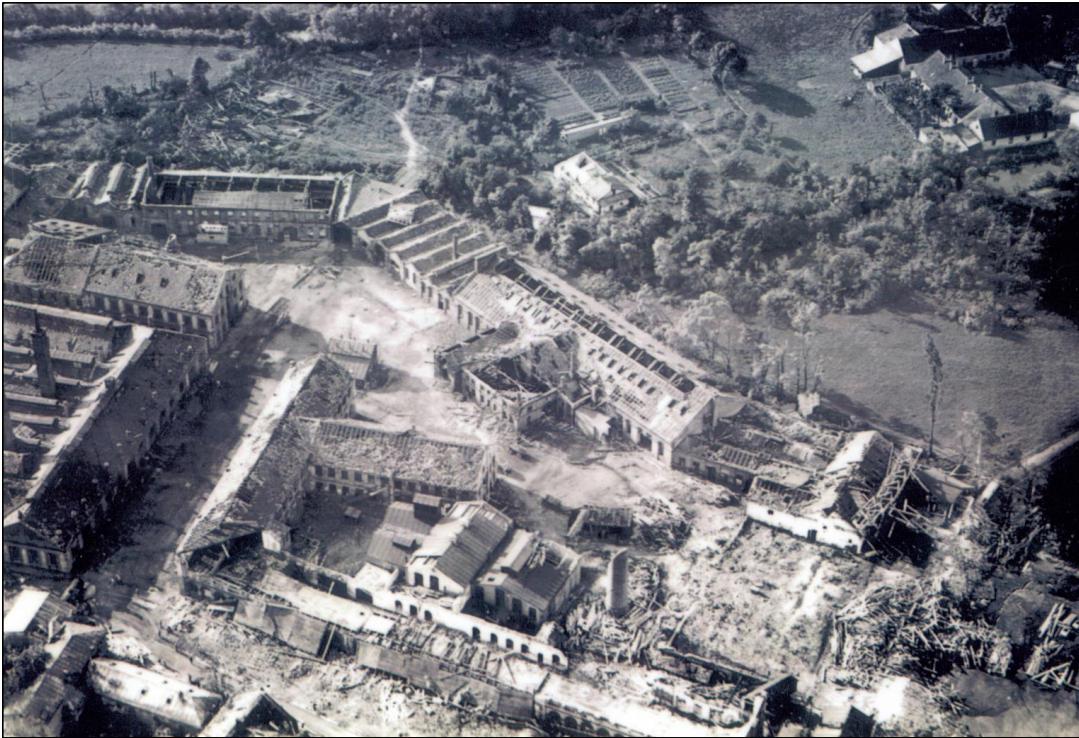
Fig. 5: Aerial view of parts of the most damaged old locomotive factory. Most destroyed area in the lower right quarter of the photo. Source: Industrieviertelmuseum Wiener Neustadt.

As illustrated by the aerial photograph (Fig. 5), the degree of damage varies substantially within extremely small distances, from nearly untouched to total destruction. The spatial pattern of damage substantiates a statement by Fujita and Merriam (1992): „These examples show that tornado winds are highly variable within a short distance both in wind direction and speed, necessitating the use of all types of structures in mapping the F-scale wind pattern.“

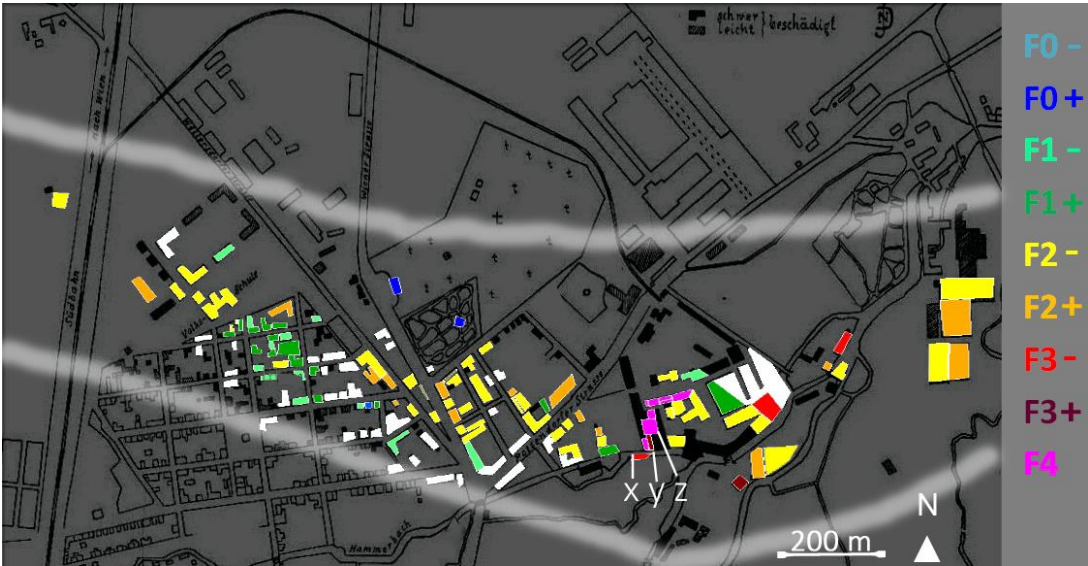
Fig. 6: Damage map of urban Wiener Neustadt area. Coloured shading represents new findings with corresponding scale values given to the right. White filling means that damage was seen on imagery, but an intensity rating was not possible. Soft white boundaries mark southern and northern edges of damages (drawn with manual interpolation). Background map: historic city map (Dörr, 1917). Buildings shaded in dark grey have shown minor damage (“leicht beschädigt”), buildings shaded in black have shown major damage (“schwer beschädigt”) in the historical damage survey.

Over the Josefstadt neighbourhood, a maximum intensity in the upper F2 range of the Fujita Scale was reached, while the damage width of F0 measured about 400 m. An eyewitness reported a visible tornado diameter of up to 1000 m (WNN, 1916). Further east, in the vicinity of the old locomotive factory, the maximum intensity reached F4 (Figs. 3-5). The width of the damage track at this most devastated place measures about 600 m (Fig. 6).

- 20 As can be seen from the city map detail with the historical building structures (Fig. 6), the damage path is widest in the region of the highest intensity ratings (F4, purple). Some abrupt changes in intensity close to the worst damage (F2 damage adjacent to F4 damage) may be attributed to the fact that in the affected industrial zone some sturdy structures largely survived and may have provided shelter to neighbouring objects (see also aerial photo in Fig. 5). In the damaged area with smaller houses to the west the pattern seems to be much smoother.

in Fig. 6). Another example in the vicinity of the locomotive factory was a factory building with unknown original building type and preservation stage located at 47.823442 N, 16.251017 E. Only piles of bricks and rather massive construction wood can be seen, but no remaining walls (image not shown). Our cautious assumption in this case was DI “C” (“strong outbuilding / weak frame house”) and DoD “f4”, leading to a final rating of F3+ (Building “y” in Fig. 6). A neighbouring building with similar uncertainties and swept-clean foundations was classified as DI “B” and DoD “f5”, resulting in an F3-rating (Building “x” in Fig. 6).
