Author`s response for minor revision on 7 May 2018:

Second Review of "A forensic re-analysis of the one of the deadliest tornadoes in European history"

A forensic re-analysis of one of the deadliest European tornadoes in European history

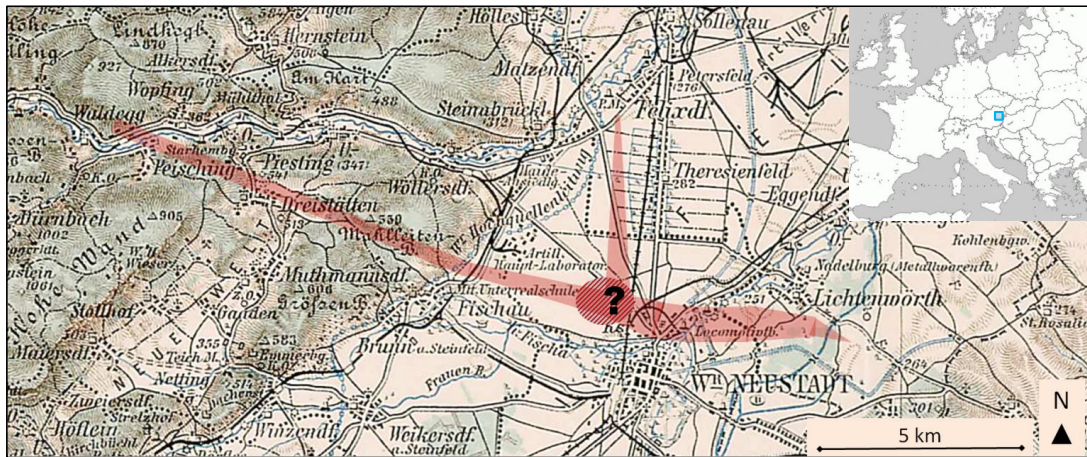
Fig. 2: Map of tornado damage tracks (red shadings) in the Wiener Neustadt area. The hatched area with the question mark denotes the airfield west of town, where the exact genesis of the main tornado is unknown. Basis map: “Generalkarte von Mitteleuropa des k.u.k. Militärgeographischen Instituts Wien, Blatt 34° 48° Wien” of 1893.

“An idea of how complex tracks of different tornadoes in one close area can be we
can get from a track map that was made after the 3 July 1980 Grand Island,
15 Nebraska, tornadoes (p. 44, Fujita and Merriam, 1992), showing between the
tornadoes no. 5 and no. 6 a similar angle as can be seen from our Fig. 2.”

The first damages were documented in the village of Peisching (Dörr, 1917), located in the Piesting valley, 15 km west-north-west of Wiener Neustadt (Fig. 2). The tornado was reported to have formed on a slope to the west of the village, while in Peisching roofs were damaged, and beyond Peisching, a continuous visible damage track extended to the Leitha River east of Wiener Neustadt. In the northern part of the following village Dreistetten a few houses were severely damaged, and the first severe injury is evident (Karl, 2017; Schramböck, 2017). A young farmer, who was at home on furlough from World War I, sustained a severe leg injury after being picked up by the tornado a few metres in height and thrown back to the ground.

Interestingly, this trustworthy eyewitness report, although published soon after the event, was not mentioned ~~in the study~~ by Dörr (1917). Independent from the findings of the eyewitness reports, the analyses of the damages reveal that two objects well north of the western predecessor tornado were indeed heavily damaged. It is likely that both predecessor tornadoes co-existed for at least several minutes and either merged or approached each other in the area of the airfield in a very narrow time span. **These two predecessor tornadoes approached each other in an angle of about 70 degrees.**

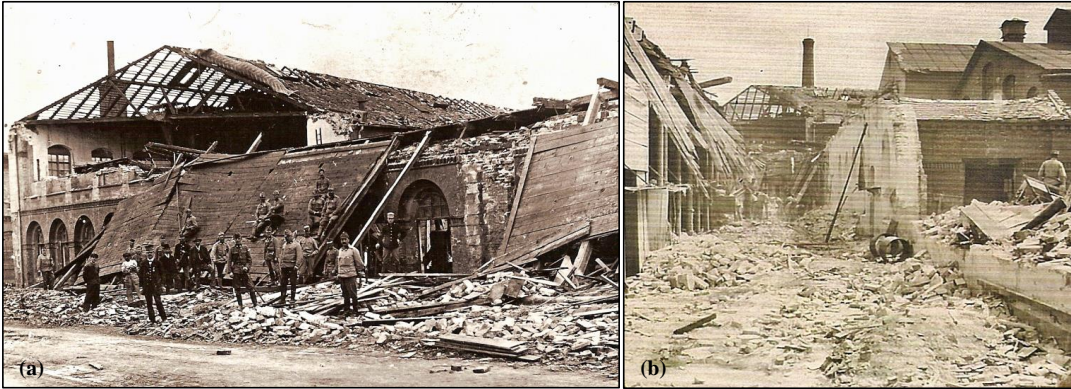
Fig. 3: Details of the old locomotive factory. Left (a): inner ceiling flipped outside, in foreground whole upper floor with massive brick walls collapsed (similar as the building parts that are still visible in the background). Right (b): Former indoor part of the same building with destruction of up to 1 m thick walls down to the ground level. Source of photos: Industrieviertelmuseum Wiener Neustadt.

- An example for a DI-DoD pair from the region of highest interest is the old locomotive factory, located at 47.82861 N, 16.251412 E (Fig. 3b): The photographer documented in the foreground the (pre-event) indoor part of the factory. Remaining foundations of a largely destroyed massive brick wall are visible on the right side. The remaining building parts on the left can also be seen in Fig. 3a, with a viewing angle from further left. The chosen DI for this building was “E” (“strong brick structure”), while the determined DoD was “f3” (“walls partly collapsed”) for the left section and “f4” (“largely blown down”) for the right section. A DoD “f3” leads to F4-, whereas a DoD “f4” leads to F5 category. Because of the unknown preservation stage, the final combined rating for this building leans towards the lower F4 rating (Building “z”

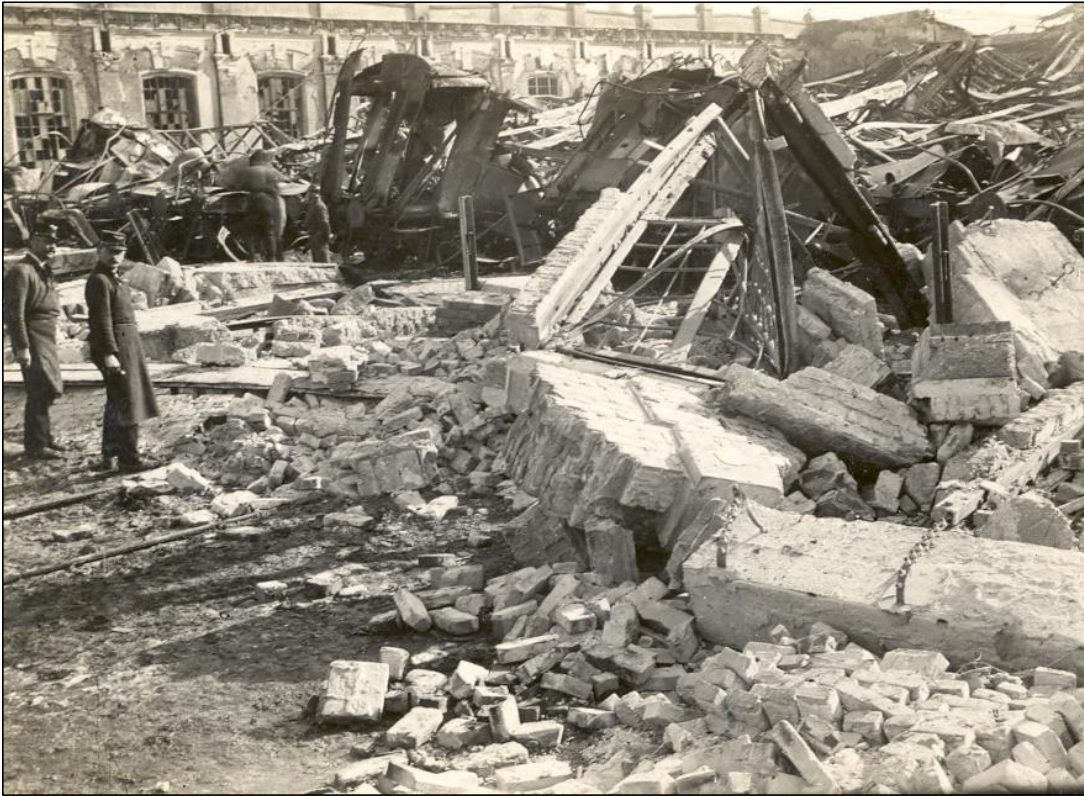
Fig. 4: F4 destruction on the plot of the old locomotive factory. Photo committed from a private archive in Wiener Neustadt.

- 5 The main justification for the F4 rating in the most devastated area is the fact that several brick walls of about 1-m thickness belonging to the old locomotive factory collapsed. The ceiling between the ground floor and the first upper floor of this building was supported by steel beams, leading to an even more robust sturdiness. A large piece of this floor was flipped outside the exterior walls. An aggressive rating could have classified the DoD as “largely blown down” for important parts of the factory in an area of about 50 m of diameter, which would have resulted in a final F5 rating. Given the uncertainties in

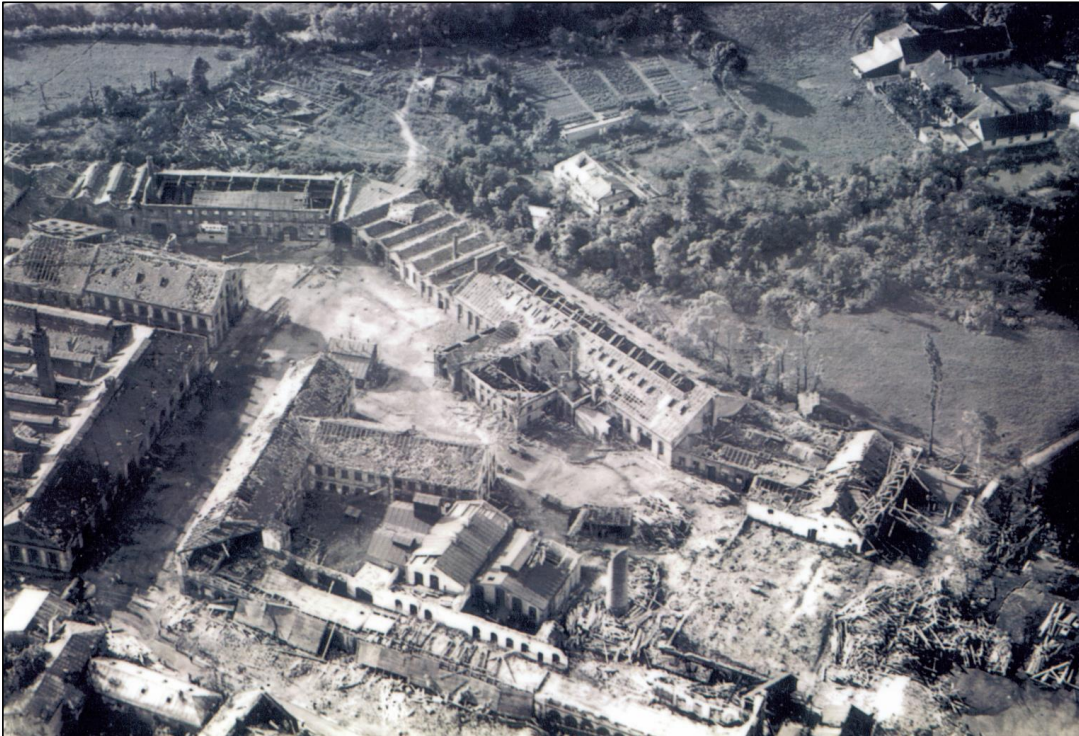
As illustrated by the aerial photograph (Fig. 5), the degree of damage varies substantially within extremely small distances, from nearly untouched to total destruction. The spatial pattern of damage substantiates a statement by Fujita and Merriam (1992): “These examples show that tornado winds are highly variable within a short distance both in wind direction and speed, necessitating the use of all types of structures in mapping the F-scale wind pattern.”

Fig. 5: Aerial view of parts of the most damaged old locomotive factory. Most destroyed area in the lower right quarter of the photo. Source: Industrieviertelmuseum Wiener Neustadt.

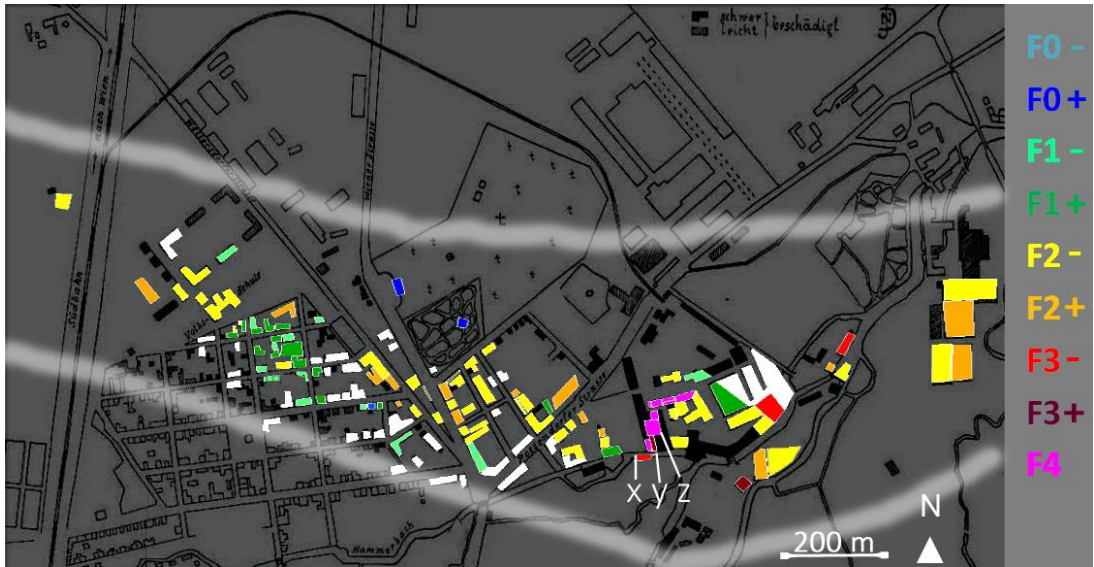
- As can be seen from the city map detail with the historical building structures (Fig. 6), the damage path is widest in the region of the highest intensity ratings (F4, purple). Some abrupt changes in intensity close to the worst damage (F2 damage adjacent to F4 damage) may be attributed to the fact that in the affected industrial zone some sturdy structures largely survived and may have provided shelter to neighbouring objects (see also aerial photo in Fig. 5). In the damaged area with smaller houses to the west the pattern seems to be much smoother.

Fig. 6: Damage map of urban Wiener Neustadt area. Coloured shading represents new findings with corresponding scale values given to the right. White filling means that damage was seen on imagery, but an intensity rating was not possible. Soft white boundaries mark southern and northern edges of damages (drawn with manual interpolation). Background map: historic city map (Dörr, 1917). Buildings shaded in dark grey have shown minor damage (“leicht beschädigt”), buildings shaded in black have shown major damage (“schwer beschädigt”) in the historical damage survey.

Over the Josefstadt neighbourhood, a maximum intensity in the upper F2 range of the Fujita Scale was reached, while the damage width of F0 measured about 400 m. An eyewitness reported a visible tornado diameter of up to 1000 m (WNN, 1916). Further east, in the vicinity of the old locomotive factory, the maximum intensity reached F4 (Figs. 3-5). The width of the damage track at this most devastated place measures about 600 m (Fig. 6).

in Fig. 6). Another example in the vicinity of the locomotive factory was a factory building with unknown original building type and preservation stage located at 47.823442 N, 16.251017 E. Only piles of bricks and rather massive construction wood can be seen, but no remaining walls (image not shown). Our cautious assumption in this case was DI “C” (“strong outbuilding / weak frame house”) and DoD “f4”, leading to a final rating of F3+ (Building “y” in Fig. 6). A neighbouring building with similar uncertainties and swept-clean foundations was classified as DI “B” and DoD “f5”, resulting in an F3- rating (Building “x” in Fig. 6).
