# Re-Analysis of one of the deadliest Tornadoes in European History and its implications

Alois M. Holzer<sup>1</sup>, Thomas M. E. Schreiner<sup>1, 2</sup> and Tomáš Púčik<sup>1</sup>

<sup>1</sup>ESSL, European Severe Storms Laboratory, Wiener Neustadt, 2700, Austria

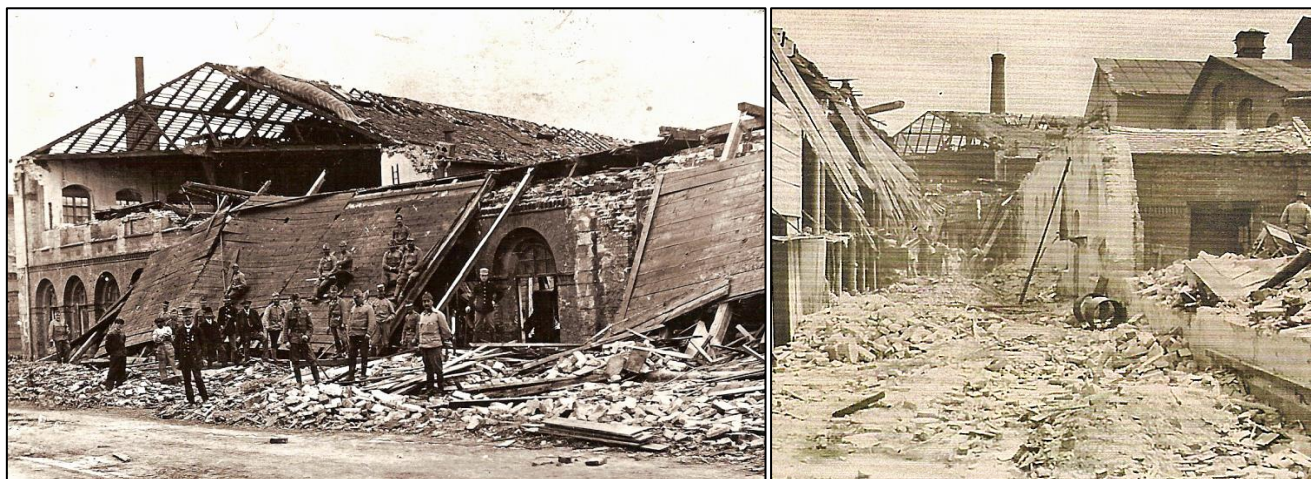
Fig. 7: Details of the old locomotive factory. Left: inner ceiling flipped outside, in foreground whole upper floor with massive brick walls collapsed (similar as the building parts that are still visible in the background). Right: Backyard of the same building with destruction of up to 1 m thick walls down to the ground level. Source of photos: Industrieviertelmuseum

5 Wiener Neustadt.

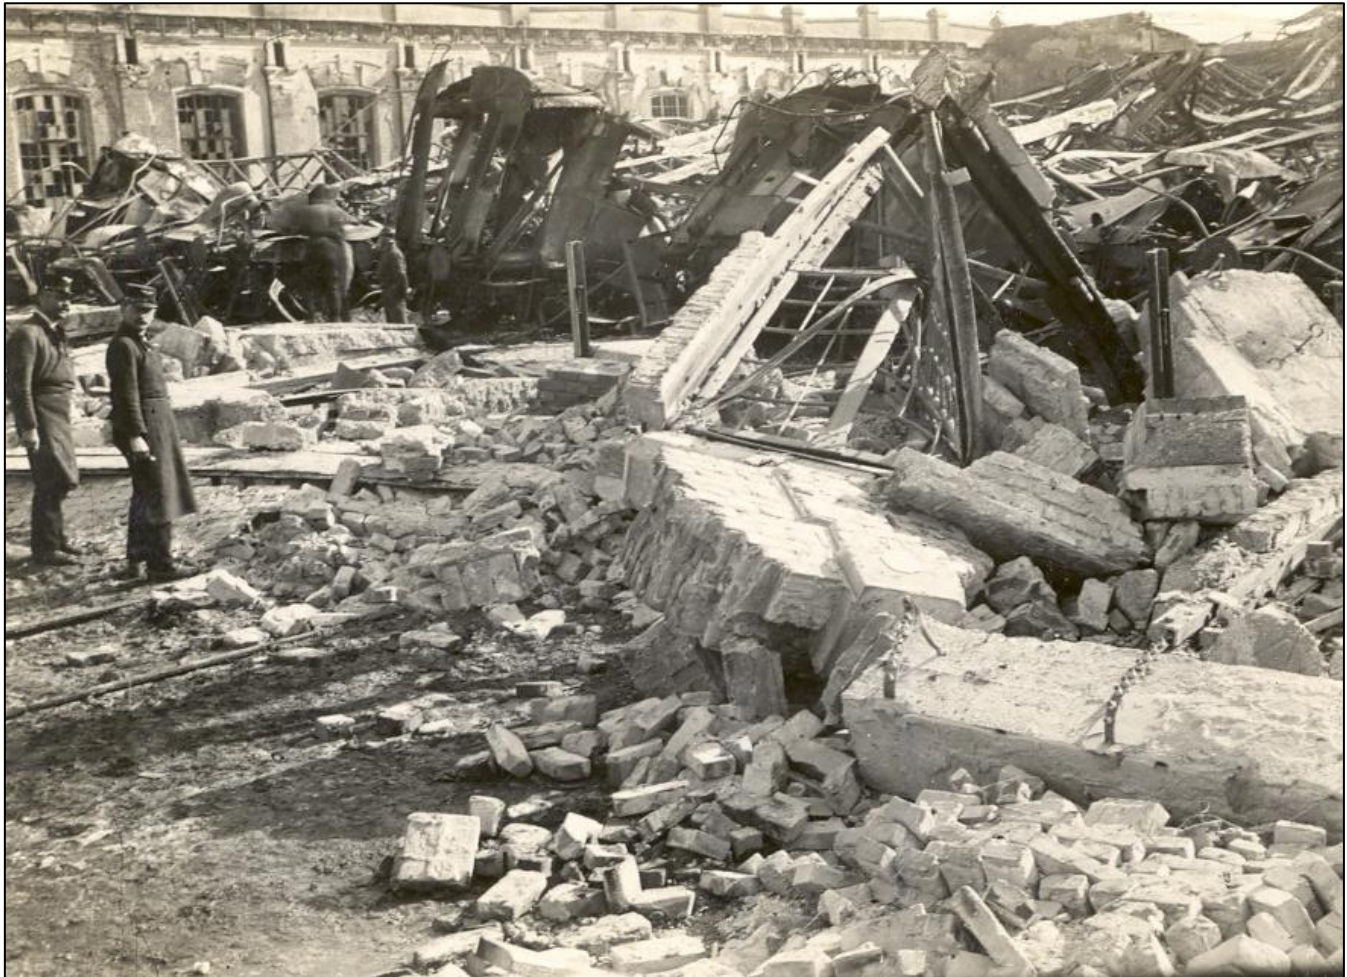
Fig. 8: F4 destruction on the plot of the old locomotive factory. Photo committed from a private archive in Wiener Neustadt.

- 5 The main support for the F4 rating in the most devastated area is the fact that several brick walls of about 1 m thickness belonging to the old locomotive factory collapsed. The ceiling between the ground floor and the first upper floor of this building was supported by steel beams, leading to an even more robust sturdiness. A large piece of this floor was flipped outside the exterior walls. An aggressive rating could have called the DoD “largely blown down” for important parts of the factory in an area of about 50 m of diameter, which would have resulted in a final F5 rating. Given the uncertainties in the

- b) Shortly before the “Tornado of Wiener Neustadt” struck the town, two predecessor tornadoes existed.
- c) The maximum intensity of F4 is supported by the collapse of thick brick walls of two neighbouring buildings. The heaviest damage was found in the old locomotive factory, where brick walls of about 1 m thickness were levelled.

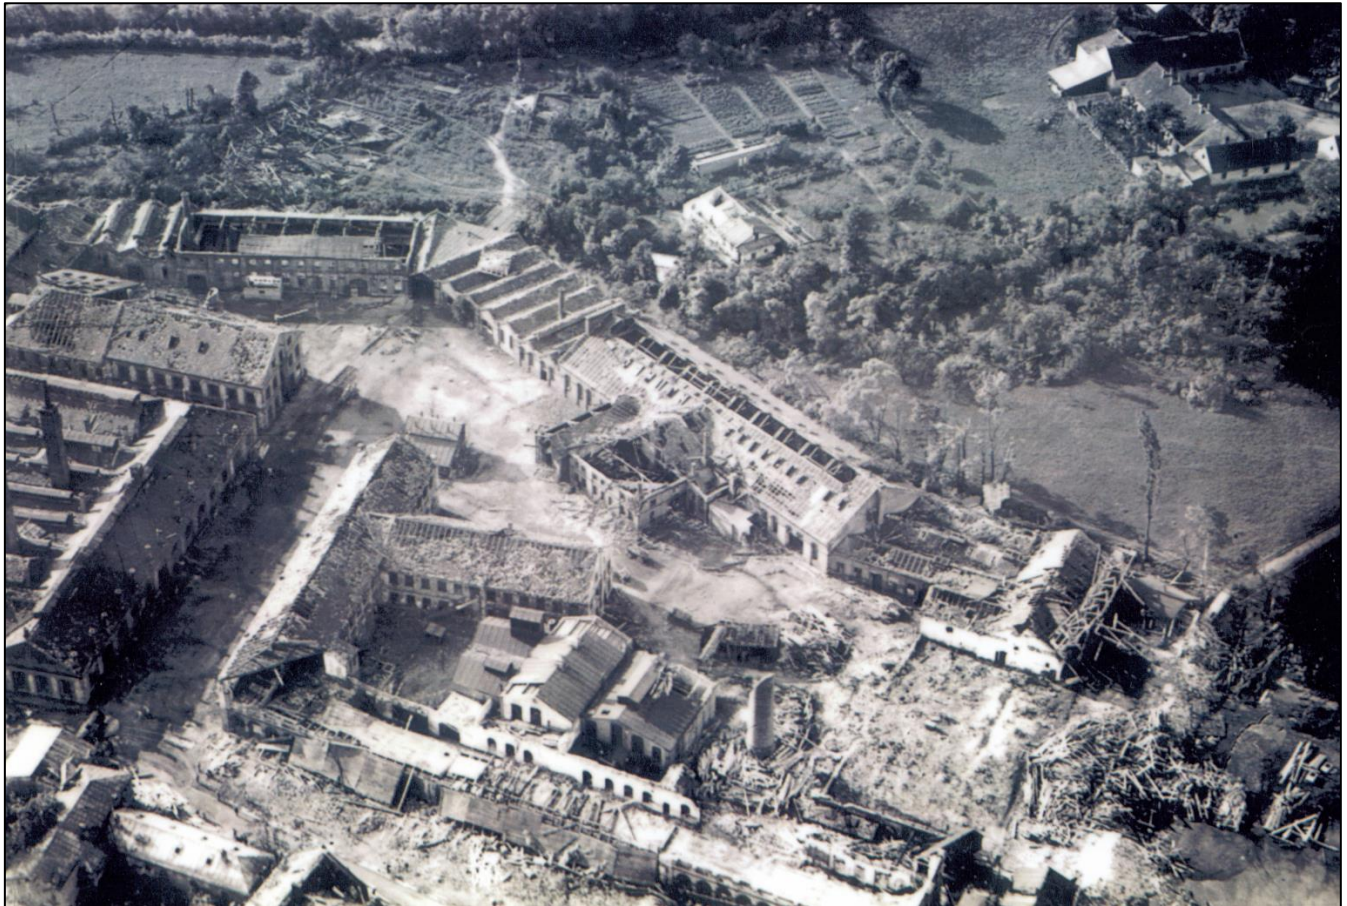
As can be seen from the aerial photograph (Fig. 9), the degree of damage varies substantially within extremely short ranges  
5 from nearly untouched to total destruction. This substantiates a statement by Fujita and Merriam (1992): „These examples  
show that tornado winds are highly variable within a short distance both in wind direction and speed, necessitating the use of  
all types of structures in mapping the F-scale wind pattern.“

Fig. 9: Aerial view of parts of the most damaged old locomotive factory. Most destroyed area in the lower right quarter of the photo. Source: Industrieviertelmuseum Wiener Neustadt.
