Response to reviewers

Development and application of a tsunami fragility curve of the 2015 tsunami in Coquimbo, Chile

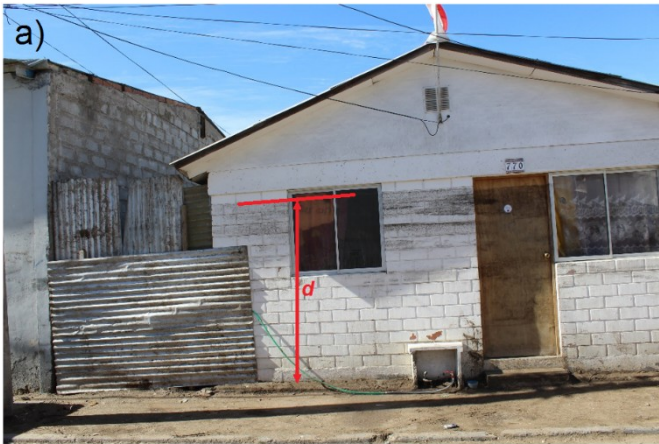
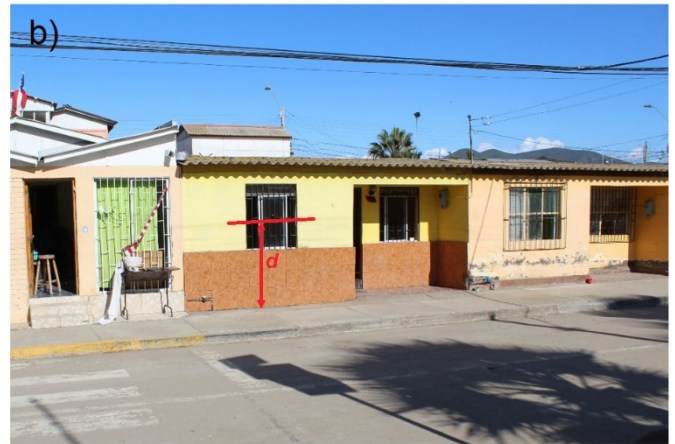
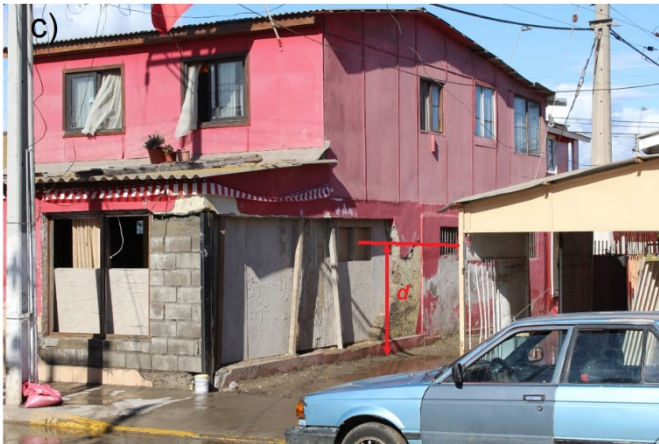
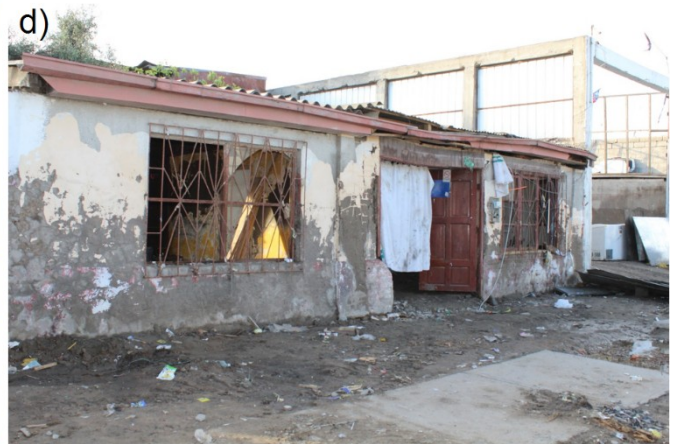
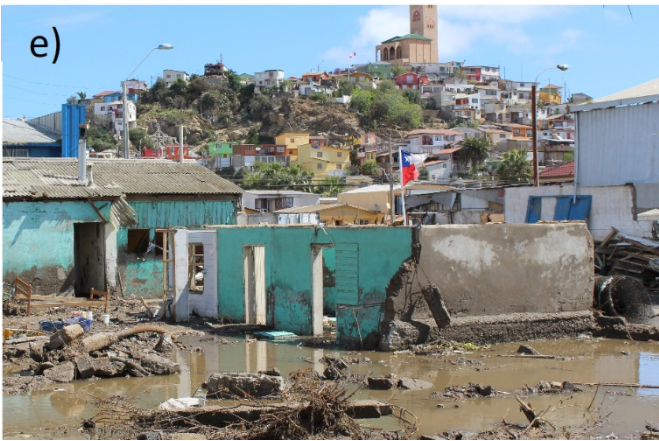
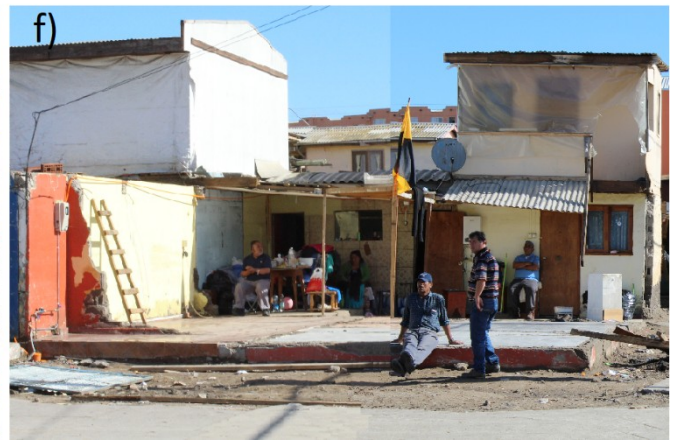
660 **Figure 2: Photographs of structures undamaged and masonry houses damaged by the September 16th 2015 tsunami in the Coquimbo area. The red letter d indicates the observed tsunami inundation depth. All photos were taken on September 22nd of 2015.**

130 2015 tsunami. Figures 2a and b show masonry houses that were not damaged by the tsunami despite inundation depths that
ranged from 1.5 to 2 m. Meanwhile, Figures 2c and d show houses with moderate to major damage, possibly to be used after
major repairs. ~~As a matter of~~In fact, the house in Figure 2c was being repaired at the time of the field survey and the gray
wall in the corner had been built a few days earlier. Meanwhile, the house in Figure 2d was abandoned, since all interior
walls, windows, doors and the roof were ~~completely damaged~~destroyed and major repairs and retrofitting will be needed.
Figure 2e shows a ~~completely damaged~~destroyed structure with its interior walls and roof completely removed, while Figure
135 2f shows the remaining foundation of a washed-away structure. Even though the damage to the structure could be due to
~~both~~ the earthquake and tsunami, it was observed that ~~the~~ damage due to the earthquake was limited (Candia et al., 2017) and

In addition, the two-level damage scale was used due to the small amount of inundated structures (568) and for comparison
with the existing fragility curve of Dichato (Mas et al., 2012), which has only two damage levels. The first level, called “not-
destroyed,” included structures with no damage or minor to major damage, corresponding to levels 1, 2 and 3 given by
145 Suppasri et al. (2013). These damage levels ~~imply~~indicate that there is slight to severe damage to non-structural
components; therefore, it would be possible to use the structures after moderate to major repairs (Figures 2a, b and c). The
other damage level, called “destroyed,” included damage levels 4 to 6 according to Suppasri et al. (2013), i.e., structures that
~~experienced~~underwent severe damage to walls or columns or that had completely collapsed (Figures 2 d, e and f).

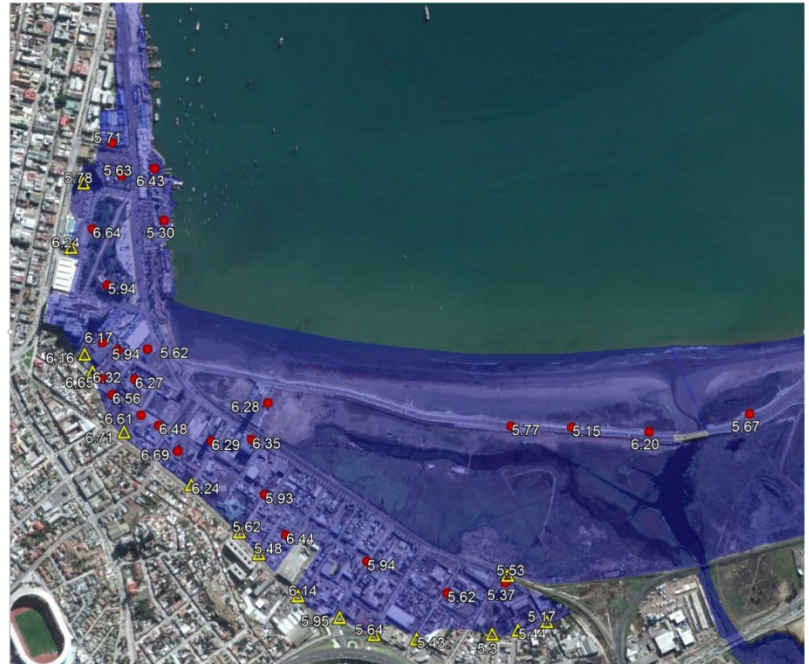
Figure 3. a) Surveyed damage to structures due to the 2015 tsunami; RC: reinforced concrete structures, L.S.: Light structures. b) Coquimbo inundated area (Aránguiz et al., 2016) and survey data. Red circles represent inundation measures and yellow triangles tsunami runup.

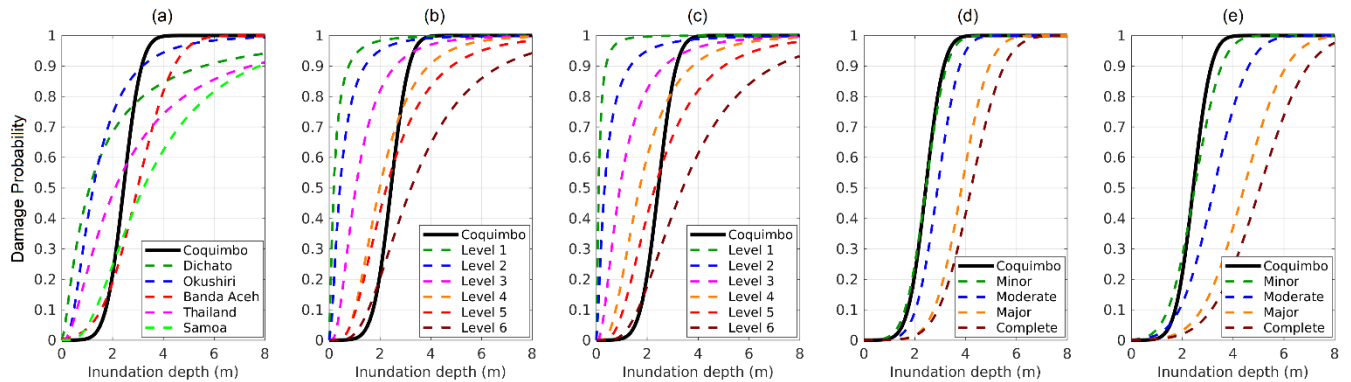
Figure 9. Tsunami fragility curves for damage probability developed for other locations and different damage levels. a) Two levels of damage obtained for three different cities in Chile, Japan and Indonesia. b) Six damage levels for wooden structures given by Suppasri et al. (2013). c) Six damage levels for mixed-material structures by Suppasri et al. (2013). d) Four damage levels for wooden houses given by Suppasri et al. (2012). e) Four damage levels for mixed-material structures given by Suppasri et al. (2012). (695

It is noteworthy that the Coquimbo fragility curve ~~(destroyed or completely damaged)~~for destruction or complete damage overlaps with the minor-damage-level curve for wood and mixed-material houses in flat areas in Japan (Figure 9d and e). A possible explanation is that houses in Japan are relatively new and built according to strict construction standards (Suppasri et al., 2012), in contrast to what was observed in Coquimbo, where old houses are found (See Figure 2), although it could also be due to the local topographic features of Coquimbo. This finding suggests that both topography ~~as well as and~~ structure quality should be considered in tsunami damage estimation.

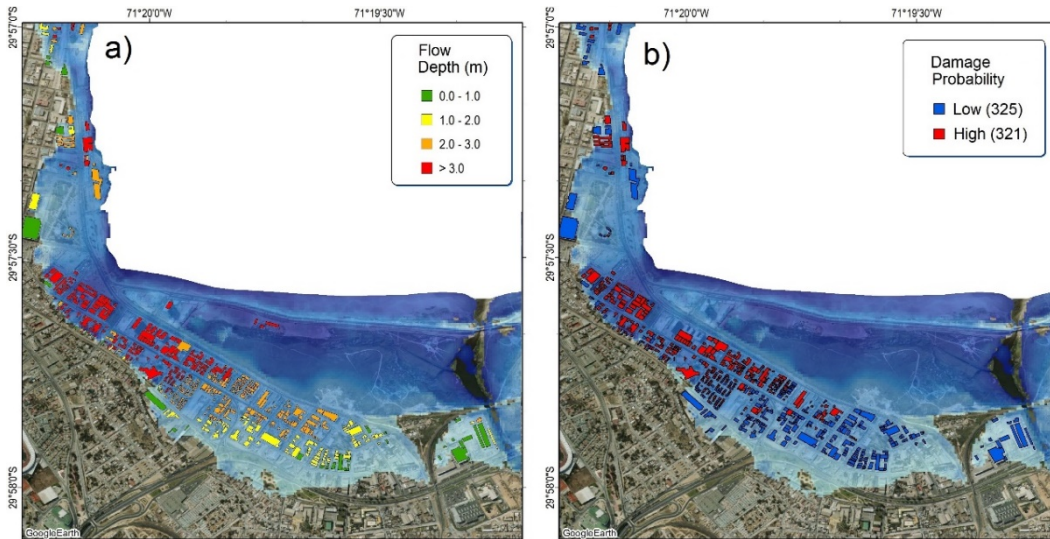
Figure 13. a) Tsunami inundation map and inundation depth on structures. b) Tsunami inundation map and low and high probabilities of damage to the flooded structures.

Figure 13a shows the low-lying area of the city of Coquimbo and the computed inundation depth given by the numerical simulation of scenario S1. 646 structures of mixed-construction materials structures were identified within the inundation area, and they are colored according to inundation depth level. Figure 13b shows the result of the damage estimation. It was found that 321 structures, i.e., 49.6% of the flooded structures, have a high probability of damage, a figure that is much higher than the 20% surveyed right after the 2015 tsunami. As expected, the structures behind the railway embankment and wetland would experience less damage than those located close to the shore.
