# Usability of aerial video footage for 3D-scene reconstruction and structural damage assessment

## **Abstract.**

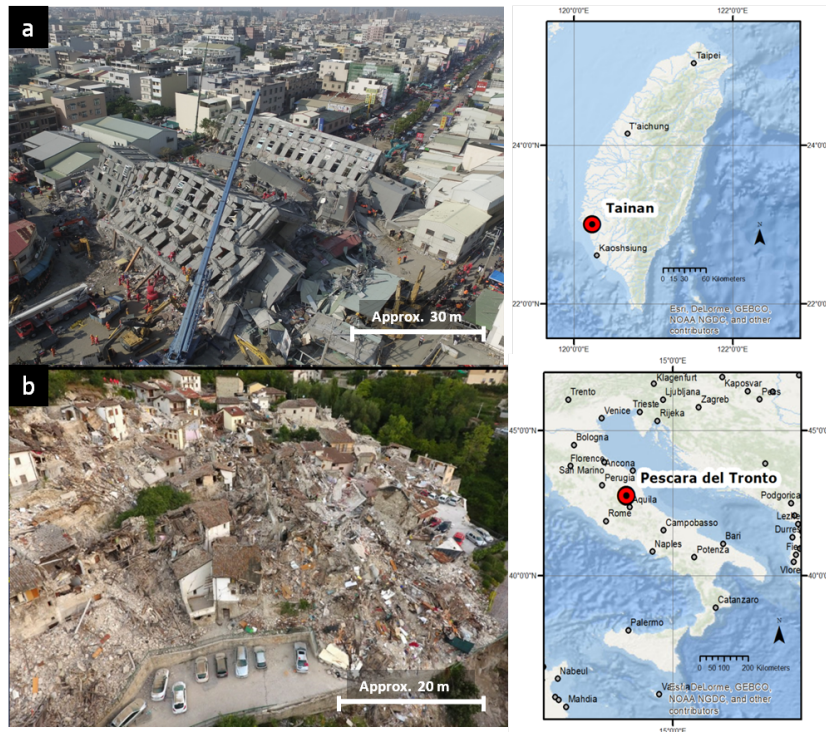
**Figure 1.** Study cases. (a) Taiwan earthquake February, 2016: Flat terrain, smoke presence and highly localized damage (Weiguan Jinglong collapsed building in the middle) (b) Pescara del Tronto earthquake August, 2016: Hilly terrain and more diverse, widespread damage.

Two earthquake-affected urban areas were selected for this research due to their contrasting characteristics, Tainan (Taiwan) and Pescara del Tronto (Italy; Figure 1). Both cities were affected by earthquakes of similar magnitude; 6.4 and 6.2 in February and August 2016, respectively. Tainan is a large city with regular topography where most buildings are composed of reinforced-concrete. Conversely, Pescara de Tronto is a rural city settled on one hillside of the Tronto Valley, hence topography there is hilly and houses are mainly made of stone. These disparate characteristics give each case study different damage features: while in Tainan damage was largely confined to a single collapsed high-rise building, in Pescara del Tronto it was extensive and highly variable (i.e., also intermediate damage levels can be found). The aim of selecting these contrasting cases is to obtain a broader understanding of video data usability in SDA.

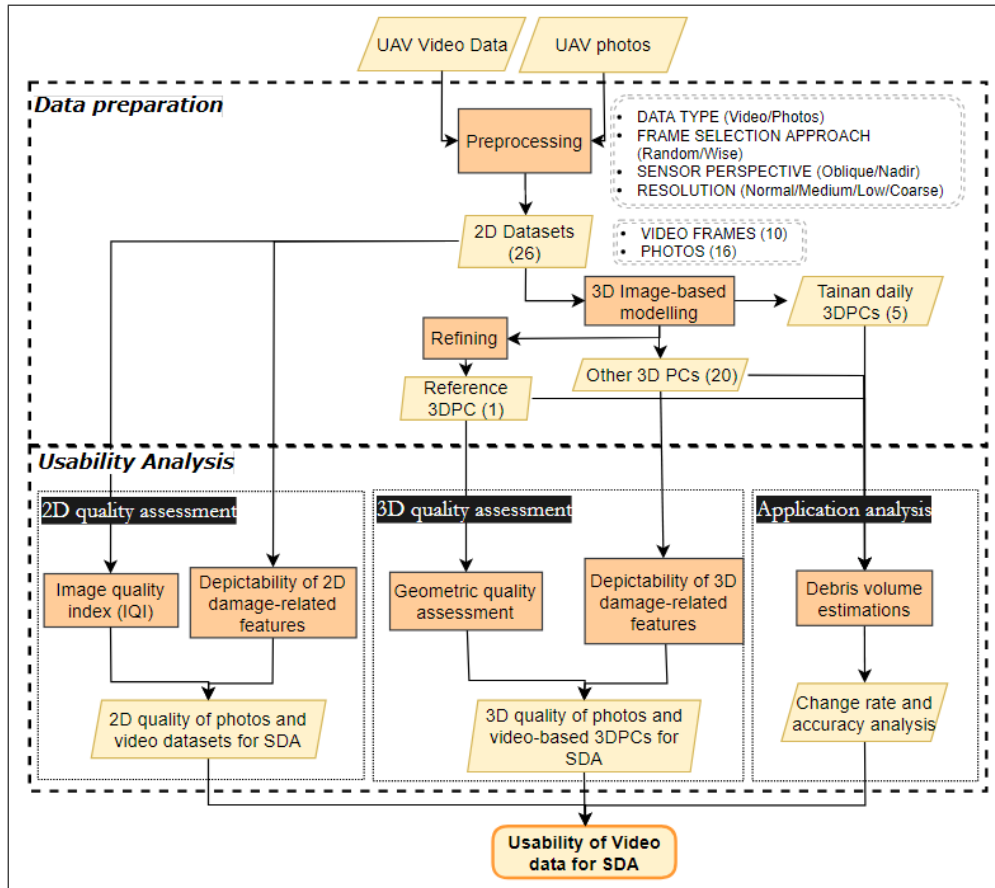
**Figure 2.** Workflow to determine usability of video data in 2D and 3D-based SDA. Dashed rectangles: Main phases.

Once all the datasets and 3DPCs were prepared, as described in Subsection 2.2, their usability was analyzed in three sections:

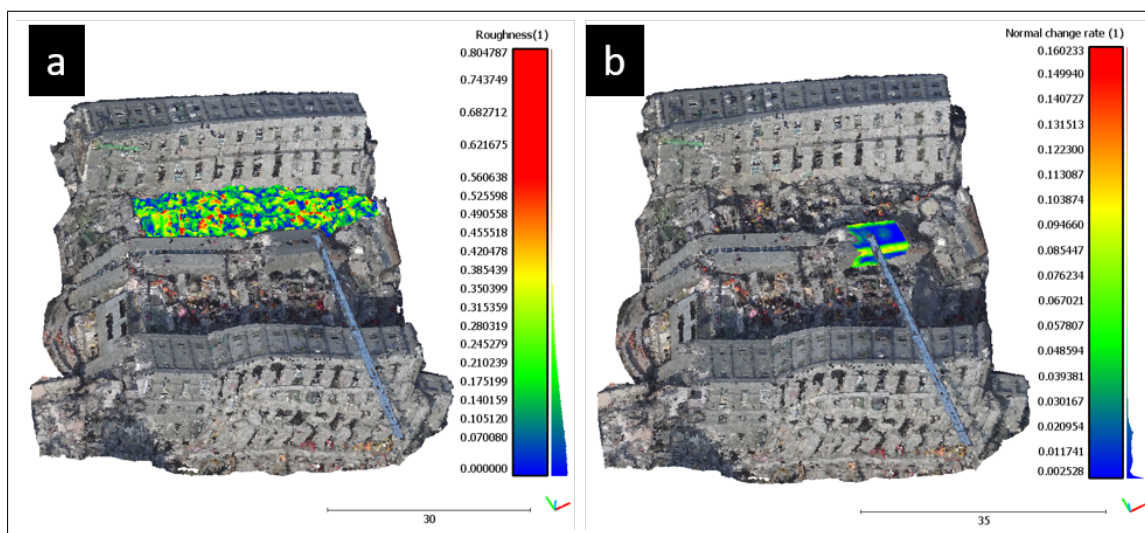
**Figure 3.** Segments selected for the depictability of damage-related features analysis. (a) Damage segment (Roughness values) (b) Non-Damage segment (Normal Change Rate values)

damage-related features were identified using a mesh model generated from the studied 3DPCs. Thus, the feasibility on this visual identification was compared and interpreted. As complement, a more elaborated approach using 3D damage-related features based on Vetrivel et al. (2017) was applied. This consisted of a segment-level representation of different 3D features. Three 3D features were used: Mean Curvature, Normal Change Rate and Roughness. These point-level features were estimated using a kernel (neighborhood size) of 1 m for all 3DPCs. A damaged area in Tainan was delineated to retrieve the segment-level distributions of these 3D features for every 3DPC, including the reference 3DPC (Table 2: Dataset 2). Through the use of box-plots, the segment-level distributions derived from every photo and video-based 3DPC were compared to the ones retrieved from the reference model to determine their depictability of 3D damage-related features. Additionally, non-damage segment distributions were retrieved from the reference 3DPC to confirm the relation of the chosen 3D features with damage (Figure 3).

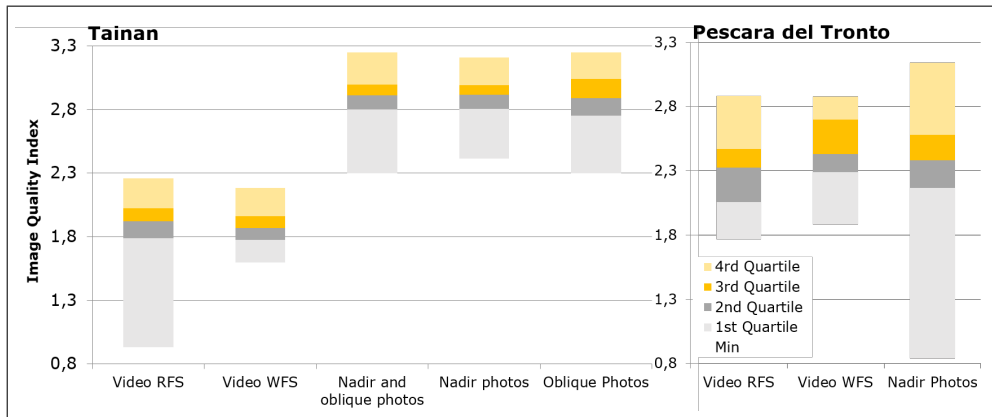
Figure 4. Boxplot of the Image Quality Index (IQI) computed for Tainan and Pescara del Tronto datasets.

Lower IQI values for video datasets were observed in the Tainan case, compared to all photo datasets (Figure 4). The WFS dataset have greatly reduced variance and in the case of Pescara del Tronto raised IQI values. Of the oblique and nadir photos, the nadir dataset showed less variance but similar IQI values in the case of Tainan. In Pescara del Tronto the nadir dataset contained substantial variance. A direct relation between IQI values with resolution was observed also when analyzing resolution-degraded datasets, the better the resolution the higher IQI values.

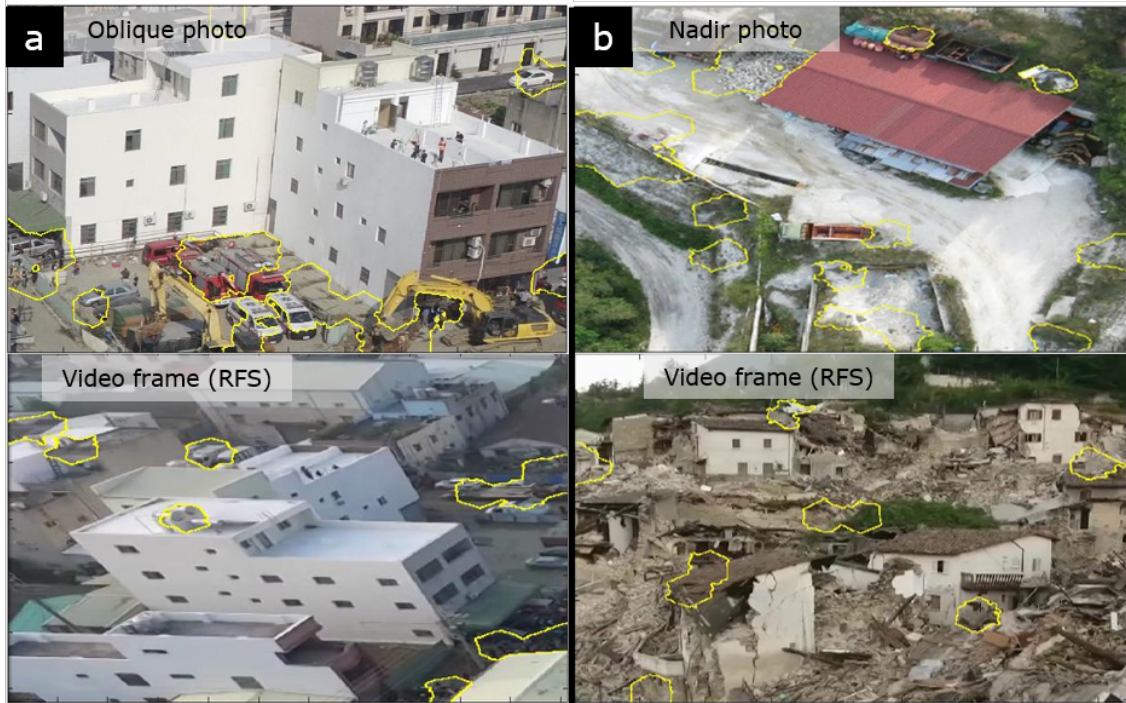
**Figure 5.** Extraction of 2D damage-related features using different datasets. Polygons: False positives in the extraction of 2D damage-related features for (a) Tainan oblique photo and video frame (Random Frame Selection RFS) and (b) Pescara del Tronto nadir photo and video frame (RFS).

10 Similar extraction and classification accuracies were obtained for both data types (Table 3). Between the two study areas, higher accuracies of 84 and 82% were achieved for the Pescara del Tronto video and photo datasets, respectively. For Tainan they were of 77 and 78%. Errors were mainly associated with false positives (i.e. misclassified and extracted damage features), caused by texture-rich super-pixels with the presence of cars or people in Tainan, and low texture super-pixels, such as bare ground, in the case of Pescara del Tronto (Figure 5).

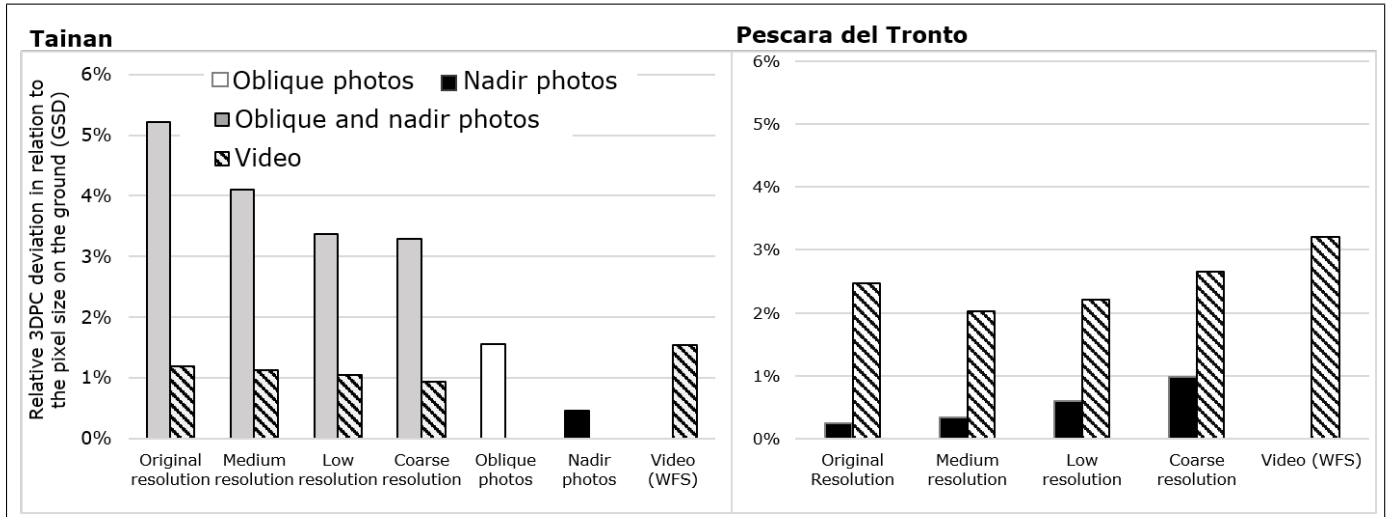
**Figure 6.** Planar fitting analysis of Tainan and Pescara del Tronto 3D Point Clouds as part of the internal 3D quality assessment. Comparison of the mean distance of 3D points to the theoretical planar object. Larger distance implies lower 3D point cloud precision.

Planar fitting and completeness assessments were performed to determine internal accuracy. For the former large deviations from the chosen planar object, and thus low precision, were computed in the case of Tainan for the 3DPCs generated with the combined oblique and nadir photos (Figure 6). The software used was not able to merge oblique and nadir photos resulting in a highly displaced 3DPC. Improved precision was obtained when using individually the oblique or nadir photo datasets; however

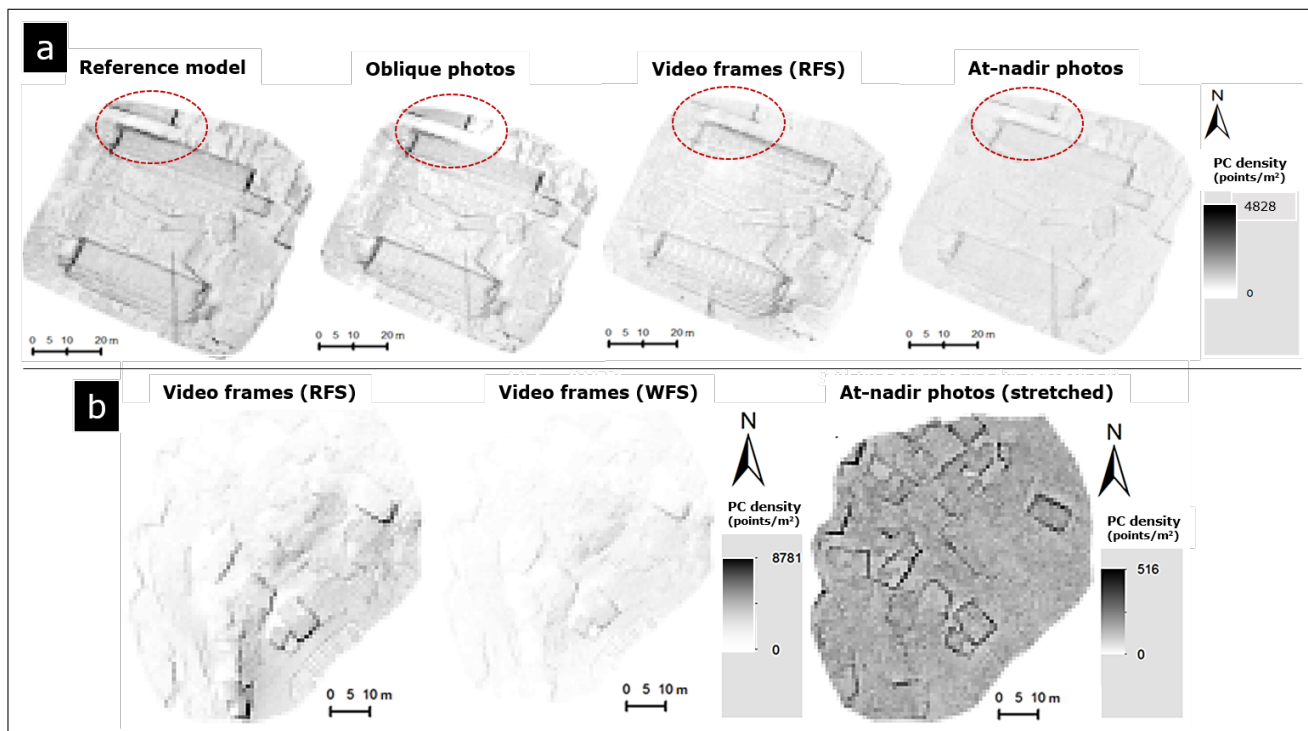
**Figure 7.** Vertical point cloud density raster maps generated for the completeness analysis. (a) 3D Point Clouds of Tainan and (b) of Pescara del Tronto. Dashed red circle: noticeable difference in completeness between 3DPCs of Tainan.

generated with oblique photos were denser than the video-based 3DPCs in the Tainan case. The RFS video-based 3DPC in turn was denser than the one generated from nadir photos in both study cases. However, considering the percentage of empty cell, the RFS video-based 3DPCs percentages are low, and outperform percentages of oblique and nadir-based 3DPC in the vertical and horizontal perspective, respectively (Figure 7 and Table 4). The WFS video dataset produced low-density 3DPCs with a large percentages of empty cell in both study cases and perspectives.

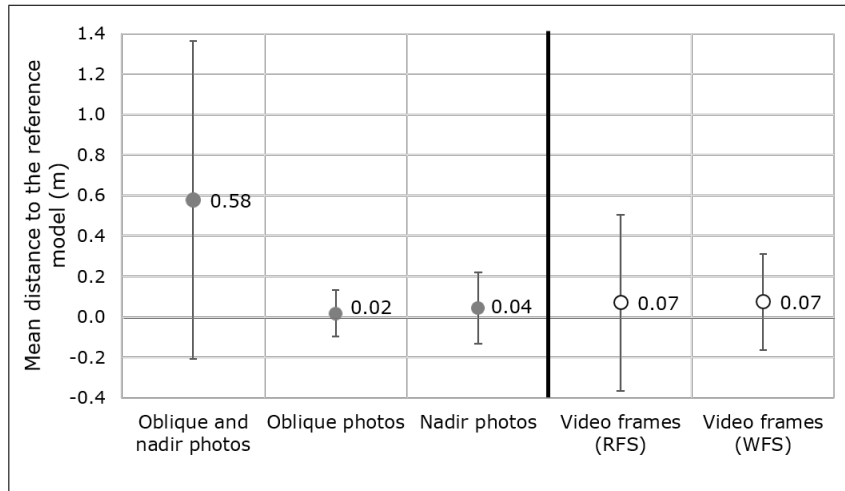
**Figure 8.** External accuracy assessment of video and photo-based 3DPCs of Tainan. Comparison of the mean distance between the analyzed and the reference 3D Point Clouds.

Concerning external accuracy, the combined oblique and nadir photos-based 3DPC also resulted highly inaccurate. Independent oblique and nadir photos-based 3DPCs registered high accuracies, with mean distances of 2 and 4 cm to the reference model, respectively (Figure 8). Video-based 3DPCs, with a mean distance of 7 cm to the reference model, resulted less accurate than individual oblique or nadir photos-based 3DPCs. It was observed that the WFS video-based 3DPCs removed some noise in 3DPCs (i.e. less variability), but its accuracy was still the same of RFS video-based 3DPCs.

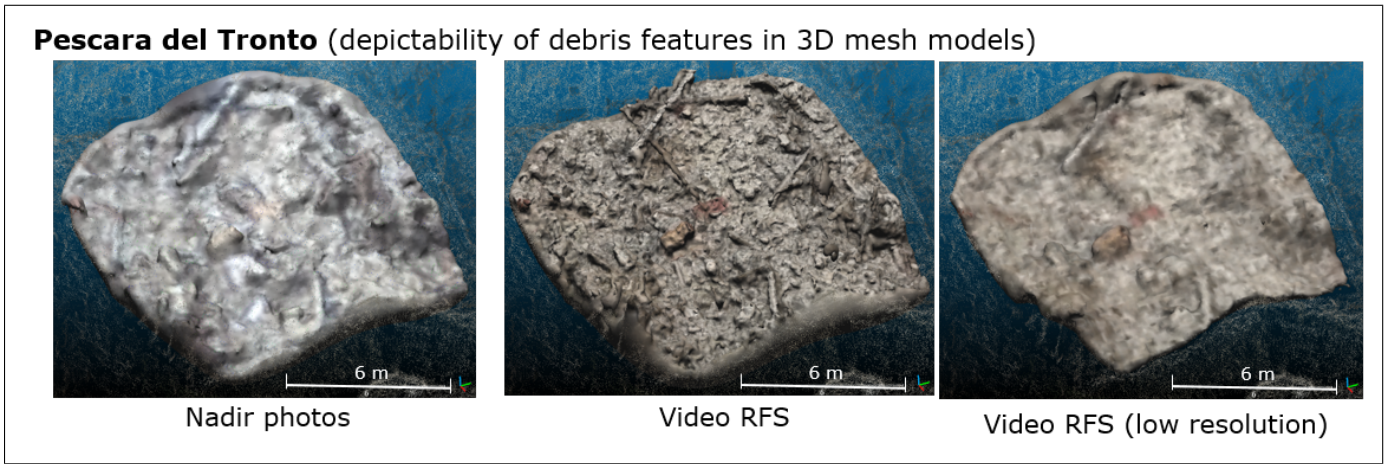
**Figure 9.** Comparison of the depictability of debris features in photo and video-based mesh models of Pescara del Tronto. Lower depictability in nadir photos-based mesh due to their high GSD and the presence of motion-blur effects.

In the case of Pescara del Tronto building deformations, cracks and debris features could be readily identified by visual inspection in video-based mesh models. These models outperformed representations of nadir photos-based 3DPC and even better representations were obtained using degraded-resolution video frames (Figure 9). In the Tainan case, cracks and spalling features were better represented in the oblique photos-based models than in the video-based ones; however, their identification was still difficult specially compared to the reference mesh. Other damage characteristics, such as inclined walls and spalling were only extractable from the reference model.

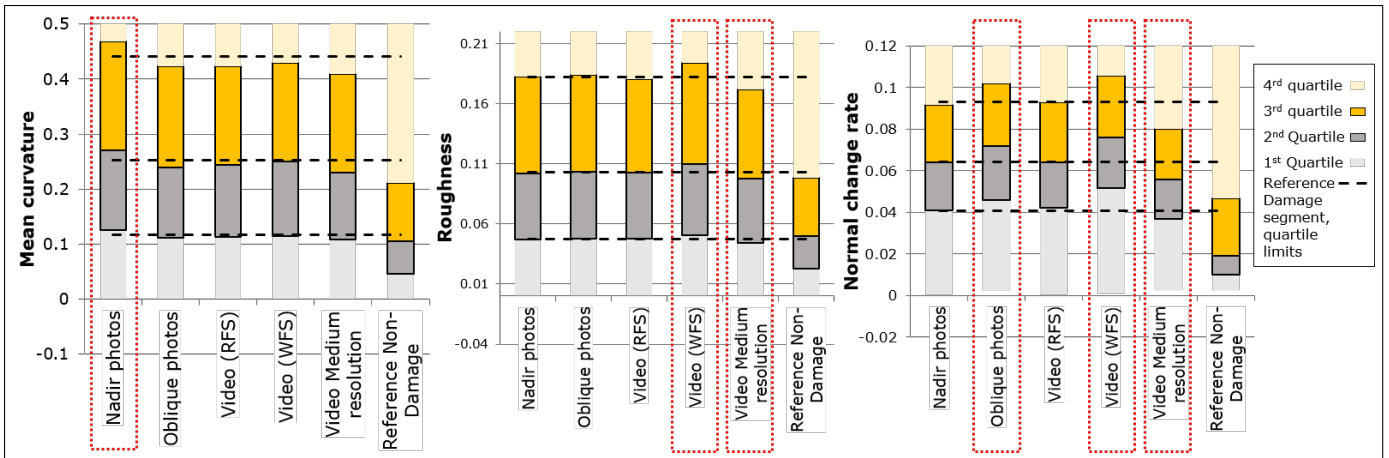
**Figure 10.** Tainan segment-level distributions of 3D damage-related features. Dotted rectangles highlight discordant distributions from the reference damage segment and thus low depictability of 3D damage-related features.

The analysis of the distribution of 3D damage-related features showed more deviating distributions, therefore less depictability in photo-based 3DPCs (Figure 10). RFS video-based 3DPCs distributions were consistently aligned with the distributions extracted from the reference 3DPC for all 3D features analyzed. The distributions of the other 3DPCs showed deviations in at least one feature. The relation of these features with damage characteristics was confirmed by the inclusion and analysis of a non-damaged segment extracted from the reference 3DPC, which clearly presented deviations in all 3D features.

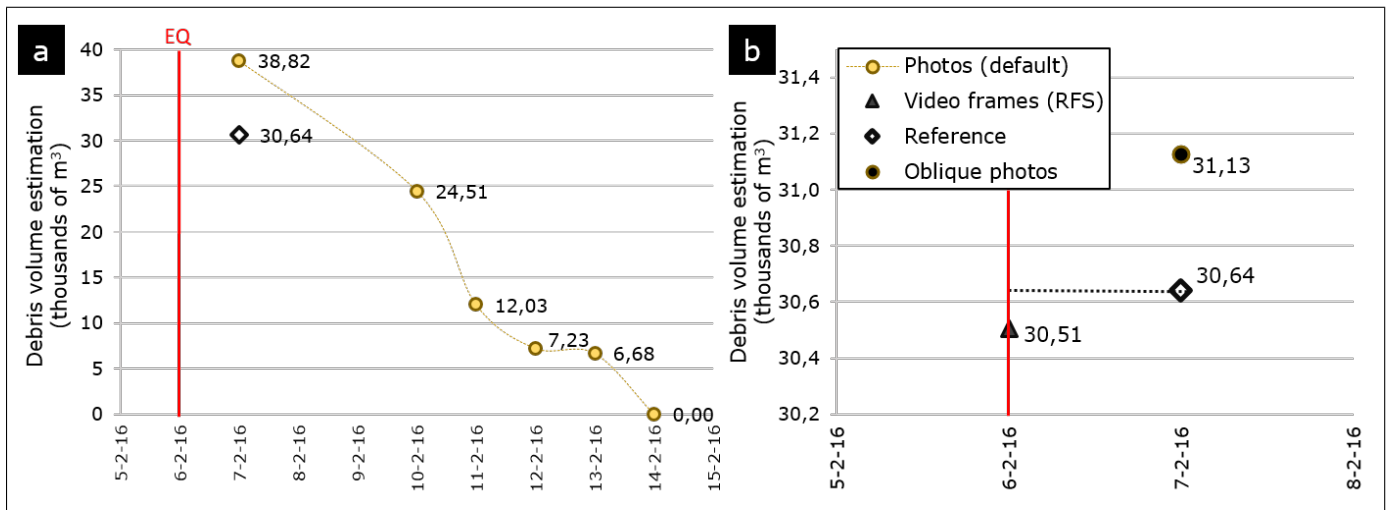
**Figure 11.** (a) Debris volume change analysis using the Tainan multi-temporal photo-based 3DPC and reference model. (b) Volume estimations for video-based 3DPC (Random Frame selection), oblique photos-based 3DPC and reference model. Red line: Earthquake (EQ) date.

Debris volume change was analyzed for Tainan using multi-temporal photo-based 3DPCs, and as expected a negative trend was observed in accordance with the cleanup operations (Figure 11). However, the comparison with the estimation made with the reference 3DPC for the first date (7 February, 2016), revealed a large overestimations in these series. Debris volume estimation made with the 3DCP generated from the default dataset (i.e. the combined oblique and nadir photos) was of around 8000 m<sup>3</sup> more than the estimation done with the reference 3DPC. This is linked to the displacement effects observed in the 3D external accuracy assessment. In contrast, volume estimations made with the oblique photo-based 3DPCs and video RFS dataset for the

same date presented more accurate results. The estimation with the oblique-based 3DPC was only 486 m<sup>3</sup> above the reference (1.6% of error); while, the most accurate estimation was obtained with the RFS video-based 3DPC, with an error of only 136 m<sup>3</sup> (0.4%).

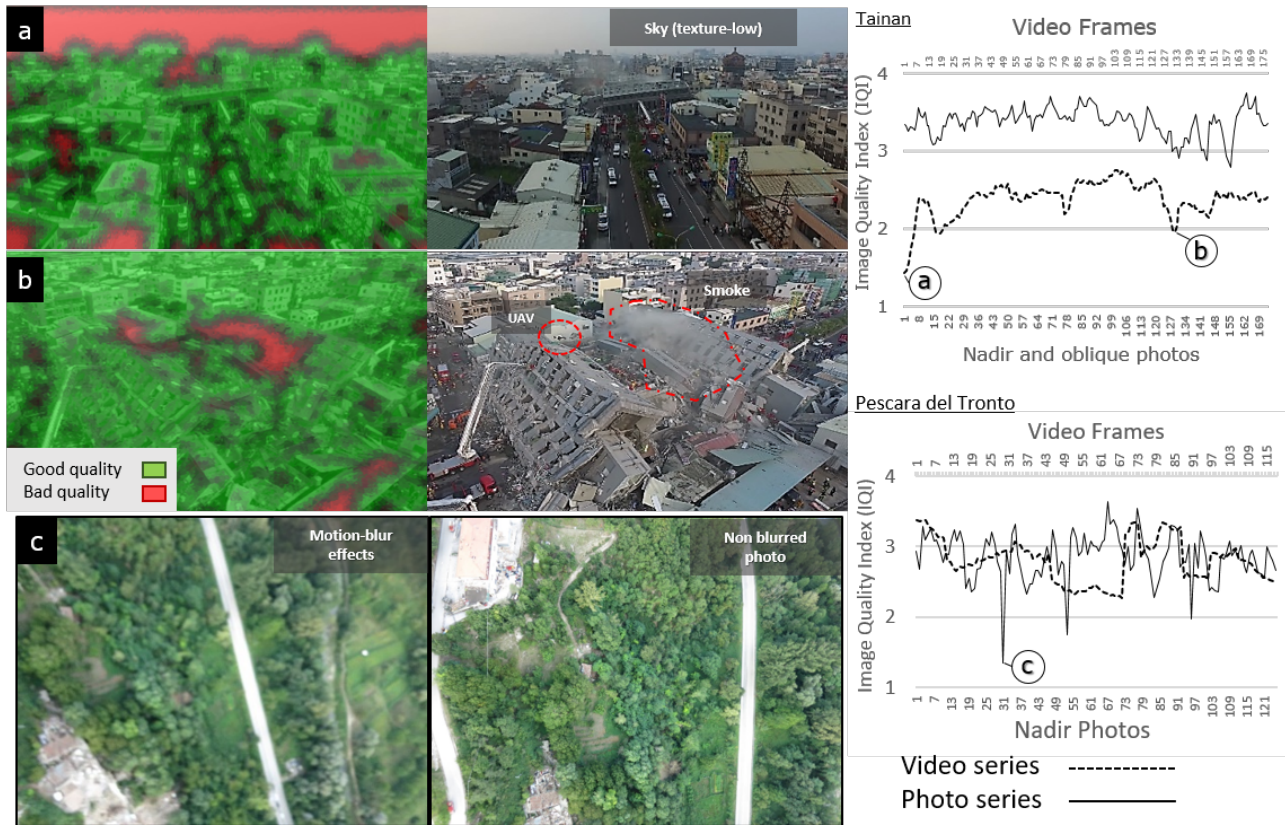
**Figure 12.** Image Quality Index (IQI) series for Pescara del Tronto and Tainan. (a) The sky as a low-texture area is considered a likely source of 3D modelling error in IQI maps (red area). (b) Also smoke and moving objects (UAV). (c) In Pescara del Tronto motion-blur effects result in IQI values.

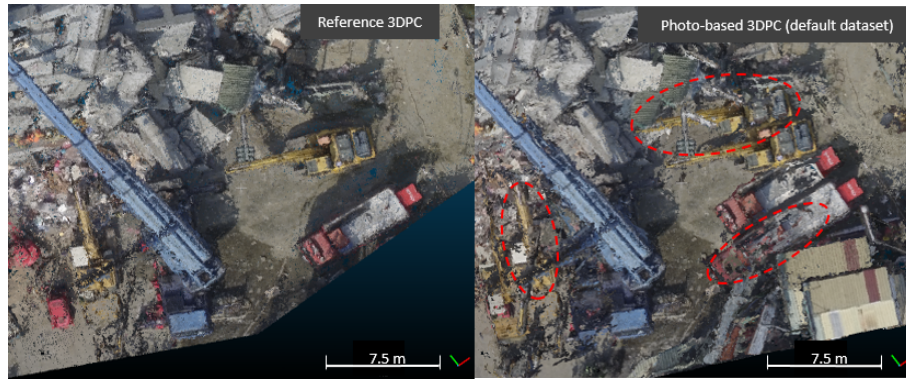
**Figure 13.** Displacement effect in 3DPC generated with the default photo dataset (combined nadir and oblique photos), due to a misregistration or differences in spectral and spatial characteristics between oblique and nadir datasets. Red dashed circles: noise in 3DPCs.
