Final response to the Referees' comments

Authors: The title of our manuscript have been changed as "Application of UAV-SfM photogrammetry and aerial LiDAR to a disastrous flood: repeated topographic measurement of a newly formed crevasse splay of the Kinu River, central Japan". In other parts of the manuscript, "multitemporal" have been replaced by "repeated".

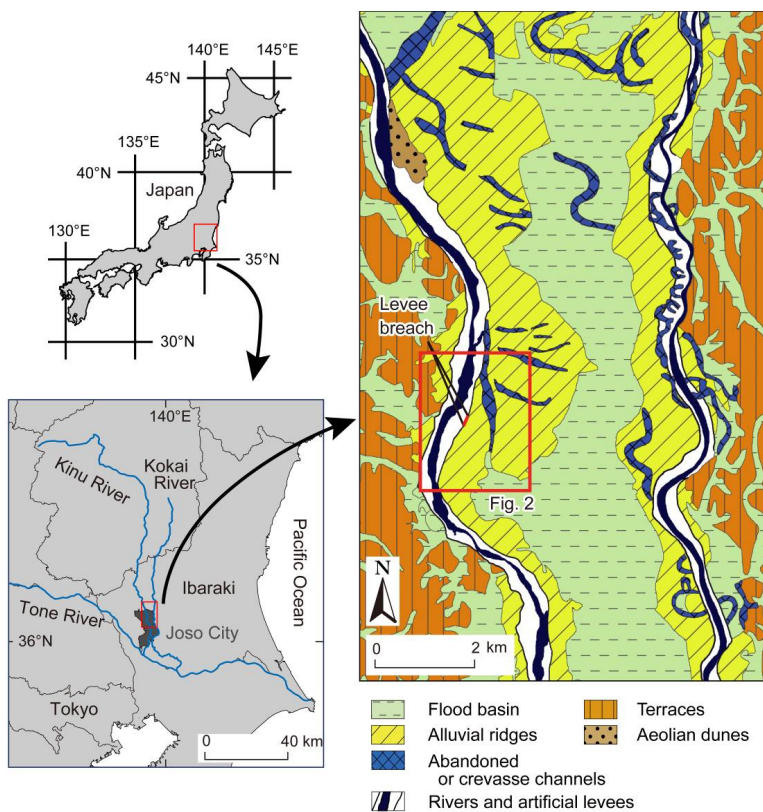
Figure 1: Location map of Joso City and the Kinu River, and geomorphic map showing the location of the levee breached during the 2015 flood. *Modified from Izumida and Sugai (in review).*

“The research area covered by the DSMs was on the southern part of an alluvial ridge along the Kinu River; the width of which was about 1.5 km (Fig. 1). Within the research area, the elevation of the ridge was high along the channel, especially near the breached levee, although the ground level there might have been raised for construction. The artificial levee was about 2 m higher than the top of the alluvial ridge. The alluvial ridge was divided by a shallow valley oriented north–south along the eastern margin of the study area, which Sadakata (1971) suggested was a past crevasse channel. In the present, an agricultural canal ran along the valley, and a network of smaller canals covered the research area. The part of the alluvial ridge in the study area was mainly used for cultivating agricultural crops; most of the area was not covered by pavement or buildings except close to the levee.”

The Kinu River, which is 177 km long with a catchment area of 1760 km², is one of several large rivers in the Kanto Region, central Japan; it originates in the mountains north of the Kanto Region and joins the Tone River in the central Kanto Plain (Fig. 1). Volcanic Neogene and Quaternary age rocks are complexly distributed in the mountains that occupy the upper 60% of its catchment area. The remaining about 35% of the catchment is on the Kanto Plain and consists mainly of the present floodplain of the river and Pleistocene fluvial terraces. Mean annual precipitation is 1600–2100 mm in the mountains, and 1300–1500 mm on the plain.

The area affected by the 2015 flood is located about 50 km northeast from Tokyo (Fig. 1) and about 20 km upstream of the Kinu River's confluence with the Tone River. The Kinu River in this area has low sinuosity and a sandy bed with a gradient of about 1/2500, and it flows southward. The Kinu River and the Kokai River, another tributary of the Tone River, flow along the western and eastern margin, respectively, of a floodplain, and both these rivers and their abandoned channels are surrounded by alluvial ridges 1–2 m higher than flood basin, which occupies the center of the floodplain. The floodplain itself is 4–8 km wide, and it is bordered on both the east and west by fluvial terraces (Fig. 1). The largest alluvial ridges, which are 1.5–2 km wide, are those to the east of the Kinu River in Joso City. Older crevasse channels dissect the wide alluvial ridges by 1 m in depth, suggesting that the Kinu River has flooded repeatedly in this region (Sadakata, 1971). The alluvial ridges in this floodplain are densely inhabited and most villages are located on them. Other part of the alluvial ridges are used as agricultural lands, predominantly paddy fields. On the other hand, irrigation canals are entirely equipped in the flood basin and abandoned channels, and almost all area are used as paddy fields.

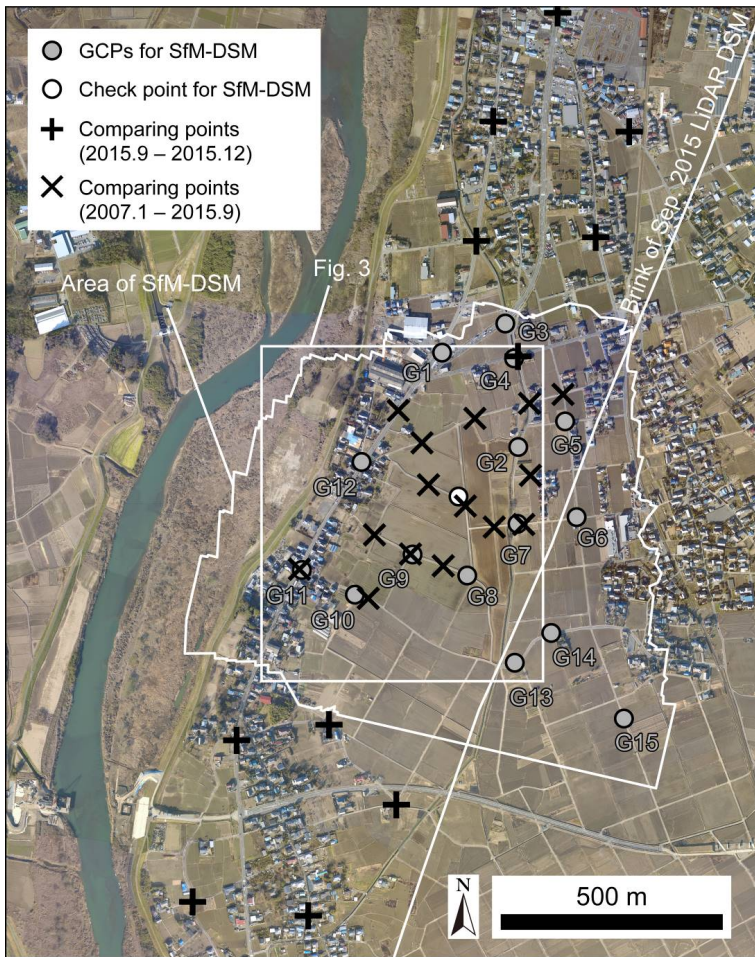
Figure 2: The distribution of the GCPs and the check point for the SfM-derived DSM and comparing points for each pair of DSM subtraction.

Authors: New figure (Fig. 2) and table (Table 1) have been added in [page 21 and 27](#).

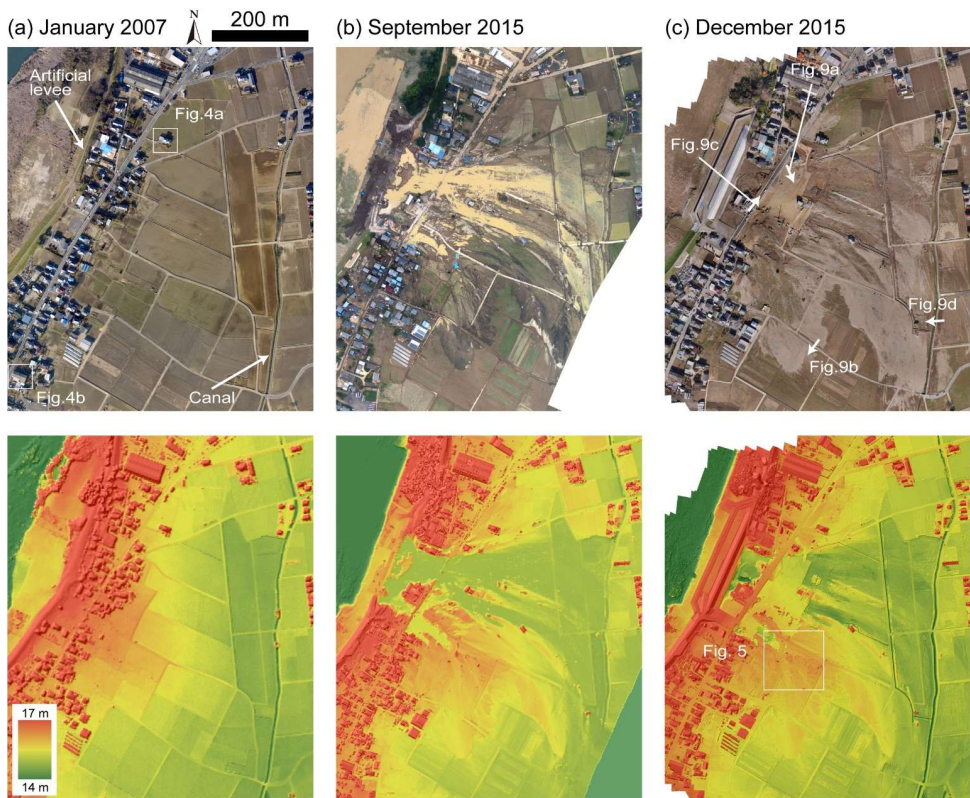
Figure 32: The three DSMs and orthophotos used in this study. See the text for the information about the acquisition of each data set. Elevations are relative to mean sea level in Tokyo Bay. Note the research area does not correspond to the extent of these DSMs.

Three months after the flood (December 2015), the crevasse channel was no longer submerged, and the areas of sand deposition appeared lighter in color than other, more muddy areas (Fig. 2c). Other than natural changes, some restoration and repair works by humans were apparent. The breached levee had already been repaired temporarily, the scouring along prefectural road had been partly filled and leveled, and the road had been reopened. Modification of the immediate post-flood topography was less in distal areas, although some changes are visible in the DSM and orthophoto: for example, crops had grown or been cut in the agricultural lands, and sediments trapped in the canal had been removed along with the obstacles within the crevasse channel. Numerous wheel tracks on the ground indicate that many vehicles (Fig. 6b) had been driven across the study area after the flood, even where marked modification of the topography was not observed.

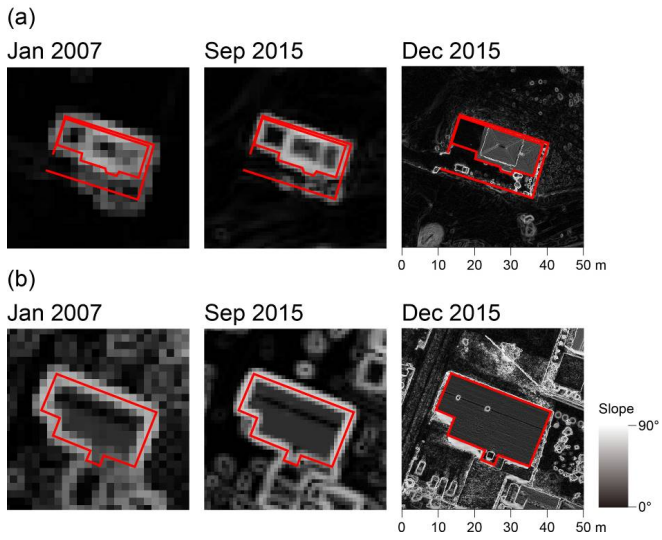
Figure 4: Gradient maps showing two buildings used to evaluate the horizontal accuracy of the DSMs. The cell sizes are the same as in the originals. Red lines indicate the edges of the buildings or walls on the December 2015 map. Note that these lines are within high slope areas on the maps for the other two dates. See Fig. 3.2a for the locations.

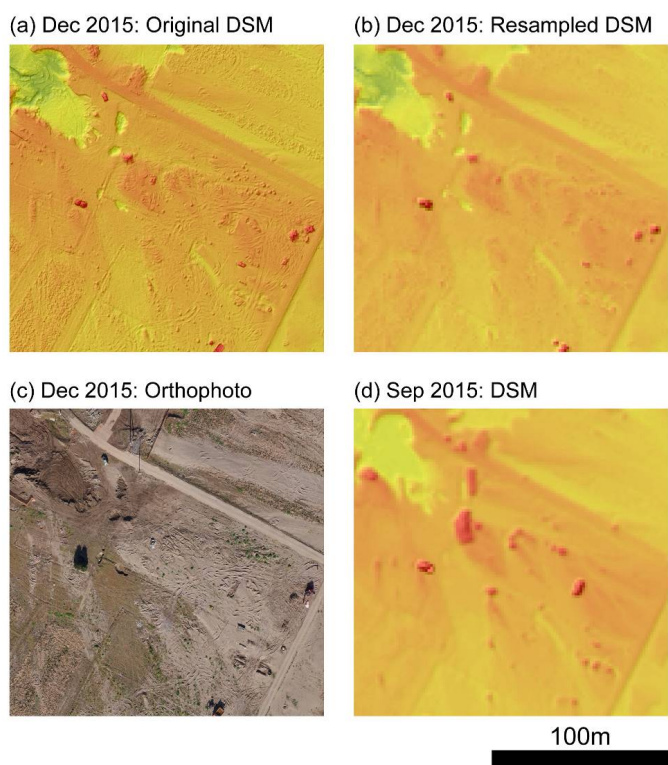
Figure 5: Enlarged views of Fig. 3 for comparison of the DSMs with different resolutions. (a) Original DSM in December 2015 (resolution: 3.84 cm). (b) Down-sampled DSM in December 2015 (resolution: 1m). (c) Orthophoto in December 2015. (d) DSM in September 2015 (resolution: 1m). Note that the trivial relief in (a) was greatly removed in the down-sampled DSM in (b).

DSM, and applied to the comparison and the volumetric analysis. Figure 5 explains the effect of down-sampling to remove trivial relief of the original DSM. The texts and figures below have been modified.

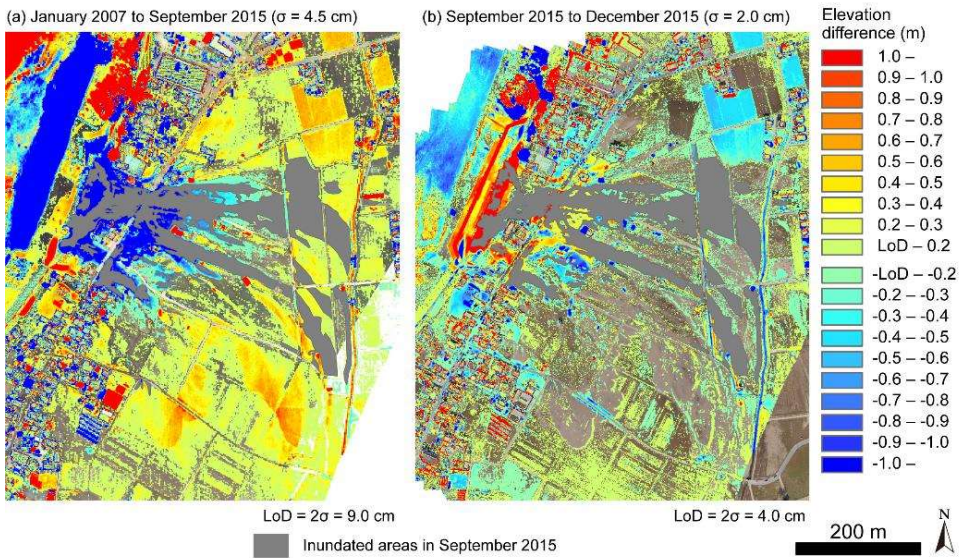
Figure 6: Differential rasters indicating the elevation differences between two successive snapshots after the removal of the systematic error and the adjustment of resolution. (a) The January 2007 DSM subtracted from the September 2015 DSM. Note that erosion near the breached levee was more than 1 m. (b) The September 2015 DSM subtracted from the December 2015 DSM. Note that inundated areas in period of the second DSM were masked (see Fig. 8 for the elevation changes in these areas).

The differential raster of the DSMs between 3 days after (September 2015) and 3 months after (December 2015) the flood is shown in Fig. 65b and 7b. Significant topographic changes can be observed where restoration works exceeded those completed immediately after the flood. The most remarkable change is the temporary repair of the breached levee, which was raised in height by up to 5.5 m (>1 m in the figure). The area to the east of the repaired prefectural road seemed mostly flat in the December 2015 DSM and orthophoto, but in fact the amount of fill varied between 10 and 60 cm compared with the original scour topography. In contrast, up to 100 cm of flood deposits were removed to level the ground in the depositional area near the levee. Several buried canals were restored by excavation, and the sand was heaped on both sides of the canals. In the case of the large canal on the east side of the research area, however, the removed sand had been transported elsewhere by December 2015. Although there were some points which experienced local aggradation or degradation due to similar restoration works as such, other than in those areas, the crevasse splay was left mostly undisturbed, or had little modification so its features were deformed only-mainly by natural phenomena occurring during the 3 months after the flood, except for the reconstruction of the artificial levee and the land filling and leveling along the prefectural road near the breached levee.

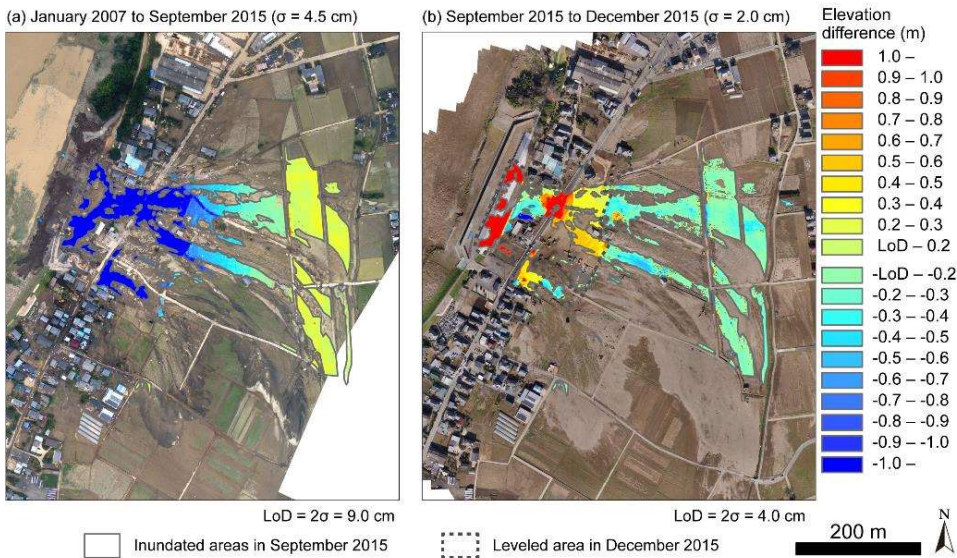
Figure 7: Differential rasters indicating the elevation differences between two successive snapshots after the removal of the systematic error the adjustment of resolution in the inundated areas in period of the second DSM. (a) The January 2007 DSM subtracted from the September 2015 DSM. Note that erosion near the breached levee was more than 1 m. (b) The September 2015 DSM subtracted from the December 2015 DSM. The elevation changes within the dashed line does not represent the water depths due to the land filling.

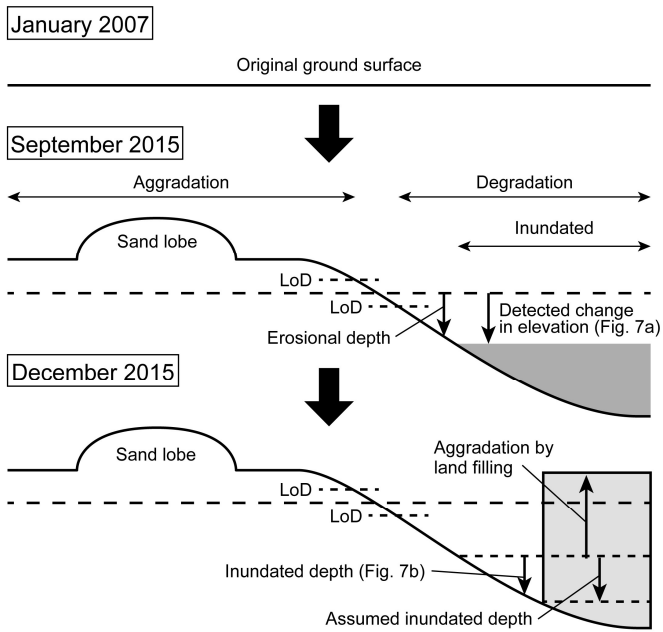
Figure 8: Schematic description of the topographic changes by the flood and the afterward disappearance of inundated water and landfilling in this study. Note that elevation changes smaller than LoD were neglected in the differential rasters and the volume calculation.

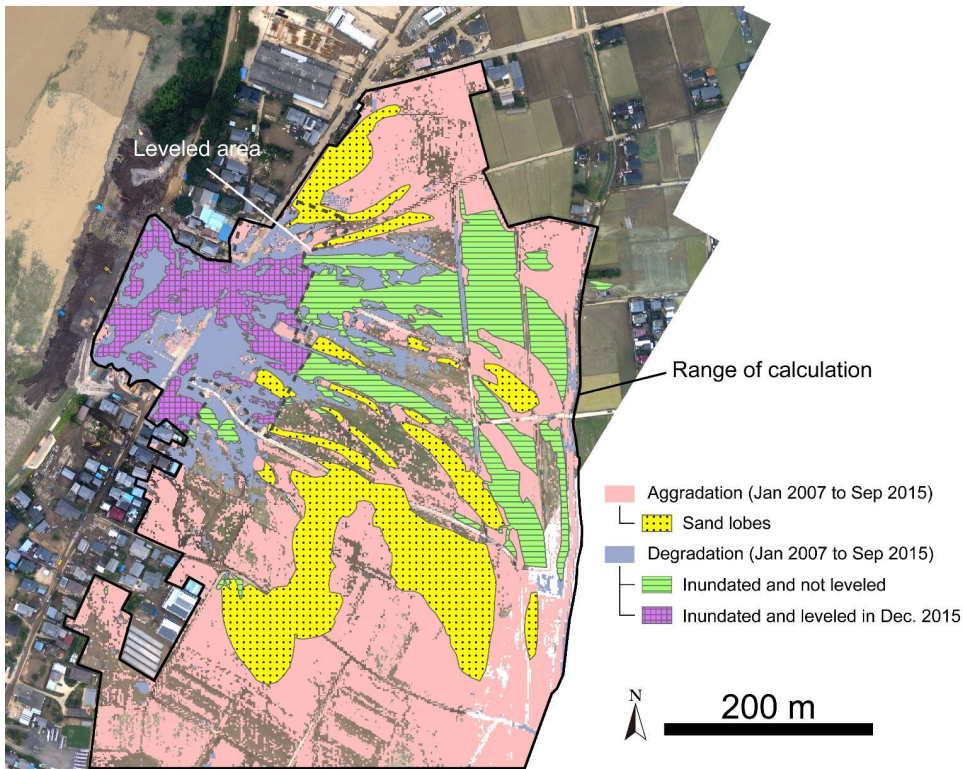
Figure 10: The calculation range of the volumetric evaluation and topography types used in the calculation. Note that the areas which were inundated but not leveled in December 2015 (green) contain aggradational pixels, which were not used for the estimation of the water volume (but included in the volume gain).

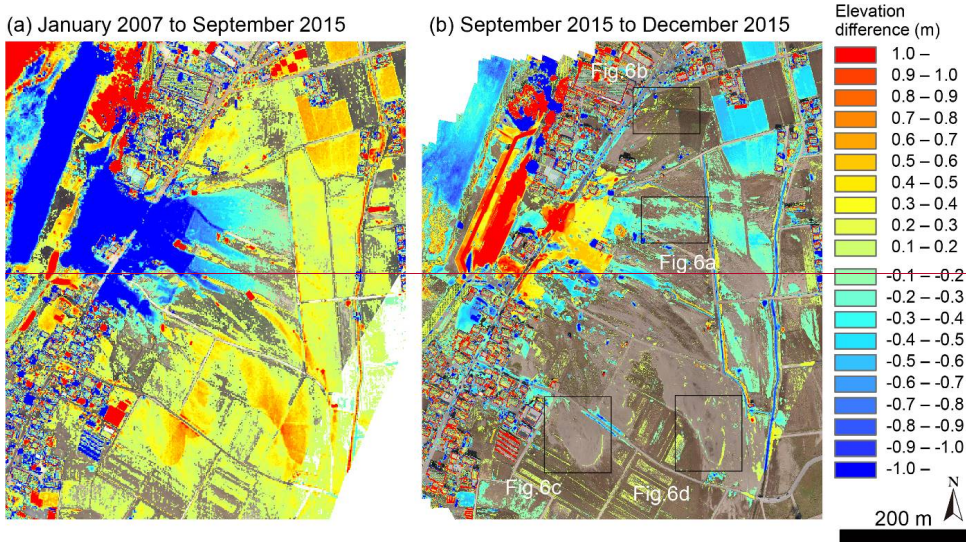
Figure 5: Differential rasters indicating the elevation differences between two successive snapshots after the removal of the systematic error. (a) The January 2007 DSM subtracted from the September 2015 DSM. Note that erosion near the breached levee was more than 1 m. (b) The September 2015 DSM subtracted from the December 2015 DSM. Enlarged views of several locations are shown in Fig. 6.

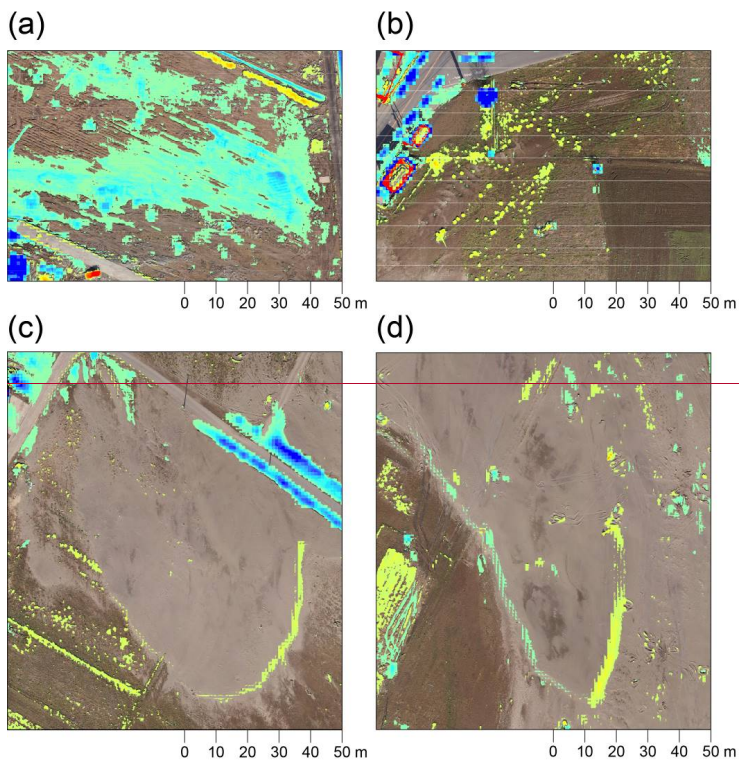
Figure 6: Enlarged views of areas of the differential raster between the September and December 2015 DSMs (Fig. 5b) showing where the topography of the crevasse splay was changed during the research period by specific processes. (a) The bottom of the crevasse channel after evaporation of the flood water. (b) Some newly grown shrubs. (c) and (d) Sand remobilized by the seasonal northwesterly winter winds and moved to the edges of sand splays.
