Response to the Editor's comments

Application of UAV-SfM photogrammetry and aerial LiDAR to a disastrous flood: repeated topographic measurement of a newly formed crevasse splay of the Kinu River, central Japan

Atsuto Izumida¹, Shoichiro Uchiyama^{1,2}, Toshihiko Sugai¹

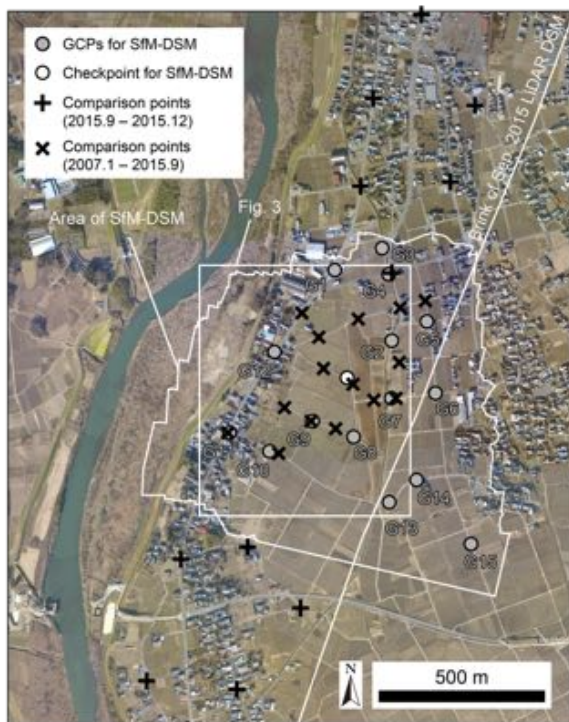
Figure 2: Distributions of GCPs and checkpoints for the SfM-derived DSM and comparison points for each DSM subtraction pair.
