Interactive comment on “Slope stability and rock fall hazard assessment of volcanic tuffs using RPAS and TLS with 2D FEM slope modelling” by Ákos Török et al.

Answers to the review of interactive comment on “Slope stability and rock fall hazard assessment of volcanic tuffs using RPAS and TLS with 2D FEM slope modelling” by Ákos Török et al. Anonymous Referee #2 Received and published: 15 April 2017
Reply: 10 June 2017

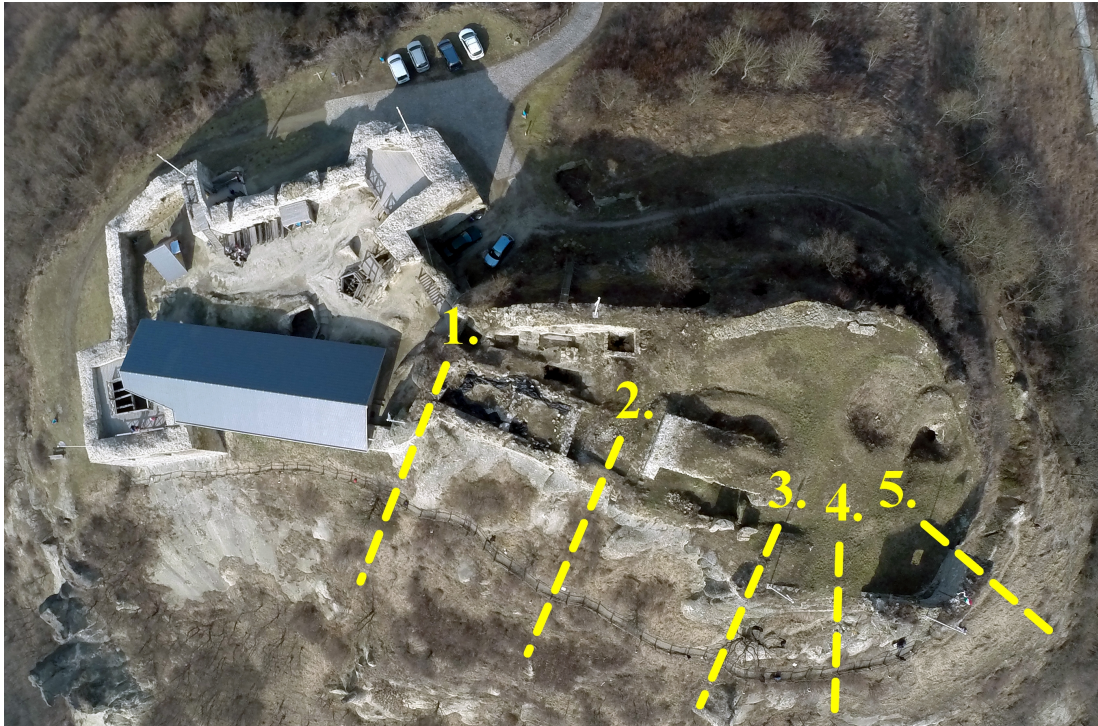
Fig. 1. New Figure, Fig. 14 Location of some studied cross sections

Answer: Fig. 2, Fig. 11, Fig. 12, Fig. 13 and Fig. 21 were deleted from the text. A new Figure was added to show which parts of the slope are shown in new Figures. An additional Figure describes the location of cross sections was added to make it more clear. Out of 55 tested cross-sections 5 were chosen to analyze the global stability. Figure 22 shows two examples for the results of the analyses: Section 1 and 3 (see new Fig). Local stability analyses were not constrained to specified sections. Areas of the possible failures were determined with kinematic analyses.

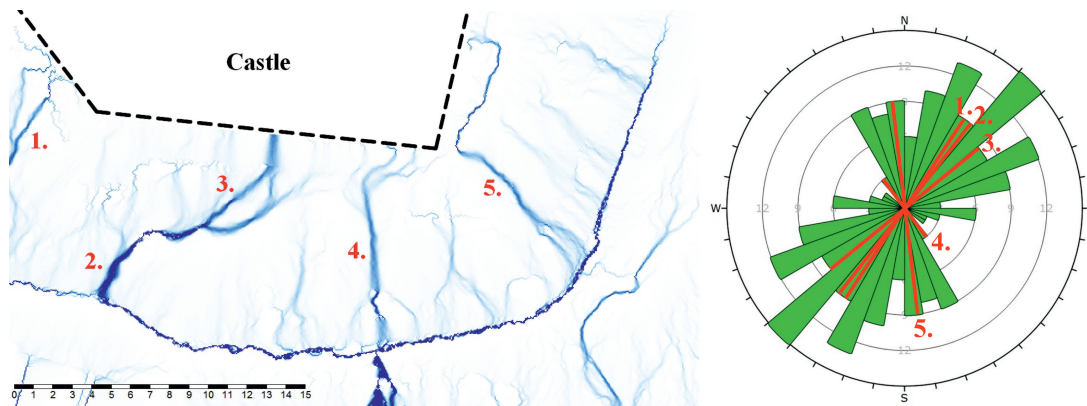
Fig. 2. New Figure: Fig. 12. Joint system obtained by RPAS (marked on catchment area DEM) and also measured on the field. Numbers refer to major joint systems marked on DEM map and on rose diagram

Answer: Former Figures 18 and 19 (now new Figures) show the stereographic projection of the measured discontinuities as a lower hemisphere projection. Each point on the stereonet represents a normal vector of a discontinuity plane. Based on the

projections six main joint sets (85/156, 88/312, 79/110, 81/089, 82/064, 61/299) can be separated.

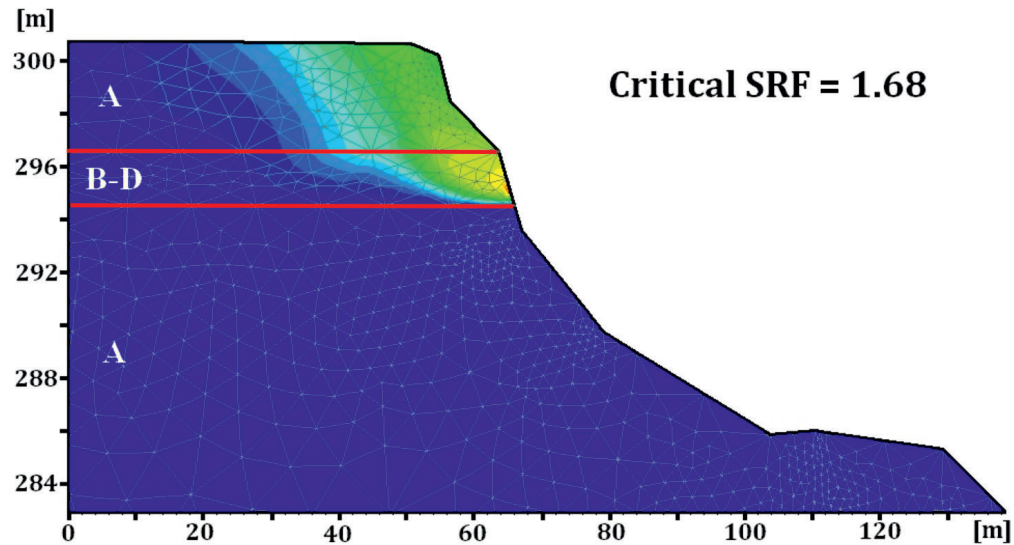
Fig. 3. The results of the global stability analysis of the slopes (sections 3 and 4 on Fig. 14), total displacements are marked in blue to red (lithology is indicated by letters A-D, note the weak zone)

Answer: The slope stability analysis was modified in the revised paper. A modified figure that shows the "weak layers" in the slope stability model was added to the revised manuscript, clearly marking the calculated slip surface at the weak layers. A new figure that describes the studied sections is now part of the revised manuscript. The difference between this model and the planar failure and wedge failure were described in more details. A figure that shows the joint orientation (and DEM model) explains better these types of potential failures.
