Answers to the reviewers

“Slope stability and rock fall assessment of volcanic tuffs using RPAS with 2D FEM slope modelling”.

Slope stability and rock fall ~~hazard~~ assessment of volcanic tuffs using RPAS with 2D FEM slope modelling

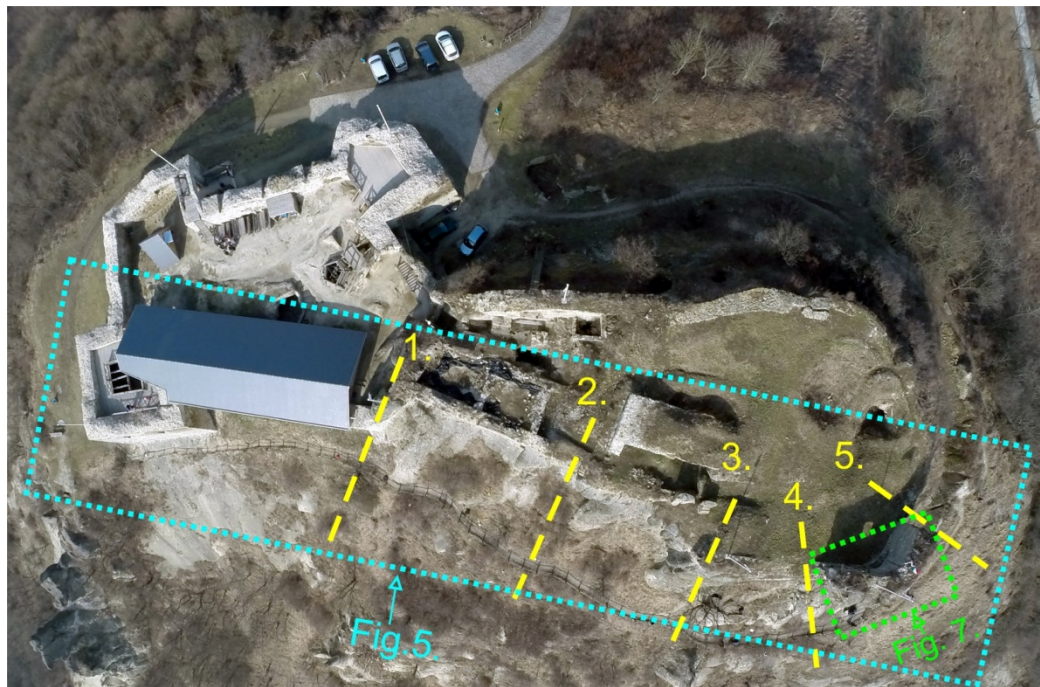
93 Fig.3. Location of the illustrations in the paper and the ~~sections (1 to 5 marked~~rock fall affected area. Red dot-and-dash line
 94 represents zones affected by ~~yellow~~rock fall. Yellow dashed lines) 1 to 5 mark the sections where slope stability was calculated by
 95 using 2D FEM model (Fig.8). Dotted lines indicate the areas shown on Fig. 4~~5~~ and Fig. 7~~9~~.

The study area is marked on Fig. 3, and now the zone where rock falls occur are also marked in the revised figs (red dot-and-dash lines).

On the revised Fig. 3, the zone that is affected by rock fall is marked (as well as on the new DTM on the new Fig. 6.). The direction of North is also marked on revised Fig. 3.

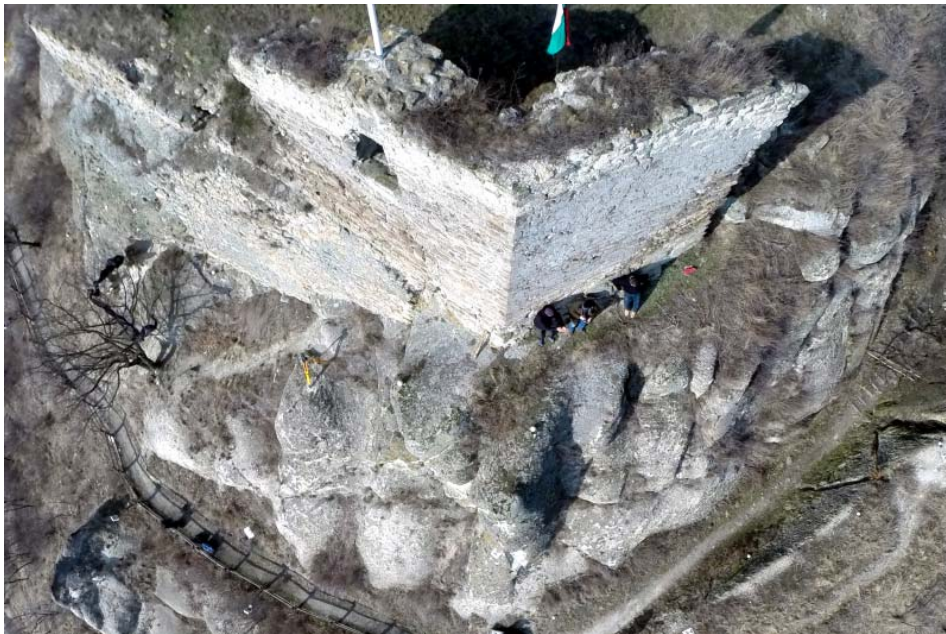
256 Fig.79. Top view of the cliff (see the location on Fig. 3) obtained with RPAS and the catchment area diagram obtained from
 257 **DEMDSM** analysis (Fig. 4) that by using **Catchment Area** module (Costa-Cabral et al. 1994). The latter one was used for joint
 258 pattern recognition. Numbers refer to major joint systems marked on **DEMcatchment area** map and on rose diagram of the field
 259 measurements and **RPASDSM** data set.

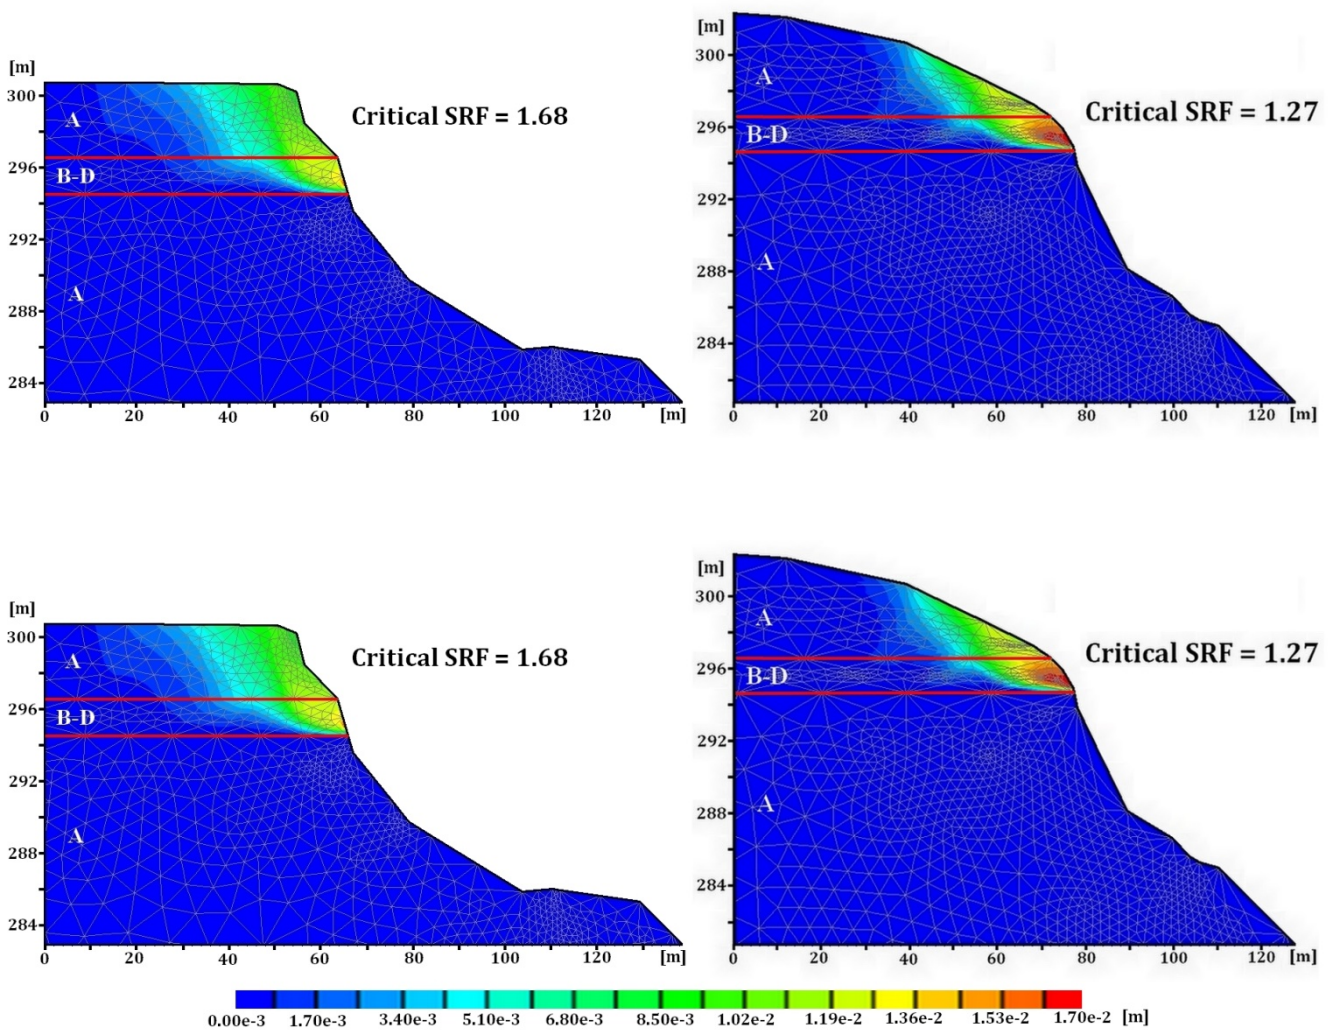
283 **Fig. 810.** The results of the global stability analysis of the slopes (sections 3 and 4 on Fig. 3), total displacements are marked in blue
 284 to red (lithology is indicated by letters A-D, note the weak zone marked by B-D, description of lithologies is given on Fig.68.)
