Slope stability and rock fall hazard assessment of volcanic tuffs using RPAS with 2D FEM slope modelling

Abstract. Low strength rhyolite tuff forms steep, hardly accessible cliffs in NE Hungary. The slope is affected by rock falls. RPAS (Remotely Piloted Aircraft System) was used to generate a digital terrain model (DTM) for slope stability analysis and rock fall hazard assessment. Cross sections and joint system data was obtained from DTM. Joint and discontinuity system was also verified by field measurements. On site and laboratory tests provided additional engineering geological data for modelling. Stability of cliffs and rock fall hazard were assessed by 2D FEM (Finite Element Method). Global analyses of cross-sections show that weak intercalating tuff layers may serve as potential slip surfaces, however at present the highest hazard is related to planar failure along ENE-WSW joints and to wedge failure. The paper demonstrates that without RPAS no reliable terrain model could be made and it also emphasizes the efficiency of RPAS in rock fall hazard assessment in comparison with other remote sensing techniques such as terrestrial laser scanning (TLS) and tachymetry.

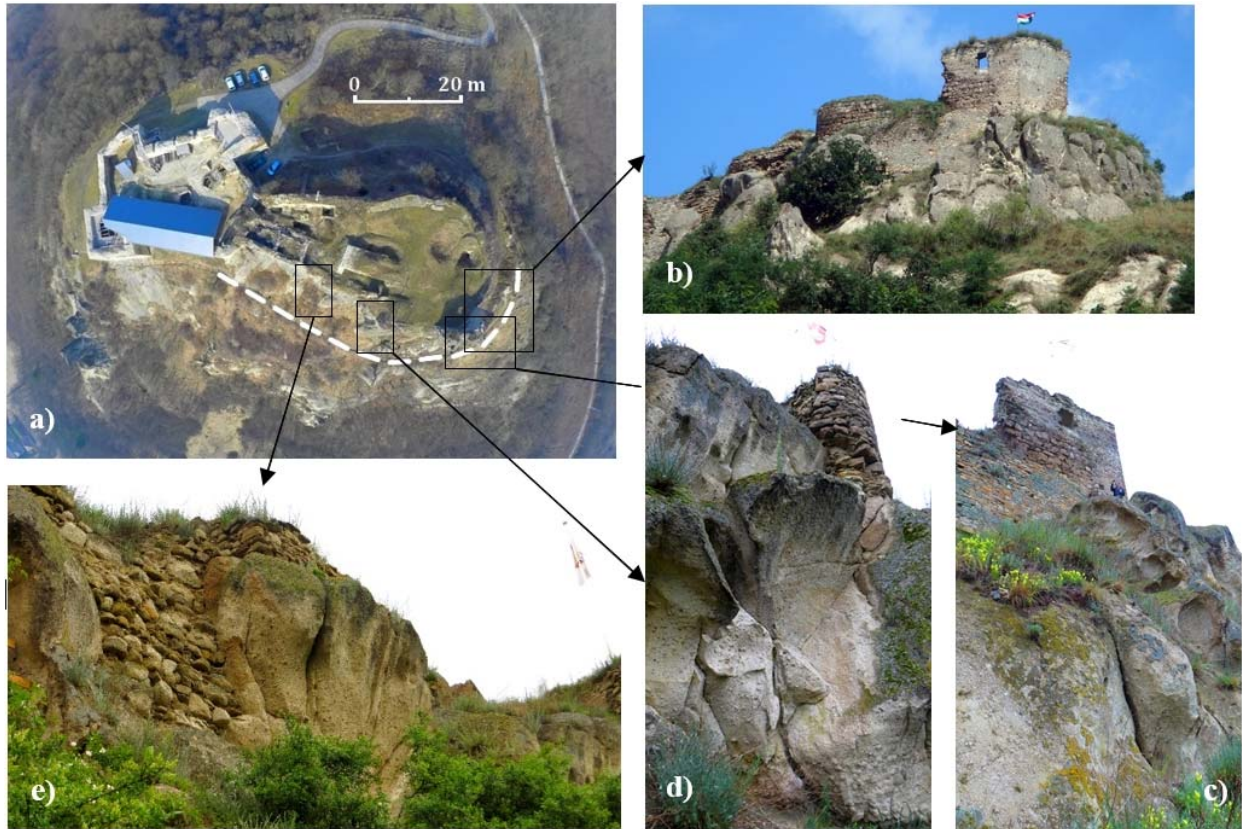
Fig.2. Studied southern cliff faces (clockwise): a) image of the castle obtained by RPAS with marked details; b) distant view of the eastern part of the cliff section; c) weathered rounded cliff with larger taffoni; d) vertical to sub-vertical cliff face with steep joints and traces of rock fall; e) steep cliffs dissected by joints.

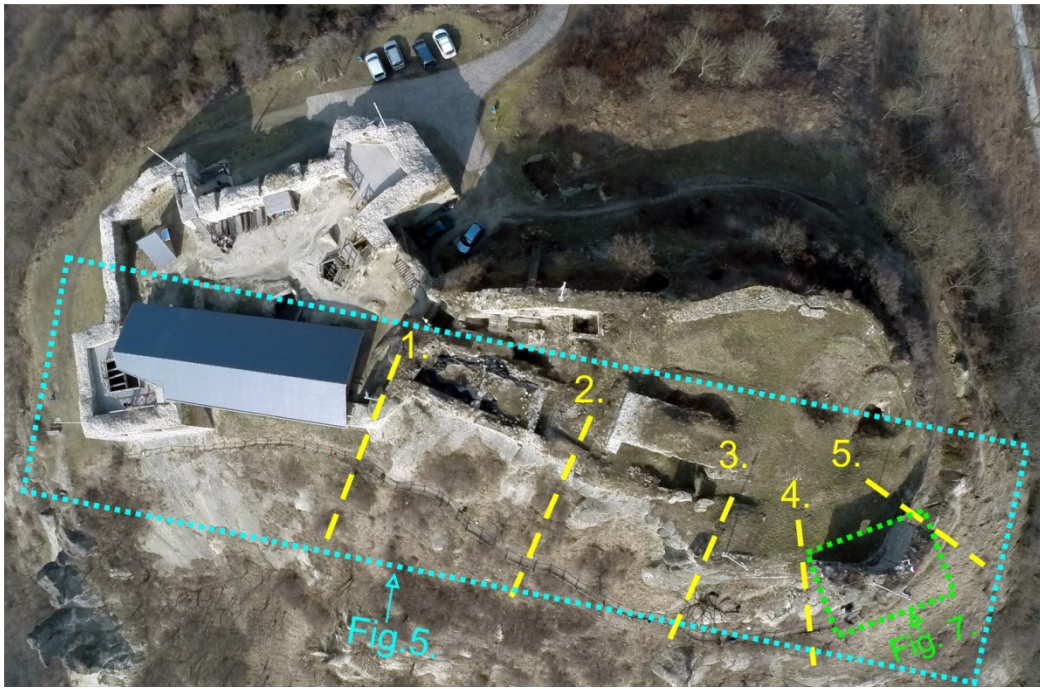
Fig.3. Location of the illustrations in the paper and the sections (1 to 5 marked by yellow dashed lines) where slope stability was calculated by using 2D FEM model (Fig.8). Dotted lines indicate the areas shown on Fig. 4 and Fig. 7.

The falling blocks can endanger the touristic footpath bellow the castle on the southern slopes, therefore the stability analysis of the rocky slopes was focused on this part of the cliff (Fig. 3). First, the rock mass failure was analysed with by the RocFall FEM software of the Rocscience (RS2). The steepest sections were determined from to the terrain model obtained from RPAS data. The GSI values of the rock masses were determined according to Marinós et al. (2005). The global stability of the hillslope of selected sections was calculated with RS2 software. Since the rhyolite tuff is a weak rock with few joints the rock mass failure and the failure along discontinuities were also analysed. This kinematic analysis had been done with stereographic tool. The orientations of main joint sets were obtained from RPAS (DTM model, Fig. 4) and at accessible

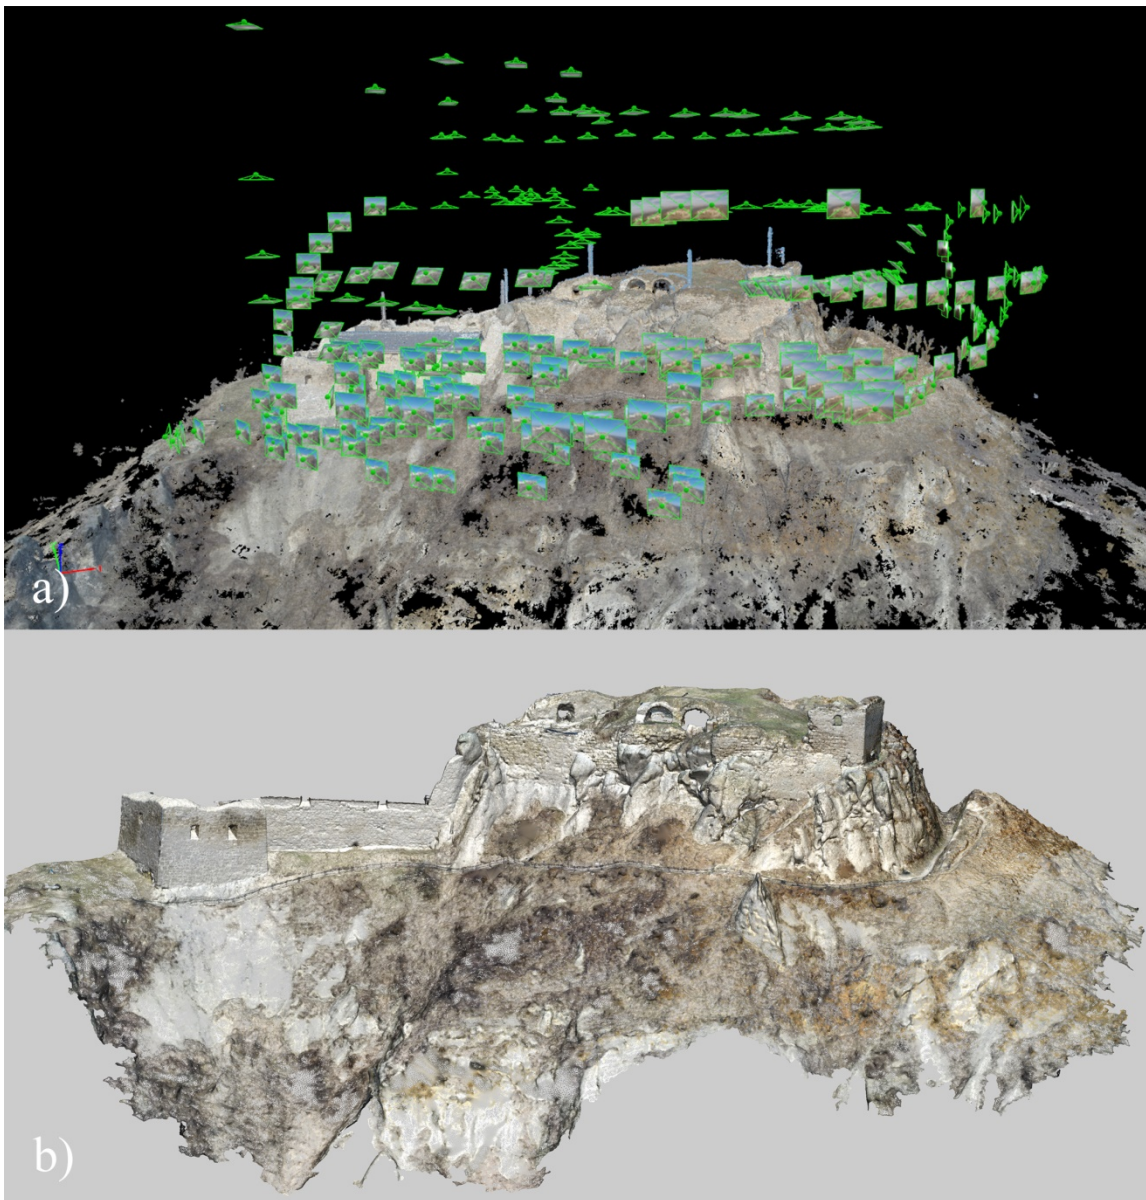
Fig.5. The captured image positions around the reconstructed castle hill (top) and the point clouds obtained by RPAS technology (bottom) (see top view on Fig. 3.)

A GoPro Hero 3+ (GoPro, 2017) action camera was mounted onto a 2-DoF gimbal of the unmanned aerial vehicle (UAV). The camera has a fixed 2.77 mm focal length objective that is capable of capturing 4000 × 3000 pixel sized JPG images. The images were captured with a sensitivity of ISO 100 and sRGB color space. The lens was used with a fixed aperture of 2.8 and the camera was able to adjust the adequate shutter speed. Generally the exposure time was set to 1/1400 s and the images were compressed at a rate of 4.5 bits/pixel. There were three imaging flights; two around noon and one about 5 in the afternoon. The flying times were 13, 12 and 13 minutes, respectively, where 390, 365 and 419 images were captured. All 1174 images were involved in the photogrammetric object reconstruction (Fig. 5). The photogrammetric reconstruction has been done by Pix4Dmapper (Pix4D, 2017), which is based on Structure-from-Motion (SfM) technology (Westoby et al. 2012, Danzi et al. 2013, Lowe 2004). SfM automatically identifies tie points considering initial requirements (e.g. preliminary image centre positions, time stamps). Camera calibration was executed during post-processing, no prior calibration was needed. After the image alignment, the image projection centres and attitudes can be observed in (Fig. 4). 12 million points were obtained by the photogrammetric reconstruction.

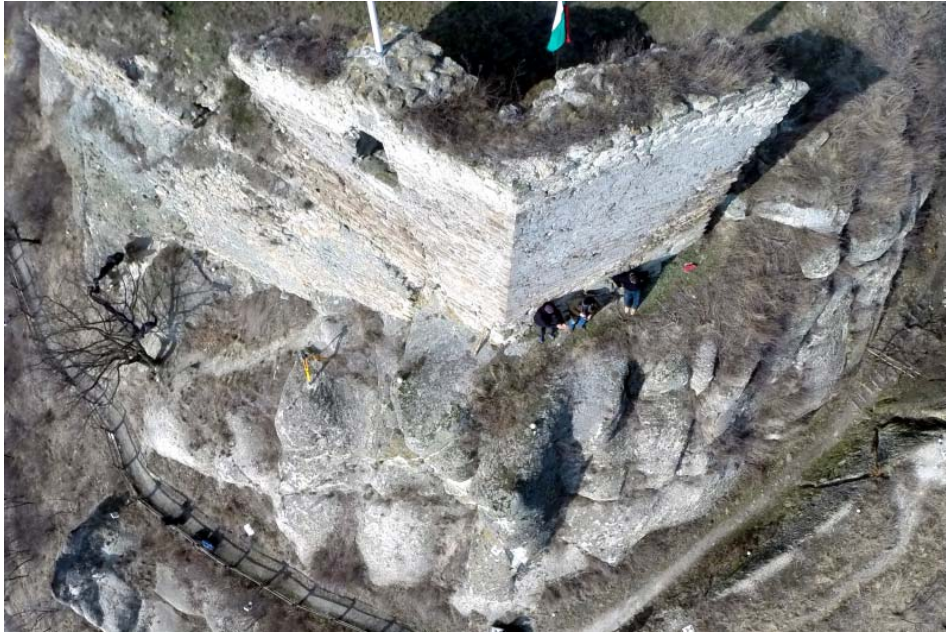
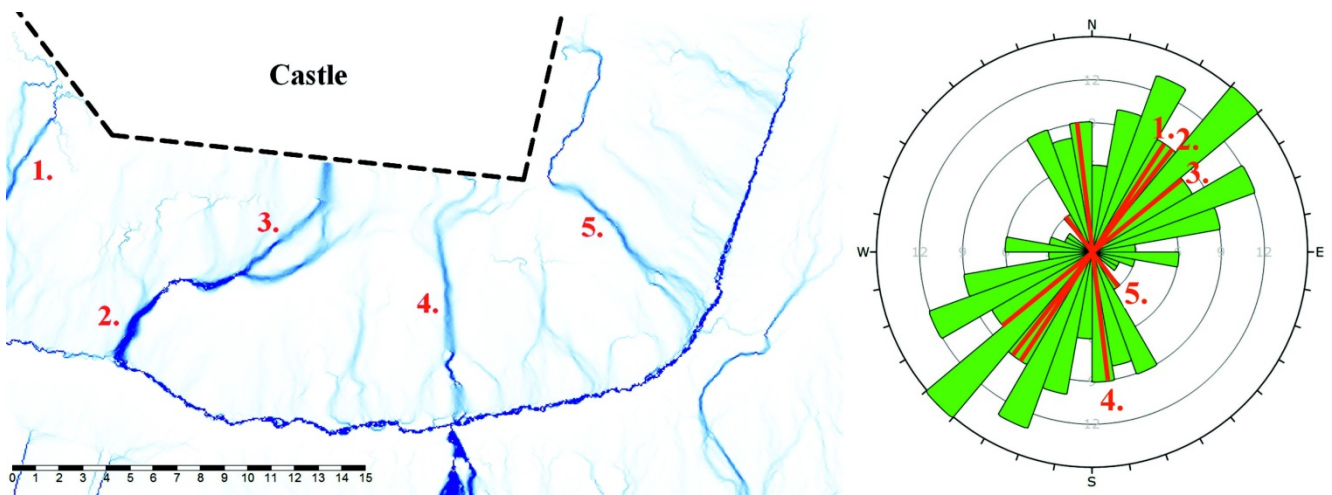
10 **Fig.7. Top view of the cliff (see the location on Fig. 3) obtained with RPAS and the catchment area diagram obtained from DEM analysis (Fig. 4) that was used for joint pattern recognition. Numbers refer to major joint systems marked on DEM map and on rose diagram of the field measurements and RPAS data set.**

Combining and comparing all measured data of discontinuities and joints, using DTM and morphological index (Fig. 4) the structural geological conditions were clarified: six main joint sets (85/156, 88/312, 79/110, 81/089, 82/064, 61/299) were identified with prevailing NE – SW direction (Fig. 7).

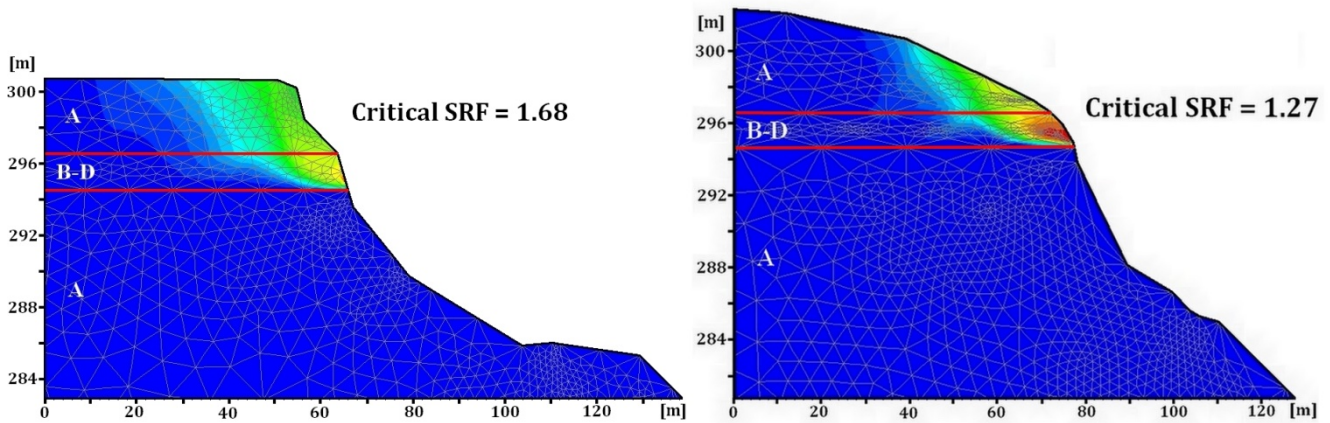
Fig.8. The results of the global stability analysis of the slopes (sections 3 and 4 on Fig. 3), total displacements are marked in blue to red (lithology is indicated by letters A-D, note the weak zone marked by B-D, description of lithologies is given on Fig.6.)

The results of RS2 FEM analyses suggest that the global factor of safety is SRF=1.27-1.71 in the studied sections (see some of the selected sections are shown on Fig 4). The SRF factor is influenced by the weak tuff layer (Fig. 6) which has very low shear strength compared to the lapilli tuff. Our failure analyses have demonstrated that the bottom of the slip surface would be in the weaker layer (marked by B-D on Fig. 8) and could lead to a larger mass movement.
