Interactive comment on “Geophysical and Geodetical Investigation of A Landslide Area (Koyulhisar-Sivas, Turkey)” by Sevda Özel et al.

Geophysical and Geodetical Investigation of A Landslide Area (Koyulhisar-Sivas, Turkey) Sevda Özel¹, Demet Över², Kemal Ö. Hastaoğlu³ ^{1,2}Department of Geophysical Engineering, Cumhuriyet University, 58140, Sivas, Turkey ³Department of Geomatics Engineering, Cumhuriyet University, 58140, Sivas, Turkey Correspondence to: Sevda Özel (sozel@cumhuriyet.edu.tr.) Abstract. The study area is in the west of Koyulhisar (Sivas) town center and approximately 200x250 m². This area is one of the most active locations where the landslide displacement amount is the greatest. The aim of this study is to determine the depth of the sliding surface with geophysical (seismic refraction tomography (SRT), ground-penetrating radar (GPR)) methods. The results of TÜBİTAK-111Y111 project were also used. According to the geophysical results, within ~20 m of investigation depth, three layers with the

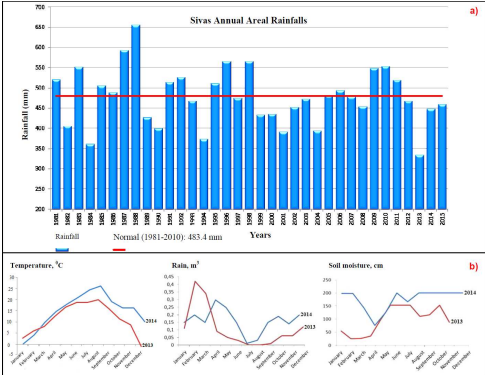
Fig. 2.

Figure 3. a) Precipitation distribution in between 1981-2015 years of Sivas (MGM, 2016). b) Graphics of monthly average temperature (T, °C), rainfall (m³) and soil moisture content (cm) of the study area and its surroundings in the years of 2013 and 2014. They were prepared from the project data (Hastaoglu et al., 2015).

there are loose units and deformations on the sliding surfaces). In particular, they further affected the landslide mass along with the rain and caused large amounts of displacement in the landslide area. 2.2 Meteorological and geodetic results The data regarding the rainfalls with the effects of triggering the landslides are presented in Table 1 and Fig. 3a and Fig. 3b (MGM, 2016; Hastaoğlu et al., 2015). With these data, the rainfall status of the study area and its surrounding was examined by months as average annual rainfalls and the annual areal amount of rainfall. According to the data obtained between 1950-2015 in Table 1, the rainy periods are generally between October-November-December and January-February-March-April. The highest total daily amount of rainfall in the rainiest years was observed as snowfall in 1950 (110 cm) and as rain in 1991 (55 kg/m²). In Fig. 3a, the annual normal average rainfall value calculated for the years between 1981-2010 was calculated as over 483.4 mm (MGM, 2016). However, 1987-1988 and 1997-1998 were the rainiest years. It is seen that the annual areal amount of rainfall exceeded the normal values and was higher than 550 mm in these rainy years that took place in every 10 years. Similarly, it is also seen that there were high rainfalls for 3-4 years after the years of 1985-1995-2005 with an interval of 10 years. Therefore, annual areal rainfalls were observed to be more before some large landslides like the landslide in 1998. When geological features of the region are taken into account, it is remarkable that the landslide in 1998 and 2000 occurred in the summer months after the winter with a heavy fall of snow. However, the landslide in 2005 occurred during the rainy season. In Fig. 3b, GNSS studies and multi-disciplinary studies of Hastaoğlu et al. (2015) have carried out for many years (about 6 years) to determine the deformation and annual sliding amounts especially after the landslides in 1998-2000-2005. The seismological and meteorological data, which were updated by the geodetic (GNSS (DH), geological (IDH (Inclinometer Drilling Holes)) and meteorological data collected in this local study were reorganized and evaluated. Fig. 3a-b and Table 1 which were reprepared for the study which is the subject of this article were associated with the results of GNSS studies (Fig. 3b). The monthly and annual meteorological data should certainly be evaluated particularly

within the scope of monitoring activities, as the area is a landslide area. Hastaoğlu et al. (2015) followed in DH wells in the area in 2013-2014 (Fig. 3b). If Fig. 4 is examined, there are seven DH point in the nearest of the geophysical profiles (DH8, DH12, DH16 is near the area A and DH4, DH6, DH9, DH10 is near the area C). The graphics in Fig. 3b was prepared from the combined data (unpublished data in the project) and the temperature (°C), precipitation (mm) and soil moisture content (cm) were compared in these graphics. The temperature and precipitation were observed to be inversely proportional during the summer months called as a dry period. It is seen that the soil moisture is changeable apart from the rainy period and has very high water content during the rainy periods. The soil moisture is very high (average 150 cm) in winter, summer, autumn seasons. In the study area, the water contents in the drilling data change from 24.6 % to 13.3 % at between 0-10 m depth and these values are also high (from 29.1 % to 17.3 %) after 10 m (Hastaoğlu et al., 2015). Water generated from precipitation and melting snow is blocked by the impermeable layer when it infiltrates downward, and the local moisture content increases (see Hu and Shan (2016)). Thus, the water infiltrates the interface between the permeable and impermeable layer, can form a slip zone. Then, these results were compared with geophysical results in interpretation. The GPR results show that the moisture content of soils at the sliding surface of the landslide mass is relatively high. The drilling data and soil moisture values also show very high moisture content of the sliding surface of the landslide mass in the study area, which is completely consistent with the results obtained from the GPR-SRT profiles, meteorological and geological results. On the other hand, it was understood that the precipitation increased by the decrease in temperatures. It is also seen that the total annual amount of rainfall increased about 2-fold in 2014 compared to 2013 (Fig. 3a-b). According to all results, rainfalls are considered to be effective in triggering of the landslide because the ground of this landslide area, which is filled with loose units and old cracks, is supersaturated with water due to the rainfalls. Besides, Hastaoğlu et al. (2015) determined that the groundwater level gets close to the surface for 4-6 m on average at the end of the rainy

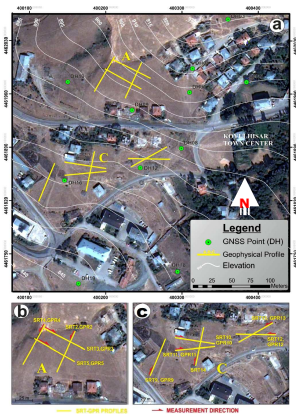
Fig. 3.

Figure 4. (a) The study area. (b) and (c) The details of geophysics profiles for the A and C areas.
