Interactive comment on “Geophysical and Geodetical Investigation of A Landslide Area (Koyulhisar-Sivas, Turkey)” by Sevda Özel et al.

Geophysical and Geodetical Investigation of A Landslide Area (Koyulhisar-Sivas, Turkey) Sevda Özel¹, Demet Över², Kemal Ö. Hastaoğlu³ ^{1,2}Department of Geophysical Engineering, Cumhuriyet University, 58140, Sivas, Turkey ³Department of Geomatics Engineering, Cumhuriyet University, 58140, Sivas, Turkey Correspondence to: Sevda Özel (sozel@cumhuriyet.edu.tr.) Abstract. The study area is in the west of Koyulhisar (Sivas) town center and approximately 200x250 m². This area is one of the most active locations where the landslide displacement amount is the greatest. The aim of this study is to determine the depth of the sliding surface with geophysical (seismic refraction tomography (SRT), ground-penetrating radar (GPR)) methods. The results of TÜBİTAK-111Y111 project were also used. According to the geophysical results, within ~20 m of investigation depth, three layers with the average seismic P-wave velocities (VP) of 650, 1200 and 2100 m/sec were identified. It was determined that the depth of the sliding surface which was between ~3-7 m and the seis

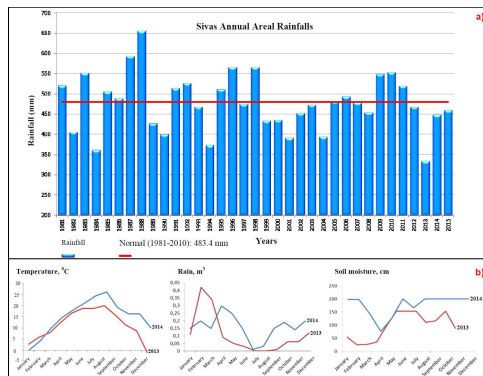
Figure 3. a) Precipitation distribution in between 1981-2015 years of Sivas (MGM, 2016). b) Graphics of monthly average temperature (T, °C), rainfall (m³) and soil moisture content (cm) of the study area and its surroundings in the years of 2013 and 2014. They were prepared from the project data (Hastaoglu et al., 2015).

The data regarding the rainfalls with the effects of triggering the landslides are presented in Table 1 and Fig. 3a and Fig. 3b (MGM, 2016; Hastaoğlu et al., 2015). With these data, the rainfall status of the study area and its surrounding was examined by months as average annual rainfalls and the annual areal amount of rainfall. According to the data obtained between 1950-2015 in Table 1, the rainy periods are generally between October-November-December and January-February-March-April. The highest total

daily amount of rainfall in the rainiest years was observed as snowfall in 1950 (110 cm) and as rain in 1991 (55 kg/m²). In Fig. 3a, the annual normal average rainfall value calculated for the years between 1981-2010 was calculated as over 483.4 mm (MGM, 2016). However, 1987-1988 and 1997-1998 were the rainiest years. It is seen that the annual areal amount of rainfall exceeded the normal values and was higher than 550 mm in these rainy years that took place in every 10 years. Similarly, it is also seen that there were high rainfalls for 3-4 years after the years of 1985-1995-2005 with an interval of 10 years. Therefore, annual areal rainfalls were observed to be more before some large landslides like the landslide in 1998. When geological features of the region are taken into account, it is remarkable that the landslide in 1998 and 2000 occurred in the summer months after the winter with a heavy fall of snow. However, the landslide in 2005 occurred during the rainy season. In Fig. 3b, GNSS studies and multi-disciplinary studies of Hastaoğlu et al. (2015) have carried out for many years (about 6 years) to determine the deformation and annual sliding amounts especially after the landslides in 1998-2000-2005. The seismological and meteorological data, which were updated by the geodetic (GNSS (DH), geological (IDH (Inclinometer Drilling Holes)) and meteorological data collected in this local study were reorganized and evaluated. Fig. 3a-b and Table 1 which were repared for the study which is the subject of this article were associated with the results of GNSS studies (Fig. 3b). The monthly and annual meteorological data should certainly be evaluated particularly within the scope of monitoring activities, as the area is a landslide area. Hastaoğlu et al. (2015) followed in DH wells in the area in 2013-2014 (Fig. 3b). If Fig. 4 is examined, there are seven DH point in the nearest of the geophysical profiles (DH8, DH12, DH16 is near the area A and DH4, DH6, DH9, DH10 is near the area C). The graphics in Fig. 3b was prepared from the combined data (unpublished data in the project) and the temperature (OC), precipitation (m3) and soil moisture content (cm) were compared in these graphics. The temperature and precipitation were observed to be inversely proportional during the summer months called as a dry period. It is seen that the soil moisture is changeable apart from the rainy period and has very

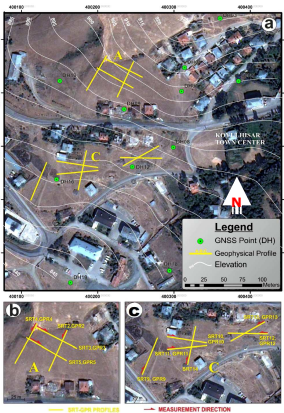
Figure 4. (a) The study area. (b) and (c) The details of geophysics profiles for the A and C areas.

applications were used in the geophysical data collection in the area (Fig. 4). The high-frequency electromagnetic waves can reach deeper in the environments with low conductivity like sand. However, the conductive units such as clay and shale decrease the penetration depth of the signal transmitted and lead to absorption (Annan et al., 1988; Davis and Annan, 1989). Firstly, SRT and GPR data were collected along multiple transects in two different areas of the study area named A and C (see Fig. 4). Then, the geophysical profiles were processed to the satellite map according to the coordinates along with the topographical elevation curves and GNSS measurement locations for the ease of interpretation (Fig. 4a). Geophysical measurements were taken due to the geologic bedding and topographic features (Fig. 4b-c). SRT profiles and on these seismic profiles GPR profiles in the area defined by A in Fig. 4b is approximately in the NE-SW (SRT2, SRT4, GPR2, GPR4)) and NW-SE (SRT3, SRT5, GPR3, GPR5) directions (Fig. 4b). Similarly, in area C, SRT11-SRT12-GPR11-GPR12 profiles are approximately in the E-W directions, SRT9-SRT14-GPR9-GPR14 profiles are approximately in the NE-SW direction, SRT10-GPR10 profiles are in the NW-SE directions and SRT13-GPR13 profiles are approximately in the NE-SW directions (Fig. 4c). The profile lengths usually range from 25 to 60 m according to the method applied. The profile shooting technique in the seismic study, hammer and iron plate of 8 kg weight as the source P geophone of 14 Hz (the total number of geophones is 12) and Geometrics branded seismic device as the receiver was used while collecting the SRT data. In all profiles, the geophone interval was 5 m, offset distance was 2.5 m, the sampling interval was 256 ms and the record length was 512 ms. The geophones were respectively fixed on the ground within the selected geophone range and their connections with the seismic device were made. Then, seismic measurements were recorded by starting from the offset distance of 2.5 m, reducing to sledgehammer plate and making at least 5 times shots between each geophone, respectively. In the evaluation of the SRT data collected in the field, SeisImager program was used for displaying, processing and evaluation of the seismic refraction waves. The marking of the first arrivals of the SRT data was performed using Pickwin, and the evaluation

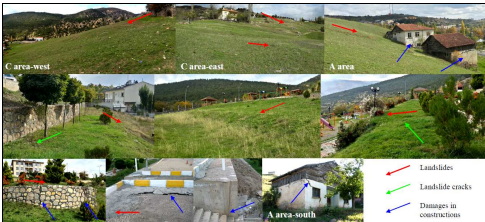
Figure 5. The photos of the study area and its surroundings, in which the landslides, landslide cracks or constructional damages are also observed.

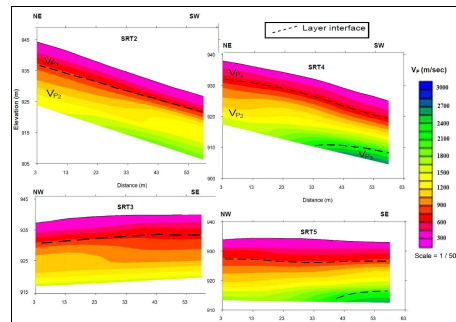
Figure 6. The seismic profiles of the area A. The uppermost boundary of the V_{p2} layer is the depth of the sliding surface (This depth changes between ~3-7 m). The lower velocity V_{p1} layer consists of soil and alluvium (the average seismic V_{p1} < 650 m/sec).

of the first arrival data was performed using Plotrefa module. The GPR data were collected by Ramac2 device using a shielded antenna of 250 MHz. The GPR data were processed in Reflexw program. In order to collect the GPR data, other parameters were selected 512 ns-number of samples, 16-number of stacking and 0.1 m-trace interval. 2D GPR data processing for data analysis of the GPR data, it includes Static correction (10 ns in dry or wet clay and sandy), Muting, Bandpass filter (100, 200, 300, 400 Hz), Gain (0.512 ms) and Migration (0.01 ms) steps. The migration was made to show up small vertical structures invisible during data processing. Thus, very large hyperballs with strong reflections may limit the display of non-migrated GPR data. Moreover, the peak points of hyperbolas observed in GPR cross-sections show the reflection surface of the electromagnetic wave. During data processing, velocity analysis was performed on the reflection surfaces through the hyperbola superposition method and EM wave propagation velocity was calculated in all GPR cross-sections. The topographic corrections were made by selecting the "Correct for two layers" option in Static Correction/Muting in the Reflex program. The height values collected in the study area were manually entered and saved in the "Correct for two layers" option. Thus, the models were converted from m to ns and the GPR sections were prepared for interpretation. Thus, the collected geophysical data were converted into 2D (two-dimension) elevation-distance (SRT) and depth-distance (GPR) sections by assessed in the appropriate software. The geophysical study area is one of the most active locations of the landslide area. As it is seen in Fig. 5, geomorphologically the landslide cracks on the surface, displacement traces, and structural damages in the study area and its immediate surroundings can be monitored clearly in this activity area. Visibly, the damaging effects of still active or old landslides on residences, roads and walls are also observed easily by field observations. Therefore, none of the damaged constructions are used in the Koyulhisar. 3.2 Geophysical analysis, results and discussion Geophysical interpretations were made according to these sections and compared with the results of the other studies. SRT sections: 2D seismic cross-sections giving seismic VP-depth information are presented in Fig. 6 and 7.

In the seismic data evaluation, the coincidence was provided with RMS (Root Mean Square) errors ranging between 3.4-4.5% in 2D inversion operation. According to these sections, two or three layers were identified at about 20 m depth (Fig. 6 and 7). It was understood that the tilts of these layers were southeast oriented, and their tilt was greater than 50. According to the average seismic velocities (VP) calculated, three layers with the layer velocities of 650, 1200 and 2100 m/sec were defined from top to bottom. Thus, the seismic VP velocities were observed that they increased towards the depth. It was determined that the depth of the sliding surface varied about between 3-7 m (Fig. 6 and 7). Therefore, these depths were defined as the layer with the risk of dislocation. This area was considered to have a risk of dislocation due to these loose units, rainfall and tilt conditions. The seismic velocity of the first layer is lower than $VP_1 < 650$ m/sec, but the seismic velocity of the third layer may be greater than $VP_3 > 2100$ m/sec. GPR sections: The investigation depth was further calculated from the SRT sections compared to the GPR sections due to the differences of geophysical methods in the application. Because GPR sections were obtained in high-resolution for about the first 10 m depth after data processing of the GPR data. It is clearly observed that the strong reflections are within 10 m depth in Fig. 8 and 9. These strong reflections seen in black dashed ellipses are interpreted as deformation areas in the layer. In a similar manner, these areas being interpreted as deformations were also observed in the studies of Bubeck et al. (2015), Hu and Shan (2016), Su et al. (2016) and Popescu et al. (2016). The strong reflected wave signal shows distinctive characteristics, presenting a low-frequency high-amplitude sync-phase axis, which can be inferred as the sliding surface in Fig. 8 and 9. In other words, two layers were identified in GPR sections. The first layer is weak, loose, cracked, moved and also have lost their tightness, and their seismic velocity is low. Therefore, in Fig. 8 and 9, it was thought that deformations developed on the sliding surfaces due to the geology of the study area in A and C area. It was identified the deformations, called sliding surfaces, landslide furrows, scarps, collapsed zones, and cracks. If the areas of A and C are compared, the deformations are more in area C than in area A. Therefore, the

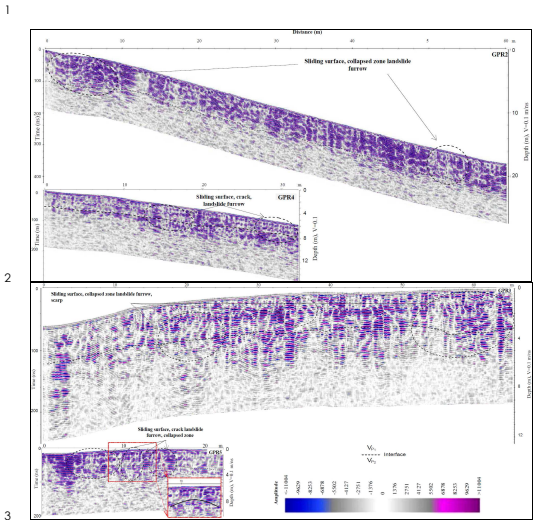
Figure 8. GPR profiles in A area and the deformations in the loose layers (the seismic V_{p1} layer).

risk of landslides may be higher in area C. In Fig. 8, the EM wave velocity calculated for the reflection surface in GPR5 cross-section -representing the GPR profiles- was shown as an example. The picks were exported with the attribute of two-way travel time and the velocity of propagation of the wave was calculated about 0.1 m/ns (Fig. 8). This value is generally observed in dry or wet soil, dry or wet clay and sandy environments (Wilchek, 2000; Cardomina, 2002). Therefore, it was thought that this velocity value was compatible with the geological units and electromagnetic waves led to rapid absorption due to the silty sandy clay layer. Because the first geological unit is medium-very stiff, low-high plasticity, silty sandy clay. The deformation structures as sliding surfaces, landslide furrows, scarps, collapsed zones, and cracks were observed in the GPR cross-sections (Fig. 8 and 9). In other words, the geological unit, the layer or topography slope and precipitation cause deformations in the loose upper unit. Therefore, these structures may develop or occur in the landslide mass, as shown in Fig. 8 and 9. Additionally, the geological units were observed in DH wells in the geophysics study area (Fig. 4). These are mostly silty sandy clay and they have different characteristics above and below about 10 m in DH well. The topography of the study area decreases from 925 m to 840 m and the elevation difference is 85 m (Fig. 4). The amount of slope in the topography increases from south to north (>50-100) in the geophysical sections (Fig. 6 and 7). It was determined that the landslide type in the area was planar sliding and observed that the direction of sliding was SE. As this information was associated with topography and the field observations, it was observed that the topography was inclined from the north to the south of the study area. The results of the various studies and also the findings of this article have proved that Koyulhisar landslides are generally caused by the known reasons that trigger the landslide. Therefore, it was seen that the geological bedding was compatible with the topographical sloping and the groundwater was compatible with the direction of flow.
