## ***Interactive comment on “Geophysical and Geodetical Investigation of A Landslide Area (Koyulhisar-Sivas, Turkey)” by Sevda Özel et al.***

Geophysical and Geodetical Investigation of A Landslide Area (Koyulhisar-Sivas, Turkey) Sevda Özel<sup>1</sup>, Demet Över<sup>2</sup>, Kemal Ö. Hastaoğlu<sup>3</sup> <sup>1,2</sup>Department of Geophysical Engineering, Cumhuriyet University, 58140, Sivas, Turkey <sup>3</sup>Department of Geomatics Engineering, Cumhuriyet University, 58140, Sivas, Turkey Correspondence to: Sevda Özel (sozel@cumhuriyet.edu.tr.) Abstract. The study area is in the west of Koyulhisar (Sivas) town center and approximately 200x250 m<sup>2</sup>. This area is one of the most active locations where the landslide displacement amount is the greatest. The aim of this study is to determine the depth of the sliding surface with geophysical (seismic refraction tomography (SRT), ground-penetrating radar (GPR)) methods. The results of TÜBİTAK-111Y111 project were also used. According to the geophysical results, within ~20 m of investigation depth, three layers with the average seismic P-wave velocities (VP) of 650, 1200 and 2100 m/sec were identified. It was determined tha

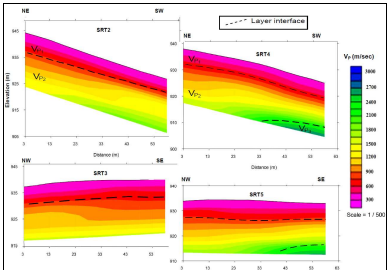
Fig. 4.

Figure 6. The seismic profiles of the area A. The uppermost boundary of the  $V_p$  layer is the depth of the sliding surface (This depth changes between ~3-7 m). The lower velocity  $V_p$  layer consists of soil and alluvium (the average seismic  $V_p$  < 650 m/sec).

In the seismic data evaluation, the coincidence was provided with RMS (Root Mean Square) errors ranging between 3.4-4.5% in 2D inversion operation. According to these sections, two or three layers were identified at about 20 m depth (Fig. 6 and 7). It was understood that the tilts of these layers were southeast oriented, and their tilt was greater than 50. According to the average seismic velocities (VP) calculated, three layers with the layer velocities of 650, 1200 and 2100 m/sec were defined from top to bottom. Thus, the seismic VP velocities were observed that they increased towards the depth. It was determined that the depth of the sliding surface varied about between 3-7 m (Fig. 6 and 7). Therefore, these depths were defined as the layer with the risk of dislocation. This area was considered to have a risk of dislocation due to these loose units, rainfall and tilt conditions. The seismic velocity of the first layer is lower than  $VP1 < 650$  m/sec, but the seismic velocity of the third layer may be greater than  $VP3 > 2100$  m/sec. GPR sections: The investigation depth was further calculated from the SRT sections compared to the GPR sections due to the differences of geophysical methods in the application. Because GPR sections were obtained in high-resolution for about the first 10 m depth after data processing of the GPR data. It is clearly observed that the strong reflections are within 10 m depth in Fig. 8 and 9. These strong reflections seen in black dashed ellipses are interpreted as deformation areas in the layer. In a similar manner, these areas being interpreted as deformations were also observed in the studies of Bubeck et al. (2015), Hu and Shan (2016), Su et al. (2016) and Popescu et al. (2016). The strong reflected wave signal shows distinctive characteristics, presenting a low-frequency high-amplitude sync-phase axis, which can be inferred as the sliding surface in Fig. 8 and 9. In other words, two layers were identified in GPR sections. The first layer is weak, loose, cracked, moved and also have lost their tightness, and their seismic velocity is low. Therefore, in Fig. 8 and 9, it was thought that deformations developed on the sliding surfaces due to the geology of the study area in A and C area. It was identified the deformations, called sliding surfaces, landslide furrows, scarps, collapsed zones, and cracks. If the areas of A and C are compared, the deformations are more in area C than in area A. Therefore, the

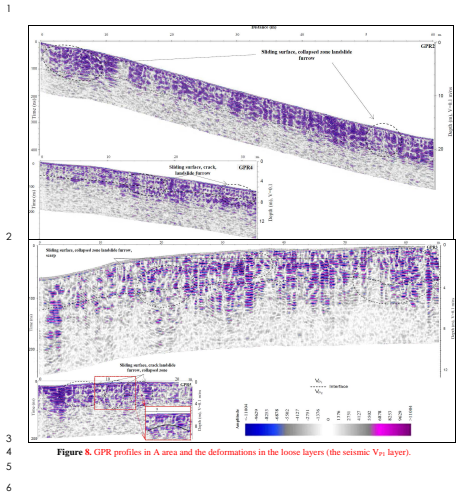
Fig. 5.

Figure 8. GPR profiles in A area and the deformations in the loose layers (the seismic  $V_p$  layer).

risk of landslides may be higher in area C. In Fig. 8, the EM wave velocity calculated for the reflection surface in GPR5 cross-section -representing the GPR profiles- was shown as an example. The picks were exported with the attribute of two-way travel time and the velocity of propagation of the wave was calculated about 0.1 m/ns (Fig. 8). This value is generally observed in dry or wet soil, dry or wet clay and sandy environments (Wilchek, 2000; Cardomina, 2002). Therefore, it was thought that this velocity value was compatible with the geological units and electromagnetic waves led to rapid absorption due to the silty sandy clay layer. Because the first geological unit is medium-very stiff, low-high plasticity, silty sandy clay. The deformation structures as sliding surfaces, landslide furrows, scarps, collapsed zones, and cracks were observed in the GPR cross-sections (Fig. 8 and 9). In other words, the geological unit, the layer or topography slope and precipitation cause deformations in the loose upper unit. Therefore, these structures may develop or occur in the landslide mass, as shown in Fig. 8 and 9. Additionally, the geological units were observed in DH wells in the geophysics study area (Fig. 4). These are mostly silty sandy clay and they have different characteristics above and below about 10 m in DH well. The topography of the study area decreases from 925 m to 840 m and the elevation difference is 85 m (Fig. 4). The amount of slope in the topography increases from south to north (>50-100) in the geophysical sections (Fig. 6 and 7). It was determined that the landslide type in the area was planar sliding and observed that the direction of sliding was SE. As this information was associated with topography and the field observations, it was observed that the topography was inclined from the north to the south of the study area. The results of the various studies and also the findings of this article have proved that Koyulhisar landslides are generally caused by the known reasons that trigger the landslide. Therefore, it was seen that the geological bedding was compatible with the topographical sloping and the groundwater was compatible with the direction of flow. 4 Conclusions The landslides may develop under various geological, morphological, topographical and physical reasons. The information provided from many studies (geodetical, geological, morphological, seismological,
