Interactive comment on “Geophysical and Geodetical Investigation of A Landslide Area (Koyulhisar-Sivas, Turkey)” by Sevda Özel et al.

Geophysical and Geodetical Investigation of A Landslide Area (Koyulhisar-Sivas, Turkey) Sevda Özel¹, Demet Över², Kemal Ö. Hastaoğlu³ ^{1,2}Department of Geophysical Engineering, Cumhuriyet University, 58140, Sivas, Turkey ³Department of Geomatics Engineering, Cumhuriyet University, 58140, Sivas, Turkey Correspondence to: Sevda Özel (sozel@cumhuriyet.edu.tr.) Abstract. The study area is in the west of Koyulhisar (Sivas) town center and approximately 200x250 m². This area is one of the most active locations where the landslide displacement amount is the greatest. The aim of this study is to determine the depth of the sliding surface with geophysical (seismic refraction tomography (SRT), ground-penetrating radar (GPR)) methods. The results of TÜBİTAK-111Y111 project were also used. According to the geophysical results, within ~20 m of investigation depth, three layers with the average seismic P-wave velocities (VP) of 650, 1200 and 2100 m/sec were identified. It was determined that the depth of the sliding surface which was between ~3-7 m and the seis

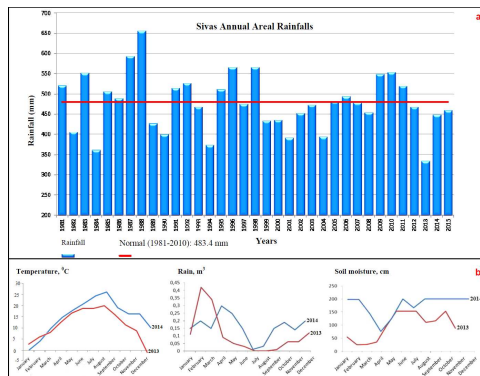
Figure 3. a) Precipitation distribution in between 1981-2015 years of Sivas (MGM, 2016). b) Graphics of monthly average temperature (T, °C), rainfall (m³) and soil moisture content (cm) of the study area and its surroundings in the years of 2013 and 2014. They were prepared from the project data (Hastaoglu et al., 2015).

The data regarding the rainfalls with the effects of triggering the landslides are presented in Table 1 and Fig. 3a and Fig. 3b (MGM, 2016; Hastaoğlu et al., 2015). With these data, the rainfall status of the study area and its surrounding was examined by months as average annual rainfalls and the annual areal amount of rainfall. According to the data obtained between 1950-2015 in Table 1, the rainy periods are generally between October-November-December and January-February-March-April. The highest total

daily amount of rainfall in the rainiest years was observed as snowfall in 1950 (110 cm) and as rain in 1991 (55 kg/m²). In Fig. 3a, the annual normal average rainfall value calculated for the years between 1981-2010 was calculated as over 483.4 mm (MGM, 2016). However, 1987-1988 and 1997-1998 were the rainiest years. It is seen that the annual areal amount of rainfall exceeded the normal values and was higher than 550 mm in these rainy years that took place in every 10 years. Similarly, it is also seen that there were high rainfalls for 3-4 years after the years of 1985-1995-2005 with an interval of 10 years. Therefore, annual areal rainfalls were observed to be more before some large landslides like the landslide in 1998. When geological features of the region are taken into account, it is remarkable that the landslide in 1998 and 2000 occurred in the summer months after the winter with a heavy fall of snow. However, the landslide in 2005 occurred during the rainy season. In Fig. 3b, GNSS studies and multi-disciplinary studies of Hastaoğlu et al. (2015) have carried out for many years (about 6 years) to determine the deformation and annual sliding amounts especially after the landslides in 1998-2000-2005. The seismological and meteorological data, which were updated by the geodetic (GNSS (DH), geological (IDH (Inclinometer Drilling Holes)) and meteorological data collected in this local study were reorganized and evaluated. Fig. 3a-b and Table 1 which were repared for the study which is the subject of this article were associated with the results of GNSS studies (Fig. 3b). The monthly and annual meteorological data should certainly be evaluated particularly within the scope of monitoring activities, as the area is a landslide area. Hastaoğlu et al. (2015) followed in DH wells in the area in 2013-2014 (Fig. 3b). If Fig. 4 is examined, there are seven DH point in the nearest of the geophysical profiles (DH8, DH12, DH16 is near the area A and DH4, DH6, DH9, DH10 is near the area C). The graphics in Fig. 3b was prepared from the combined data (unpublished data in the project) and the temperature (OC), precipitation (m3) and soil moisture content (cm) were compared in these graphics. The temperature and precipitation were observed to be inversely proportional during the summer months called as a dry period. It is seen that the soil moisture is changeable apart from the rainy period and has very

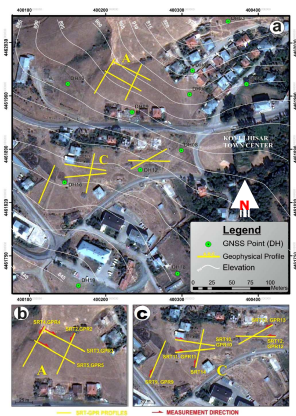
Figure 4. (a) The study area. (b) and (c) The details of geophysics profiles for the A and C areas.

applications were used in the geophysical data collection in the area (Fig. 4). The high-frequency electromagnetic waves can reach deeper in the environments with low conductivity like sand. However, the conductive units such as clay and shale decrease the penetration depth of the signal transmitted and lead to absorption (Annan et al., 1988; Davis and Annan, 1989). Firstly, SRT and GPR data were collected along multiple transects in two different areas of the study area named A and C (see Fig. 4). Then, the geophysical profiles were processed to the satellite map according to the coordinates along with the topographical elevation curves and GNSS measurement locations for the ease of interpretation (Fig. 4a). Geophysical measurements were taken due to the geologic bedding and topographic features (Fig. 4b-c). SRT profiles and on these seismic profiles GPR profiles in the area defined by A in Fig. 4b is approximately in the NE-SW (SRT2, SRT4, GPR2, GPR4)) and NW-SE (SRT3, SRT5, GPR3, GPR5) directions (Fig. 4b). Similarly, in area C, SRT11-SRT12-GPR11-GPR12 profiles are approximately in the E-W directions, SRT9-SRT14-GPR9-GPR14 profiles are approximately in the NE-SW direction, SRT10-GPR10 profiles are in the NW-SE directions and SRT13-GPR13 profiles are approximately in the NE-SW directions (Fig. 4c). The profile lengths usually range from 25 to 60 m according to the method applied. The profile shooting technique in the seismic study, hammer and iron plate of 8 kg weight as the source P geophone of 14 Hz (the total number of geophones is 12) and Geometrics branded seismic device as the receiver was used while collecting the SRT data. In all profiles, the geophone interval was 5 m, offset distance was 2.5 m, the sampling interval was 256 ms and the record length was 512 ms. The geophones were respectively fixed on the ground within the selected geophone range and their connections with the seismic device were made. Then, seismic measurements were recorded by starting from the offset distance of 2.5 m, reducing to sledgehammer plate and making at least 5 times shots between each geophone, respectively. In the evaluation of the SRT data collected in the field, Seislmager program was used for displaying, processing and evaluation of the seismic refraction waves. The marking of the first arrivals of the SRT data was performed using Pickwin, and the evaluation

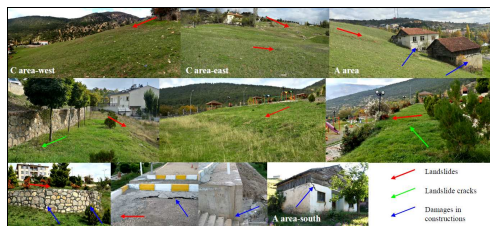
Figure 5. The photos of the study area and its surroundings, in which the landslides, landslide cracks or constructional damages are also observed.

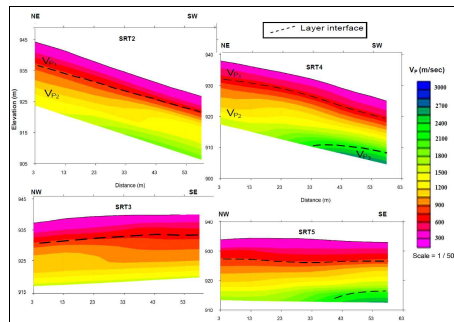
Figure 6. The seismic profiles of the area A. The uppermost boundary of the V_{p1} layer is the depth of the sliding surface (This depth changes between ~3-7 m). The lower velocity V_{p1} layer consists of soil and alluvium (the average seismic V_{p1} < 650 m/sec).

In the seismic data evaluation, the coincidence was provided with RMS (Root Mean Square) errors ranging between 3.4-4.5% in 2D inversion operation. According to these sections, two or three layers were identified at about 20 m depth (Fig. 6 and 7). It was understood that the tilts of these layers were southeast oriented, and their tilt was greater than 50. According to the average seismic velocities (VP) calculated, three layers with the layer velocities of 650, 1200 and 2100 m/sec were defined from top to bottom. Thus, the seismic VP velocities were observed that they increased towards the depth. It was determined that the depth of the sliding surface varied about between 3-7 m (Fig. 6 and 7). Therefore, these depths were defined as the layer with the risk of dislocation. This area was considered to have a risk of dislocation due to these loose units, rainfall and tilt conditions. The seismic velocity of the first layer is lower than $VP_1 < 650$ m/sec, but the seismic velocity of the third layer may be greater than $VP_3 > 2100$ m/sec. GPR sections: The investigation depth was further calculated from the SRT sections compared to the GPR sections due to the differences of geophysical methods in the application. Because GPR sections were obtained in high-resolution for about the first 10 m depth after data processing of the GPR data. It is clearly observed that the strong reflections are within 10 m depth in Fig. 8 and 9. These strong reflections seen in black dashed ellipses are interpreted as deformation areas in the layer. In a similar manner, these areas being interpreted as deformations were also observed in the studies of Bubeck et al. (2015), Hu and Shan (2016), Su et al. (2016) and Popescu et al. (2016). The strong reflected wave signal shows distinctive characteristics, presenting a low-frequency high-amplitude sync-phase axis, which can be inferred as the sliding surface in Fig. 8 and 9. In other words, two layers were identified in GPR sections. The first layer is weak, loose, cracked, moved and also have lost their tightness, and their seismic velocity is low. Therefore, in Fig. 8 and 9, it was thought that deformations developed on the sliding surfaces due to the geology of the study area in A and C area. It was identified the deformations, called sliding surfaces, landslide furrows, scarps, collapsed zones, and cracks. If the areas of A and C are compared, the deformations are more in area C than in area A. Therefore, the
