Interactive comment on “Geophysical and Geodetical Investigation of A Landslide Area (Koyulhisar-Sivas, Turkey)” by Sevda Özel et al.

Geophysical and Geodetical Investigation of A Landslide Area (Koyulhisar-Sivas, Turkey) Sevda Özel¹, Demet Över², Kemal Ö. Hastaoğlu³ 1,2Department of Geophysical Engineering, Cumhuriyet University, 58140, Sivas, Turkey 3Department of Geomatics Engineering, Cumhuriyet University, 58140, Sivas, Turkey Correspondence to: Sevda Özel (sozel@cumhuriyet.edu.tr.) Abstract. The study area is in the west of Koyulhisar (Sivas) town center and approximately 200x250 m². This area is one of the most active locations where the landslide displacement amount is the greatest. The aim of this study is to determine the depth of the sliding surface with geophysical (seismic refraction tomography (SRT), ground-penetrating radar (GPR)) methods. The results of TÜBİTAK-111Y111 project were also used. According to the geophysical results, within ~20 m of investigation depth, three layers with the

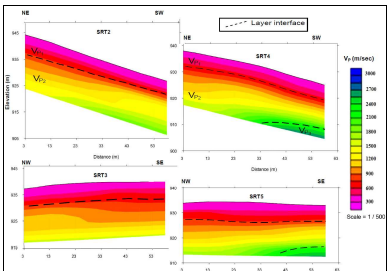
Fig. 3.

Figure 6. The seismic profiles of the area A. The uppermost boundary of the V_p layer is the depth of the sliding surface (This depth changes between ~3-7 m). The lower velocity V_p layer consists of soil and alluviums (the average seismic V_p ~ 650 m/sec).

Geophysical interpretations were made according to these sections and compared with the results of the other studies. SRT sections: 2D seismic cross-sections giving seismic VP-depth information are presented in Fig. 6 and 7. In the seismic data evaluation, the coincidence was provided with RMS (Root Mean Square) errors ranging between 3.4-4.5% in 2D inversion operation. According to these sections, two or three layers were identified at about 20 m depth (Fig. 6 and 7). It was understood that the tilts of these layers were southeast oriented, and their tilt was greater than 50. According to the average seismic velocities (VP) calculated, three layers with the layer velocities of 650, 1200 and 2100 m/sec were defined from top to bottom. Thus, the seismic VP velocities were observed that they increased towards the depth. It was determined that the depth of the sliding surface varied about between 3-7 m (Fig. 6 and 7). Therefore, these depths were defined as the layer with the risk of dislocation. This area was considered to have a risk of dislocation due to these loose units, rainfall and tilt conditions. The seismic velocity of the first layer is lower than $VP1 < 650$ m/sec, but the seismic velocity of the third layer may be greater than $VP3 > 2100$ m/sec. GPR sections: The investigation depth was further calculated from the SRT sections compared to the GPR sections due to the differences of geophysical methods in the application. Because GPR sections were obtained in high-resolution for about the first 10 m depth after data processing of the GPR data. It is clearly observed that the strong reflections are within 10 m depth in Fig. 8 and 9. These strong reflections seen in black dashed ellipses are interpreted as deformation areas in the layer. In a similar manner, these areas being interpreted as deformations were also observed in the studies of Bubeck et al. (2015), Hu and Shan (2016), Su et al.

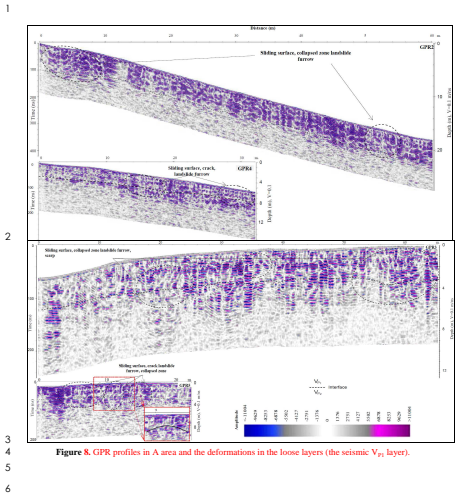
Fig. 4.

Figure 8. GPR profiles in A area and the deformations in the loose layers (the seismic V_p layer).

(2016) and Popescu et al. (2016). The strong reflected wave signal shows distinctive characteristics, presenting a low-frequency high-amplitude sync-phase axis, which can be inferred as the sliding surface in Fig. 8 and 9. In other words, two layers were identified in GPR sections. The first layer is weak, loose, cracked, moved and also have lost their tightness, and their seismic velocity is low. Therefore, in Fig. 8 and 9, it was thought that deformations developed on the sliding surfaces due to the geology of the study area in A and C area. It was identified the deformations, called sliding surfaces, landslide furrows, scarps, collapsed zones, and cracks. If the areas of A and C are compared, the deformations are more in area C than in area A. Therefore, the risk of landslides may be higher in area C. In Fig. 8, the EM wave velocity calculated for the reflection surface in GPR5 cross-section -representing the GPR profiles- was shown as an example. The picks were exported with the attribute of two-way travel time and the velocity of propagation of the wave was calculated about 0.1 m/ns (Fig. 8). This value is generally observed in dry or wet soil, dry or wet clay and sandy environments (Wilchek, 2000; Cardomina, 2002). Therefore, it was thought that this velocity value was compatible with the geological units and electromagnetic waves led to rapid absorption due to the silty sandy clay layer. Because the first geological unit is medium-very stiff, low-high plasticity, silty sandy clay. The deformation structures as sliding surfaces, landslide furrows, scarps, collapsed zones, and cracks were observed in the GPR cross-sections (Fig. 8 and 9). In other words, the geological unit, the layer or topography slope and precipitation cause deformations in the loose upper unit. Therefore, these structures may develop or occur in the landslide mass, as shown in Fig. 8 and 9. Additionally, the geological units were observed in DH wells in the geophysics study area (Fig. 4). These are mostly silty sandy clay and they have different characteristics above and below about 10 m in DH well. The topography of the study area decreases from 925 m to 840 m and the elevation difference is 85 m (Fig. 4). The amount of slope in the topography increases from south to north (>50-100) in the geophysical sections (Fig. 6 and 7). It was determined that the landslide type in the area was planar sliding and observed that the direction
