## ***Interactive comment on “Geophysical and Geodetical Investigation of A Landslide Area (Koyulhisar-Sivas, Turkey)” by Sevda Özel et al.***

Geophysical and Geodetical Investigation of A Landslide Area (Koyulhisar-Sivas, Turkey) Sevda Özel<sup>1</sup>, Demet Över<sup>2</sup>, Kemal Ö. Hastaoğlu<sup>3</sup> 1,2Department of Geophysical Engineering, Cumhuriyet University, 58140, Sivas, Turkey 3Department of Geomatics Engineering, Cumhuriyet University, 58140, Sivas, Turkey Correspondence to: Sevda Özel (sozel@cumhuriyet.edu.tr.) Abstract. The study area is in the west of Koyulhisar (Sivas) town center and approximately 200x250 m<sup>2</sup>. This area is one of the most active locations where the landslide displacement amount is the greatest. The aim of this study is to determine the depth of the sliding surface with geophysical (seismic refraction tomography (SRT), ground-penetrating radar (GPR)) methods. The results of TÜBİTAK-111Y111 project were also used. According to the geophysical results, within ~20 m of investigation depth, three layers with the

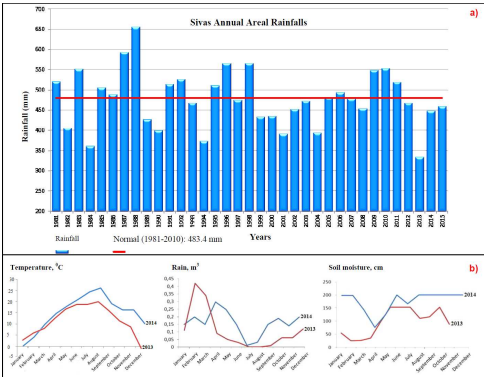
Fig. 2.

Figure 3. a) Precipitation distribution in between 1981-2015 years of Sivas (MGM, 2016). b) Graphics of monthly average temperature (T, °C), rainfall (m³) and soil moisture content (cm) of the study area and its surroundings in the years of 2013 and 2014. They were prepared from the project data (Hastaoglu et al., 2015).

there are loose units and deformations on the sliding surfaces). In particular, they further affected the landslide mass along with the rain and caused large amounts of displacement in the landslide area. 2.2 Meteorological and geodetic results The data regarding the rainfalls with the effects of triggering the landslides are presented in Table 1 and Fig. 3a and Fig. 3b (MGM, 2016; Hastaoğlu et al., 2015). With these data, the rainfall status of the study area and its surrounding was examined by months as average annual rainfalls and the annual areal amount of rainfall. According to the data obtained between 1950-2015 in Table 1, the rainy periods are generally between October-November-December and January-February-March-April. The highest total daily amount of rainfall in the rainiest years was observed as snowfall in 1950 (110 cm) and as rain in 1991 (55 kg/m<sup>2</sup>). In Fig. 3a, the annual normal average rainfall value calculated for the years between 1981-2010 was calculated as over 483.4 mm (MGM, 2016). However, 1987-1988 and 1997-1998 were the rainiest years. It is seen that the annual areal amount of rainfall exceeded the normal values and was higher than 550 mm in these rainy years that took place in every 10 years. Similarly, it is also seen that there were high rainfalls for 3-4 years after the years of 1985-1995-2005 with an interval of 10 years. Therefore, annual areal rainfalls were observed to be more before some large landslides like the landslide in 1998. When geological features of the region are taken into account, it is remarkable that the landslide in 1998 and 2000 occurred in the summer months after the winter with a heavy fall of snow. However, the landslide in 2005 occurred during the rainy season. In Fig. 3b, GNSS studies and multi-disciplinary studies of Hastaoğlu et al. (2015) have carried out for many years (about 6 years) to determine the deformation and annual sliding amounts especially after the landslides in 1998-2000-2005. The seismological and meteorological data, which were updated by the geodetic (GNSS (DH), geological (IDH (Inclinometer Drilling Holes)) and meteorological data collected in this local study were reorganized and evaluated. Fig. 3a-b and Table 1 which were reprepared for the study which is the subject of this article were associated with the results of GNSS studies (Fig. 3b). The monthly and annual meteorological data should certainly be evaluated particularly

within the scope of monitoring activities, as the area is a landslide area. Hastaoğlu et al. (2015) followed in DH wells in the area in 2013-2014 (Fig. 3b). If Fig. 4 is examined, there are seven DH point in the nearest of the geophysical profiles (DH8, DH12, DH16 is near the area A and DH4, DH6, DH9, DH10 is near the area C). The graphics in Fig. 3b was prepared from the combined data (unpublished data in the project) and the temperature (°C), precipitation (mm) and soil moisture content (cm) were compared in these graphics. The temperature and precipitation were observed to be inversely proportional during the summer months called as a dry period. It is seen that the soil moisture is changeable apart from the rainy period and has very high water content during the rainy periods. The soil moisture is very high (average 150 cm) in winter, summer, autumn seasons. In the study area, the water contents in the drilling data change from 24.6 % to 13.3 % at between 0-10 m depth and these values are also high (from 29.1 % to 17.3 %) after 10 m (Hastaoğlu et al., 2015). Water generated from precipitation and melting snow is blocked by the impermeable layer when it infiltrates downward, and the local moisture content increases (see Hu and Shan (2016)). Thus, the water infiltrates the interface between the permeable and impermeable layer, can form a slip zone. Then, these results were compared with geophysical results in interpretation. The GPR results show that the moisture content of soils at the sliding surface of the landslide mass is relatively high. The drilling data and soil moisture values also show very high moisture content of the sliding surface of the landslide mass in the study area, which is completely consistent with the results obtained from the GPR-SRT profiles, meteorological and geological results. On the other hand, it was understood that the precipitation increased by the decrease in temperatures. It is also seen that the total annual amount of rainfall increased about 2-fold in 2014 compared to 2013 (Fig. 3a-b). According to all results, rainfalls are considered to be effective in triggering of the landslide because the ground of this landslide area, which is filled with loose units and old cracks, is supersaturated with water due to the rainfalls. Besides, Hastaoğlu et al. (2015) determined that the groundwater level gets close to the surface for 4-6 m on average at the end of the rainy

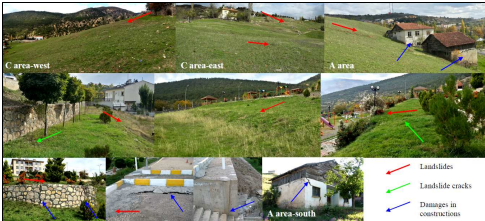
**Fig. 4.**

Figure 5. The photos of the study area and its surroundings, in which the landslides, landslide cracks or constructional damages are also observed.

active locations of the landslide area. As it is seen in Fig. 5, geomorphologically the landslide cracks on the surface, displacement traces, and structural damages in the study area and its immediate surroundings can be monitored clearly in this activity area. Visibly, the damaging effects of still active or old landslides on residences, roads and walls are also observed easily by field observations. Therefore, none of the damaged constructions are used in the Koyulhisar. 3.2 Geophysical analysis, results and discussion Geophysical interpretations were made according to these sections and compared with the results of the other studies. SRT sections: 2D seismic cross-sections giving seismic VP-depth information are presented in Fig. 6 and 7. In the seismic data evaluation, the coincidence was provided with RMS (Root Mean Square) errors ranging between 3.4-4.5% in 2D inversion operation. According to these sections, two or three layers were identified at about 20 m depth (Fig. 6 and 7). It was understood that the tilts of these layers were southeast oriented, and their tilt was greater than 50. According to the average seismic velocities (VP) calculated, three layers with the layer velocities of 650, 1200 and 2100 m/sec were defined from top to bottom. Thus, the seismic VP velocities were observed that they increased towards the depth. It was determined that the depth of the sliding surface varied about between 3-7 m (Fig. 6 and 7). Therefore, these depths were defined as the layer with the risk of dislocation. This area was considered to have a risk of dislocation due to these loose units, rainfall and tilt conditions. The seismic velocity of the first layer is lower than  $VP_1 < 650$  m/sec, but the seismic velocity of the third layer may be greater than  $VP_3 > 2100$  m/sec. GPR sections: The investigation depth was further calculated from the SRT sections compared to the GPR sections due to the differences of geophysical methods in the application. Because GPR sections were obtained in high-resolution for about the first 10 m depth after data processing of the GPR data. It is clearly observed that the strong reflections are within 10 m depth in Fig. 8 and 9. These strong reflections seen in black dashed ellipses are interpreted as deformation areas in the layer. In a similar manner, these areas being interpreted as deformations were also observed in the studies of Bubeck et al. (2015), Hu and Shan (2016), Su et al.
