Interactive comment on “Geophysical and Geodetical Investigation of A Landslide Area (Koyulhisar-Sivas, Turkey)” by Sevda Özel et al.

Geophysical and Geodetical Investigation of A Landslide Area (Koyulhisar-Sivas, Turkey) Sevda Özel¹, Demet Över², Kemal Ö. Hastaoğlu³ 1,2Department of Geophysical Engineering, Cumhuriyet University, 58140, Sivas, Turkey 3Department of Geomatics Engineering, Cumhuriyet University, 58140, Sivas, Turkey Correspondence to: Sevda Özel (sozel@cumhuriyet.edu.tr.) Abstract. The study area is in the west of Koyulhisar (Sivas) town center and approximately 200x250 m². This area is one of the most active locations where the landslide displacement amount is the greatest. The aim of this study is to determine the depth of the sliding surface with geophysical (seismic refraction tomography (SRT), ground-penetrating radar (GPR)) methods. The results of TÜBİTAK-111Y111 project were also used. According to the geophysical results, within ~20 m of investigation depth, three layers with the

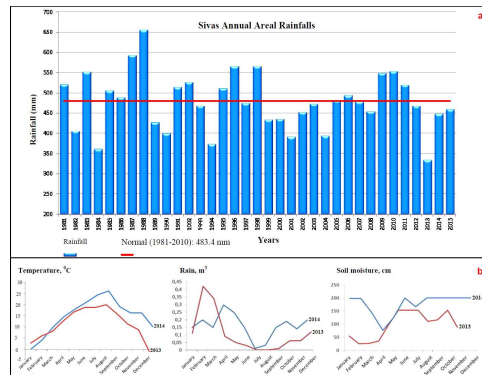
Figure 3. a) Precipitation distribution in between 1981-2015 years of Sivas (MGM, 2016). b) Graphics of monthly average temperature (T, °C), rainfall (m³) and soil moisture content (cm) of the study area and its surroundings in the years of 2013 and 2014. They were prepared from the project data (Hastaoglu et al., 2015).

there are loose units and deformations on the sliding surfaces). In particular, they further affected the landslide mass along with the rain and caused large amounts of displacement in the landslide area. 2.2 Meteorological and geodetic results The data regarding the rainfalls with the effects of triggering the landslides are presented in Table 1 and Fig. 3a and Fig. 3b (MGM, 2016; Hastaoğlu et al., 2015). With these data, the rainfall status of the study area and its surrounding was examined by months as average annual rainfalls and the annual areal amount of rainfall. According to the data obtained between 1950-2015 in Table 1, the rainy periods are generally between October-November-December and January-February-March-April. The highest total daily amount of rainfall in the rainiest years was observed as snowfall in 1950 (110 cm) and as rain in 1991 (55 kg/m²). In Fig. 3a, the annual normal average rainfall value calculated for the years between 1981-2010 was calculated as over 483.4 mm (MGM, 2016). However, 1987-1988 and 1997-1998 were the rainiest years. It is seen that the annual areal amount of rainfall exceeded the normal values and was higher than 550 mm in these rainy years that took place in every 10 years. Similarly, it is also seen that there were high rainfalls for 3-4 years after the years of 1985-1995-2005 with an interval of 10 years. Therefore, annual areal rainfalls were observed to be more before some large landslides like the landslide in 1998. When geological features of the region are taken into account, it is remarkable that the landslide in 1998 and 2000 occurred in the summer months after the winter with a heavy fall of snow. However, the landslide in 2005 occurred during the rainy season. In Fig. 3b, GNSS studies and multi-disciplinary studies of Hastaoğlu et al. (2015) have carried out for many years (about 6 years) to determine the deformation and annual sliding amounts especially after the landslides in 1998-2000-2005. The seismological and meteorological data, which were updated by the geodetic (GNSS (DH), geological (IDH (Inclinometer Drilling Holes)) and meteorological data collected in this local study were reorganized and evaluated. Fig. 3a-b and Table 1 which were reprepared for the study which is the subject of this article were associated with the results of GNSS studies (Fig. 3b). The monthly and annual meteorological data should certainly be evaluated particularly

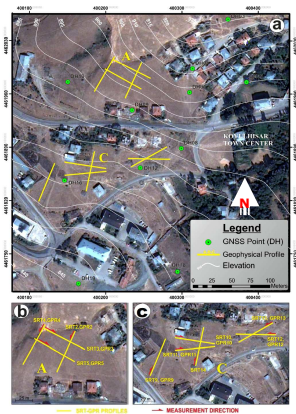
Figure 4. (a) The study area. (b) and (c) The details of geophysics profiles for the A and C areas.

within the scope of monitoring activities, as the area is a landslide area. Hastaoğlu et al. (2015) followed in DH wells in the area in 2013-2014 (Fig. 3b). If Fig. 4 is examined, there are seven DH point in the nearest of the geophysical profiles (DH8, DH12, DH16 is near the area A and DH4, DH6, DH9, DH10 is near the area C). The graphics in Fig. 3b was prepared from the combined data (unpublished data in the project) and the temperature (°C), precipitation (mm) and soil moisture content (cm) were compared in these graphics. The temperature and precipitation were observed to be inversely proportional during the summer months called as a dry period. It is seen that the soil moisture is changeable apart from the rainy period and has very high water content during the rainy periods. The soil moisture is very high (average 150 cm) in winter, summer, autumn seasons. In the study area, the water contents in the drilling data change from 24.6 % to 13.3 % at between 0-10 m depth and these values are also high (from 29.1 % to 17.3 %) after 10 m (Hastaoğlu et al., 2015). Water generated from precipitation and melting snow is blocked by the impermeable layer when it infiltrates downward, and the local moisture content increases (see Hu and Shan (2016)). Thus, the water infiltrates the interface between the permeable and impermeable layer, can form a slip zone. Then, these results were compared with geophysical results in interpretation. The GPR results show that the moisture content of soils at the sliding surface of the landslide mass is relatively high. The drilling data and soil moisture values also show very high moisture content of the sliding surface of the landslide mass in the study area, which is completely consistent with the results obtained from the GPR-SRT profiles, meteorological and geological results. On the other hand, it was understood that the precipitation increased by the decrease in temperatures. It is also seen that the total annual amount of rainfall increased about 2-fold in 2014 compared to 2013 (Fig. 3a-b). According to all results, rainfalls are considered to be effective in triggering of the landslide because the ground of this landslide area, which is filled with loose units and old cracks, is supersaturated with water due to the rainfalls. Besides, Hastaoğlu et al. (2015) determined that the groundwater level gets close to the surface for 4-6 m on average at the end of the rainy

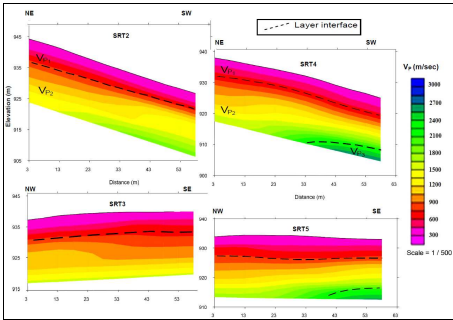
Figure 6. The seismic profiles of the area A. The uppermost boundary of the V_{p2} layer is the depth of the sliding surface (This depth changes between ~3-7 m). The lower velocity V_{p1} layer consists of soil and alluviums (the average seismic V_{p1} < 650 m/sec).

average seismic P-wave velocities (VP) of 650, 1200 and 2100 m/sec were identified. It was determined that the depth of the sliding surface which was between ~3-7 m and the seismic velocities were lower than 650 m/sec from these depths to the surface. The geophysical results demonstrated that the landslide type was identified as planar sliding, with the sliding direction in S-SE, and the tilt of the geological layer was in the same direction with the topography slope, mostly bigger than 5°. It was observed that the deformations in the landslide mass were caused by the geological unit, the layer or topography slope, and precipitation. All of these results can be effective in triggering the landslide area in the future and the landslide activity may continue in the study area. Therefore, the study area contains the risk and the natural hazards, and these threaten the settlement area and other constructions in Koyulhisar.
