# Effects of the 25 April 2015 Nepal earthquake in the Tibetan border region of China and increased post-seismic hazards

**Abstract:** The seismic effects in Nyalam, Gyirong, Tingri and Dinggye counties along the southern border of Tibet were investigated during 2-8 May, 2015, a week after the great Nepal earthquake along the Main Himalaya Thrust. The intensity was VIII in the region and reached IX at two towns on the Nepal border; resulting in the destruction of 2,700 buildings, seriously damaging over 40,000 others, while killing 27 people and injuring 856 in this sparsely populated region. The main geologic effects in this steep rugged region are collapses, landslides, rockfalls, and ground fissures; many of which are reactivations of older land slips. These did great damage to the buildings, roads and bridges in the region. Most of the effects are along four incised valleys which are controlled by N-S trending rifts and contain rivers that pass through the Himalaya Mountains and flow into Nepal; at least two of the larger aftershocks occurred along the normal faults. Areas weakened by the earthquake pose post-seismic hazards. Three valleys have the potential for dangerous post

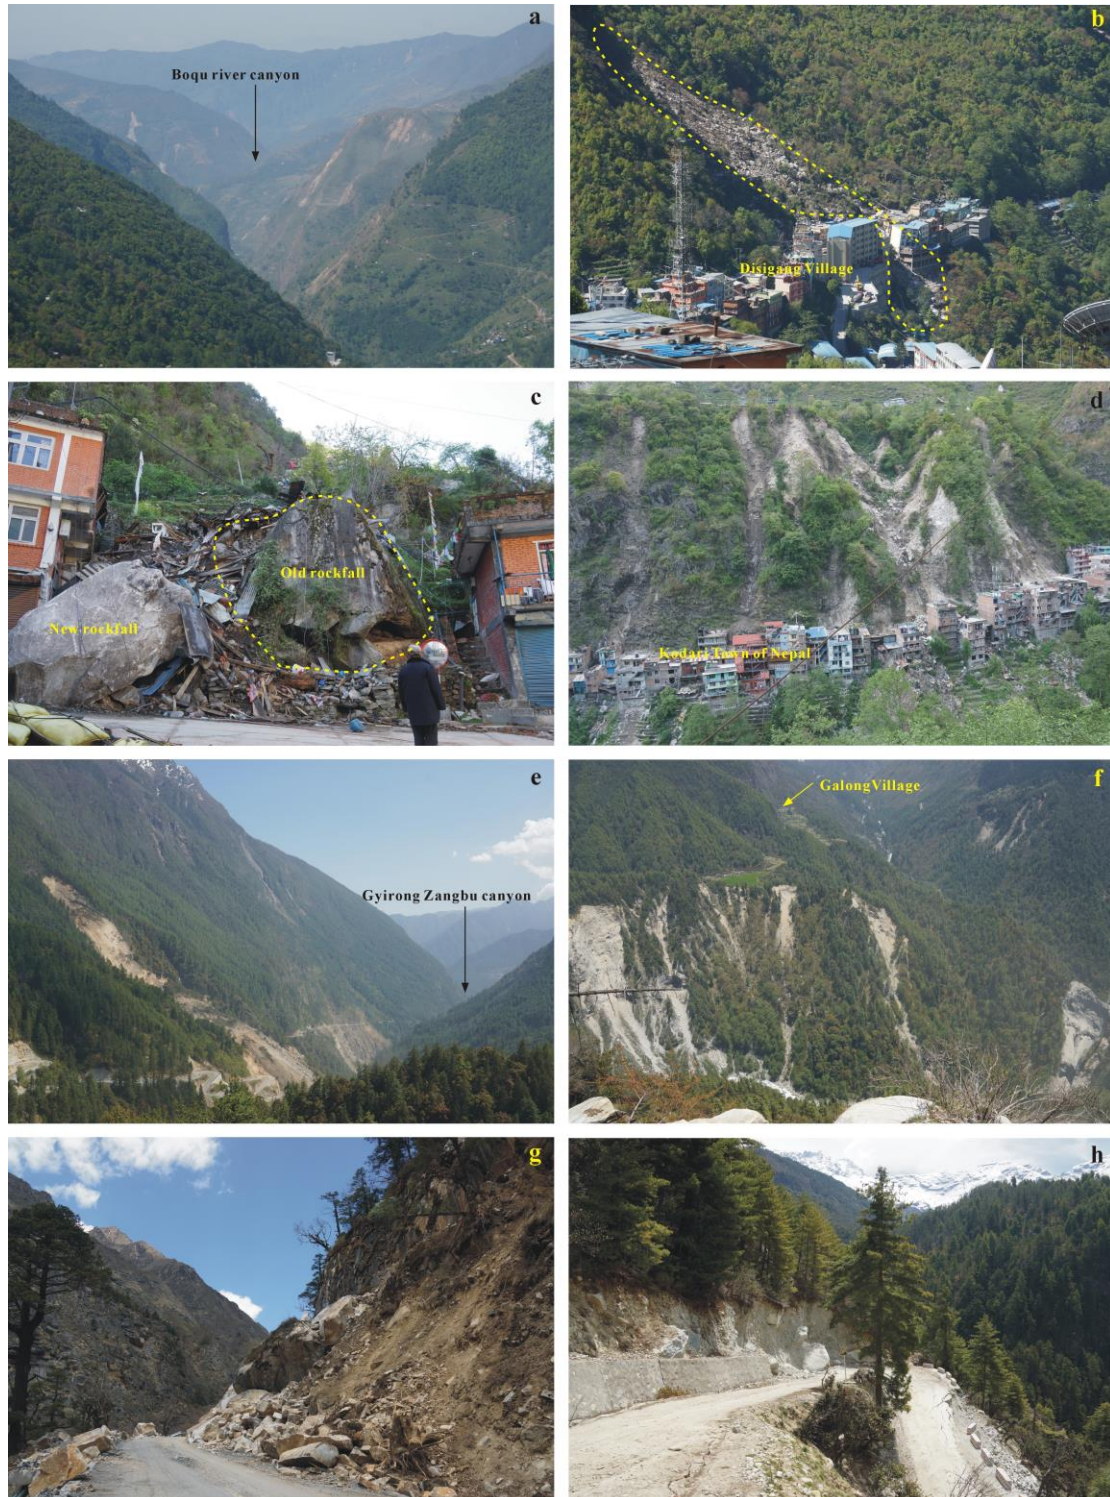
Fig. 6 Geologic effects caused during the Nepal earthquake: a, collapses in the Boqu valley; b, collapse at Disigang Village in the Boqu valley (Site1, Fig. 5a); c. new and old rockfalls at Disigang Village in the Boqu valley (Site1, Fig. 5a); d, destroyed buildings in Kodari, Nepal in the Boqu valley (Site in Fig. 4a); e, large landslide in Chongse Village in the Gyirong Zangbo valley (Site1, Fig. 5b); f, collapses in Galong Village in the Gyirong Zangbo valley (Site 7, Fig. 5b); g, collapses along highway from Gyirong County to Jilong Town in the Gyirong Zangbo

valley (Site 4, Fig. 5b); h, collapses and fissures along the highway from Jilong to Chongse Village in the Gyirong Zangbo valley (Site1, Fig. 5b).

(3) Surface damages occur often in weak, soft geologic material and unstable geomorphic positions: joint or fault-formed, high, steep bedrock cliffs and slopes (Figs. 6b and 6e); high, steep slopes of loose Quaternary sediment forming river terraces, proluvial fans, and benches (Figs. 6d and 6f) and; unstable slopes and highway road cuts (Figs. 6g and 6h). These landslides mostly occur on slopes steeper than 35-45
