1 Effects of the 25 April 2015 Nepal earthquake in the Tibetan
2 border region of China and increased post-seismic hazards

15 **Abstract:** The seismic effects in Nyalam, Gyirong, Tingri and Dinggye counties along
16 the southern border of Tibet were investigated during 2-8 May, 2015, a week after the
17 great Nepal earthquake along the Main Himalaya Thrust. The intensity was VIII in the
18 region and reached IX at two towns on the Nepal border; resulting in the destruction of
19 2,700 buildings, seriously damaging over 40,000 others, while killing 27 people and
20 injuring 856 in this sparsely populated region. The main geologic effects in this steep
21 rugged region are collapses, landslides, rockfalls, and ground fissures; many of which
22 are reactivations of older land slips. These did great damage to the buildings, roads and
23 bridges in the region. Most of the effects are along four incised valleys which are
24 controlled by N-trending rifts and contain rivers that pass through the Himalaya
25 Mountains and flow into Nepal; at least two of the larger aftershocks occurred along the

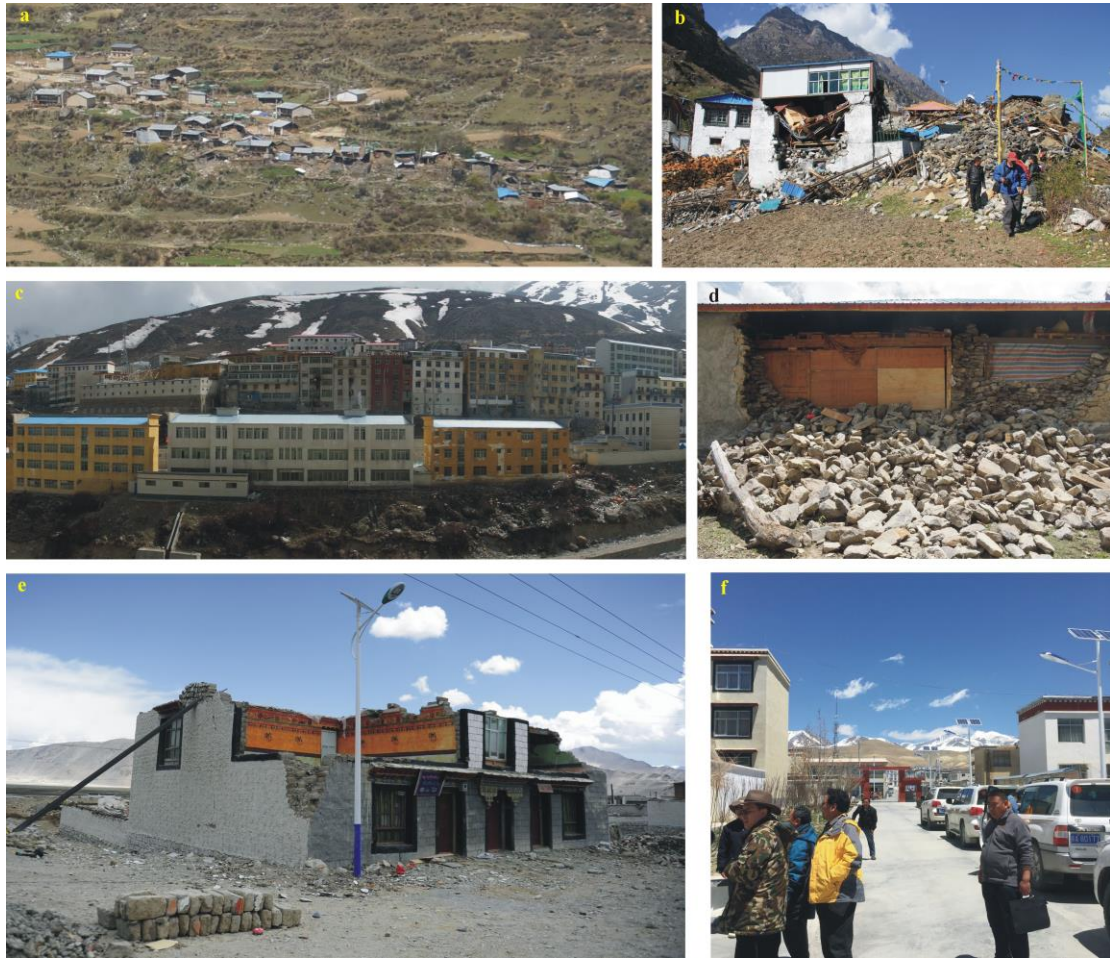
Fig. 3 The building damage resulting at different earthquake intensities: a, Many of the old stone pile or mud-brick houses collapsed, but the new brick houses rarely collapsed at Gangba Village in Sale Town in the intensity VIII zone; b, Similar building damage at Zhuobude Village of Rongxia Town in the intensity VIII zone; c, Most of buildings of brick-concrete structure did not collapse, but many walls showed obvious damage at Nyalam city located in the intensity VIII zone; d, Some walls of the stone-piled or mud-brick houses collapsed at Rema Village, Jilong County, in the intensity VII zone; e, Similar building damage at Chentang Town, Dinggyê county, in the intensity VII zone; f, Most of the houses remain intact and only few or individual walls of buildings had apparent small cracks at Jilong county city in the intensity VI zone.

151 where about 80% of the houses were completely destroyed or damaged to a large extent
152 (Figs. 3, 4). The damage is heaviest in the towns of Zhangmu in Nyalam County; Jilong
153 and Sale in Gyirong County, and Rongxia in Gyirong County (Fig. 5). Moreover, the
154 highways and communications to the towns of Zhangmu, Tingri, and Resuo Bridge as
155 well as connections to Zhangmu, Tingri, Chentang and others in Nyalam County were
156 greatly damaged and broken.

251 The specific structural damage is usually related to the material and type of
252 building construction in these areas where the heaviest destruction occurred near the
253 Nepal border. In this region of few trees most of the houses are of simple stone and
254 adobe construction and these fared poorly during the earthquake; with the majority
255 being destroyed near Nepal (Figs. 3b, 3d, 3e, 4c). Houses with cement bonded stone or
256 brick construction survived much better (Figs. 3a, 4d) and those of good brick or
257 reinforced concrete construction suffered the least (Figs. 3c, 4f) and provided a contrast
258 with those of poorer materials (Figs. 3a, 4e).

521 Third, in the repair and reconstruction of buildings, new anti-seismic construction
522 codes must be adopted. The replacement of poorly built stone and adobe building by more
523 seismic resistant brick and concrete ones should be given a high priority.

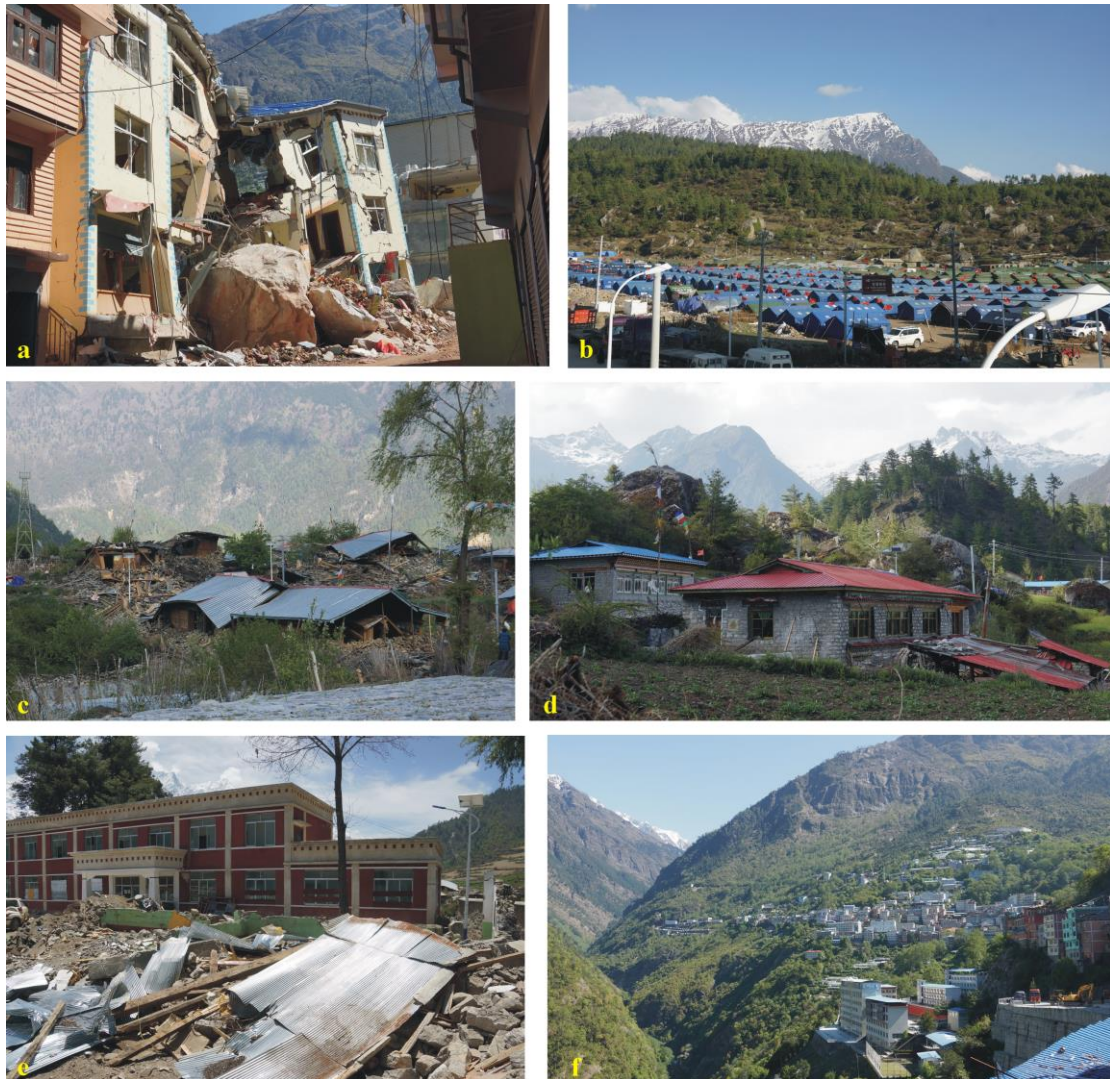
Fig. 4 Typical earthquake damage in southern Tibet and comparison of houses of different construction (locations shown in Fig. 5). Huge rockfall that smashed the resident committee office building at Disigang Village, about 0.7 km south of Zhangmu, where seven persons were killed (intensity IX) (site 1, Fig. 5a); b, A temporary settlement for earthquake survivors at Jilong; c, Destroyed houses of stone block masonry or adobe construction in Jifu Village southwest of Jilong (intensity VIII) (site 8, Fig. 5b); d, Houses of cement-bonded stone or brick construction in Jifu Village (intensity IX); e, Destroyed old houses and standing new buildings at Sale Town Primary School (intensity VIII) (site 7, Fig. 5b); f, Few collapsed houses at Zhangmu due to the brick structure or reinforced concrete construction (intensity IX).

167 block masonry were almost completely destroyed, whereas most newly built ones of
168 cement-bonded stone or brick are still standing with only minor cracks in the walls (Fig.
169 4c-d), and the same variation also is seen at the Sale Town Primary School (Fig. 4e).
170 The inhabitants of this area had to be quickly moved to temporary settlements (Fig. 4b).
171 Perhaps some poorer buildings weakened by the first earthquake were collapsed by the
172 second one or the newer buildings had more seismic resistance than realized. Some
173 undetected ground slippage at a few locations throughout the region also may have
174 augmented the effects to a slight degree.

346 All of Zhangmu is located on a group of old landslides (Figs. 4a, 7a and 7b).
347 Discontinuous tension fissures, which are tens to hundreds of meters long, about 10 cm
348 wide and 2 to 4 m deep, were found at its upper edge and on its sides after the
349 earthquake (Figs. 8a and 8b). These fissures indicate the possibility of the failure of the
350 entire landslide group.

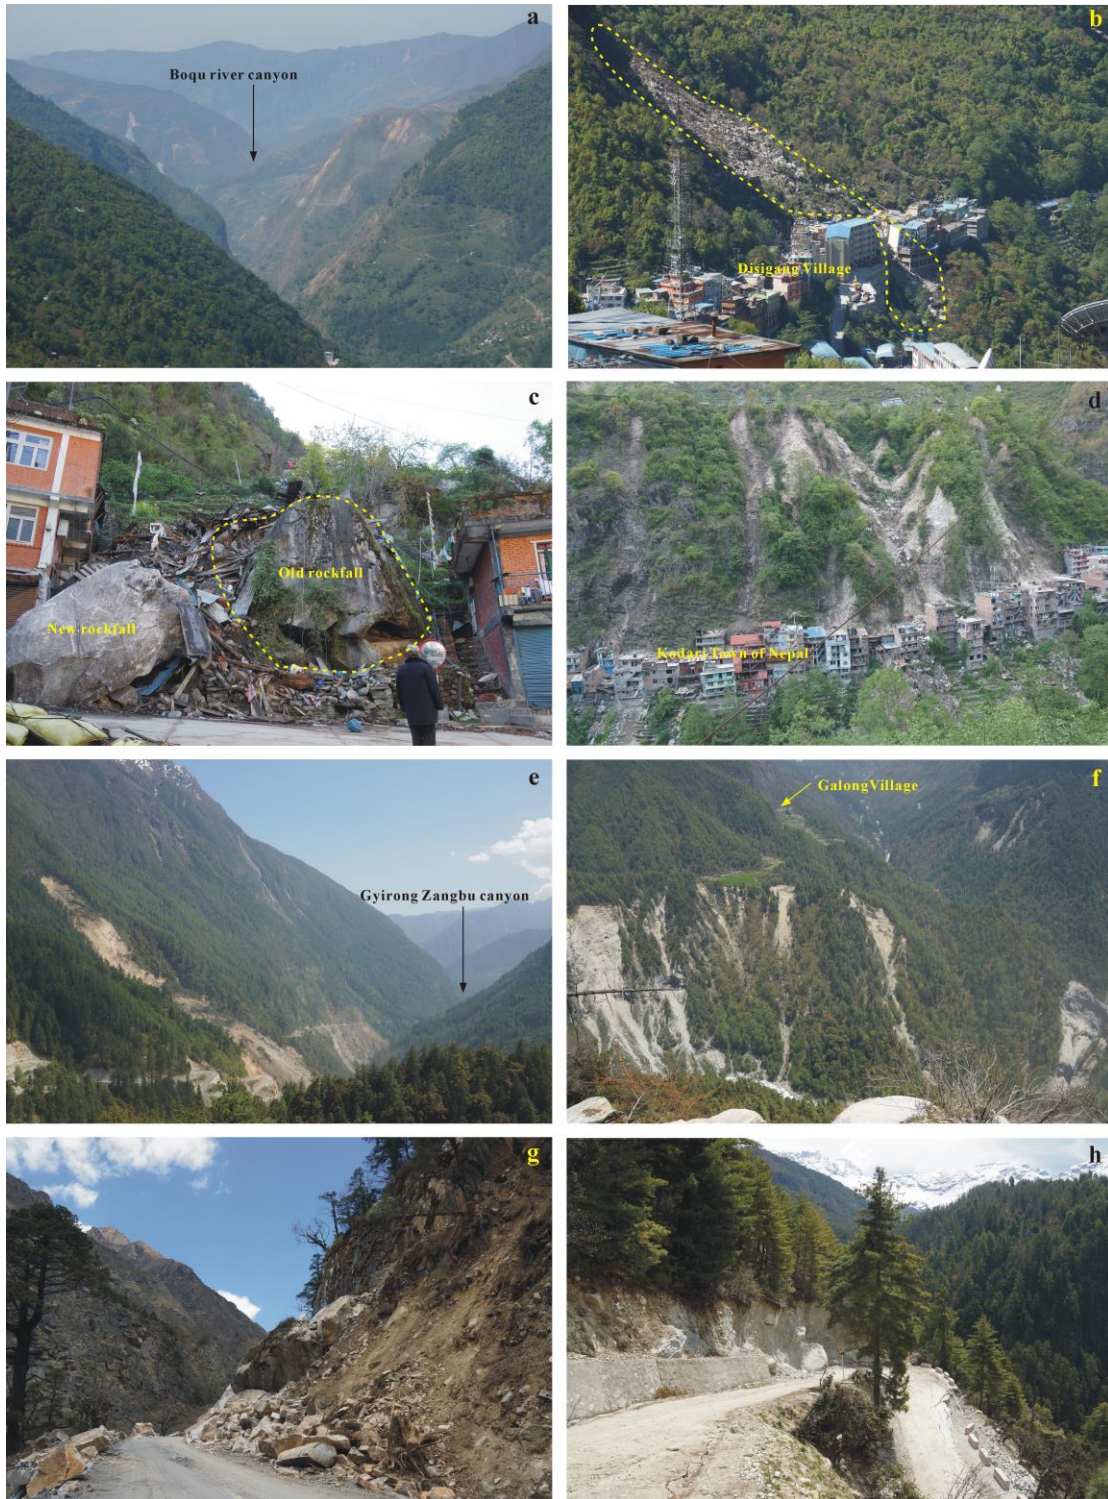
Fig. 6 Geologic effects caused during the Nepal earthquake: a, collapses in the Boqu valley; b, collapse at Disigang Village in the Boqu valley (Site1, Fig. 5a); c, new and old rockfalls at Disigang Village in the Boqu valley (Site1, Fig. 5a); d, destroyed buildings in Kodari, Nepal in the Boqu valley (Site in Fig. 4a); e, large landslide in Chongse Village in the Gyirong Zangbu valley (Site1, Fig. 5b); f, collapses in Galong Village in the Gyirong Zangbu valley (Site 7, Fig. 5b); g, collapses along highway from Gyirong County to Jilong Town in the Gyirong Zangbu

valley (Site 4, Fig. 5b); h, collapses and fissures along the highway from Jilong to ChongseVillage in the Gyirong Zangbo valley (Site1, Fig. 5b).

217 (3) Surface damages occur often in weak, soft geologic material and unstable
218 geomorphic positions: joint or fault-formed, high, steep bedrock cliffs and slopes (Figs.
219 6b and 6e); high, steep slopes of loose Quaternary sediment forming river terraces,
220 proluvial fans, and benches (Figs. 6d and 6f) and; unstable slopes and highway road
221 cuts (Figs. 6g and 6h). These landslides mostly occur on slopes steeper than 35-45
222 degrees.

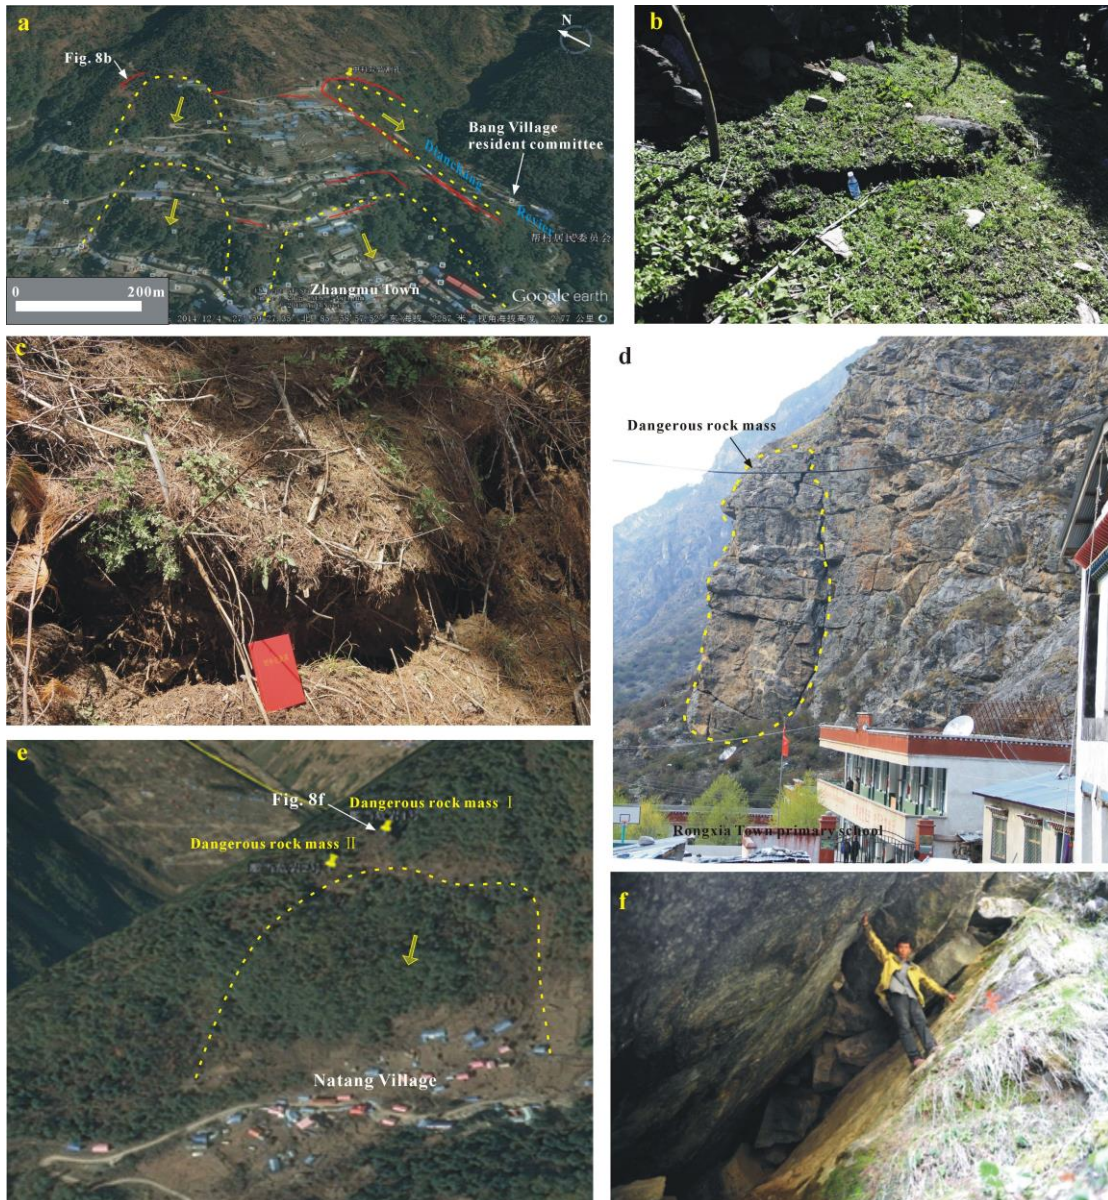
Fig. 8 Fissured and unstable rock masses formed by the earthquake that indicate hazards for additional landslides and rockfalls. Explanation: yellow dotted line, landslide group; arrow, slip direction; red line, new fissures formed during the Nepal earthquake; a, Old landslide group at Zhangmu. b. New fissure in the old landslide group at Zhangmu (site in Fig. 8a); c, Tension fissures at the back edge of Sale Village landslide (site7 in Fig. 5b); d, Dangerous rock mass at Rongxia Primary School (site 3 in Fig. 5c); e, Old landslide with unstable rock at Chentang Town (site 1 in Fig. 5d) and; f, Fissure between unstable rock and bedrock at Chentang (site in Fig. 8e).

223 (4) Most of large ground fissures are associated with collapses and landslides. They
224 either occur on the displaced masses or around their edges and only a few such fissures
225 occur on surface of loose sediments (Fig. 8).

351 The Sale Village landslide, which resulted from the earthquake, on the slope along
352 the highway from Sale Village to Seqiong Village (Fig. 5b). It is nearly 600,000 m³ in
353 volume and its fall blocked the road. Large tension fissures at its upper edge indicate a
354 danger of further slippage (Fig. 8c).

359 Natang Village near Chentang is located at the front, lower edge of an old landslide,
360 which is about 420 m long and 230 m wide, and consists of about 1,200,000 m³ (Figs.
361 5d and 8e). The steep wall at its upper edge appears as two large dangerous rock blocks
362 which are about 60,000 m³ in volume and a 1.7 m wide preexisted crack occurs between
363 the unstable rock blocks and the bedrock (Fig. 8f). The earthquake caused a partial
364 rockfall and demonstrates the dangerous instability of the mass that might come down
365 easily.
