1 Damages induced by the 25 April 2015 Nepal earthquake in the
2 Tibetan border region of China and increased post-seismic
3 hazards

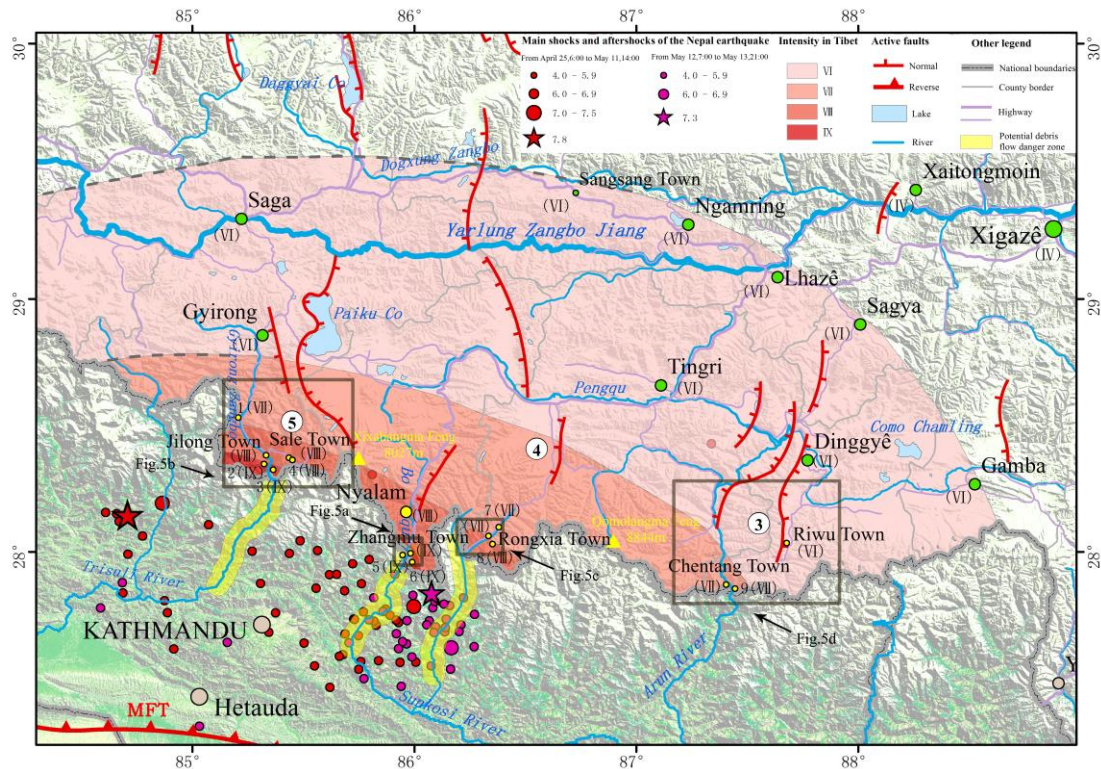
Fig. 2 Principal active faults and the distribution of seismic intensity of the 2015 Nepal earthquake in the southern Tibet region. Epicentral data from the USGS and seismic intensity from the China Earthquake Administration. The numbers and names of the principal S-N trending rifts in southern Tibet are same as on Fig. 1. The green landmarks show the sites which intensity are from China Earthquake Administration, and yellow landmarks show the spots which intensity is resulted from our field investigation. The survey spots: 1, Rema Villiage; 2, Jifu villiage; 3, Chongse Villiage; 4, Guoba Villiage; 5, Kodari Town of Nepal; 6, Lixin Viliage; 7, Bangse Villiage; 8, Zhuobude Villiage; 9, Natang Villiage.

124 damage and seismic intensity were evaluated at 29 sites in 10 affected counties (Fig. 2,
125 and Table 1).

152 north of the mountains (for their seismic intensities, see Table 1). The main effects and
153 economic losses are concentrated in Nyalam, Tingri, and Gyirong Counties (Fig. 2)
154 where about 80% of the houses were completely destroyed or damaged to a large extent
155 (Figs. 3, 4). The damage is heaviest in the towns of Zhangmu in Nyalam County; Jilong
156 and Sale in Gyirong County, and Rongxia in Gyirong County (Fig. 5). Moreover, the
157 highways and communications to the towns of Zhangmu, Tingri, and Resuo Bridge as
158 well as connections to Zhangmu, Tingri, Chentang and others in Nyalam County were
159 greatly damaged and broken.

449 Southern Tibet is an earthquake-prone region with long E-W-trending active thrust
450 faults such as caused the Nepal Earthquake; less well known are the important active
451 normal faults and grabens just to the north (Figs. 1 and 2). These normal faults form at
452 least eight nearly N-S-trending rifts across southern Tibet. Geological estimates and
453 GPS data show that the E-W extension rates cross the rifts were 10-13 mm/a during the
454 Quaternary and Holocene (Armijo et al., 1986; Chen et al., 2004). Such rates are close
455 to the Holocene slip rate of 21 ± 1.5 mm/yr along the Main Frontal Thrust of the Main
456 Himalaya Thrust (Lavé and Avouac, 2000) and to the recent GPS-based shortening rate
457 of 10-19 mm/yr across the Himalaya orogenic belt (Larson et al., 1999; Jouanne, et al.,
458 1999; Zhang et al., 2004; Bettinelli et al., 2006). There thus, appears to be a close
459 kinematic connection between the thrusting on the Main Himalaya Thrust and the

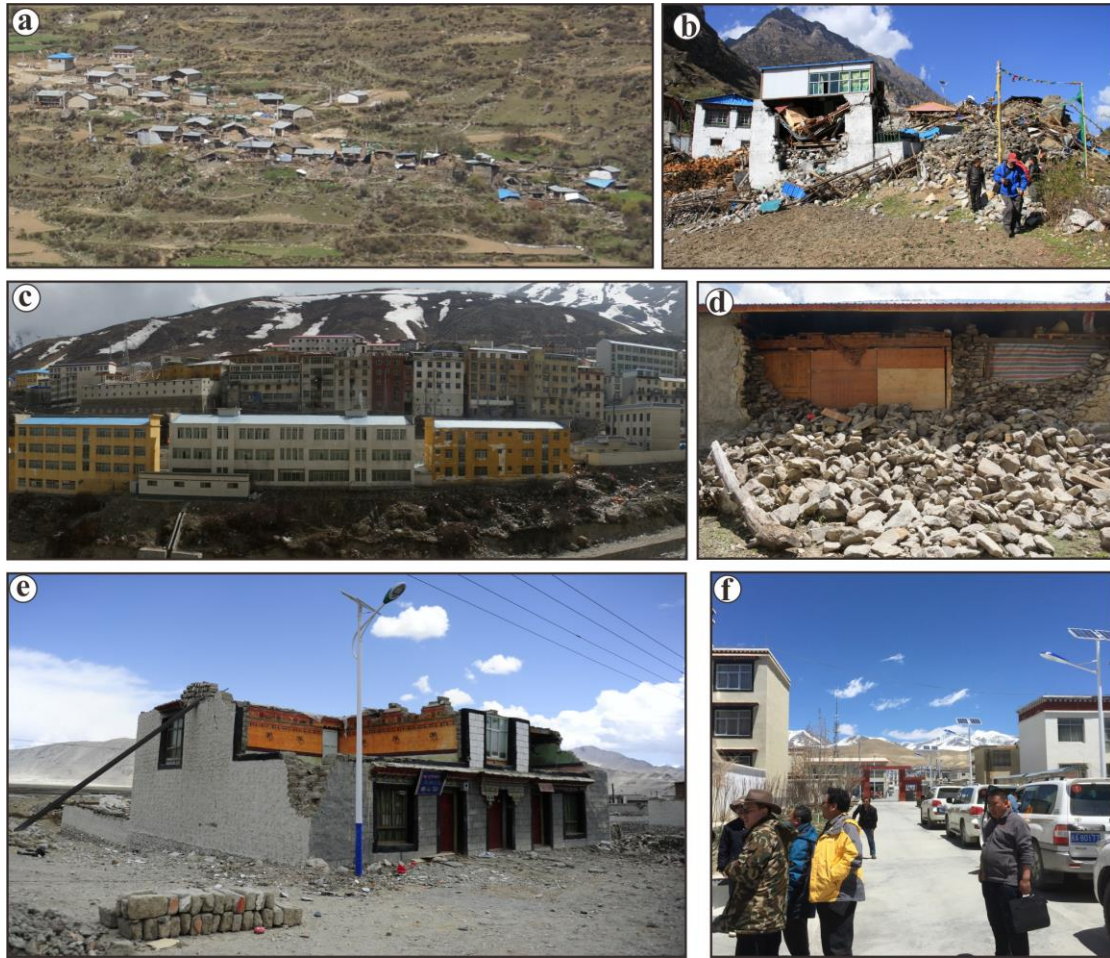
Fig. 3 The building damage resulting at different earthquake intensities: a, Many of the old stone pile or mud-brick houses collapsed, but the new brick houses rarely collapsed at Gangba Village in Sale Town in the intensity VIII zone; b, Similar building damage at Zhuobude Village of Rongxia Town in the intensity VIII zone; c, Most of buildings of brick-concrete structure did not collapse, but many walls showed obvious damage at Nyalam city located in the intensity VIII zone; d, Some walls of the stone-piled or mud-brick houses collapsed at Rema Village, Jilong County, in the intensity VII zone; e, Similar building damage at Chentang Town, Dinggyê county, in the intensity VII zone; f, Most of the houses remain intact and only few or individual walls of buildings had apparent small cracks at Jilong county city in the intensity VI zone.

253 The specific structural damage is usually related to the material and type of
254 building construction in these areas where the heaviest destruction occurred near the
255 Nepal border. In this region of few trees most of the houses are of simple stone and
256 adobe construction and these fared poorly during the earthquake; with the majority
257 being destroyed near Nepal (Figs. 3b, 3d, 3e, 4c). Houses with cement bonded stone or
258 brick construction survived much better (Figs. 3a, 4d) and those of good brick or
259 reinforced concrete construction suffered the least (Figs. 3c, 4f) and provided a contrast
260 with those of poorer materials (Figs. 3a, 4e).

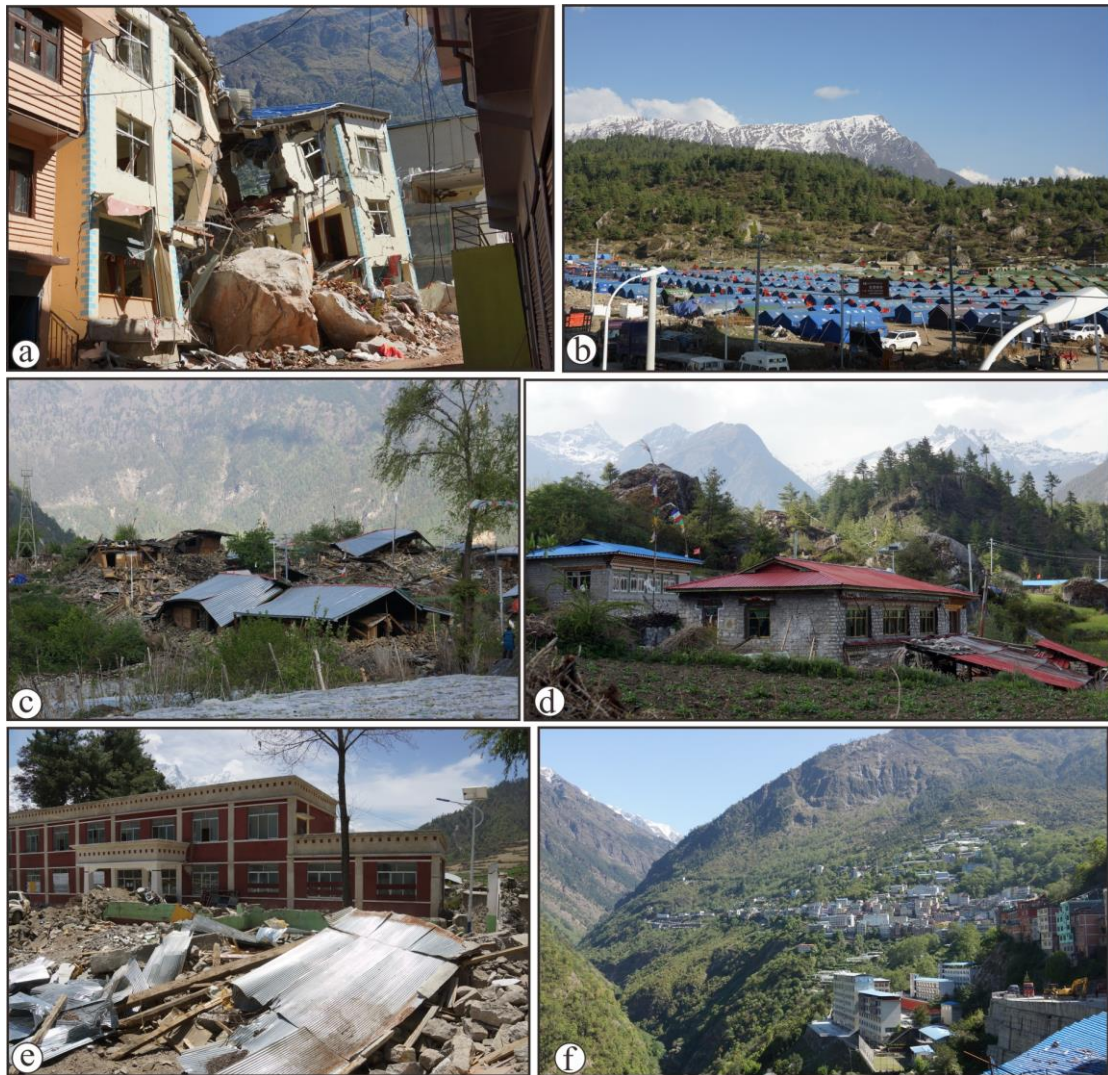
Fig. 4 Typical earthquake damage in southern Tibet and comparison of houses of different construction (locations shown in Fig. 5). Huge rockfall that smashed the resident committee office building at Disigang Village, about 0.7 km south of Zhangmu, where seven persons were killed (intensity IX) (site 1, Fig. 5a); b, A temporary settlement for earthquake survivors at Jilong; c, Destroyed houses of stone block masonry or adobe construction in Jifu Village southwest of Jilong (intensity VIII) (site 8, Fig. 5b); d, Houses of cement-bonded stone or brick construction in Jifu Village (intensity IX); e, Destroyed old houses and standing new buildings at Sale Town Primary School (intensity VIII) (site 7, Fig. 5b); f, Few collapsed houses at Zhangmu due to the brick structure or reinforced concrete construction (intensity IX).

170 block masonry were almost completely destroyed, whereas most newly built ones of
171 cement-bonded stone or brick are still standing with only minor cracks in the walls (Fig.
172 4c-d), and the same variation also is seen at the Sale Town Primary School (Fig. 4e).
173 The inhabitants of this area had to be quickly moved to temporary settlements (Fig. 4b).
174 Perhaps some poorer buildings weakened by the first earthquake were collapsed by the
175 second one or the newer buildings had more seismic resistance than realized. Some
176 undetected ground slippage at a few locations throughout the region also may have
177 augmented the effects to a slight degree.

348 All of Zhangmu is located on a group of old landslides (Figs. 4a, 7a and 7b).
349 Discontinuous tension fissures, which are tens to hundreds of meters long, about 10 cm
350 wide and 2 to 4 m deep, were found at its upper edge and on its sides after the
351 earthquake (Figs. 8a and 8b). These fissures indicate the possibility of the failure of the
352 entire landslide group.

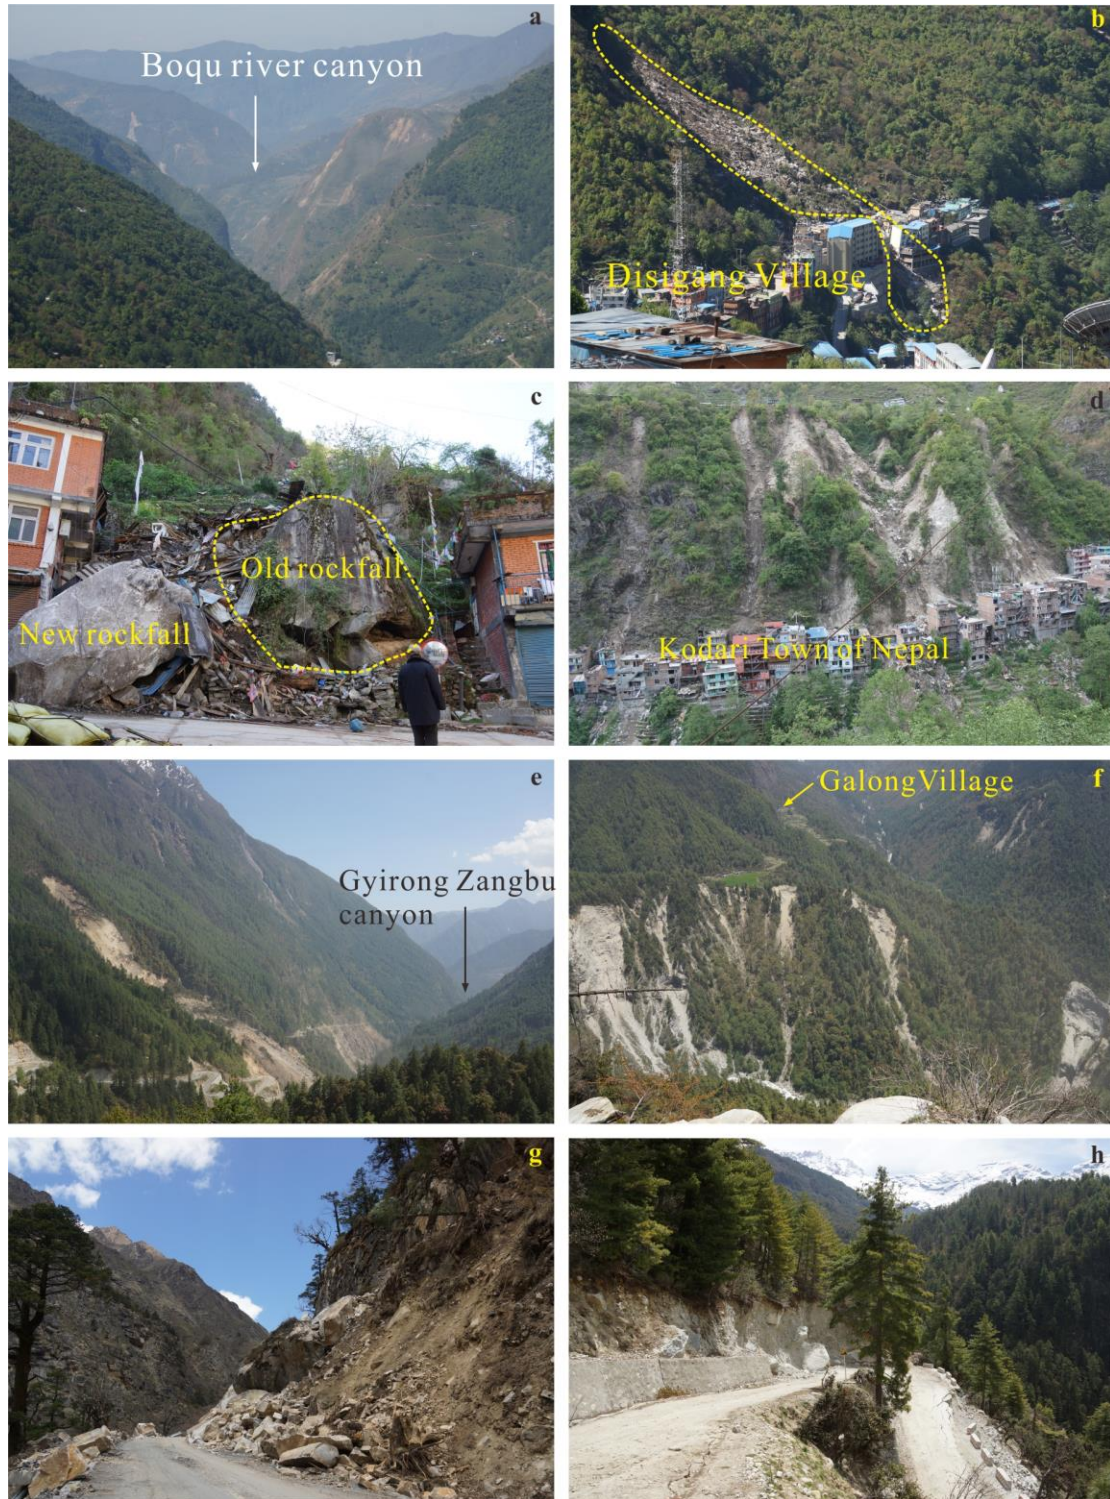
Fig. 6 Geologic effects caused during the Nepal earthquake: a, collapses in the Boqu valley; b, collapse at Disigang Village in the Boqu valley (Site1, Fig. 5a); c, new and old rockfalls at Disigang Village in the Boqu valley (Site1, Fig. 5a); d, destroyed buildings in Kodari, Nepal in the Boqu valley (Site in Fig. 4a); e, large landslide in Chongse Village in the Gyirong Zangbo valley (Site1, Fig. 5b); f, collapses in Galong Village in the Gyirong Zangbo valley (Site 7, Fig. 5b); g, collapses along highway from Gyirong County to Jilong Town in the Gyirong Zangbo

valley (Site 4, Fig. 5b); h, collapses and fissures along the highway from Jilong to ChongseVillage in the Gyirong Zangbo valley (Site1, Fig. 5b).

220 (3) Damages occur often in weak, soft geologic material and unstable geomorphic
221 positions: joint or fault-formed, high, steep bedrock cliffs and slopes (Figs. 6b and 6e);
222 high, steep slopes of loose Quaternary sediment forming river terraces, proluvial fans,
223 and benches (Figs. 6d and 6f) and; unstable slopes and highway road cuts (Figs. 6g and
224 6h). These landslides mostly occur on slopes steeper than 35-45 degrees.

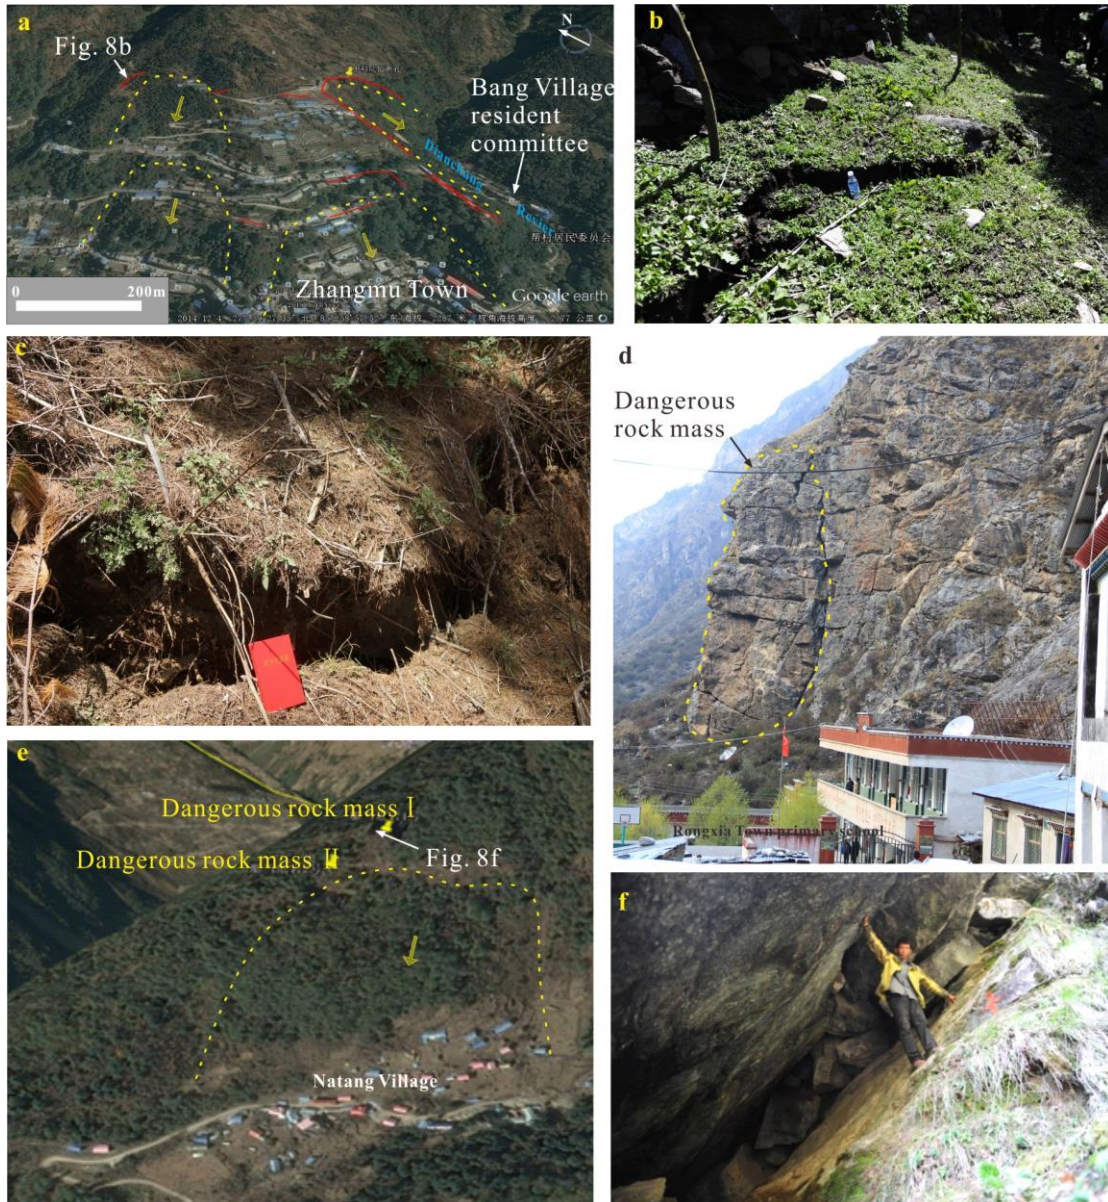
Fig. 8 Fissured and unstable rock masses formed by the earthquake that indicate hazards for additional landslides and rockfalls. Explanation: yellow dotted line, landslide group; arrow, slip direction; red line, new fissures formed during the Nepal earthquake; a, Old landslide group at Zhangmu. b. New fissure in the old landslide group at Zhangmu (site in Fig. 8a); c, Tension fissures at the back edge of Sale Village landslide (site7 in Fig. 5b); d, Dangerous rock mass at Rongxia Primary School (site 3 in Fig. 5c); e, Old landslide with unstable rock at Chentang Town (site 1 in Fig. 5d) and; f, Fissure between unstable rock and bedrock at Chentang (site in Fig. 8e).

225 (4) Most of large ground fissures are associated with collapses and landslides. They
226 either occur on the displaced masses or around their edges and only a few such fissures
227 occur on surface of loose sediments (Fig. 8).

353 The Sale Village landslide, which resulted from the earthquake, on the slope along
354 the highway from Sale Village to Seqiong Village (Fig. 5b). It is nearly 600,000 m³ in
355 volume and its fall blocked the road. Large tension fissures at its upper edge indicate a
356 danger of further slippage (Fig. 8c).

361 Natang Village near Chentang is located at the front, lower edge of an old landslide,
362 which is about 420 m long and 230 m wide, and consists of about 1,200,000 m³ (Figs.
363 5d and 8e). The steep wall at its upper edge appears as two large dangerous rock blocks
364 which are about 60,000 m³ in volume and a 1.7 m wide preexisted crack occurs between
365 the unstable rock blocks and the bedrock (Fig. 8f). The earthquake caused a partial
366 rockfall and demonstrates the dangerous instability of the mass that might come down
367 easily.

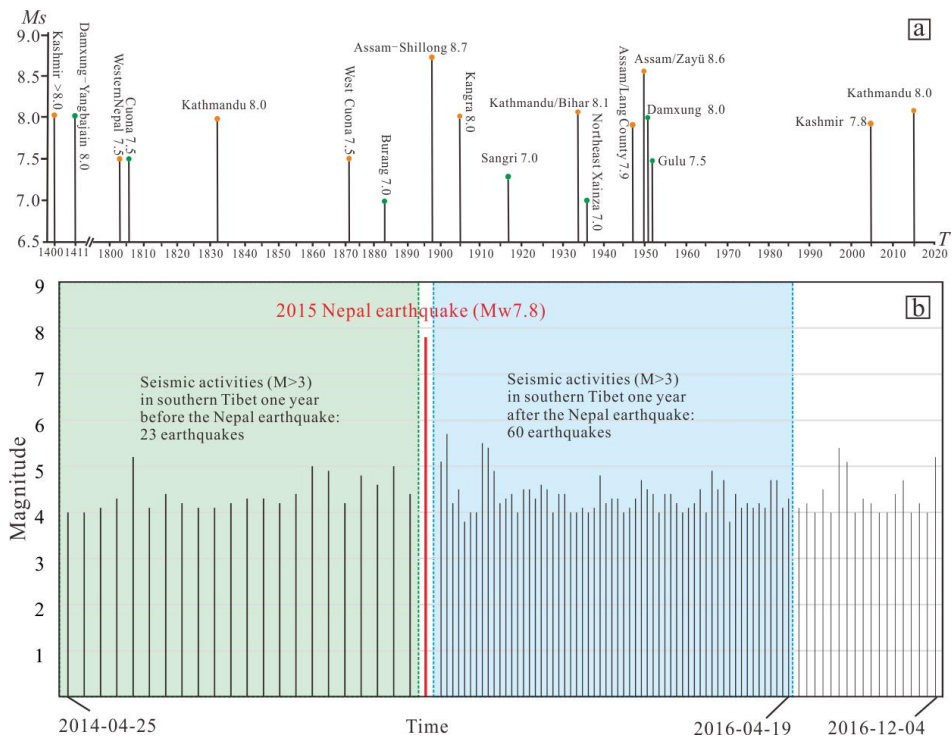
Fig.9 a: Magnitude (M_s) –Time (T) distribution of historical seismic activity along Himalaya and southern Tibet with the magnitude >7.0 . The orange circles show the earthquakes occurred along Himalaya while the green circles show the earthquakes along southern Tibetan rift. b: Magnitude (M) –Time (T) distribution of seismic activity in southern Tibet in the period of one year before and after the 2015 Nepal earthquake (data came from USGS)
