1 **Characteristics of surface damage in China during the 25 April 2015**

2 **Nepal earthquake**

3 Zhonghai Wu ^{a*} Patrick J. Barosh^b, Xin Yao ^a, Yongqiang Xu ^c

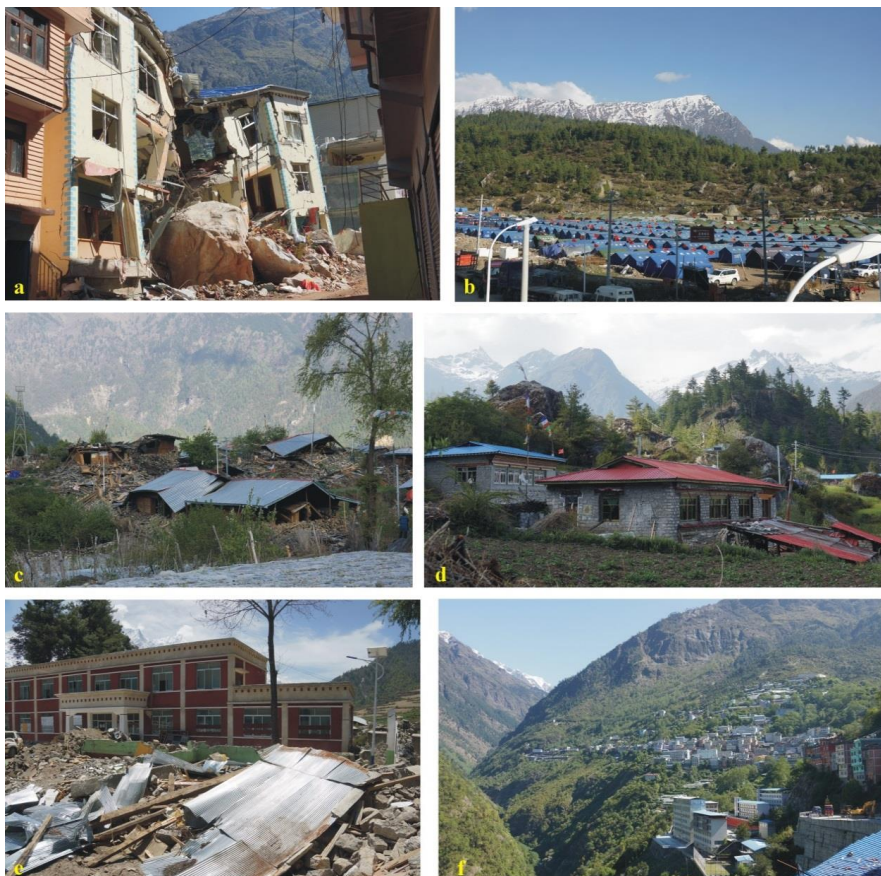
434 Fig. 3 Typical earthquake damage in southern Tibet and comparison of houses of different
435 construction (locations in Fig. 4). A, Huge rockfall smashed the resident committee office building
436 at Disigang Village about 0.7 km south of Zhangmu, where seven persons were killed (site 1, Fig.
437 4a); b, A makeshift settlement of quake survivors at Jilong; c, Destroyed houses of stone block
438 masonry or adobe construction in Jifu Village southwest of Jilong (site 8, Fig. 4b); d, Houses with
439 cement-bonded stone or brick construction in Jifu Village; e, Destroyed old houses and standing
440 new buildings at Sale Town Primary School (site 7, Fig. 4b); f, Zhangmu after the earthquake with
441 few collapsed houses due to the brick structure or reinforced concrete construction.

56 The earthquake affected northern India, Pakistan, Bhutan, and the southern Tibetan
57 region of China. In China the tremors were felt in Xigazê and Lhasa to the north but
58 were strongest in the China-Nepal border area which is only about 40 km (Fig. 1, 2)
59 from the epicenter. The earthquake disaster caused 27 deaths, 856 injured, and 3
60 missing, and extensive damage in China (Fig. 3a). The affected people are about 30
61 thousand and the direct economic loss is more than 33,000 million Yuan (RMB).
62 Fortunately, the border area has a low population density and the earthquake occurred
63 in the afternoon when many were outside, otherwise the casualty and economic loss
64 would be much higher. Due to the rapid response of local government the affected
65 people were soon resettled in southern Tibet (Fig. 3b).

125 There was a variation of earthquake damage and seismic intensity between
126 different sites in the same affected area. The intensity IX appeared at some sites in
127 Zhangmu, Nyalam County and Jilong, Gyirong County equals the seismic intensity of
128 some parts of Kathmandu, while seismic intensity VIII appeared in other sites of the
129 same towns (Fig. 3c~f). This seems to be mainly because of differences in building
130 material and structure: most houses in the former are earlier self-built of blocks of stone
131 masonry or adobe structure without seismic resistance, while most houses in the latter
132 are newly built of cement-bonding stone or brick structure. For example, in Jifu Village
133 about 2.4 km south of Jilong, all houses built of stone block masonry were almost
134 completely destroyed, while most newly built ones of cement-bonded stone or brick are
135 still standing with only minor cracks in the walls (Fig. 3c~d), and the same situation

136 occurred at Sale Town Primary School (Fig. 3e).

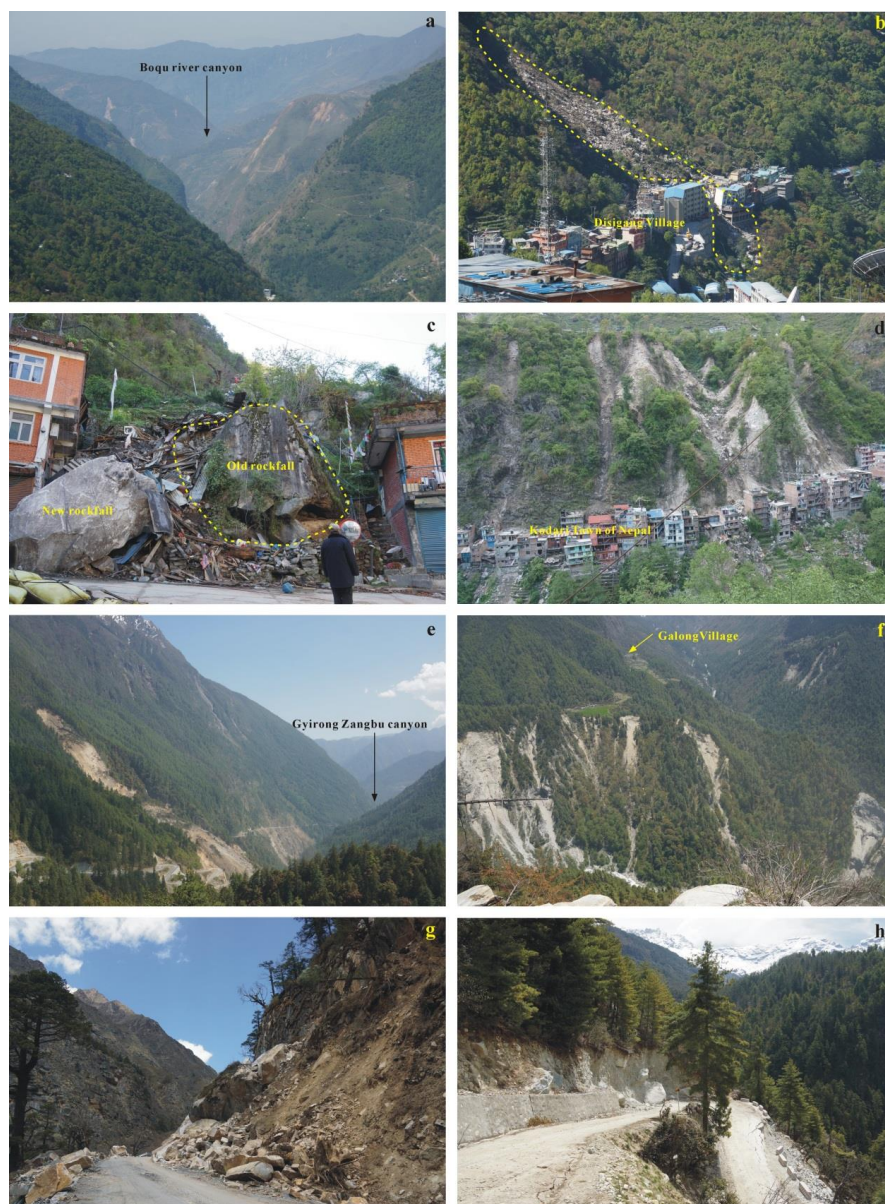
448
449 Fig. 5 Geologic effects caused during the Nepal earthquake: a, collapses in the Boqu valley; b,
450 collapse at Disigang Village (Site1, Fig. 4a); c. new and old rockfalls at Disigang Village (Site1, Fig.
451 4a); d, destroyed buildings in Kodari, Nepal (Site in Fig. 4a); e, large landslide in Chongse Village
452 (Site1, Fig. 4b); f, collapses in Galong Village(Site 7, Fig. 4b); g, collapses along highway from
453 Gyrong County to Jilong Town (Site 4, Fig. 4b); h, collapses and fissures along the highway from
454 Jilong to ChongseVillage (Site1, Fig. 4b).
455

161 collapse, landslide, and rockfall to increase towards Nepal along these valleys (Fig. 5a).
162 Remotely-sense images issued by Google Earth after the great earthquake show that the
163 Gyirong Zangbo valley and the Buqu River valley contain the maximum density and
164 scale of collapses and landslides. Moreover, some dammed lakes due to the collapse
165 rock and soil can be seen in these two valleys of Nepal. For example, in the Gyirong
166 Zangbo valley, a 0.07 km² dammed lake and a 0.04 km² dammed lake occur about 2.5
167 km north of and about 7.3 km southwest of Dhunche Village, respectively, whereas in
168 the Boqu River valley, a 0.24 km² dammed lake occurs on the north side of Dabi
169 Village.

170 (2) Geologic slips occur often in weak, soft or unstable geologic or geomorphic
171 positions: joint or fault-developed, high and steep bedrock cliffs and slopes (Fig. 5b, e);
172 high and steep slopes of Quaternary loose sediment forming river terraces, proluvial
173 fans, and kames (Fig. 5d, f); and unstable slope and highways roadcuts (Fig. 5g, h).

206 The Sale Village landslide induced by this earthquake occurred along the highway
207 slope from Sale Village to Seqiong Village. It is nearly 600,000 m³ in volume and had
208 blocked the road (Fig. 5b). Large tension fissures at its back edge indicate a danger of
209 further collapses (Fig. 7c).
