# Changes in ground deformation prior to and following a large urban landslide in La Paz, Bolivia, revealed by advanced InSAR

**Abstract.** We characterize and compare creep preceding and following the complex 2011 Pampahasi landslide ( $\sim 40 \text{ Mm}^3 \pm 50\%$ ) in the city of La Paz, Bolivia, using spaceborne RADAR interferometry (InSAR) that combines displacement records  
15 from both distributed and point scatterers. The failure remobilised deposits of an ancient complex landslide in weakly cemented, predominantly fine-grained sediments and affected  $\sim 1.5 \text{ km}^2$  of suburban development. During the 30 months preceding failure, about half of the toe area was creeping at 3-8 cm/a and localized parts of the scarp area showed displacements of up to 14 cm/a. Changes in deformation in the 10 months following the landslide demonstrate an increase in slope activity and indicate that stress redistribution resulting from the discrete failure decreased stability of parts of the slope.  
20 During that period, most of the landslide toe and areas near the headscarp accelerated, respectively, to 4-14 and 14 cm/a. The extent of deformation increased to cover most, or prob

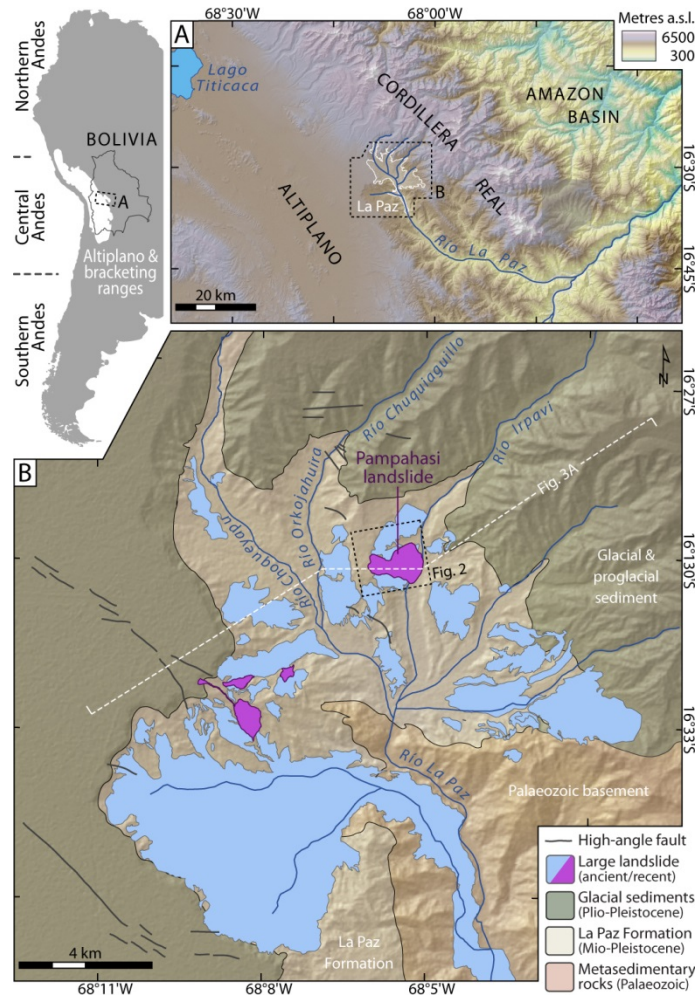
**Figure 1. Setting of La Paz, Bolivia. A.** Location and physiographic context. **B.** Generalized geology after Dobrovlny (1962) and Anzoleaga et al. (1977), with faults from Dobrovlny (1962) and Lavenu (1978). Terrain is from the ASTER GDEM 2 produced by METI and NASA.

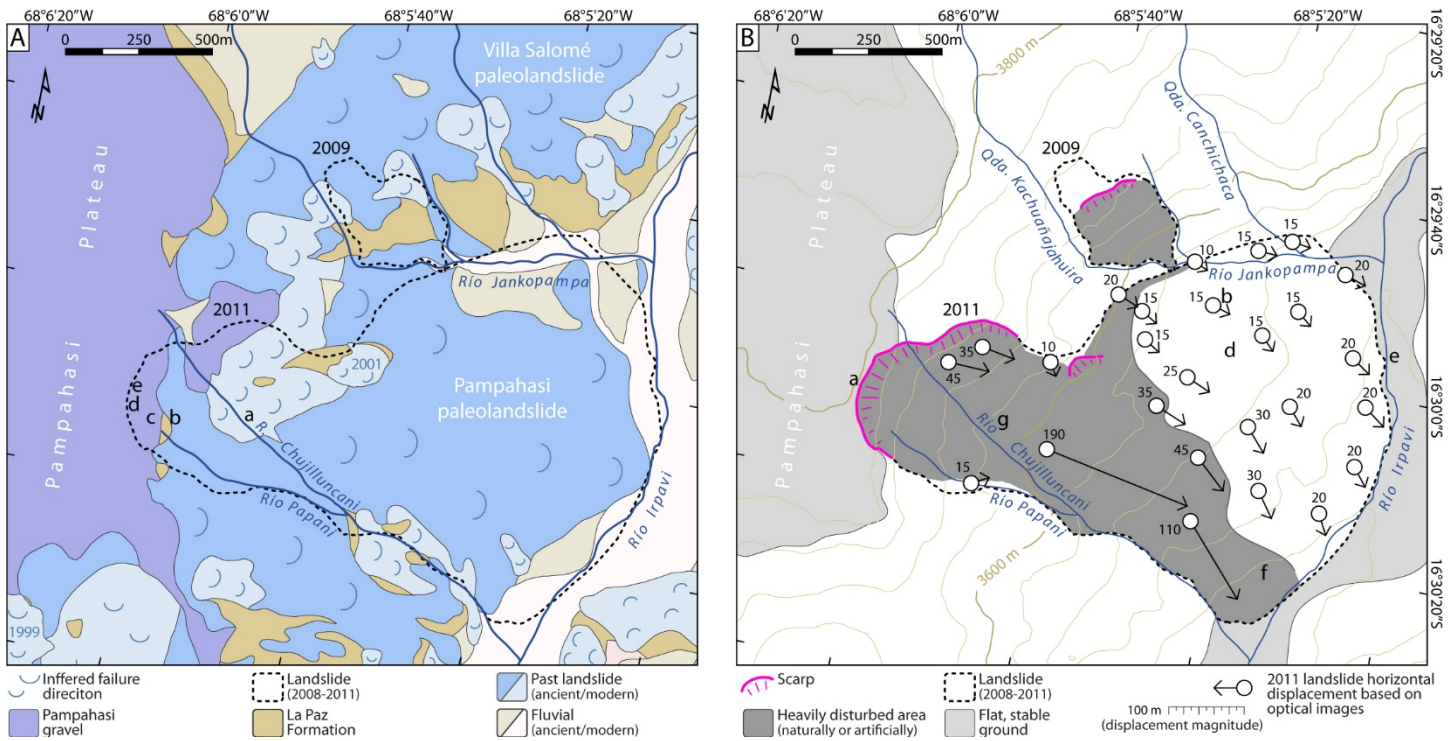
**Figure 2. Ground surface conditions in the Pampahasi area. A.** Surficial geology prior to the start of the twenty-first century; adapted from Anzoleaga et al. (1977). **B.** Slope morphology and ground disturbance showing the extent and morphologic features of landslides that occurred during the period of RADAR acquisition (September 2008 to December 2011). Horizontal displacements during the 2011 Pampahasi landslide are based on comparison of pre-failure and post-failure WorldView-2 scenes. Contours are from NASA's Shuttle RADAR Topographic Mission V3.0.

Many slopes descending from Pampahasi Plateau are mantled by ancient landslide deposits derived from the La Paz Formation (Dobrovolsky, 1962; Anzoleaga et al., 1977). The deposits consist of largely intact brittle blocks of La Paz Formation within a matrix of softer, ductile and completely disaggregated La Paz Formation. Small (<1 to 20 ha) failures evident in aerial photographs have occurred since at least the early twentieth century in many places within large (~20-200 ha) prehistoric failures. The slope descending ~380 m to Río Irpavi directly east of the southern half of Pampahasi Plateau comprises the undated Pampahasi paleolandslide (Fig. 2A).

The Pampahasi landslide<sup>1</sup> occurred at the end of February 2011 following a week of variable precipitation (0-39.2 mm daily, Fig. 4), which included one of the wettest days on record (25 February, Table S3). The ~1.5-km<sup>2</sup> failure remobilized a large part of the Pampahasi paleolandslide deposit between the east side of Pampahasi Plateau and Río Irpavi (Fig. 2). In addition to previously failed material, it included small volumes of in situ, weakly cemented La Paz Formation and, in the headscarp area, the overlying uncemented Pampahasi gravel (Fig. 2A). None of the sediments involved were substantially weathered.

The 2011 Pampahasi landslide occurred in several phases from the evening of 26 February to 1 March (Fig. 6, locations in Fig. 2B). Eyewitness accounts suggest that failure initiated in an area of earlier small slumps along Río Chujilluncani<sup>2</sup> (Hermanns et al., 2012; Fig. 5A) ~400 m downslope of the east margin of Pampahasi Plateau. Motion was fastest (up to several metres per second) and largely vertical in the head region, which failed shortly after, lasting one to two hours and forming a ~60°, 80-m-high headscarp (Fig. 6A). Movement in the central zone and at the toe, which began soon after the initial formation of the headscarp, was slower (metres per minute to metres per day) and largely horizontal. The degree of ground disturbance and the magnitude of displacement generally decreased to the east and north (Fig. 2B). The northern part of the landslide's toe experienced relatively limited, but economically costly, ground disturbance (e.g. Fig. 6B-D) and moved as a more-or-less coherent mass ~15 m southeastward (Fig. 2B). Deformation of the lower part of the landslide continued for days. A bridge across Río Irpavi (Fig. 6E) was shifted 10 m and uplifted on the morning of 27 February; uplift of several metres at the east end of the bridge suggests a rotational failure zone passing, at least locally, under Río Irpavi. Buildings near the south toe of the landslide (Fig. 6F) collapsed on 28 February and 1 March due to delayed, relatively minor translation.

The assumption of slope-parallel motion is likely incorrect in some parts of the Pampahasi area. The complex nature of the 2011 failure, particularly the variability in the displacement directions (Fig. 2B), suggests that separate masses may have moved obliquely relative to one another during pre-failure and post-failure creep. Localized compression or extension within  
10 the landslide would additionally impart vertical components of movement. Additional error is thus introduced in the conversion from measured one-dimensional (LOS) displacement to approximate three-dimensional (true) motion. Provided that the sense of movement at any given location on the slope has not substantially changed following the 2011 failure, LOS motion vectors record similarly scaled changes in the true rate of motion and thus reliably represent the degree of change in slope activity. Additionally, the close alignment between the RADAR LOS and the fall-line of the slope ensures that the

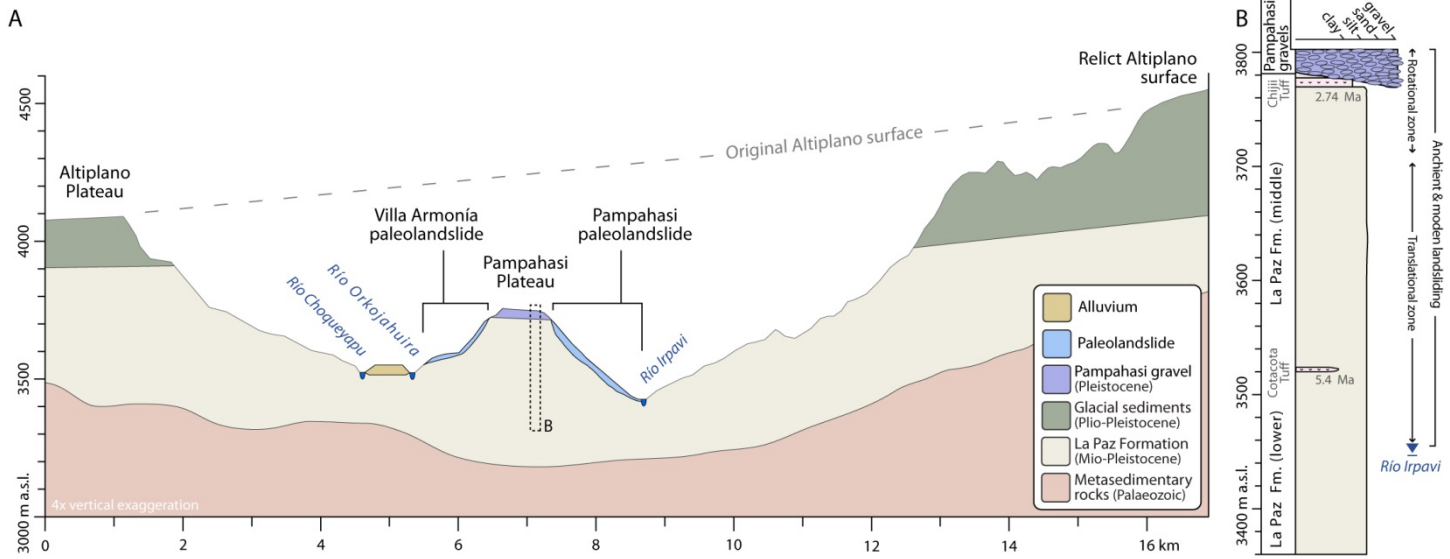
**Figure 3. Stratigraphic sequence.** **A.** Cross-section oblique to the trend of the Cordillera Real through the fill underlying the Altiplano (location in Fig. 1B). **B.** Lithostratigraphy beneath Pampahasi Plateau, including principle units involved in the Pamphasi paleolandslide and 2011 Pampahasi landslide. Modified from Anzoleaga et al. (1977) based on field mapping throughout the La Paz area.

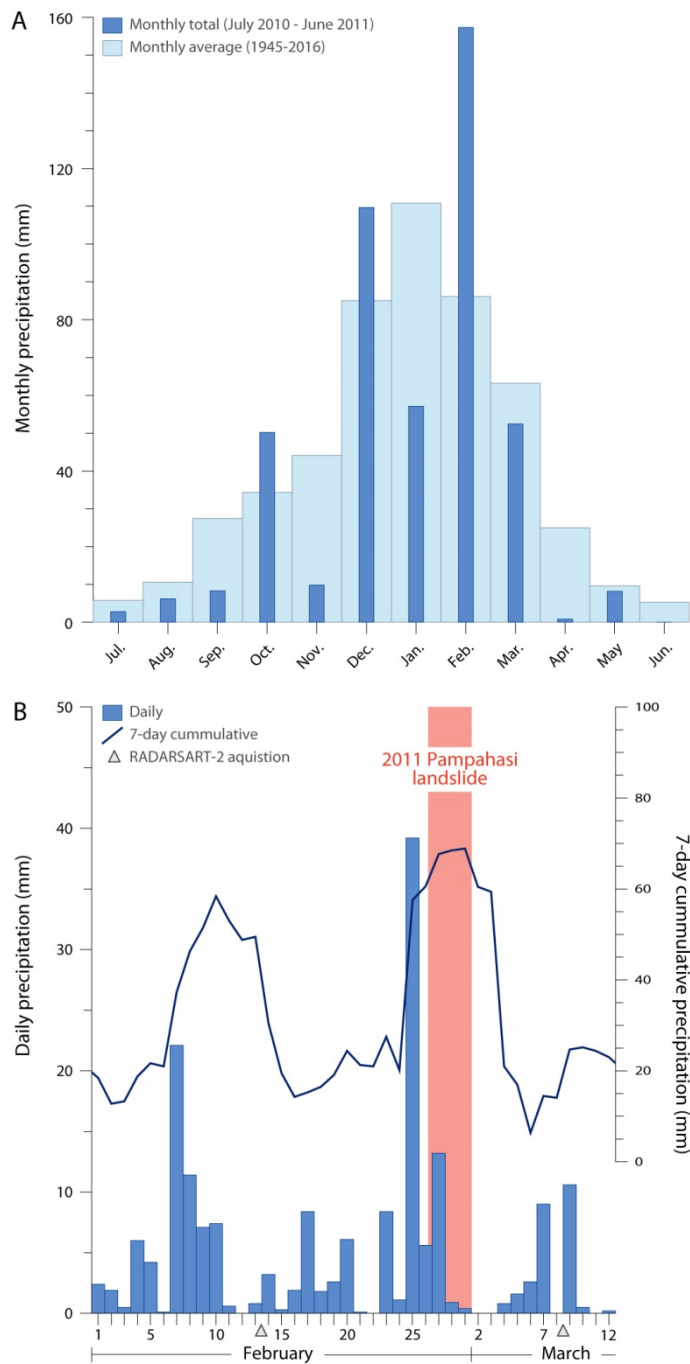
**Figure 4. The precipitation record for the Laykacota meteorological station (see Fig. S1 for station location). A.** Comparison of monthly average precipitation (1945-2016) with monthly precipitation for the second half of 2010 and first half of 2011. **B.** Daily precipitation and seven-day cumulative precipitation during February and early March 2011.

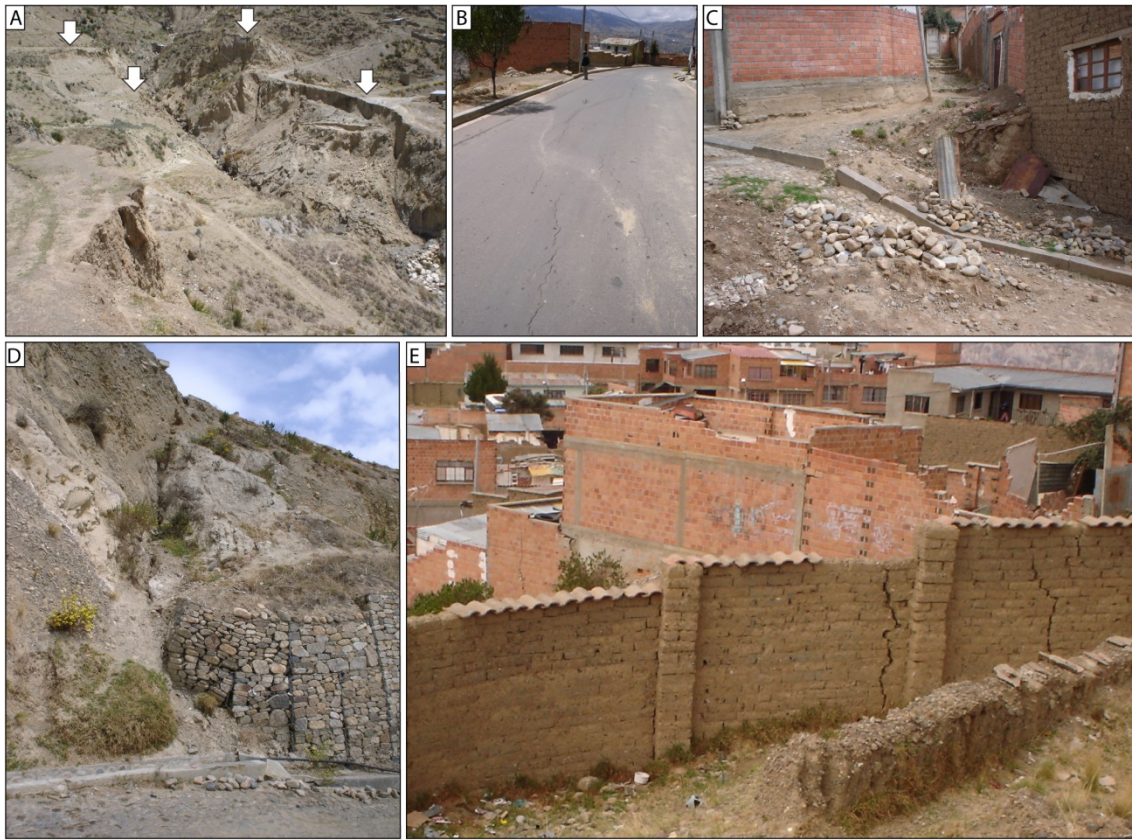
**Figure 5. Field evidence of pre-failure creep in what would become the head region of the 2011 Pampahasi landslide.** **A.** Small recent slumps (arrows) along Río Chujilluncani, ~400 m downslope from the east margin of Pampahasi Plateau. **B.** Minor cracking and centimeter-scale vertical offset of a paved road about 200 m east of, and 75 m below, the east margin of the plateau. **C.** Unpaved road with ~1 m displacement near the 2011 headscarp. **D.** Vertical offset along a gully ~75 m from the future south lateral margin of the 2011 landslide. The side of the gully nearer the middle of the 2011 landslide (right of the photo) has dropped ~0.5 m relative to the adjacent slope, causing deformation of the gabions and curb in the foreground. **E.** Cracks in an adobe wall (right foreground) and brick house (left middle ground) ~50 m downslope of the east margin of the plateau, corresponding to the middle of the 2011 landslide headscarp. See Figures 2A and 7A, B for locations of photographs. Photos taken by R.L. Hermanns in October 2005.

Several locations in the upper part of the slope showed field evidence of slow ground deformation, largely visible as offset walls and road surfaces (Fig. 5, locations in Fig. 2A) in the years prior to catastrophic failure (Quenta and Calle, 2005; Hermanns et al., 2012). These features were recognized as evidence of an impending landslide (Quenta and Calle, 2005), although not of the magnitude of the 2011 failure. In response, the Municipality of La Paz increased risk communication and installed concrete pillars to remediate what became the 2011 landslide headscarp (Hermanns et al., 2012). However, due to their localized and shallow nature, the stabilization efforts probably had little, if any influence on the stability of the slope or behaviour of the subsequent failure.

failure motion (9 cm/a LOS) was restricted to the upper portion of the future landslide where infrastructure damage had been documented in prior years (Fig. 5B, C). Aside from a small, slow-moving (0.5 cm/a LOS; 'vi') area, no motion is evident along the future landslide headscarp, including sites of localized deformation observed in 2005 (Fig. 5D, E) or on the plateau behind it ('vii'- 'x').

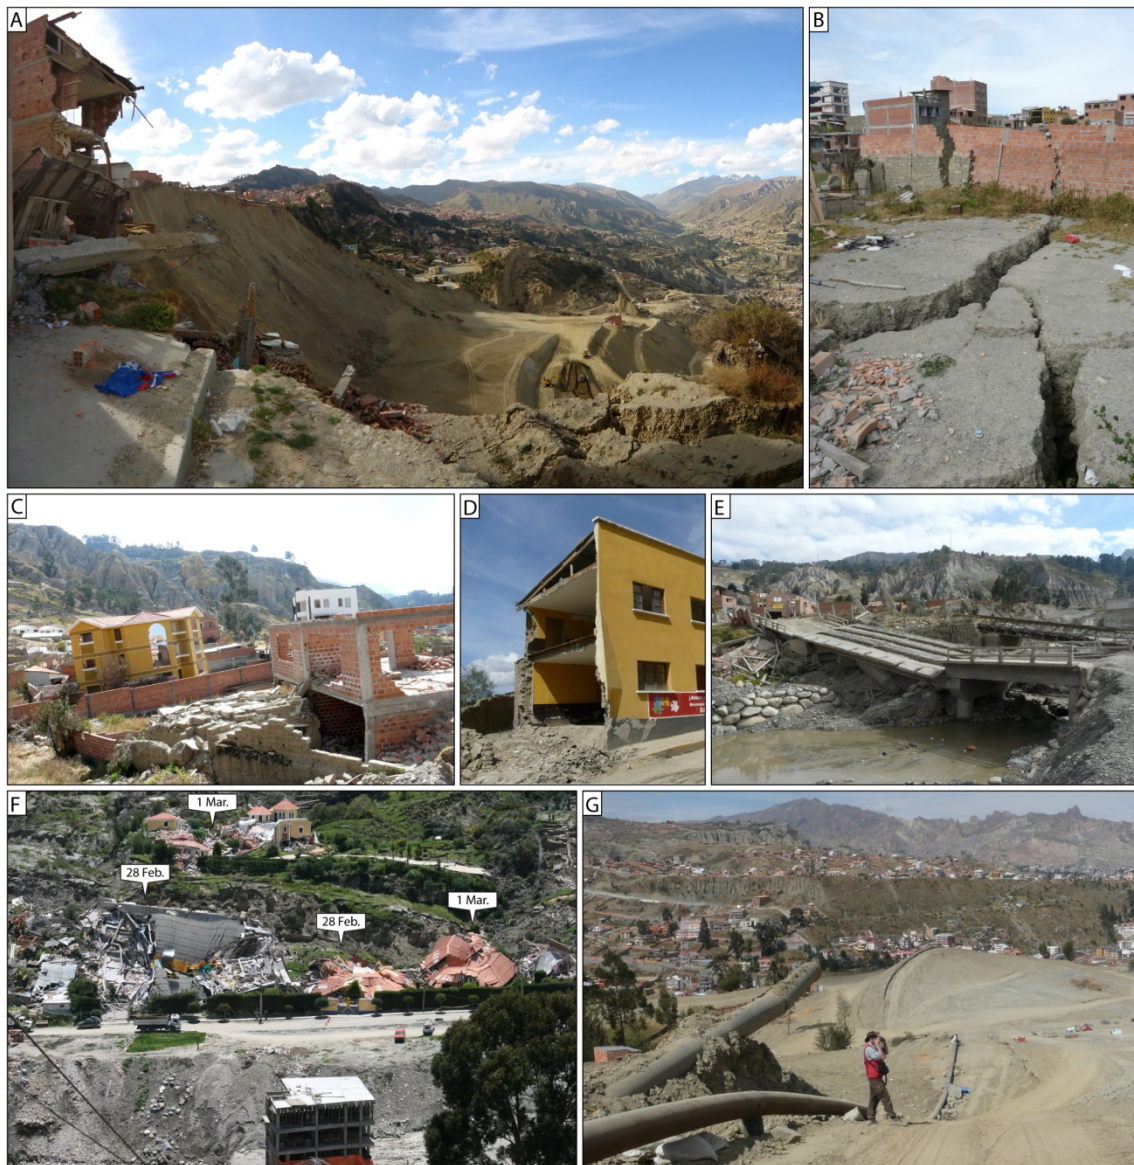
**Figure 6. Impacts of the 2011 Pampahasi landslide.** **A.** Headscarp (80 m height) along the east margin of Pampahasi Plateau (note excavator and trucks in lower middle ground for scale). **B.** Ground fissures in the northern part of the lower landslide mass. The wall in the background is ~2 m high. **C.** Back-tilted houses and apartment buildings on the northern part of the lower landslide mass (movement was from left to right). **D.** Community building with collapsed wall on the northern part of the lower landslide mass. **E.** Bridge across Río Irpavi that was deformed and shifted from its footings on 28 February near the centre of the landslide toe. **F.** Buildings on the southern part of the toe of the landslide that collapsed on 28 February and 1 March (dates of collapse shown; photo by M.A. Guzmán, 2 March 2011). **G.** Water service line ruptured by the landslide (upper pipe) and replacement water service line (lower pipe). See Figures 2B and 7C, D for locations of photographs. Photos taken by N.J. Roberts in May 2011 unless otherwise indicated.

10 The new displacements behind the headscarp and along the upper lateral margins of the 2011 landslide (Fig. 8B) gradually expanded over time into, respectively, the Pampahasi gravel (Fig. 9B) and paleolandslide deposits ('iv' and 'v' in Fig. 9A). Movement in the latter suggests post-failure reactivation of landslide material as a result of the 2011 landslide. Movements on the plateau are likely the result of dilation of the Pampahasi gravel in response to removal of material to a depth of up to 80 m along the 2011 headscarp (Fig. 6A).

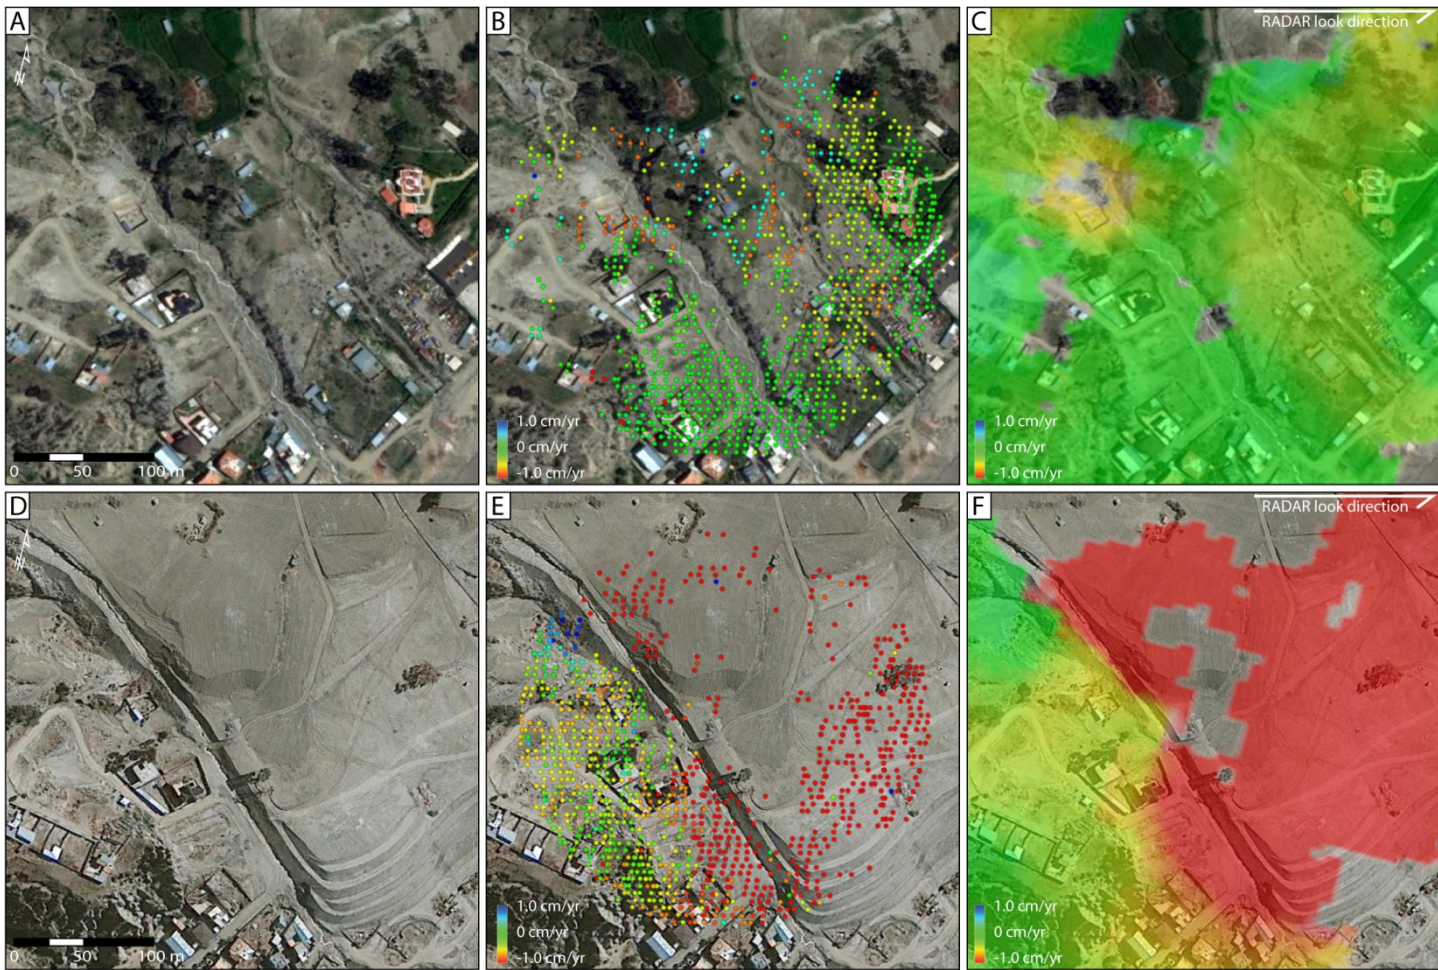
5 **Figure 7. Typical density and spacing of HDS-InSAR results for an area of mixed suburban, agricultural, and commercial development.** Both the pre-failure stack (A, B, C) and post-failure stack (D, E, F) are shown. Panels For each stack depict: satellite image showing land cover without InSAR data (A, D); point data representing HDS neighbourhoods (pixel neighbourhoods) (B, E), each recording a displacement time history; and linear displacement map interpolated from HDS points (C, F). Localized variability in HDS results is suppressed by linear deformation interpolation. Displacement rates are in the satellite line of sight. The deforming area is the southern boundary of the active part of the landslide toe (see Fig. 7 for location). Base image is a 4 January 2011 Quickbird image viewed in GoogleEarth™. Base images are from GoogleEarth ([A, B, C] 4 January 2011 and [D, E, F] 25 July 2011). See Fig. 8A, C for location.

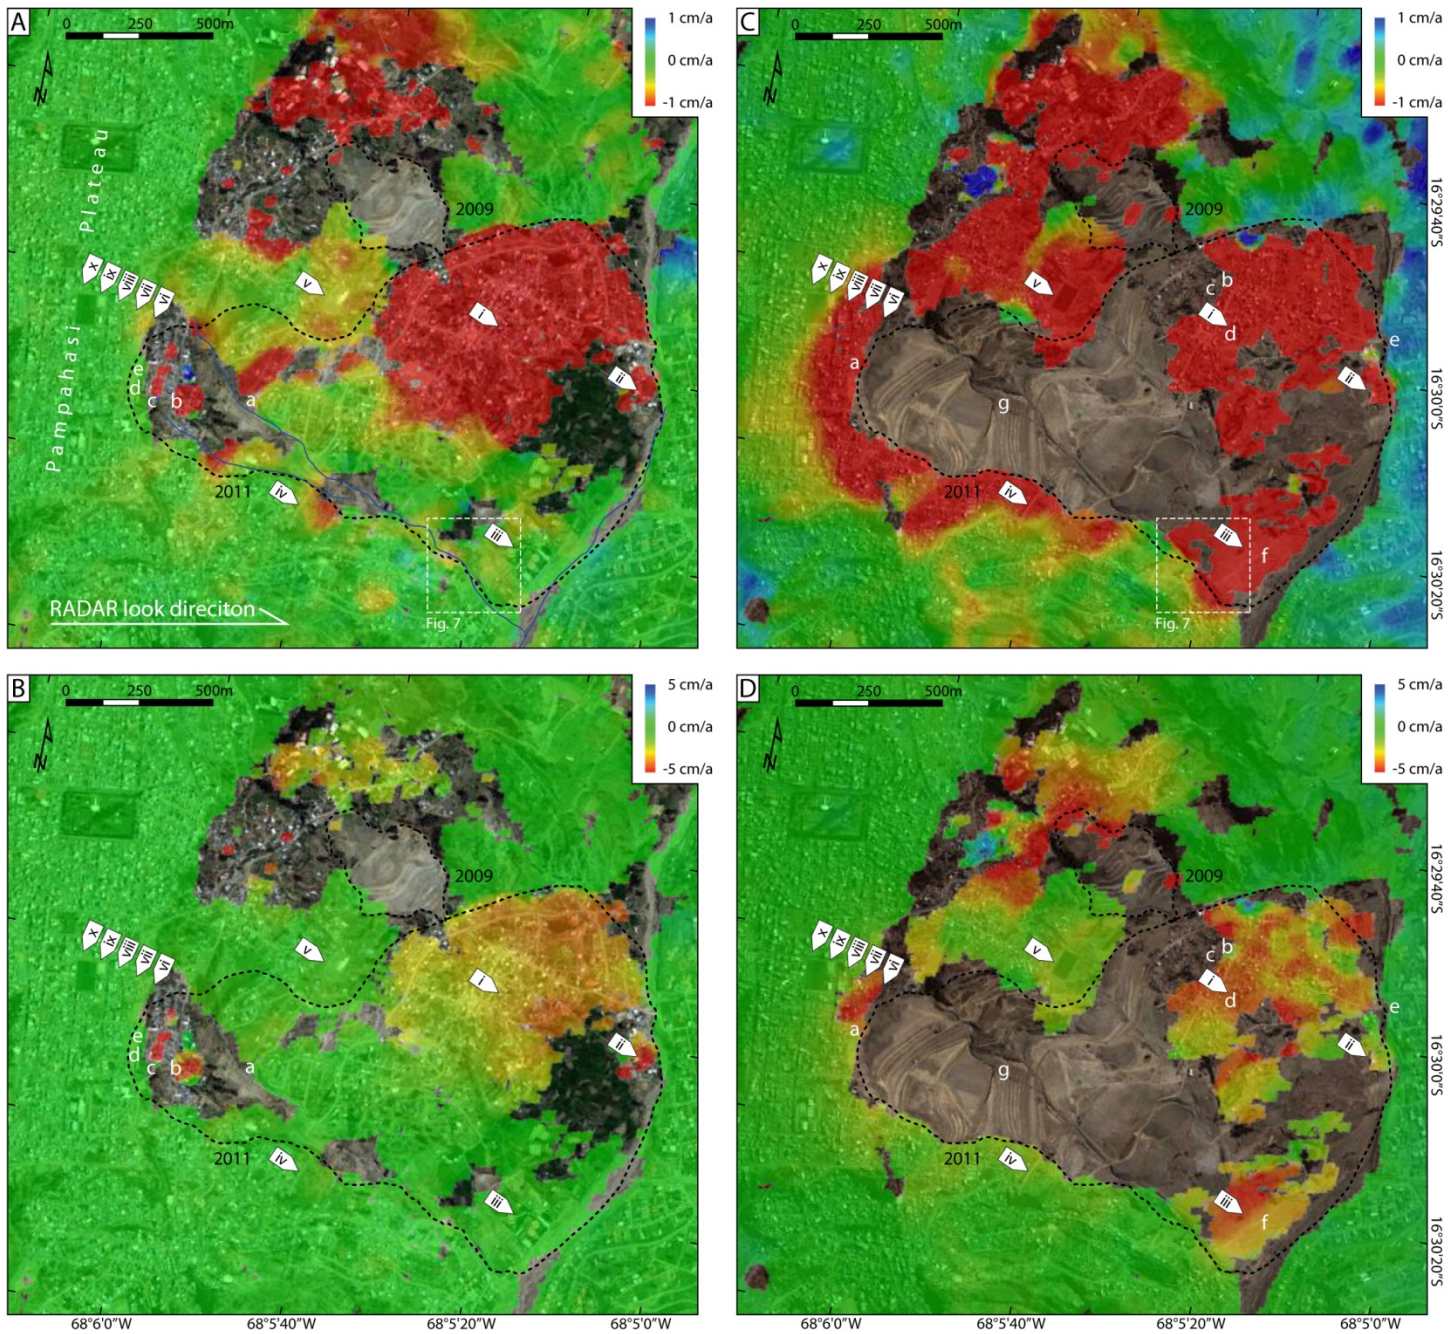
**Figure 8. InSAR-measured line-of-sight ground displacements in the Pampahasi area.** Average linear deformation rates during (A, B) the 30-month period before and (C, D) the 10-month period after the Pampahasi landslide. Compressed (-1 to 1 cm/a; A and C) and expanded (-5 to 5 cm/a; B and D) displacement scales emphasize, respectively, the spatial limits and spatial variability of slope activity. Dashed lines are the limits of landslides that occurred in 2009 and 2011 during the period of RADAR scene acquisition. Roman numerals

show locations of displacement histories in Figure 5. Letters show locations of photos taken, respectively, before (Fig. 5) and after (Fig. 6) the 2011 landslide. Base images are from GoogleEarth ([A, B] 4 January 2011 and [C, D] 25 July 2011).

20 The most striking change in ground motion following the 2011 failure is the development of a new area of creep several hundred metres wide fringing the head region of the landslide (Fig. 8C). This zone extends up to nearly 400 m beyond the headscarp on Pampahasi Plateau, in one place reaching the opposite margin of the plateau surface. The magnitude of creep decreases steadily away from the headscarp ('vi'- 'x' in Figs. 8C, D, and 9B). This zone of new deformation extends hundreds of metres down both lateral margins.

5 The failing slope has many interconnected components that are largely within, but also extend locally beyond, the Pampahasi paleo-landslide (Fig. 11A). Slope morphology before and after the 2011 landslide shows that long-term failure occurs predominantly by complex rotational-translational sliding (Fig. 11B). Differing displacement behaviour of several zones within the slope indicate separate, although likely interacting, kinematic components. The northern part of the Pampahasi slope toe consists of an apparently competent mass that crept uniformly at rates of 2-5 cm/a LOS prior to late February 10 2011 (Fig. 8B) and moved more-or-less coherently during the 2011 landslide (Fig. 2B). This block-like mass accelerated slightly to 3-6 cm/a LOS following the 2011 failure and displayed a more spatially variable pattern of deformation (Fig. 8D) suggesting partial break-up during the failure event. The resulting removal of toe support – rapidly during the 2011 landslide, but otherwise gradually – likely drove creep of the 12-ha zone of paleo-landslide material ('v') directly upslope (to the northwest). Although not part of a historic landslide event (Fig. 2), this zone was creeping slowly (~0.5 cm/a LOS, Fig. 8A) 15 prior to the 2011 failure and accelerated thereafter (>1 cm/a LOS, Fig. 8C).

A 1-ha zone near the midline of the landslide toe ('ii') is one of the few locations of decreased post-failure activity (Fig. 10). Its high, localized activity prior to the 2011 landslide (5-8 cm/a LOS, Fig. 8C) suggests a shallow failure driven by incision at a location where Río Irpavi impinges on the toe of the slope (Fig. 2B). This localized activity is probably similar to the east-bank landslide mapped by Anzoleaga et al. (1977) ~ 400 m farther upstream, opposite the Río Jankopampa confluence 20 (Fig. 8A), which was creeping throughout the entire period of RADAR monitoring (Fig. 8). Decreased post-failure activity of the small west-bank instability may reflect local modification of the Río Irpavi channel by the 2011 landslide and subsequent channel remediation efforts, or it may result from post-failure stress reorganization. Several similar, linear areas of decreased post-failure creep along the toe of the 2011 landslide as far north as Río Jankopampa (Fig. 10) may represent similar conditions.

25 The southern part of the toe of the paleo-landslide ('iii'), which was stationary prior to the 2011 Pampahasi landslide (Fig. 8A), reactivated following the failure (Fig. 8C). Although the exact cause of the reactivation is uncertain, it is clearly a result of forces imposed on the toe of the paleo-landslide by the 2011 event and may be related to consequent adjustment of stream erosion along the east margin of the deposit. Creep in this area was greatest directly upslope of the place where several buildings collapsed (Fig. 6F) in the final days (February 28 and March 1) of the landslide event, suggesting that delayed 30 infrastructure damage there relates to the transition from the failure event to the new post-failure instability regime.

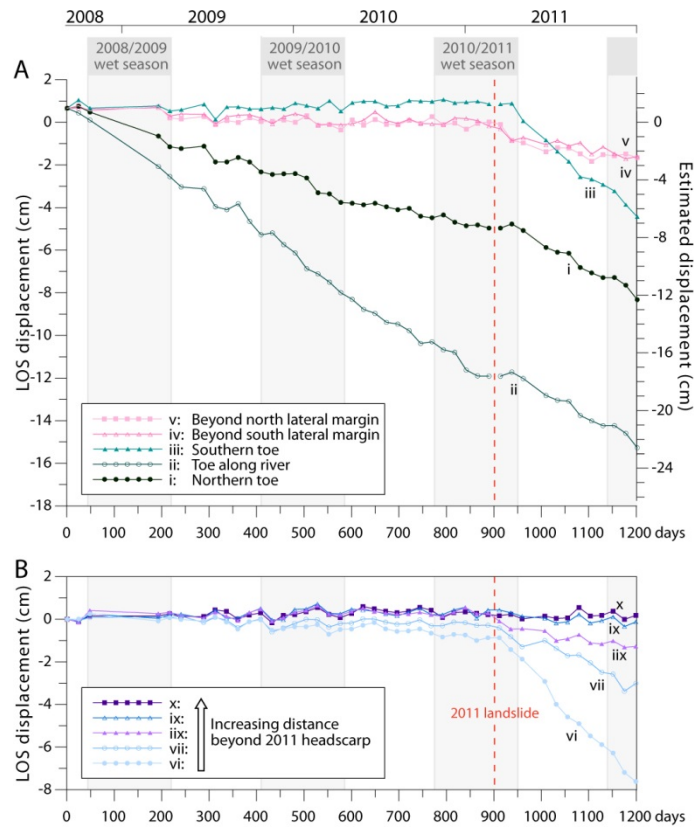
**Figure 9. Displacement time series from the Pampahasi area (locations ‘i’ to ‘x’ in Fig. 8).** **A.** Movement of the west slope of the Río Irpavi valley within the area affected by the 2011 landslide (i-iii) and adjacent paleolandslide deposits (iv-v). The right axis is approximate, given that additional error is introduced from conversion from LOS to true motion. **B.** Movement on Pampahasi Plateau behind the headscarp of the 2011 landslide (vi-x). Variability in the data, which is most pronounced in parts of the time series with low displacement rates, indicates phase noise resulting from factors unrelated to ground motion. Displacements between the end of the pre-failure stack and the start of the post-failure stack are not precisely constrained within the limits of the 2011 landslide (i-iii). For the Pampahasi slope adjacent to the 2011 failure and for the Pampahasi Plateau, displacements between the stacks are based on results of full-stack processing (see Supplement, section 4.8).

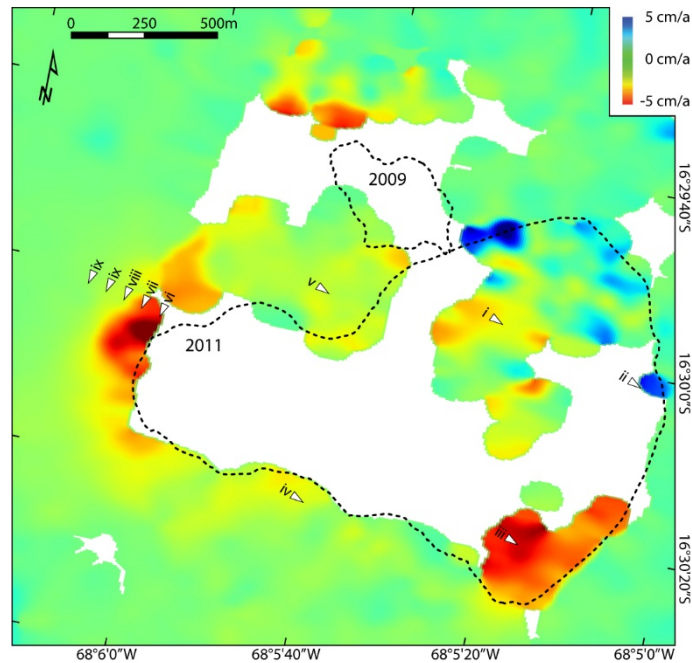
5 **Figure 10. Change in line-of-sight slope creep of the Pampahasi area following the 2011 failure relative to pre-failure creep.** Positive and negative values indicate, respectively, decreased and increased post-failure displacement rates away from the satellite. Green areas experienced no change in displacement and were largely stable both before and after the 2011 landslide. White areas lacked coherence phase in pre-failure scenes, post-failure scenes, or both. Roman numerals show locations of displacement histories in Figure 5. Pre-failure and post-failure imagery spans, respectively, 08 September 2008 to 13 February 2011 and 09 March 2011 to 22 December 2011.

25 All portions within the 2011 landslide area where coherence was maintained in both InSAR stacks and most areas within several hundred metres of the landslide experienced post-failure changes in slow ground motion (Fig. 10). The changes largely involved increased motion away from the satellite of between 2 cm/a and at least 5 cm/a LOS. Only a few small areas (totaling < 4 ha) in the northeast part of the toe, which were creeping at 4 cm/a LOS or more prior to February 2011, slowed following failure.

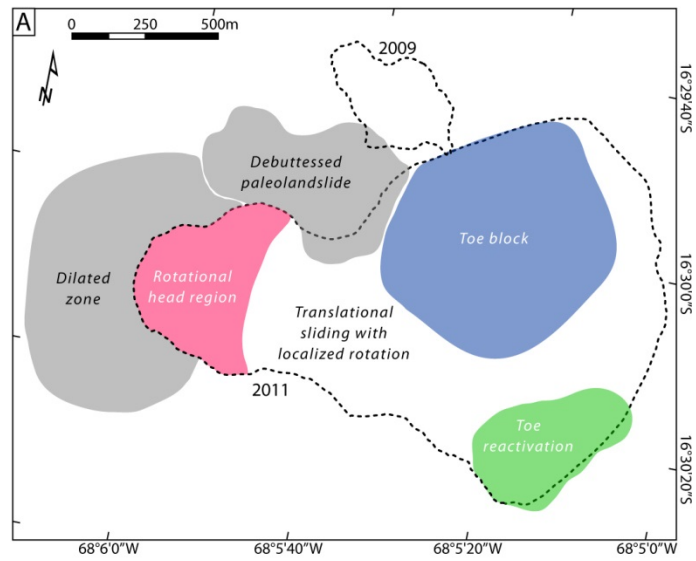
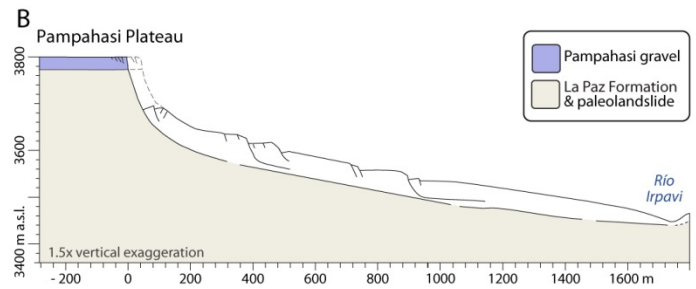
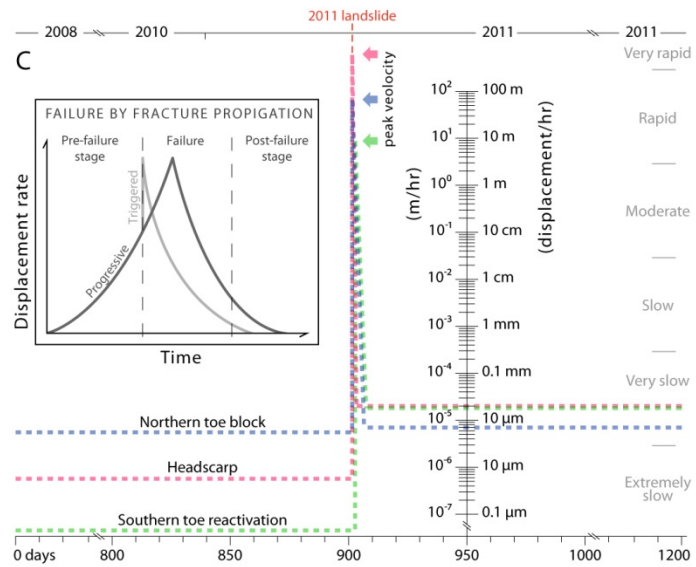
**Figure 11. Proposed geomechanical model for the Pampahasi landslide and adjacent terrain. A.** Components of failure, which differ in kinematics and activity history. **B.** Generalized section through the failing slope illustrating the approximate depth and attitude of the failure zone. The topographic surface is based on NASA's Shuttle RADAR Topographic Mission V3.0, which depicts the generalized pre-failure terrain. Dashed and solid line work in the source area (0 to ~150 m x-axis distance) represent, respectively, pre-failure topography and post-failure topography based on terrain changes measured in the field using a handheld laser rangefinder. Terrain lower on the failed slope changed comparatively little during the landslide; solid line work beyond ~150 m x-axis distance is thus generally representative of both the pre-failure and post-failure topography. **C.** Schematic temporal displacement history generalized from InSAR measurements bracketing the 2011 Pampahasi landslide and eyewitness accounts. Due to the revisit frequency of RADARSAT-2 (24 days), the lack of acceleration leading up to the 2011 Pampahasi landslide is based on the lack of such effects reported by local residents. Velocity classes are from Cruden and Varnes (1996), spanning all classes except for 'extremely rapid' (>5 m/s). Triangles denote timing of RADARSAT-2 acquisitions (dates provided in Table S4). Inset shows schematic stages of slope movement during first-time failure by fracture propagation (after Hermanns and Longva, 2012).

The height and steepness of the 2011 landslide headscarp indicates a deep-seated basal failure zone in the upper slope (Fig. 11B). Neither the paleolandslide nor the 2011 failure align with documented faults (Dobrovlny, 1962; Lavenu, 1978; Fig. 1B) that might indicate a structural control. A lack of displacement records for the head region following the 2011 landslide limit inferences about post-failure behaviour. However pre-failure records, although incomplete, provide some insight into localized activity. Displacements within the head region prior the landslide and the lack of movement in adjacent steep paleolandslide scarps suggest that pre-failure creep was part of the ongoing slope failure, rather than localized instability resulting only from steep slopes. Localized, small-scale slumping occurred lower in the head region along Río Chujilluncani ('a' in Fig. 8A, B) adjacent to, or potentially within, a region of pre-failure creep (~1 cm/a LOS), supporting eyewitness accounts suggesting that the 2011 landslide initiated there.

were greatest in the source area (Fig. 11B). Temporal soil moisture variability is unlikely to affect phase by more than  $100^\circ$  (Rabus et al., 2010), which equates to approximately one-third of an interferometric fringe or 0.9 cm for the sensor used here. Comparison of precipitation records in the 30 months before and 10 months after the 2011 Pampahasi landslide indicates that long-term precipitation amounts during the pre-failure and post-failure stacks were comparable (Fig. S2; Table  
5 S3). Spatial moisture gradients are a more substantial error source (Rabus et al., 2010), but major differences present in a single scene are removed during stack processing.
