Changes in ground deformation prior to and following a large urban landslide in La Paz, Bolivia revealed by advanced InSAR

Abstract. We characterize and compare creep preceding and following the 2011 Pampahasi landslide ($\sim 40 \text{ Mm}^3 \pm 50\%$) in the city of La Paz, Bolivia, using spaceborne RADAR interferometry (InSAR) that combines displacement records from both distributed and point scatterers. The failure remobilised deposits of an ancient landslide in weakly cemented, predominantly fine-grained sediments and affected $\sim 1.5 \text{ km}^2$ of suburban development. During the 30 months preceding failure, about half of the toe area was creeping at 3-8 cm/a and localized parts of the scarp area showed displacements of up to 14 cm/a. Changes in deformation in the 10 months following the landslide are contrary to the common assumption that stress released during a discrete failure increases stability. During that period, most of the landslide toe and areas near the headscarp accelerated, respectively, to 4-14 and 14 cm/a. The extent of deformation increased to cover most, or probably all, of the 2011 landslide as well as adjacent parts of the slope and plateau above. Th

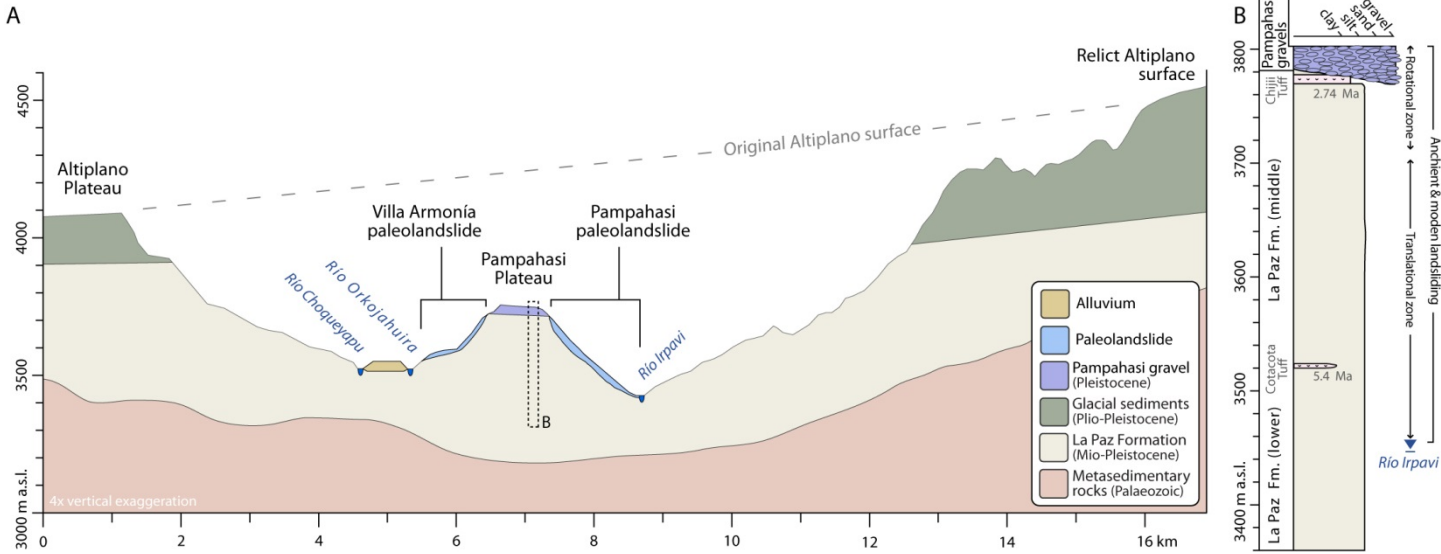
Figure 3. Stratigraphic sequences. **A.** Cross-section oblique to the trend of the Cordillera Real through fills underlying the Altiplano (location in Fig. 1B). **B.** Lithostratigraphy beneath Pampahasi Plateau, including principle units involved in the Pamphasi paleolandslide and 2011 Pampahasi landslide. Modified from Anzoleaga et al. (1977) based on field mapping throughout the La Paz area.

Pampahasi Plateau, measuring 2.2 km long by 0.2-0.7 km wide, forms part of the interfluvium between ríos Chuquiaguillo and Irpavi (Fig. 1B). Its margins are generally scalloped (Fig. 2) and in several places terminate in nearly vertical cliffs dropping 20-80 m to irregular, locally steep valley slopes below. The plateau surface dips slightly southward and lies at an elevation several hundred metres below the local southwest-dipping Altiplano and its erosional remnants (Fig. 3A).

of the city (Lavenu et al., 1989), and the 2.74-Ma Chijini Tuff (Roberts et al., 2017), which crops out along the west margin of the plateau (Dobrovlny, 1962) between 3800 and 3850 m a.s.l. The local Altiplano surface formed atop the thick sequence of Plio-Pleistocene glacial sediments by 1.8 Ma or possibly as recently as 1.0 Ma (Roberts et al., 2018), attaining an elevation of approximately 4200 m a.s.l. in the vicinity of Pampahasi (Fig. 3A).

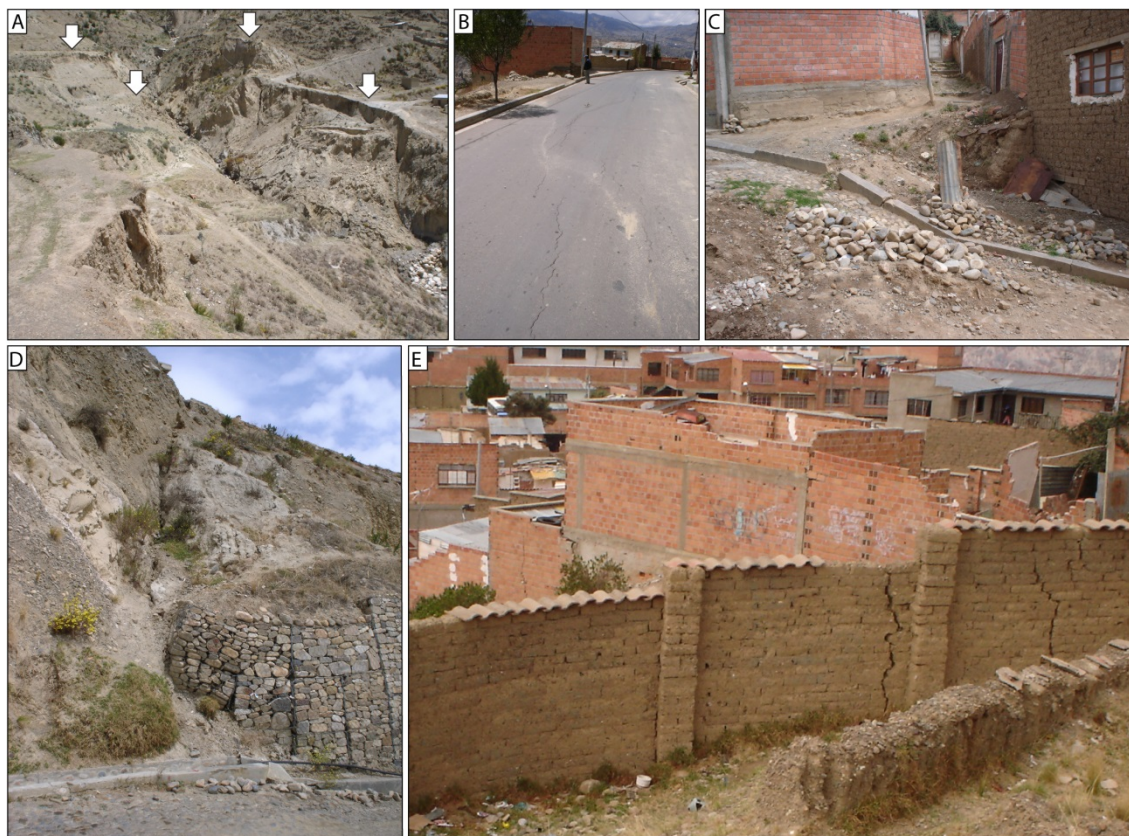
Figure 4. Field evidence of pre-failure creep in what would become the head region of the 2011 Pampahasi landslide. **A.** Small recent slumps (arrows) along Río Chujilluncani, ~400 m downslope from the east margin of Pampahasi Plateau. **B.** Minor cracking and centimeter-scale vertical offset of a paved road about 200 m east of, and 75 m below, the east margin of the plateau. **C.** Unpaved road with ~1 m displacement near the 2011 headscarp. **D.** Vertical offset along a gully ~75 m from the future south lateral margin of the 2011 landslide. The side of the gully nearer the middle of the 2011 landslide (right of the photo) has dropped ~0.5 m relative to the adjacent slope, causing deformation of the gabions and curb in the foreground. **E.** Cracks in an adobe wall (right foreground) and brick house (left middle ground) ~50 m downslope of the east margin of the plateau, corresponding to the middle of the 2011 landslide headscarp. See Figures 2A and 7A, B for locations of photographs. Photos taken by R.L. Hermanns in October 2005.

Several locations in the upper part of the slope showed field evidence of slow ground deformation, largely visible as offset walls and road surfaces (Fig. 4; locations in Fig. 2A) in the years prior to catastrophic failure (Quenta and Calle, 2005; Hermanns et al., 2012). These features were recognized as evidence of an impending landslide (Quenta and Calle, 2005), although not of the magnitude of the 2011 failure. In response, the Municipality of La Paz increased risk communication and conducted localized remedial engineering works (Hermanns et al., 2012). However, due to their localized and shallow nature, the stabilization efforts probably had little, if any influence on the stability of the slope or behaviour of the subsequent failure.

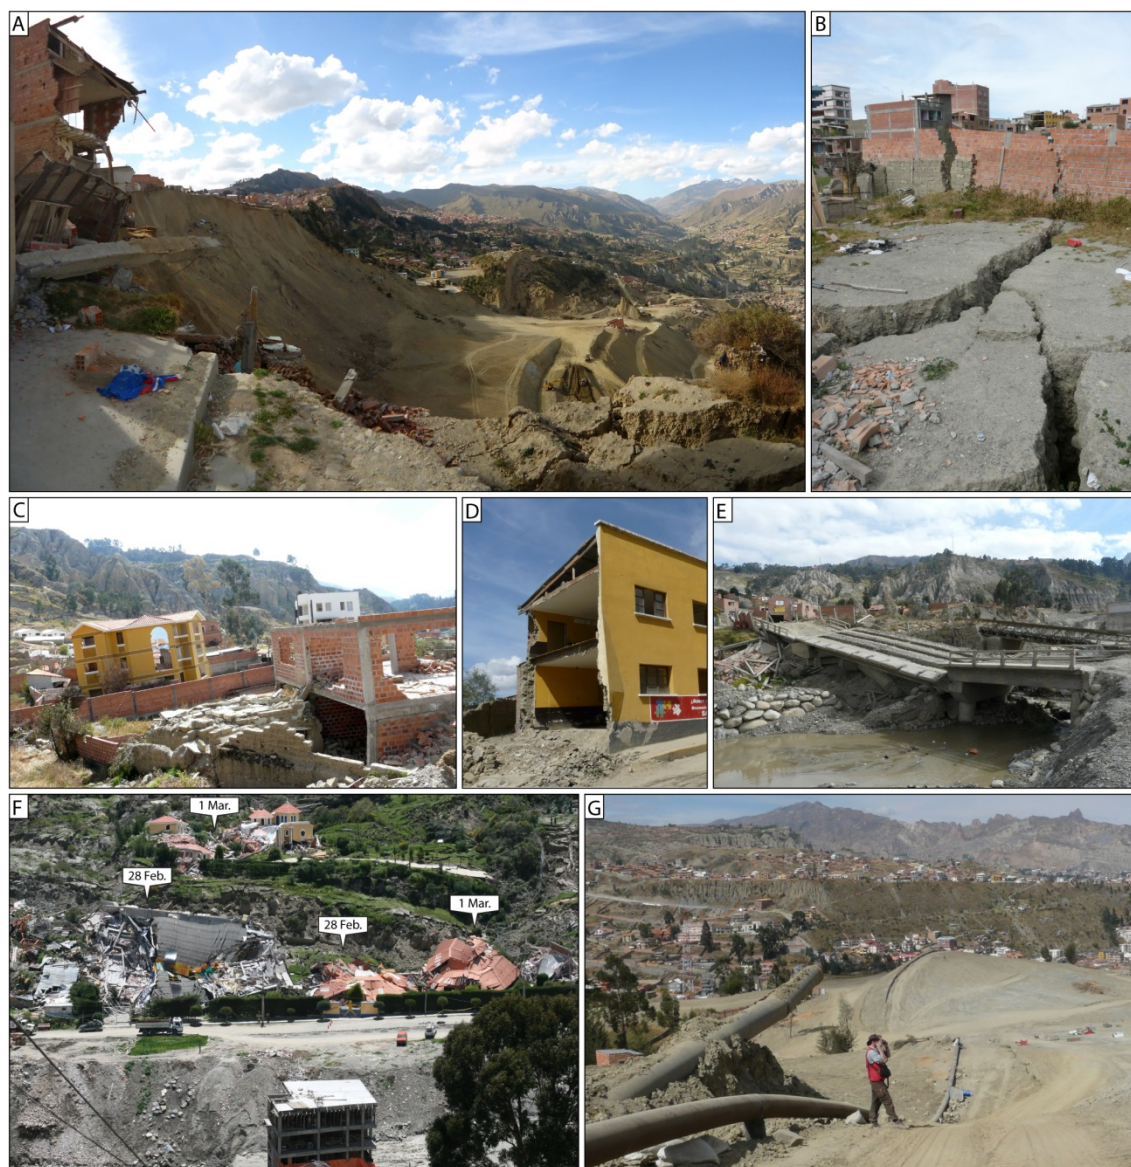
Figure 5. Impacts of the 2011 Pampahasi landslide. **A.** Headscarp (80 m height) along the east margin of Pampahasi Plateau (note excavator and trucks in lower middle ground for scale). **B.** Ground fissures in the northern part of the lower landslide mass. The wall in the background is ~2 m high. **C.** Back-tilted houses and apartment buildings on the northern part of the lower landslide mass (movement was from left to right). **D.** Community building with collapsed wall on the northern part of the lower landslide mass. **E.** Bridge across Río Irpavi that was deformed and shifted from its footings on 28 February near the centre of the landslide toe. **F.** Buildings on the southern part of the toe of the landslide (that collapsed on 28 February and 1 March (dates of collapse shown; photo by M.A. Guzmán, 2 March 2011)). **G.** Water service line ruptured by the landslide (upper pipe) and replacement water service line (lower pipe). See Figures 2B and 7C, D for locations of photographs. Photos taken by N.J. Roberts in May 2011 unless otherwise indicated.

The 2011 Pampahasi landslide occurred in several phases from the evening of 26 February to 1 March (Fig. 5; locations in Fig. 2B). Eyewitness accounts suggest that failure initiated in an area of earlier small slumps along Río Chujilluncani (Hermanns et al., 2012; Fig. 4A) ~400 m downslope of the eastern margin of Pampahasi Plateau. Motion was fastest (up to several metres per second) and largely vertical in the head region, lasting one to two hours and forming a ~60°, 80-m-high headscarp (Fig. 5A). Movement in the central zone and at the toe, which began soon after the initial formation of the headscarp, was slower (metres per minute to metres per day) and largely horizontal. The degree of ground disturbance and the magnitude of displacement generally decreased to the east and north (Fig. 2B). The northern part of the landslide's toe experienced relatively limited, but economically costly, ground disturbance (e.g. Fig. 5B-D) and moved as a more-or-less coherent mass ~15 m southeastward (Fig. 2B). Deformation of the lower part of the landslide continued for days. A bridge across Río Irpavi (Fig. 5E) was shifted 10 m and uplifted on the morning of 27 February; uplift of several metres at the east end of the bridge suggests a rotational failure zone passing, at least locally, under Río Irpavi. Buildings near the south toe of the landslide (Fig. 5F) collapsed on 28 February and 1 March due to delayed, relatively minor translation.

The new displacements behind the headscarp and along the upper lateral margins of the 2011 landslide (Fig. 7B) gradually expanded over time into, respectively, the Pampahasi gravel (Fig. 8B) and paleolandslide deposits ('iv' and 'v' in Fig. 8A). Movement in the latter suggests post-failure reactivation of landslide material as a result of the 2011 landslide. Movements on the plateau are likely the result of dilation of the Pampahasi gravel in response to removal of material to a depth of up to 80 m along the 2011 headscarp (Fig. 5A).

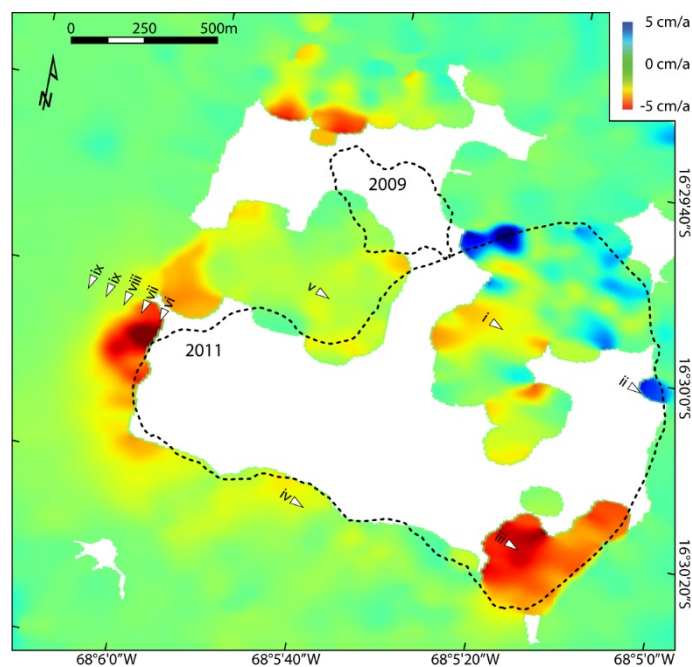
Figure 9. Change in line-of-sight slope creep of the Pampahasi area following the 2011 failure event. Positive and negative values indicate, respectively, decreased and increased post-failure displacement rates away from the satellite. Green areas experienced no change in displacement, and were largely stable both before and after the 2011 landslide. White areas lacked coherence phase in pre-failure scenes, post-failure scenes, or both. Roman numerals show locations of displacement histories in Figure 5.

All portions within the 2011 landslide area where coherence was maintained in both InSAR stacks and most areas within several hundred metres of the landslide experienced post-failure changes in slow ground motion (Fig. 9). The changes largely involved increased motion away from the satellite of between 2 cm/a and at least 5 cm/a LOS. Only a few small areas (totaling < 4 ha) in the northeast part of the toe, which were creeping at 4 cm/a LOS or more prior to February 2011, slowed following failure.

- 10
- 15 A 1-ha zone near the midline of the landslide toe ('ii') is one of the few locations of decreased post-failure activity (Fig. 9). Its high, localized activity prior to the 2011 landslide (5-8 cm/a LOS; Fig. 7C) suggests a shallow failure driven by incision at a location where Río Irpavi impinges on the toe of the slope (Fig. 2B). This localized activity is probably similar to the east-bank landslide mapped by Anzoleaga et al. (1977) ~ 400 m farther upstream, opposite the Río Jankopampa confluence (Fig. 7A), which was creeping throughout the entire period of RADAR monitoring (Fig. 7). Decreased post-failure activity of the small west-bank instability may reflect local modification of the Río Irpavi channel by the 2011 landslide and subsequent channel remediation efforts, or it may result from post-failure stress reorganization. Several similar, linear areas of decreased post-failure creep along the toe of the 2011 landslide as far north as Río Jankopampa (Fig. 9) may represent similar conditions.

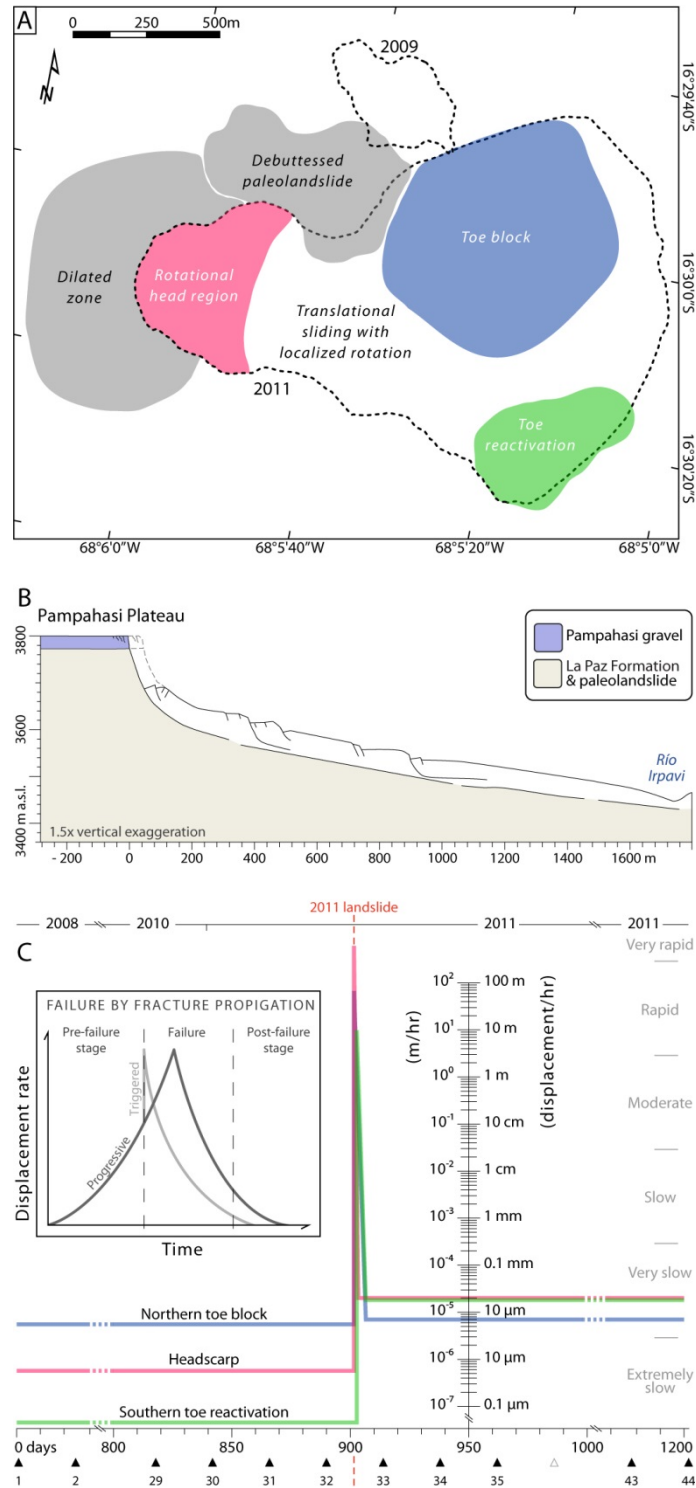
Figure 10. Proposed geomechanical model for the Pampahasi landslide and adjacent terrain. **A.** Components of failure, which differ in kinematics and activity history. **B.** Generalized section through the failing slope illustrating the approximate depth and attitude of the failure zone. Topographic surface based on NASA's Shuttle RADAR Topographic Mission V3.0. **C.** Approximate temporal displacement history based on InSAR measurements bracketing the 2011 Pampahasi landslide and eyewitness accounts. Due to the revisit frequency of RADARSAT-2 (24 days), the lack of acceleration leading up to the 2011 Pampahasi landslide is based on the lack of such effects reported by the slope's residents. Velocity classes are from Cruden and Varnes (1996), spanning all classes except for 'extremely rapid' (>5 m/s). Triangles denote timing of RADARSAT-2 acquisitions (dates provided in Table S4). Inset shows schematic stages of slope movement during first-time failure by fracture propagation (after Hermanns and Longva, 2012).

- 5 The failing slope comprises multiple interconnected components (Fig. 10A). Slope morphology before and after the 2011 landslide indicates that long-term failure is predominantly by complex rotational-translational sliding (Fig. 10B). Differing displacement behaviour of several zones within the slope indicate separate, although are likely interacting, kinematic components. The northern part of the Pampahasi slope toe consists of an apparently competent mass that crept uniformly at rates of 2-5 cm/a LOS prior to late February 2011 (Fig. 7B) and moved more-or-less coherently during the 2011 landslide (Fig. 2B). This block-like mass accelerated slightly to 3-6 cm/a LOS following the 2011 failure and displayed a more spatially variable pattern of deformation (Fig. 7D) suggesting partial break-up during the failure event. The resulting removal of toe support – rapidly during the 2011 landslide, but otherwise gradually – likely drove creep of the 12-ha zone of paleolandslide material directly upslope (to the northwest). Although not part of a historic landslide event (Fig. 2), this zone was creeping slowly (~0.5 cm/a LOS; Fig. 7A) prior to the 2011 failure and accelerated thereafter (>1 cm/a LOS; Fig. 7C).

The height and steepness of the 2011 landslide headscarp indicates a deep-seated basal failure zone in the upper slope (Fig. 10B). Neither the paleolandslide nor the 2011 failure align with documented faults (Dobrovlny 1962; Lavenu, 1978; Fig. 1B) that might indicate a structural control. A lack of displacement records for the head region following the 2011 landslide limit inferences about post-failure behaviour. However pre-failure records, although incomplete, provide some insight into localized activity. Displacements within the head region prior the landslide and the lack of movement in adjacent steep paleolandslide scarps suggest that pre-failure creep was part of the ongoing slope failure, rather than localized instability resulting only from steep slopes. Localized, small-scale slumping occurred lower in the head region along Río Chujilluncani ('a' in Fig. 7A, B) adjacent to, or potentially within, a region of pre-failure creep (~1 cm/a LOS), supporting eyewitness accounts suggesting that the 2011 landslide initiated there.
