Integrated risk assessment due to slope instabilities at the roadway network of Gipuzkoa, Basque Country

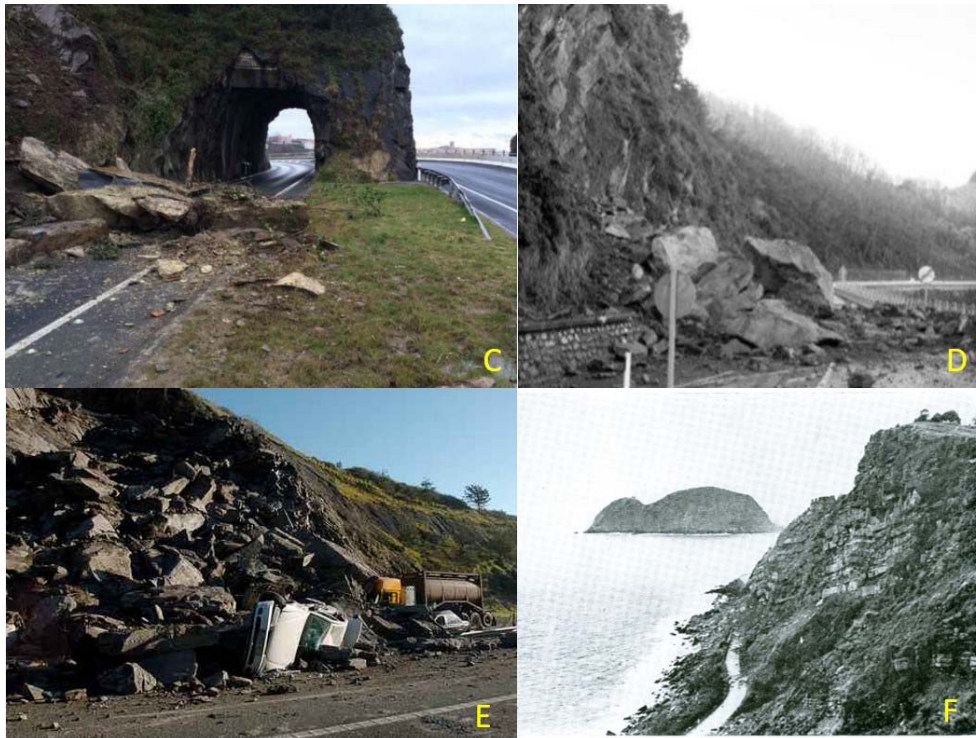
Figure 3: Examples of rockfall magnitudes (C, D, E, and F) in the study area, in relation to the classes of Table 2 (source: photo D, E: Javi Colmenero; F: Servicio Geológico de Obras Públicas)

Rockfalls are a major threat at the roads of Gipuzkoa. The rockfall hazard magnitude is classified according to the volume of the detached mass. Figure 3 shows representative examples of different rockfall magnitudes. A frequency or probability of occurrence is attributed to each volume class and the extent of disruption of the transportation corridor is determined.

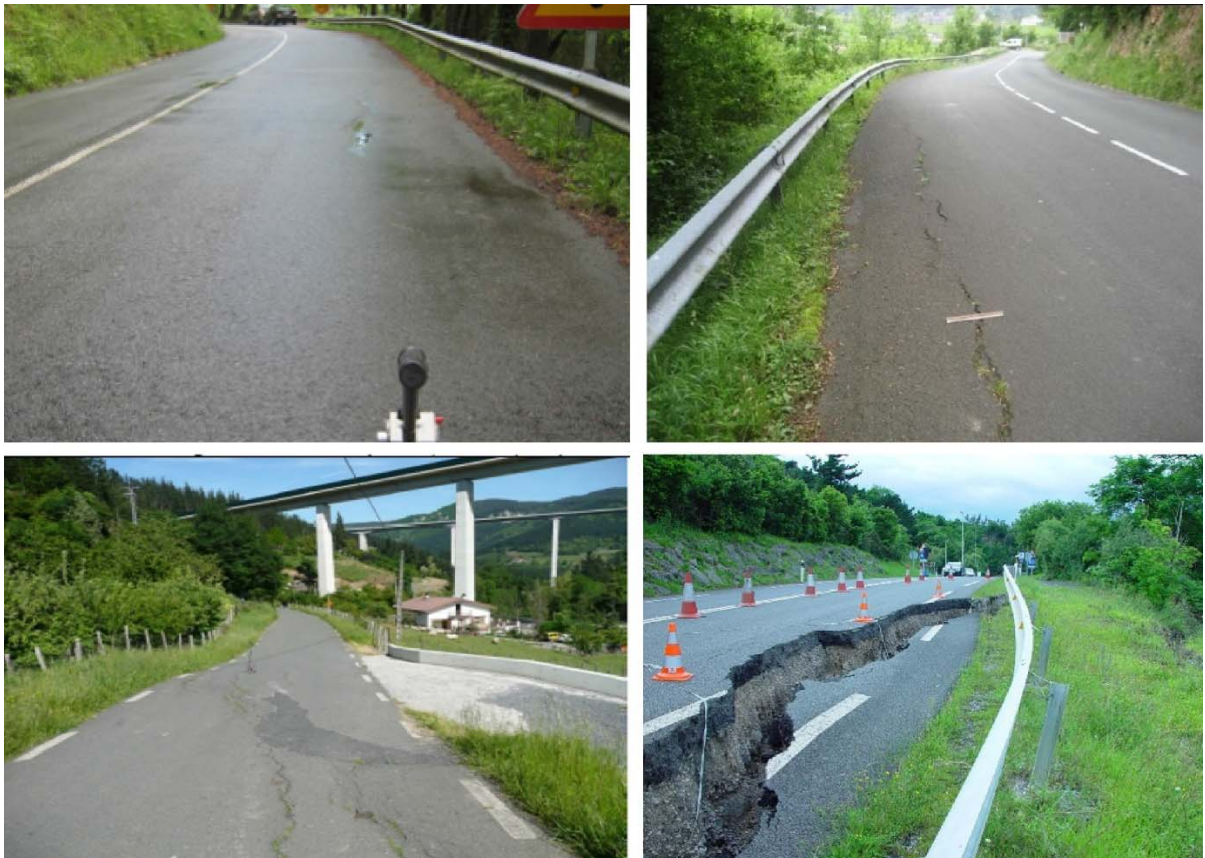
Figure 5: The four damage levels identified at the roads of Gipuzkoa: (top-left) No/Slight damage, (top-right) Moderate damage, (down-left) Severe damage, and (down-right) Partial/total destruction.

In the case study, horizontal velocity data is available from the inclinometer measurements. After 2010, deformation readings are constantly taken, every 3 months. In that sense, although the monthly velocity measurements have a limited precision, they can provide certain information on the landslide movement patterns. We inspected the in-situ damage, in order to establish the relation between the velocity and the road damage. Four levels were identified, as shown in Figure 5 and described qualitatively in the following:

- Damage level A (landslides of low intensity): There are rarely cracks and deformations. No speed reduction is required while driving. Crack sealing and resurfacing is periodically performed for periods longer than 1 year.

- Damage level B (landslides of moderate intensity): Damage includes pavement deformation and cracks and/or roadside destruction, without affecting the functioning of the road. If proper signalling is present, the chance of an accident is very low. Traffic conditions can be normally maintained if regular sealing and resurfacing is performed, until a more permanent solution.

- Damage level C (landslides of high intensity): Pavement deformation is substantial, including the presence of steps and puddles, and partial rupture of the platform affecting partly or entirely traffic lanes and/or the roadside. The normal functioning of the road is disturbed. Traffic is not interrupted, although restrictions such as alternative pass and traffic lights regulation are required. Accidents might occur if the vehicles enter the affected zone, without previous signalization. The normalization of the traffic conditions requires slope stabilization and road repair.

- Damage level D (landslides of very high intensity): Displacements are of the same order of magnitude as for level C, however with the vertical component prevailing giving place to complete destruction and loss of the pavement continuity. This situation is typical for roads situated on the crest or on the boundaries of landslides. The operation of the road is seriously affected. There is a high likelihood of an accident due to vehicles falling into the generated depressions. Important stabilization works and reconstruction of the road are required.

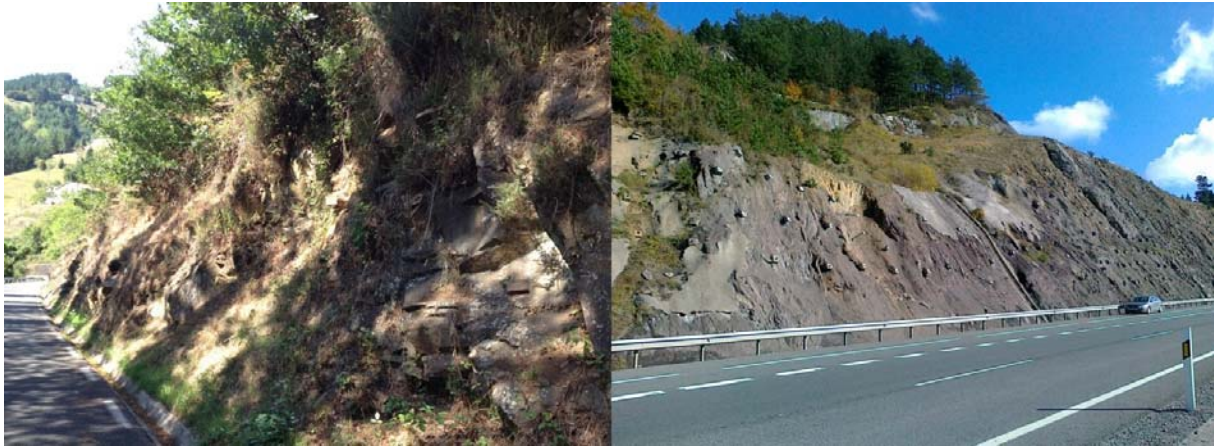
5 **Figure 7: (left) PoR L1C of the road GI-3324 (from km 0.700 to 1.450), without protection measures; (right) PoR P4C of the road N-1 (km 407.395 to 407.680) with protection measures.**

For the PoR P4C, a similar procedure was followed. For I_P : Moderate, $I_{DC} > 0.16$, I_E : No, I_{FP} : 4, and I_{SMR} : 0-40, I_F results equal to 5, which corresponds to an annual frequency of events equal to 0.2. This frequency is distributed to the magnitude classes: 0.08 for A, 0.09 for B, 0.01 for C, 0.01 for D and 0.01 for E. In this case, a correction is applied on the annual frequency. Considering that the slope is partially protected by gunite and bolts in a bad state of maintenance, and that a ditch with width smaller than 5 m exists, the summative frequency correction factors for the two types of measures from Table 6 are 0.45 and 0.2 for magnitudes A and B. For higher magnitudes, the existing protection measures are not considered to be efficient. The annual frequencies per size after correction are 0.03, 0.07, 0.01, 0.01, 0.01 for A, B, C, D and E, respectively, which after multiplication with the correspondent

UC and summing, they result in a higher total annual risk than the previous one, and equal to 3.05. The higher risk is owing to the existence of bigger rock blocks which cannot be retained by the actual protection measures.

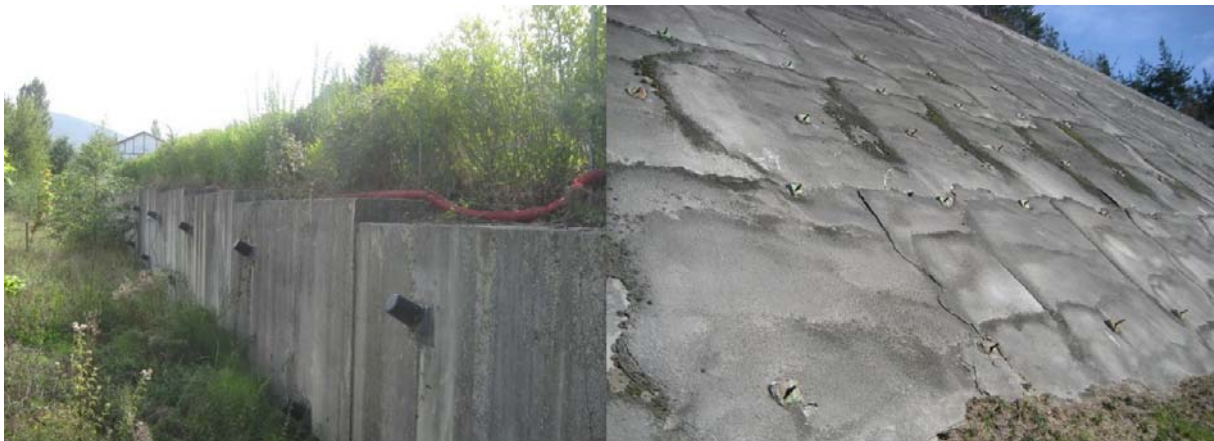
Figure 8: (left) PoR P2A of the road AP-8-1-1 (from km 77.140 to 77.210) where the crest of the slope and the retaining wall with anchors is seen; (right) C8A of the road G-2634 (32.980 to 33.150) with gunite, rock bolts, and anchors.

works for the reinforcement of this slope were performed between 1992 and 1993, with 8 strips of gunite, 5 m tall each one. Every strip includes 4 rows of bolts, except the lowest one which has 5 rows and the crest which does not have any. The load cells indicate that presently several bolts are overloaded. The rock mass is slightly to moderately weathered over the entire slope. The maximum volume that has been estimated to be unstable is 21,800 m³.

The parameters that have been used for C8A are (Figure 7, right): Safety Factor <1.30 (it is not known for this case) (5 points), working load >65% of the ultimate load (5 points), grout length >1.2m/10 t (1 point) and anchorage on a slight to moderate weathered rock (3 points). Although data exist for some anchors, it is not available for all of them, which is penalized assuming the respective value of “no” in Table 6. Construction was performed with technical assistance. The initially calculated HI is 3.67. As the bolt pressure increase is greater than 65% of the ultimate load (up to 80%), the HI is increased by 2 and it is 5.667 which corresponds to an estimated failure probability of 0.82. This value was calculated according to Table 7, after fitting a power law curve to the HI and the probability threshold values mentioned therein. As the wall height is $H > 6$ m and the affected road length is 111 m the total cost is 1343.1 UC and the risk is 1,101.34, which is substantially higher than the previous one, as a consequence of the higher hazard in this section.

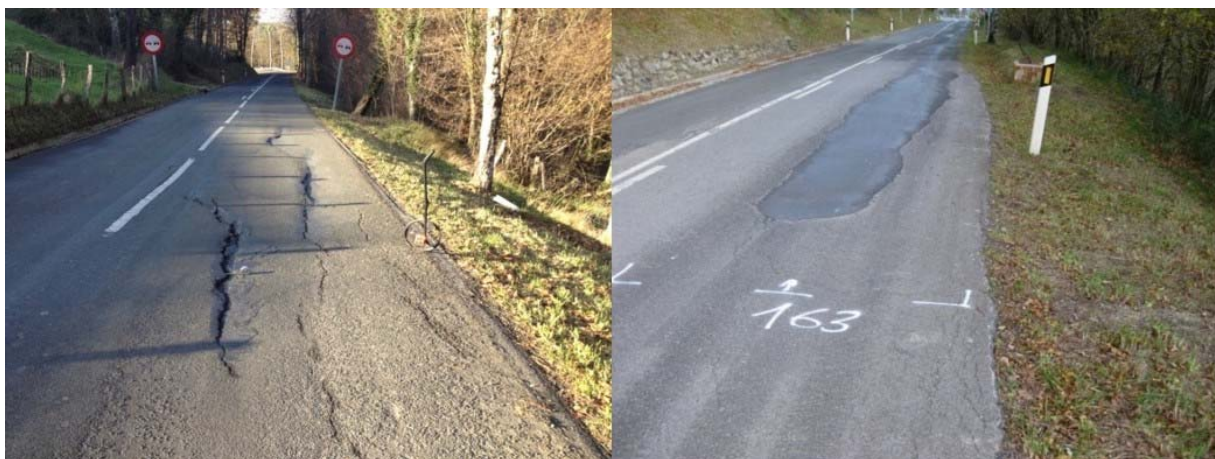
Figure 9: Road sections situated within slow moving landslides, with damage: (left) PoR C3C of the road GI-2133 (from km 8.280) with observed deformations and cracks on the road pavement; (right) PoR C9G of the road GI2637 (from km 17.891 to 18.220) showing minor cracks already sealed.

The soil instability affecting the C9G is ought as well to colluvial soil accumulations of 3-4 meters depth, over the bedrock. There are visible settlements and the ditches are deformed. The landslide is instrumented with two inclinometers that indicate that it is active.

The inclinometer measurements indicate vertical displacements lower than 2-3 mm and cumulative displacement lower than 30 mm, which points to a movement pattern of type X. There is not any scarp or developed shear displacements. Accordingly the probability of exceeding low damage is 1, moderate damage is 0.05 and high damage is 0.005. As previously, the probability is calculated for high damage: 0.005, for moderate damage: 0.045, and for low damage: 0.5, which for total a length of 300 m, and the same as previously costs, gives a total risk of 10.84.
