Integrated risk assessment due to slope instabilities at the roadway network of Gipuzkoa, Basque Country

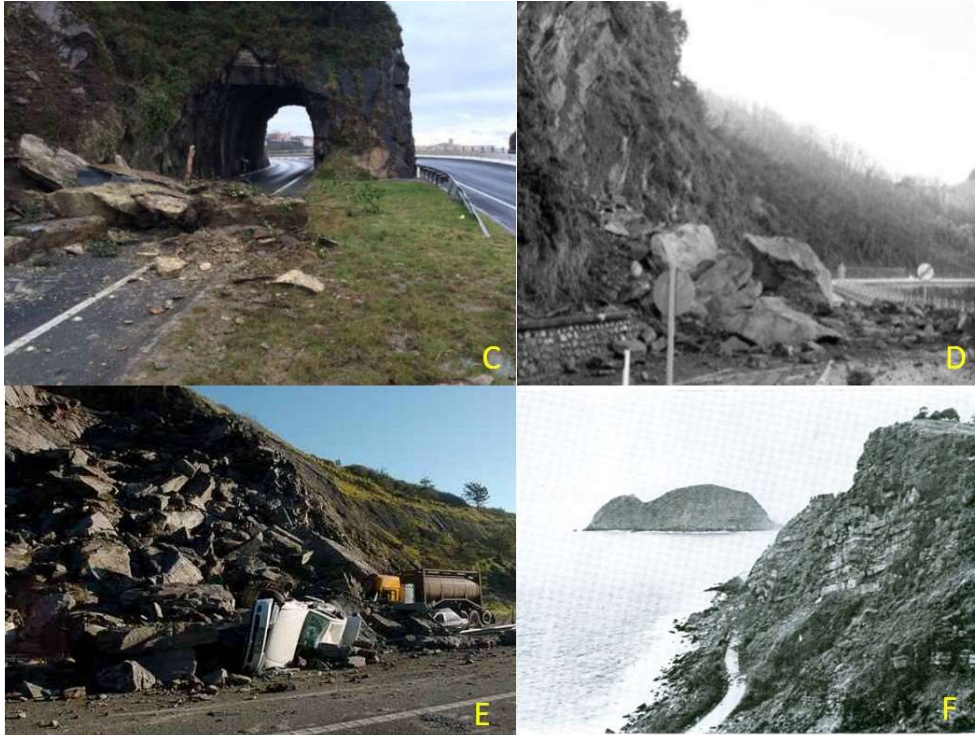
Figure 3: Examples of rockfall magnitudes (C, D, E, and F) in the study area, in relation to the classes of Table 2 (source: photo D, E: Javi Colmenero; F: Servicio Geológico de Obras Públicas)

Rockfalls are a major threat at the roads of Gipuzkoa. The rockfall hazard magnitude is classified according to the volume of the detached mass. Figure 3 shows representative examples of different rockfall magnitudes. A frequency or probability of occurrence is attributed to each volume class and the extent of disruption of the transportation corridor is determined.

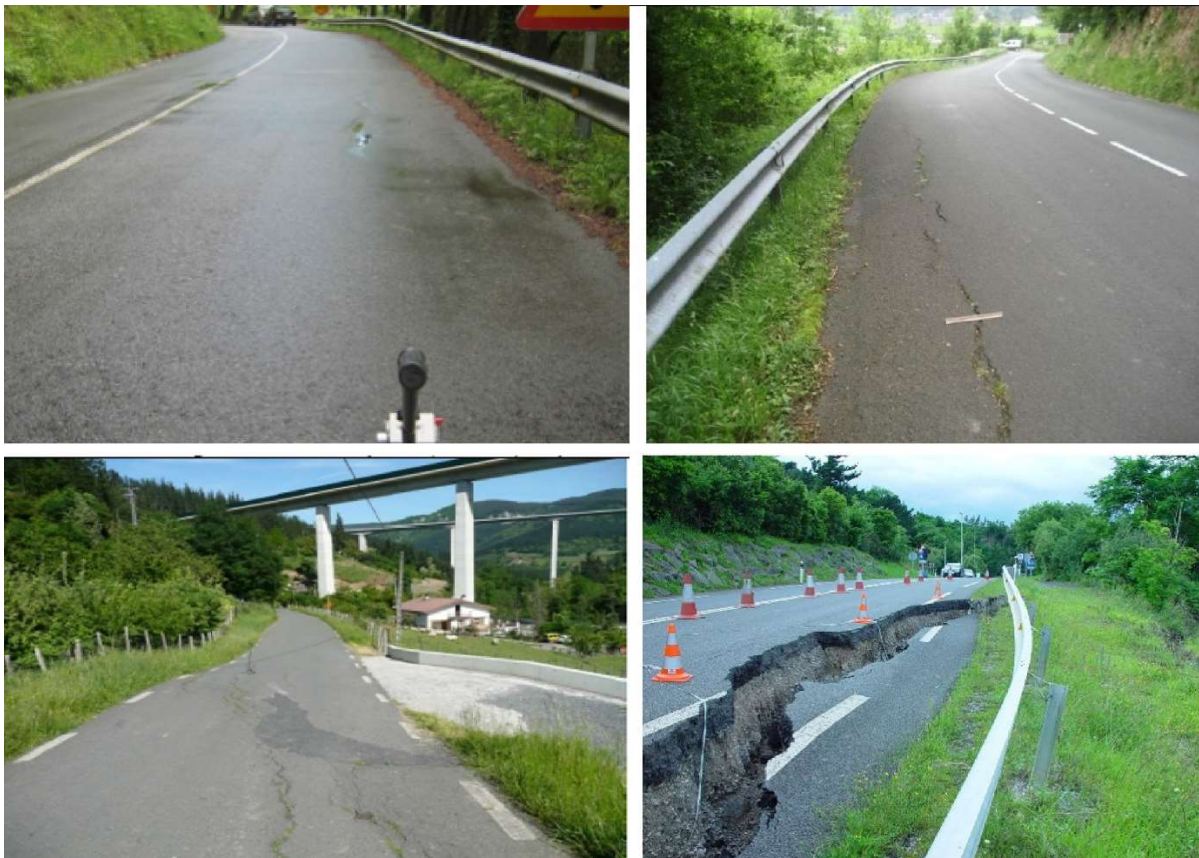
We inspected the in-situ damage, in order to establish the relation between the velocity and the road damage. Four levels were identified, as shown in Figure 5 and described qualitatively in the following:

- Damage level A (landslides of low intensity): There are rarely cracks and deformations. No speed reduction is required while driving. Crack sealing and resurfacing is periodically performed for periods longer than 1 year.

- Damage level B (landslides of moderate intensity): Damage includes pavement deformation and cracks and/or roadside destruction, without affecting the functioning of the road. If proper signalling is present, the chance of an accident is very low. Traffic conditions can be normally maintained if regular sealing and resurfacing is performed, until a more permanent solution.

- Damage level C (landslides of high intensity): Pavement deformation is substantial, including the presence of steps and puddles, and partial rupture of the platform affecting partly or entirely traffic lanes and/or the roadside. The normal functioning of the road is disturbed. Traffic is not interrupted, although restrictions such as alternative pass and traffic lights regulation are required. Accidents might occur if the vehicles enter the affected zone, without previous signalization. The normalization of the traffic conditions requires slope stabilization and road repair.

- Damage level D (landslides of very high intensity): Displacements are of the same order of magnitude as for level C, however with the vertical component prevailing giving place to complete destruction and loss of the pavement continuity. This situation is typical for roads situated on the crest or on the boundaries of landslides. The operation of the road is seriously affected. There is a high likelihood of an accident due to vehicles falling into the generated depressions. Important stabilization works and reconstruction of the road are required.

20 **Figure 5: The four damage levels identified at the roads of Gipuzkoa: (top-left) No/Slight damage, (top-right) Moderate damage, (down-left) Severe damage, and (down-right) Partial/total destruction.**

To establish damage proxies for the calculation of the expected consequences we correlated the observed road damage with the indications of the inclinometers at 24 reference PoR. The correlation was found to be positive, as, in most cases, increasing displacements were associated with more severe damage. In particular, the maximum horizontal monthly velocity and the cumulative displacement were used as the two proxies for the damage. For the establishment of the thresholds that relate the damage level with the terrain displacements, we tried to maximize the right predictions (when the observed damage level is the same with the calculated damage level), and at the same time to achieve a balance between damage underestimation and overestimation. The proposed thresholds are summarized in Table 9. Out of the 24 PoR, 20 yield right predictions, 1 presents damage overestimation and 3 damage underestimation (out of which one inclinometer measures has low reliability). Partial/total destruction occurs when the criteria for severe damage are fulfilled plus either one of two further criteria: the road is located inside the landslide scarp or a shear crack has being formed (the scarp manifests itself as a semi-circular form on the pavement).

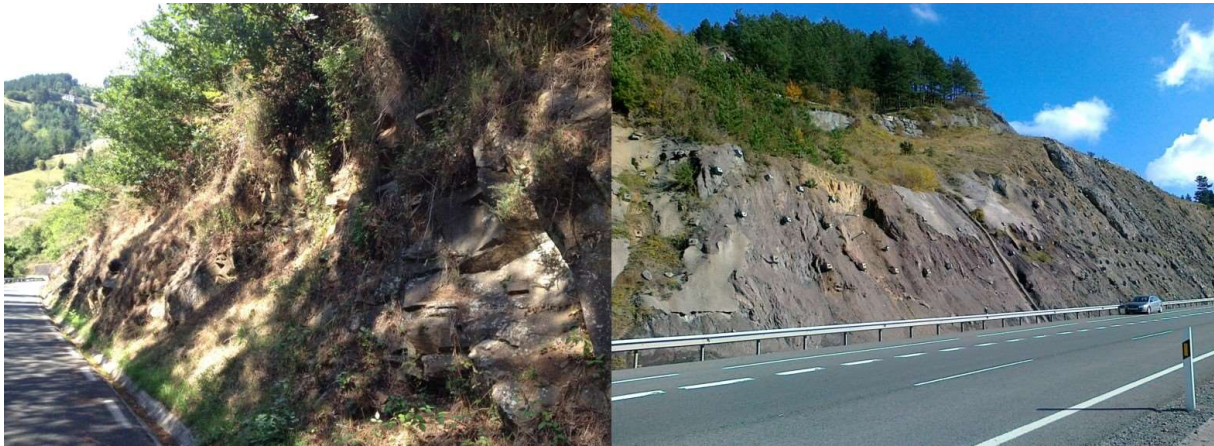
5 **Figure 7: (left) PoR L1C of the road GI-3324 (from km 0.700 to 1.450), without protection measures; (right) PoR P4C of the road N-1 (km 407.395 to 407.680) with protection measures.**

For the PoR P4C, a similar procedure was followed. For I_P : Moderate, $I_{DC} >0.16$, I_E : No, I_{FP} : 4, and I_{SMR} : 0-40, I_F results equal to 5, which corresponds to an annual frequency of events equal to 0.2. This frequency is distributed to the magnitude classes: 0.08 for A, 0.09 for B, 0.01 for C, 0.01 for D and 0.01 for E. In this case, a correction is applied on the annual frequency. Considering that the slope is partially protected by gunite and bolts in a bad state of maintenance, and that a ditch with width smaller than 5 m exists, the summative frequency correction factors for the two types of measures from Table 6 are 0.45 and 0.2 for magnitudes A and B. For higher magnitudes, the existing protection measures are not considered to be efficient. The annual frequencies per size after correction are 0.03, 0.07, 0.01, 0.01, 0.01 for A, B, C, D and E, respectively, which after multiplication with the correspondent

UC and summing, they result in a higher total annual risk than the previous one, and equal to 3.05. The higher risk is owing to the existence of bigger rock blocks which cannot be retained by the actual protection measures.

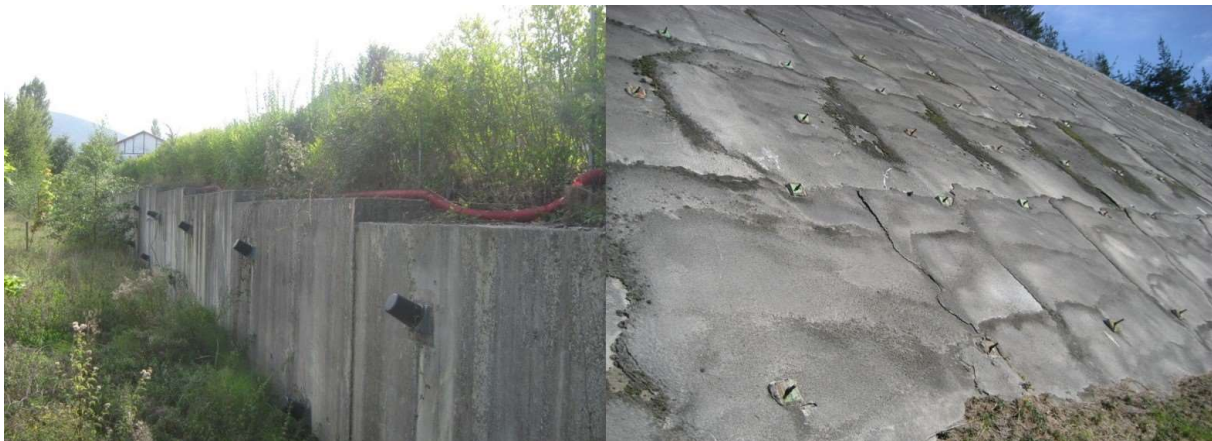
Figure 8: (left) PoR P2A of the road AP-8-1-1 (from km 77.140 to 77.210) where the crest of the slope and the retaining wall with anchors is seen; (right) C8A of the road G-2634 (32.980 to 33.150) with gunite, rock bolts, and anchors.

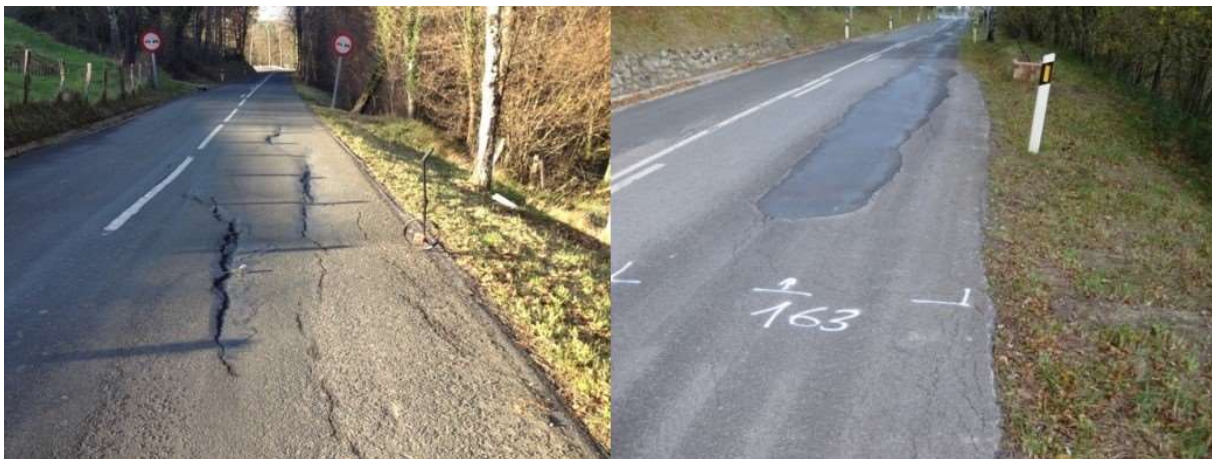
25 **Figure 9: Road sections situated within slow moving landslides, with damage: (left) PoR C3C of the road GI-2133 (from km 8.280) with observed deformations and cracks on the road pavement; (right) PoR C9G of the road GI2637 (from km 17.891 to 18.220) showing minor cracks already sealed.**

15 The soil instability affecting the C9G is ought as well to colluvial soil accumulations of 3-4 meters depth, over the bedrock. There are visible settlements and the ditches are deformed. The landslide is instrumented with two inclinometers that indicate that it is active.

The inclinometer measurements indicate vertical displacements lower than 2-3 mm and cumulative displacement lower than 30 mm, which points to a movement pattern of type X. There is not any scarp or developed shear displacements. Accordingly the probability of exceeding low damage is 1, moderate damage is 0.05 and high damage is 0.005. As previously, the probability is calculated for high damage: 0.005, for moderate damage: 0.045, and for low damage: 0.5, which for total a length of 300 m, and the same as previously costs, gives a total risk of 10.84.

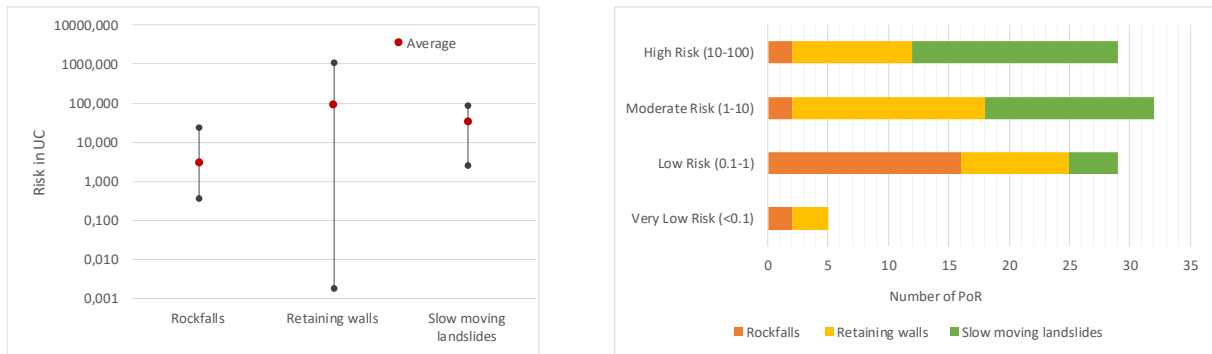
10 **Figure 10: (left) Average, maximum and minimum calculated risk for each hazard type; (right) Number of PoR per hazard type in each risk class.**

Figure 10 shows how the risk levels are distributed over the different hazard types. High risk areas mostly involve retaining wall failures or slow moving landslides. Rockfalls principally cause low and moderate risk and sea wall failure are of low or high risk. The risk classification highlights 21% of the analysed PoR being of very high risk and needing imminent protection interventions. The highest risks in the study site (above 100 UC) were observed for 9 of the retaining structures. 42% of the PoR fall into the class of high risk, 35% of moderate risk and 13% of low risk. Depending on the prioritization needs and the economical restrictions for the planning of the interventions, other thresholds can be used for the risk classification, in order to reduce the number of sections marked as of highest priority.
