# Integrated risk assessment due to slope instabilities at the roadway network of Gipuzkoa, Basque Country

**Abstract.** Transportation corridors such as roadways are often subjected to both natural instability and cut slope failures, with substantial physical damage for the road infrastructure and threat to the circulating vehicles and passengers. In the early 2000s, the Gipuzkoa Regional Council of the Basque country in Spain, marked the need for assessing the risk related to the geotechnical hazards at its road network, in order to assess and monitor their safety for the road users. The Quantitative Risk Assessment (QRA) was selected as a tool for comparing the risk for different hazards on an objective basis. Few examples of multi-hazard risk assessment along transportation corridors exist. The methodology presented here consists in the calculation of risk in terms of probability of failure and its respective consequences, and it was applied to 84 selected points of risk (PoR) of the entire road network managed by the Gipuzkoa Regional Council. The types of encountered slope instabilities which are treated are rockfalls, retaining wall failures, and slow moving landslides. The

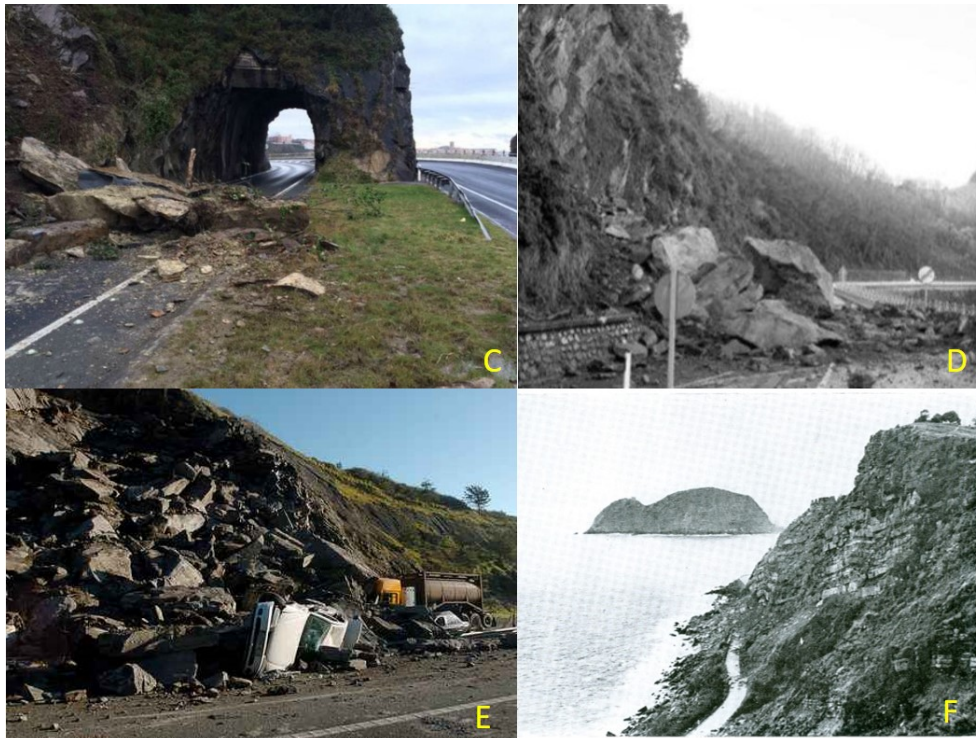
**Figure 3: Examples of rockfall magnitudes (C, D, E, and F) in the study area, in relation to the classes of Table 2 (source: photo D, E: Javi Colmenero; F: Servicio Geológico de Obras Públicas)**

15 Rockfalls are a major threat at the roads of Gipuzkoa. The rockfall hazard magnitude is classified according to the volume of the detached mass. Figure 3 shows representative examples of different rockfall magnitudes. A frequency or probability of occurrence is attributed to each volume class and the extent of disruption of the transportation corridor is determined.

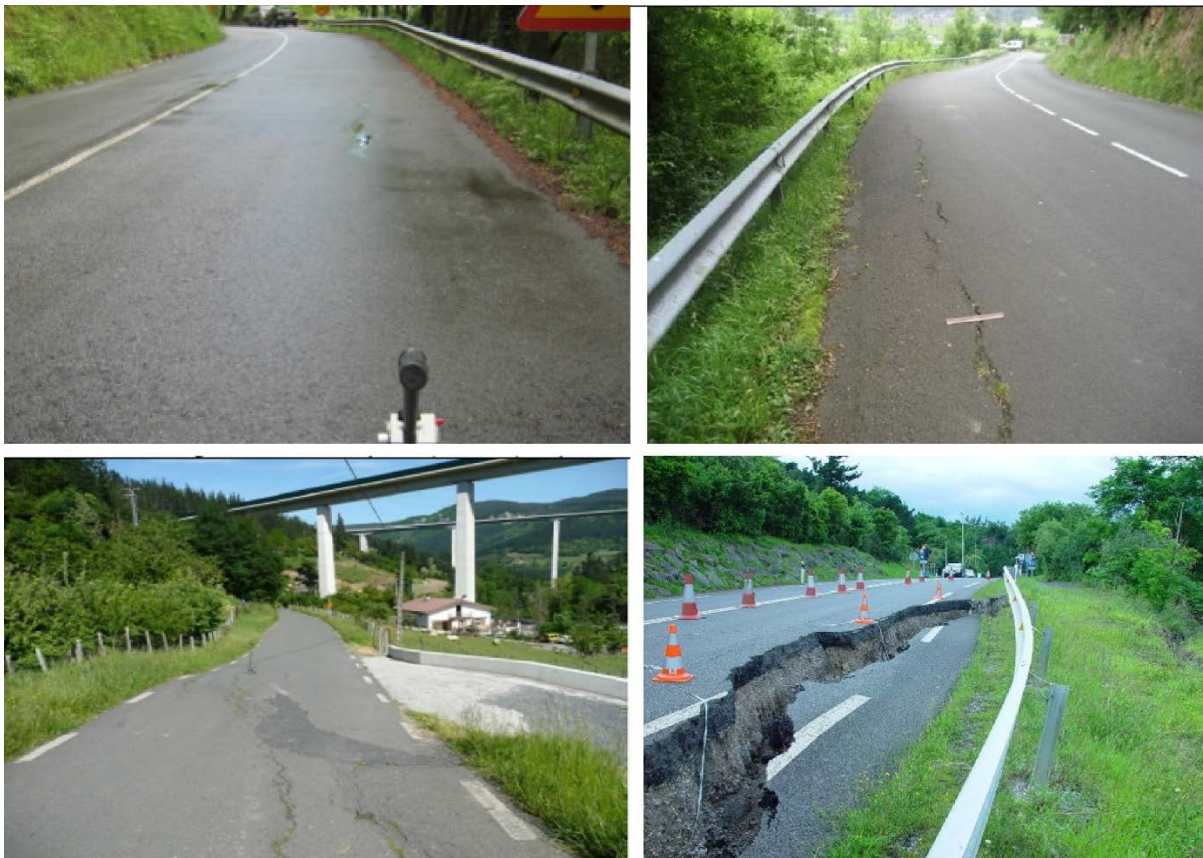
**Figure 5: The four damage levels identified at the roads of Gipuzkoa: (top-left) No/Slight damage, (top-right) Moderate damage, (down-left) Severe damage, and (down-right) Partial/total destruction.**

In the case study, horizontal velocity data is available from the inclinometer measurements. After 2010, deformation readings have been constantly taken, every 3 months. In that sense, although the monthly velocity measurements have a limited precision, they can provide certain information on the landslide movement patterns. We inspected the in-situ damage, in order to establish the relation between the velocity and the road damage. Four levels were identified, as shown in Figure 5 and described qualitatively in the following:

- Damage level A (landslides of low intensity): There are rarely cracks and deformations. No speed reduction is required while driving. Crack sealing and resurfacing is periodically performed for periods longer than 1 year.

- Damage level B (landslides of moderate intensity): Damage includes pavement deformation and cracks and/or roadside destruction, without affecting the functioning of the road. If proper signalling is present, the chance of an accident is very low. Traffic conditions can be normally maintained if regular sealing and resurfacing is performed, until a more permanent solution.

- Damage level C (landslides of high intensity): Pavement deformation is substantial, including the presence of steps and puddles, and partial rupture of the platform affecting partly or entirely traffic lanes and/or the roadside. The normal functioning of the road is disturbed. Traffic is not interrupted, although restrictions such as alternative pass and traffic lights regulation are required. Accidents might occur if the vehicles enter the affected zone, without previous signalization. The normalization of the traffic conditions requires slope stabilization and road repair.

- Damage level D (landslides of very high intensity): Displacements are of the same order of magnitude as for level C, however with the vertical component prevailing and giving place to complete destruction and loss of the pavement continuity. This situation is typical for roads situated on the crest or on the boundaries of landslides. The functioning of the road is seriously affected. There is a high likelihood of an accident due to vehicles falling into the generated depressions. Important stabilization works and reconstruction of the road are required.

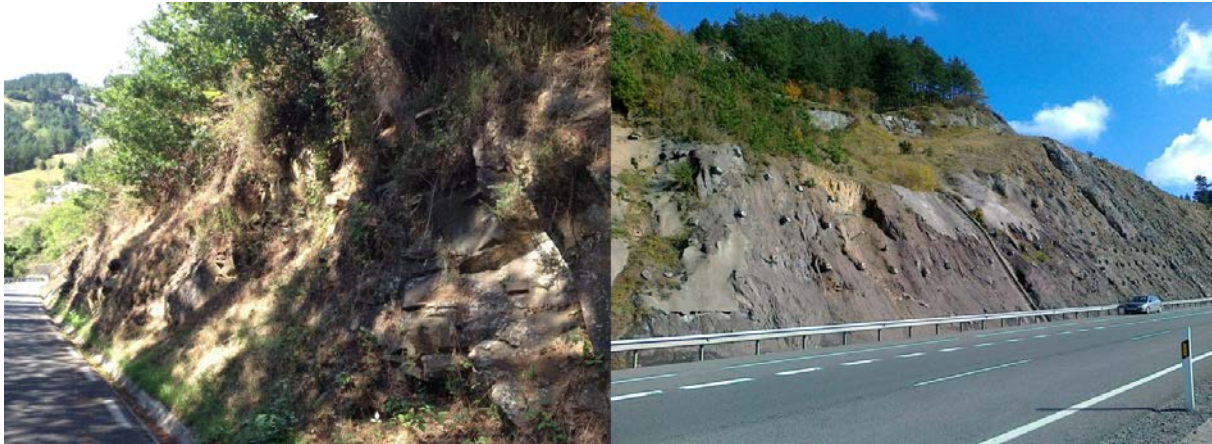
5 **Figure 7: (left) PoR L1C of the road GI-3324 (from km 0.700 to 1.450), without protection measures; (right) PoR P4C of the road N-1 (km 407.395 to 407.680) with protection measures.**

For the PoR P4C, a similar procedure was followed. For  $I_P$ : Moderate,  $I_{DC} > 0.16$ ,  $I_E$ : No,  $I_{FP}$ : 4, and  $I_{SMR}$ : 0-40,  $I_F$  results equal to 5, which corresponds to an annual frequency of events equal to 0.2. This frequency is distributed to the magnitude classes: 0.08 for A, 0.09 for B, 0.01 for C, 0.01 for D and 0.01 for E. In this case, a correction is applied on the annual frequency. Considering that the slope is partially protected by gunite and bolts in a bad state of maintenance, and that a ditch with width smaller than 5 m exists, the summative frequency correction factors for the two types of measures from Table 6 are 0.45 and 0.2 for magnitudes A and B. For higher magnitudes, the existing protection measures are not considered to be efficient. The annual frequencies per size after correction are 0.03, 0.07, 0.01, 0.01, 0.01 for A, B, C, D and E, respectively, which after multiplication with the correspondent

UC and summing, they result in a higher total annual risk than the previous one, and equal to 3.05. The higher risk is ought to the existence of bigger rock blocks which cannot be retained by the actual protection measures.

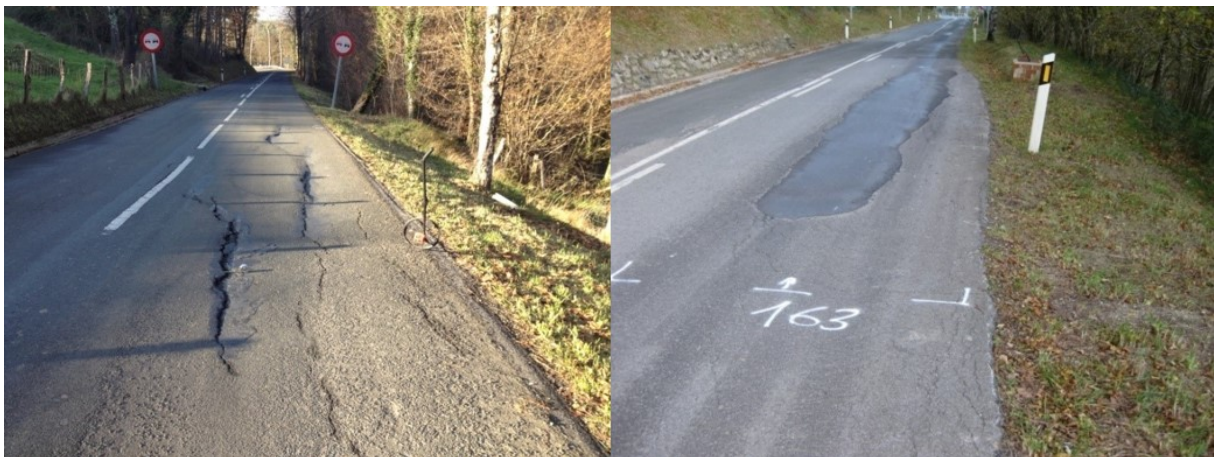
**Figure 9: Road sections situated within slow moving landslides, with damage: (left) PoR C3C of the road GI-2133 (from km 8.280) with observed deformations and cracks on the road pavement; (right) PoR C9G of the road GI2637 (from km 17.891 to 18.220) showing minor cracks already sealed.**

The soil instability affecting the C9G is ought as well to colluvial soil accumulations of 3-4 meters depth, over the bedrock. There are visible settlements and the ditches are deformed. The landslide is instrumented with two inclinometers that indicate that it is active.

The inclinometer measurements indicate vertical displacements lower than 2-3 mm and cumulative displacement lower than 30 mm, which points to a movement pattern of type X. There is not any scarp or developed shear displacements. Accordingly the probability of exceeding low damage is 1, moderate damage is 0.05 and high damage is 0.005. As previously, the probability is calculated for high damage: 0.005, for moderate damage: 0.045, and for low damage: 0.5, which for total a length of 300 m, and the same as previously costs, gives a total risk of 10.84.
