Anonymous Referee #1

**Comments from Referee 1:**

The article deals with the problem of landslides (rockslide) based on both monitoring and numerical approaches. The article is composed of two parts. The first part is dedicated to the description of the physical problem, the engineering geological properties and the monitoring results. After a successful prediction for an excavation-induced rockslide in 2011, the monitoring system is proven to be suitable to the rainfall-induced rockslide. The second part of the article deals with numerical analysis (using an advanced numerical method, FEM-LIP) of the stability problem. The stability is analyzed using the so called second-order work criterion, and a safety factor from numerical calculation is compared with the monitoring data. This paper is convincing and valuable in light of very interesting monitoring system and a deep comparison between in situ measurements and the advanced computational results. I would recommend publication once after the manuscript has been modified according to the comments provided below.

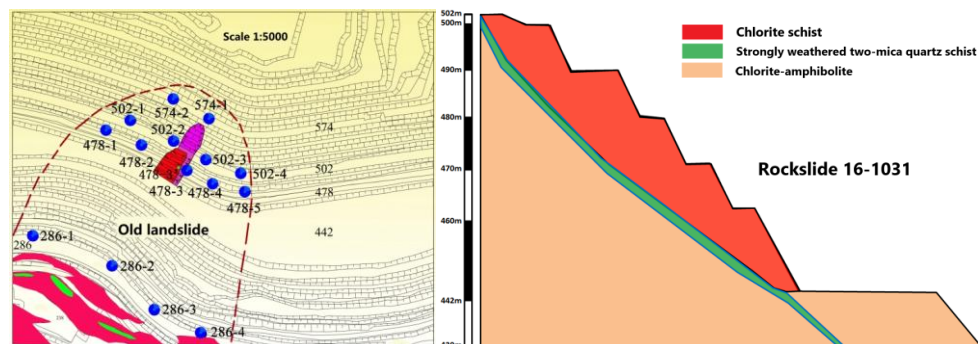
Thanks so much for your pertinent comments. The 2 figures you pointed out had been substituted, and the resolution had been improved.

Thanks for your kindly reminder. A legend has been added and the resolution improved.

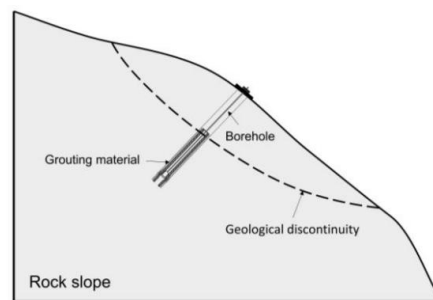
Thanks for your kindly comments. Regarding the installation of the CRLD, the borehole is drilled through the geological discontinuity as shown in the figure as follows. The sleeve pipe is anchored in the borehole by the grouting material generally with a thickness of 14.5 mm, and one end of the stands is fixed on the slope surface.

The CRLD cables are generally installed in the rock mass with an inclination of  $25^{\circ}$  and the depth depends on that of the potential sliding band, such as the weak zone. As the monitoring system is used principally for rock slopes, the weak zone is determined by boreholes. The fixed end should be anchored into the stable rock, under the weak zone. About the installation of the CRLD cables in rock mass, more details can be found in the paper [6].
