## Brief communication: Post-wildfire rockfall risk in the Eastern Alps

### Abstract.

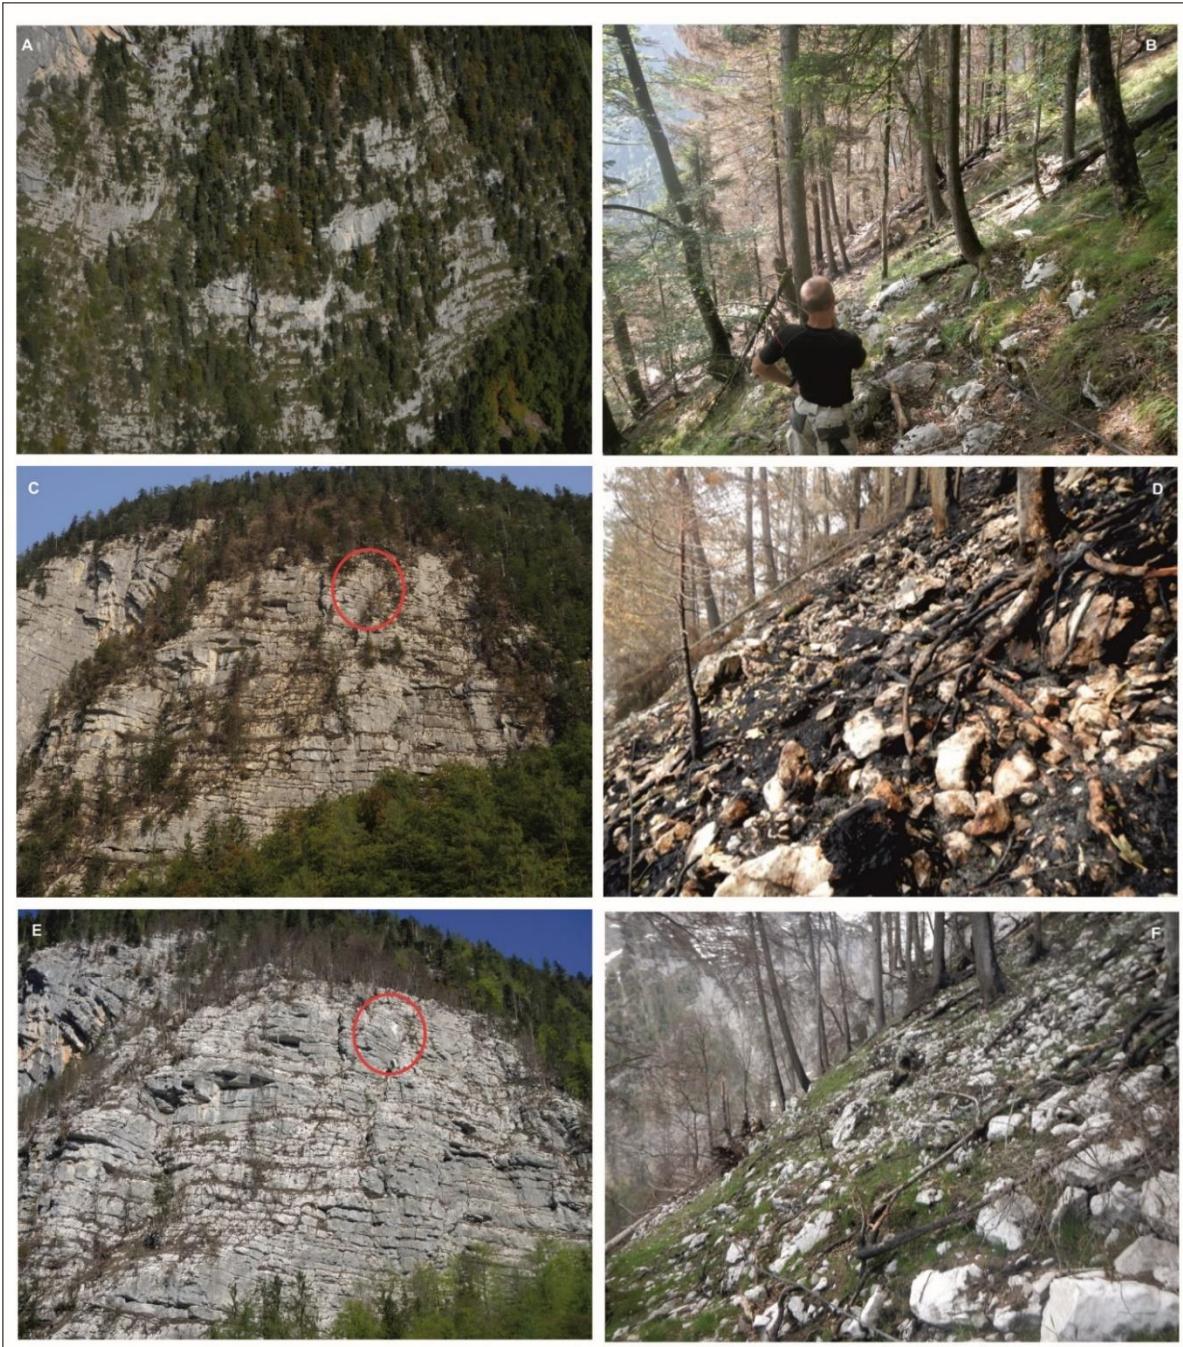
**Figure 1: Temporal changes of the wildfire affected area: biomass, soil and rock characteristics before the wildfire in 2014 (A), in the border between burned and not-burned forest in August 2018 (B), directly after the wildfire in August 2018 (C and D) and eight months after the burn in April 2019 (E and F). Post-wildfire rockfalls (red circle in E) with a volume of about a few  $\text{m}^3$  is recognizable.**

affecting the trees growing mainly on the bedding planes of the limestone (Fig. 1). The protection forest beneath the rockwall was not affected by the fire (Fig. 2). The night from 21. to 22.8.2018 the first evacuations of the houses beneath the rockwall took place as burned trunks, rootstocks and rock-blocks were falling down the rockwall, the latter approaching two houses  
65 (Fig. 3). With the exception of a minor damage to one building, no severe damages to buildings or injuries of habitants occurred. In the following days the firefighter brigades tried to extinguish the fire from above the rockwall with fire hoses and from the air with helicopters carrying water containers/buckets. In total, four police and military helicopters were flying throughout the days, constantly every two minutes refilling the buckets with water from the nearby Lake Hallstatt. During the four days of firefighting operation, up to 100 people (firefighter brigade, police, military, mountain rescue) were on duty every

Indicators of fire severity (Fig. 1 and 2) are the colour of the trees and the decomposition degree of the leafs and needles. Unaffected trees have a green and unaltered colour, whereas burned or heated trees are easily recognizable by the brown colour.  
80 Varying degrees of consumption of the needles/leafs and organic matter can be related to different classes of fire severity. According the classification of Keeley (2009), the trees in the affected area show moderate or severe surface burn. This is visible that most of the burned trees still have needles, but all understorey plants and pre-fire soil organic layer (besides a post-wildfire needle cover) are consumed. In the transition area of burned and not-burned area, the vegetation shows indicators for light fire severity, expressed by green needles although the stems may be scorched, and the understorey plants and soil organic  
85 layer is largely intact. At the foot of the rockwall we observed a burning tree that has fallen down the rockwall carrying a large rock, which burst into various rockfall boulders during the first impact with the ground.

The vertical relief of the rockwalls, the anabatic winds and patchy vegetation pattern, caused an upward jumping of the fire, resulting in a spotty fire pattern (Fig. 1). Thus, the residence time of the fire and the heating duration were reduced, leading to  
90 a less direct influence of the high temperatures on the rockmass structure. Fire induced rock surface alteration and cracking due to thermal shock are typical rock weathering processes occurring during a wildfire (Dorn, 2003; Shtober-Zisu et al., 2015). Thermal shock takes place when the thermally induced stress event is of sufficient magnitude that the material is unable to

An increased rockfall activity of rather smaller rockblocks during but as well after the wildfire is recognizable. The destabilization of small rockblocks and the burn of trees/roots may as well cause destabilization of larger rock masses (Fig. 1). These would pose a significant risk to the houses and infrastructures. Above the steep rockwall, some greater boulders in/on top of the scree slope could be remobilized as secondary rockfalls by falling trees or undercutting erosional processes (Fig. 4).

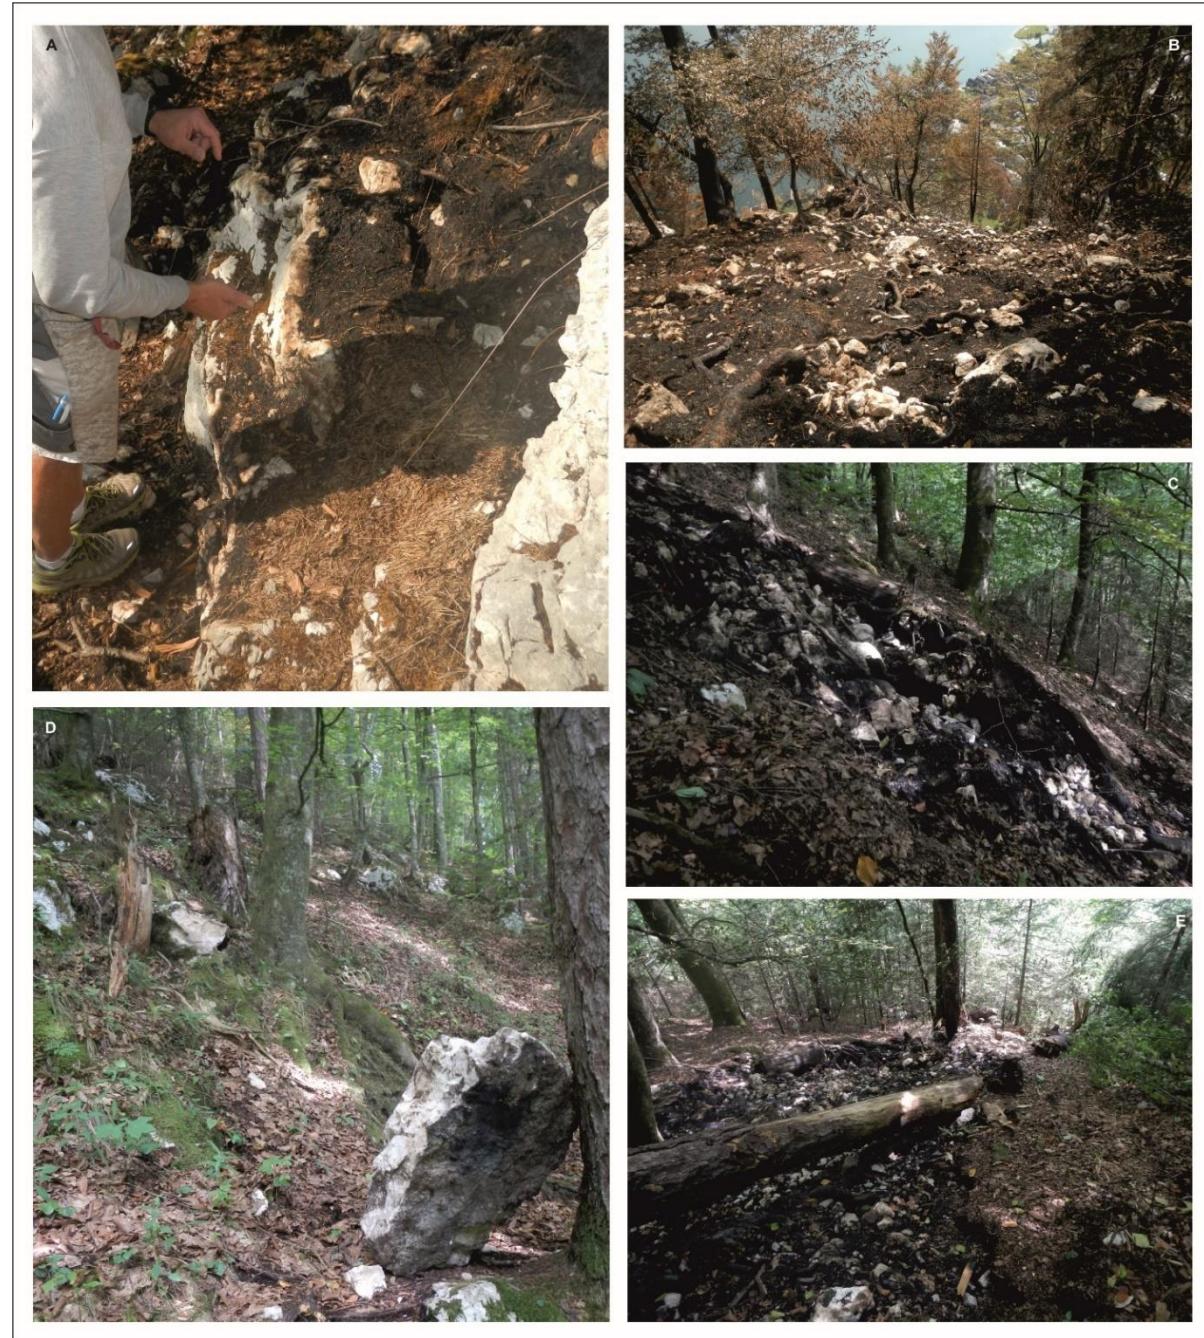
**Figure 2: Indication for wildfire severity. (A) Development of cracks in the scree, (B) ash and needle covers the terrain have a "sealing effect" reducing the infiltration capacity, (C) talus slope beneath the rockwall is covered by a thin soil layer, (D) rockfall boulders detached during the wildfire are often easily identifiable on the black colour, (E) the protection forest beneath the rockwall only got affected to a very minor extent due to the anabatic winds and high moisture of the brown rendzina/ brown earth.**

Spalling or the formation of exfoliation fissures (caused by insolation weathering), may be less severe in such exposed terrain conditions than in more gentle slopes (Blackwelder, 1927; Shakesby and Doerr, 2006; Shtober-Zisu et al., 2015; Zimmerman 100 et al., 1994). In the course of the wildfire, abundant small rock fragments had come to rest directly at the base of the rockwall. The rockfall boulders which got detached of the rockwall during the wildfire could be easily identified in the field, as they usually have at least one black (scorched) side (Fig. 2). Some smaller rockfall boulders with volumes  $<0.3\text{m}^3$  have reached the valley floor (Fig. 3).

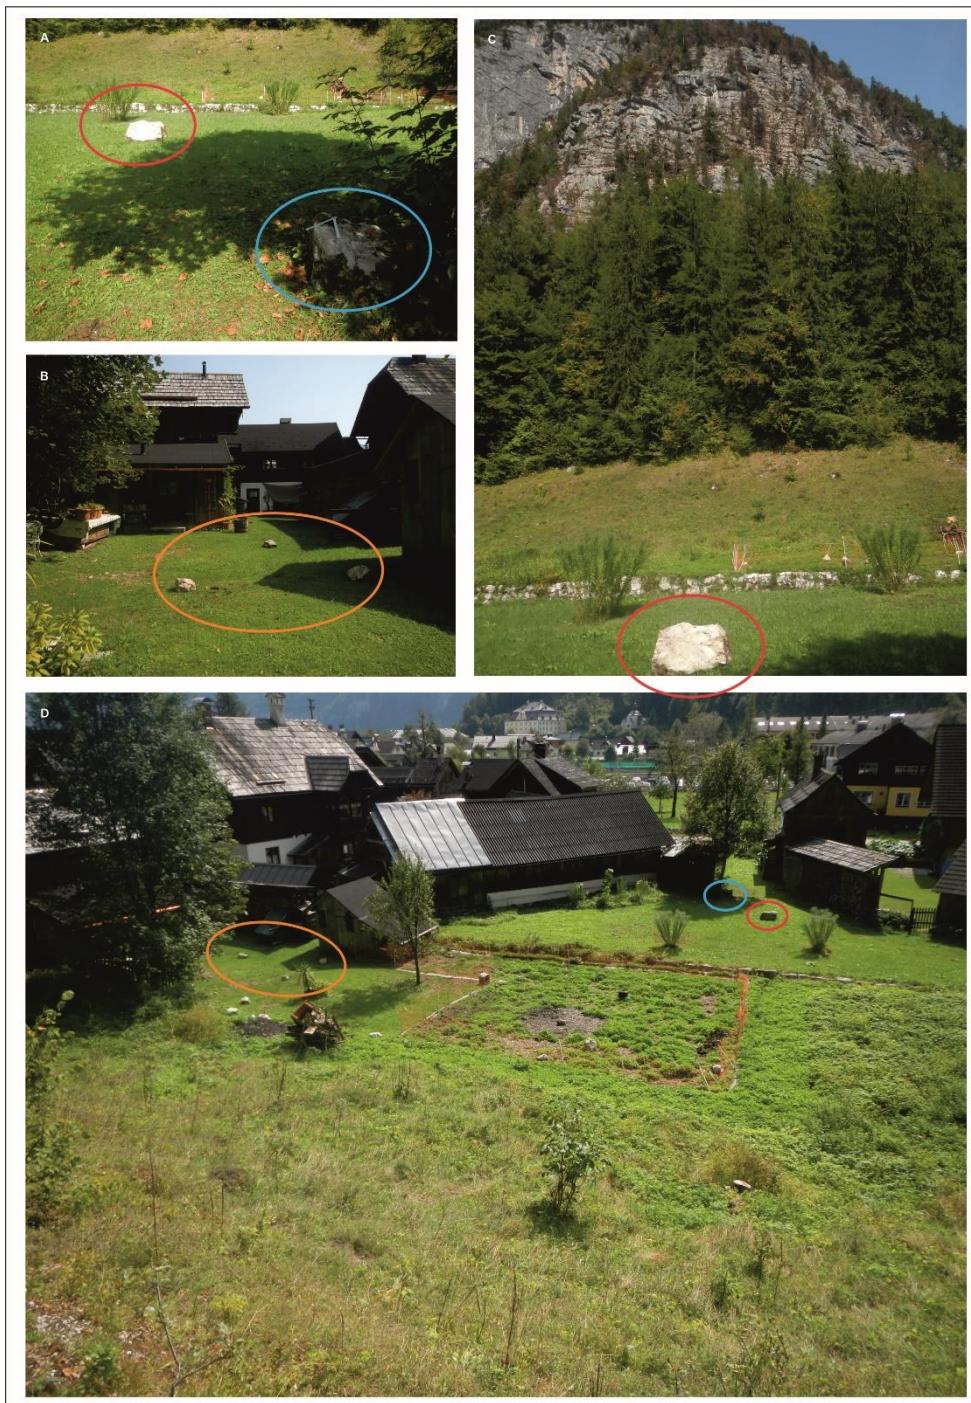
**Figure 3: Rockfall boulders, which were detached during the wildfire and reached the settlement area. An older rockfall boulder (blue circle) marks the maximum reach of past rockfalls and has a volume of about  $0,2\text{m}^3$  ( $0,8*0,6*0,4$ ), the fresh boulder (red circle) a volume of about  $0,3\text{m}^3$  ( $0,8*0,75*0,5$ ).**

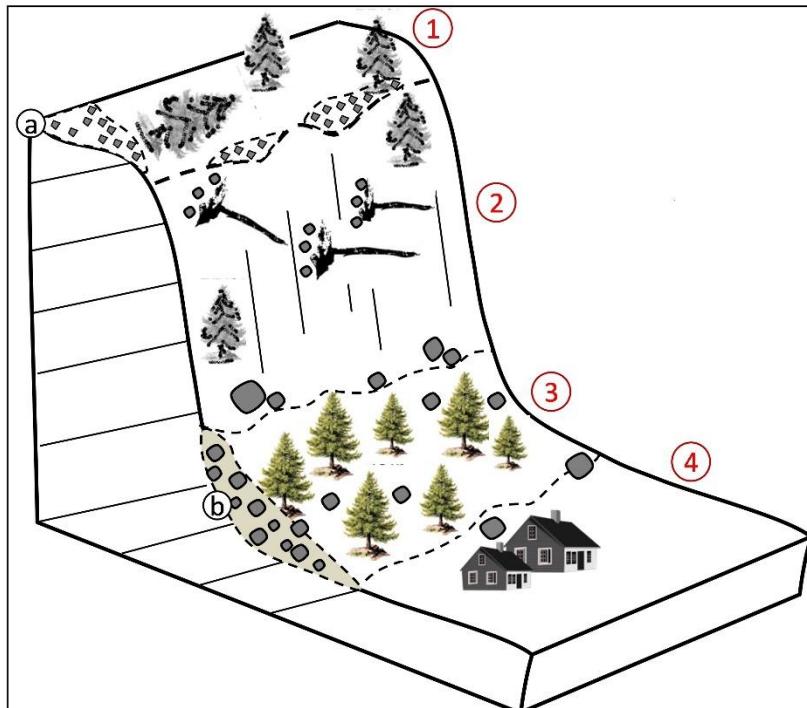
**Figure 4:** Sketch of the wildfire affected area. During the wildfire, the trees in the less inclined upper rockwall (1) covered with scree (b) and in the vertical rockwall (2) show indicators for medium fire severity; the protection forest (3) on the talus slope (b) did not get affected by the wildfire. During the fire, rockfalls were detached from the rockface and by falling trees, which reached the houses in the valley floor (4).
