Brief communication: Post-wildfire rockfall risk in the Eastern Alps

35 The aim of this work is to describe the of a wildfire, which occurred in August 2018 at a steep rockwall in the heavily toured world-heritage site “Hallstatt” in the Salzkammergut region in Upper Austria (47°33’27.00” N, 13°38’37.03’ E). In order to assess the impact of the wildfire on the recent and future rockfall activity in the area. A helicopter flight and field survey was carried out. The survey was conducted by Sandra Melzner, Geological Survey of Austria, as part of the project “Georisks Austria” (GEORIOS). The focus of the inspection was on the identification of possibly changed rockfall potentials and loosening of the rock due to the strong heat effect (Melzner, 2018) with regards to the rockfall hazard analysis conducted in 40 2014 (Melzner, 2015). A revisit of the area was conducted in May 2019 to record the temporal post-wildfire changes to the ecosystem.

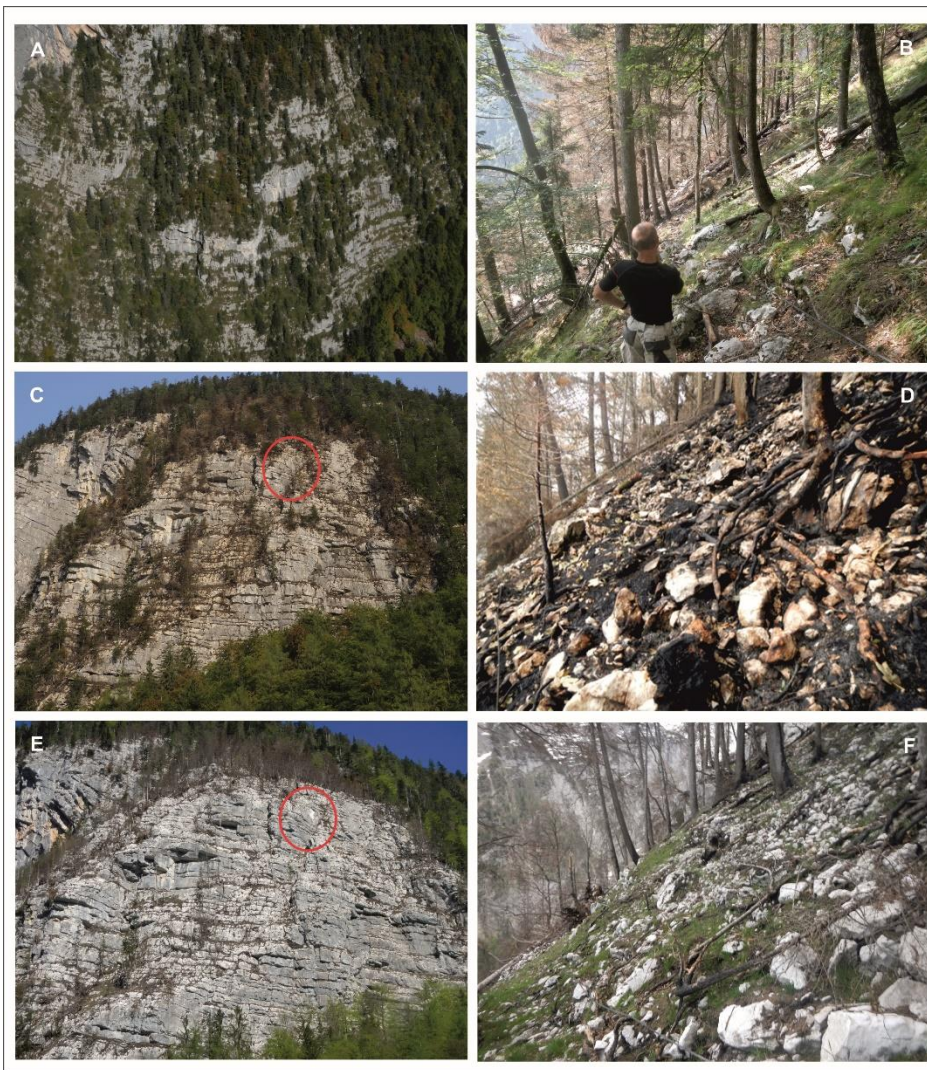
265 **Figure 1: Temporal changes of the wildfire affected area: biomass, soil and rock characteristics before the wildfire in 2014 (A), in the border between burned and not-burned forest in August 2018 (B), directly after the wildfire in August 2018 (C and D) and eight months after the burn in April 2019 (E and F). Post-wildfire rockfalls (red circle in E) with a volume of about a few m³ is recognizable.**

Indicators of fire severity (Fig. 1 and 2) are the colour of the trees and the decomposition degree of the leafs and needles. Unaffected trees have a green and unaltered colour, whereas burned or heated trees are easily recognizable by the brown colour. Varying degrees of consumption of the needles/leafs and organic matter can be related to different classes of fire severity. According the classification of Keeley (2009), the trees in the affected area show moderate or severe surface burn. This is visible that most of the burned trees still have needles, but all understorey plants and pre-fire soil organic layer (besides a post-wildfire needle cover) are consumed. In the transition area of burned and not-burned area, the vegetation shows indicators for light fire severity, expressed by green needles although the stems may be scorched, and the understorey plants and soil organic

95 The vertical relief of the rockwalls, the anabatic winds and patchy vegetation pattern, caused an upward jumping of the fire, resulting in a spotty fire pattern (Fig. 1). Thus, the residence time of the fire and the heating duration were reduced, leading to a less direct influence of the high temperatures on the rockmass structure. Fire- induced rock surface alteration and cracking due to thermal shock are typical rock weathering processes occurring during a wildfire (Dorn, 2003; Shtober-Zisu et al., 2015). Thermal shock takes place when the thermally- induced stress event is of sufficient magnitude that the material is unable to adjust quickly enough to accommodate the required deformation and accordingly fails (Hall 1999). As a result, surface failure
100 takes the form of cracking or exfoliation due to the compression and the shear stress it induces (Yatsu 1988). Moreover, rocks composed of several minerals, each with different coefficients of thermal expansion, may experience stresses resulting from the minerals' differential thermal response to heating and cooling cycles (McFadden et al. 2005).

An increased rockfall activity of rather smaller rockblocks during but as well after the wildfire is recognizable. The destabilization of small rockblocks and the burn of tree roots may as well cause destabilization of larger rock masses (Fig. 1). These would pose a significant risk to the houses and infrastructures. Above the steep rockwall, some greater boulders in/on top of the scree slope can be remobilized as secondary rockfalls by falling trees or undercutting erosional processes (Fig. 4). The wildfire probably had a superficial impact on the rockmass structure of the vertical rockwalls. According to Thomaz and Doerr, (2014) moderate temperatures ($< 400^{\circ}\text{C}$) had the most major effect on soil chemical properties. The study was conducted using a set of thermocouple that were placed at 0-2 cm soil depth. Even relatively low temperatures at the surface of the soil can trigger mineralogical changes.

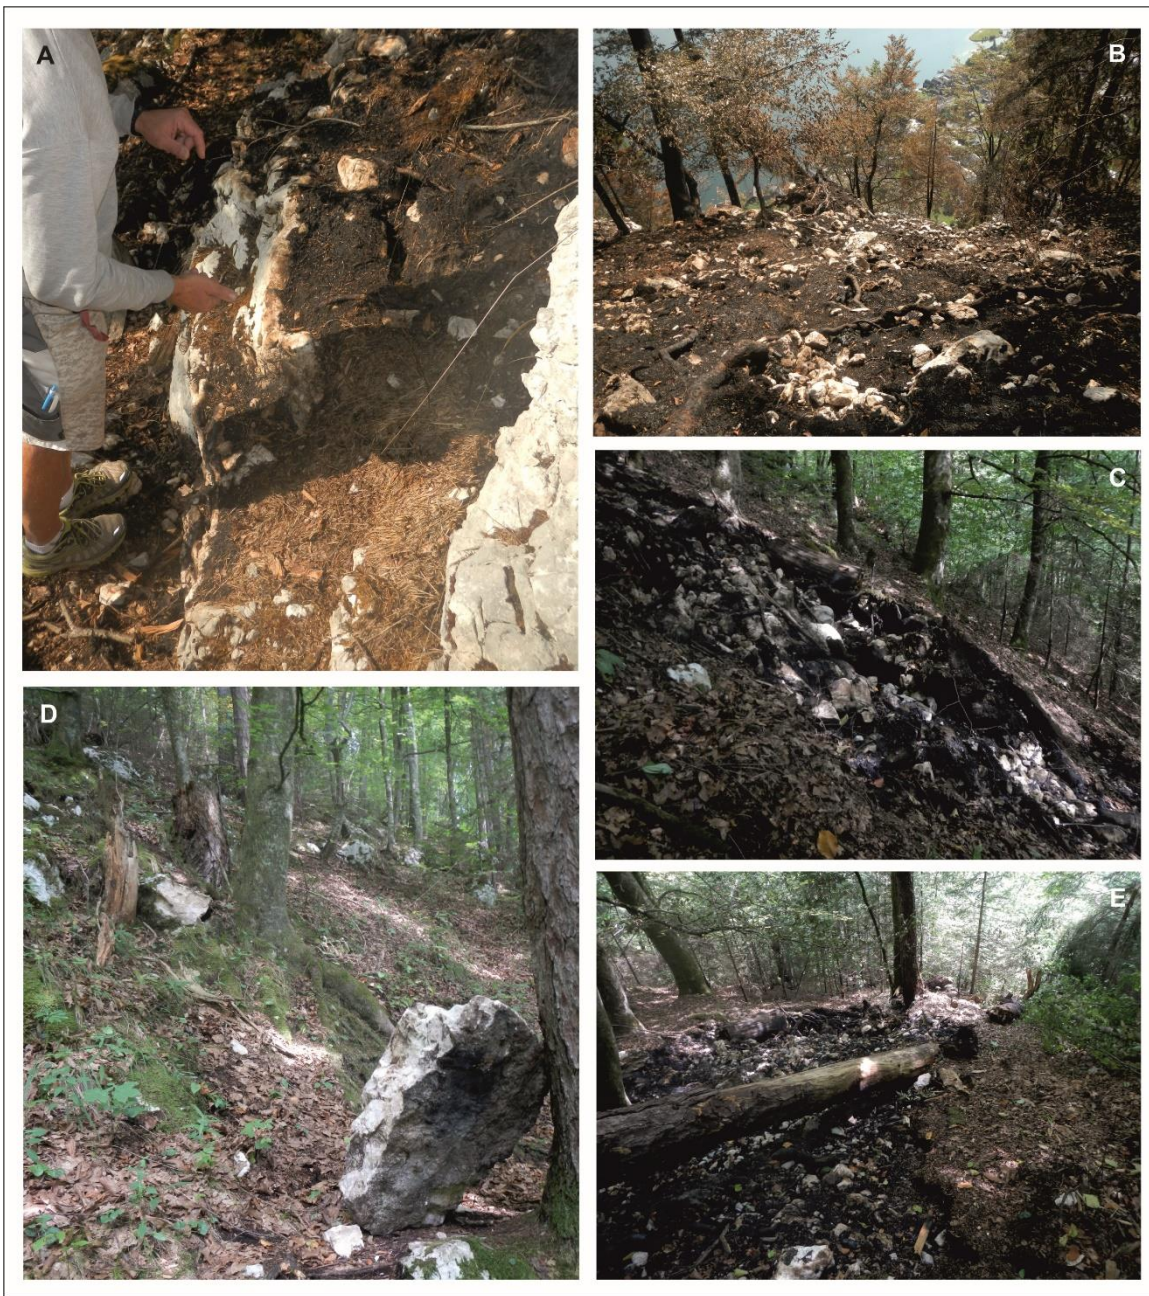
270 **Figure 2: Indication for wildfire severity. (A) Development of cracks in the scree, (B) ash and needle covers the terrain have a "sealing effect" reducing the infiltration capacity, (C) Talus slope beneath the rockwall is covered by a thin soil layer, (D) rockfall boulders detached during the wildfire are often easily identifiable on the black colour, (E) the protection forest beneath the rockwall only got affected to a very minor extent due to the anabatic winds and high moisture of the brown rendzina/ brown earth.**

Spalling or the formation of exfoliation fissures (caused by insolation weathering), may be less severe in such exposed terrain
105 conditions than in more gentle slopes (Blackwelder, 1927; Zimmerman et al., 1994; Shakesby and Doerr, 2006; Shtober-Zisu et al., 2015). In the course of the wildfire, abundant small rock fragments had come to rest directly at the base of the rockwall. The rockfall boulders which got detached of the rockwall during the wildfire could be easily identified in the field, as they usually have at least one black (scorched) side (Fig. 2). Some smaller rockfall boulders with volumes $<0.3\text{m}^3$ have reached the valley floor (Fig. 3).

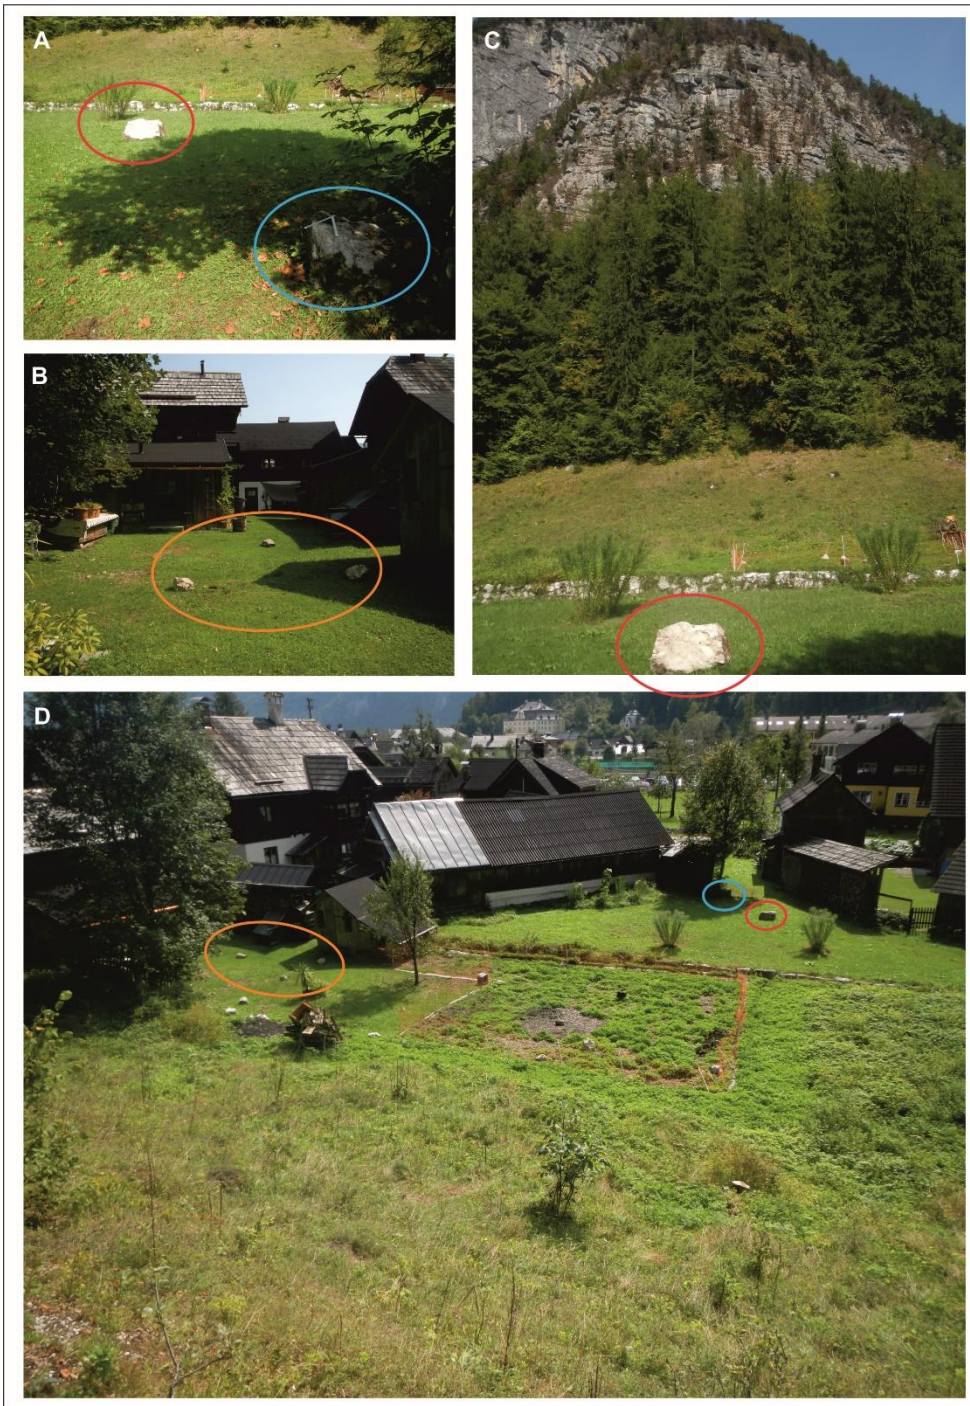
275 **Figure 3: Rockfall boulders, which were detached during the wildfire and reached the settlement area. An older rockfall boulder (blue circle) marks the maximum reach of past rockfalls and has a volume of about $0,2\text{m}^3$ ($0,8*0,6*0,4$), the fresh boulder (red circle) a volume of about $0,3\text{m}^3$ ($0,8*0,75*0,5$).**

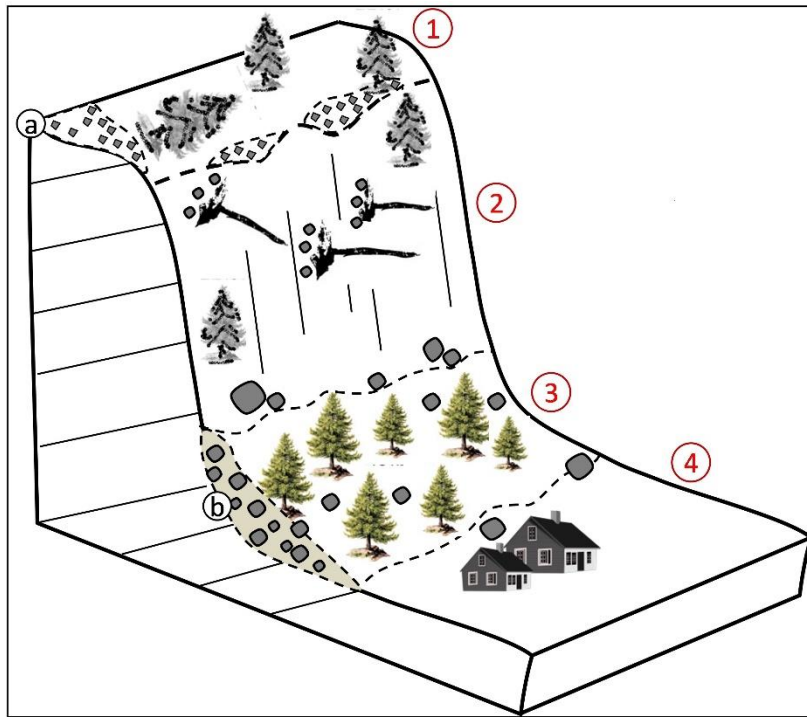
Figure 4: Sketch of the wildfire affected area. During the wildfire, the trees in the less inclined upper rockwall (1) and in the vertical rockwall (2) show indicators for medium fire severity; the protection forest (3) did not get affected by the wildfire. During the fire, rockfalls were detached from the rockface and by falling trees, which reached the houses in the valley floor (4); (a) scree; (b) talus
