Hydrogeomorphological analysis and modelling for a comprehensive understanding of flash-flood damageing processes: [The 9th October 2018 event in North-eastern Mallorca](#)

Abstract. A flash-flood event hit the north-eastern part of Mallorca Island on 9th October 2018, causing 13 casualties. Mallorca is prone to catastrophic flash floods acting on a scenario of deep landscape transformation caused by Mediterranean tourist resorts. As global change may exacerbate devastating flash floods, analyses of catastrophic events are crucial to support effective prevention and mitigation measures. Field-based, remote-sensing and modelling techniques were used in this study to evaluate

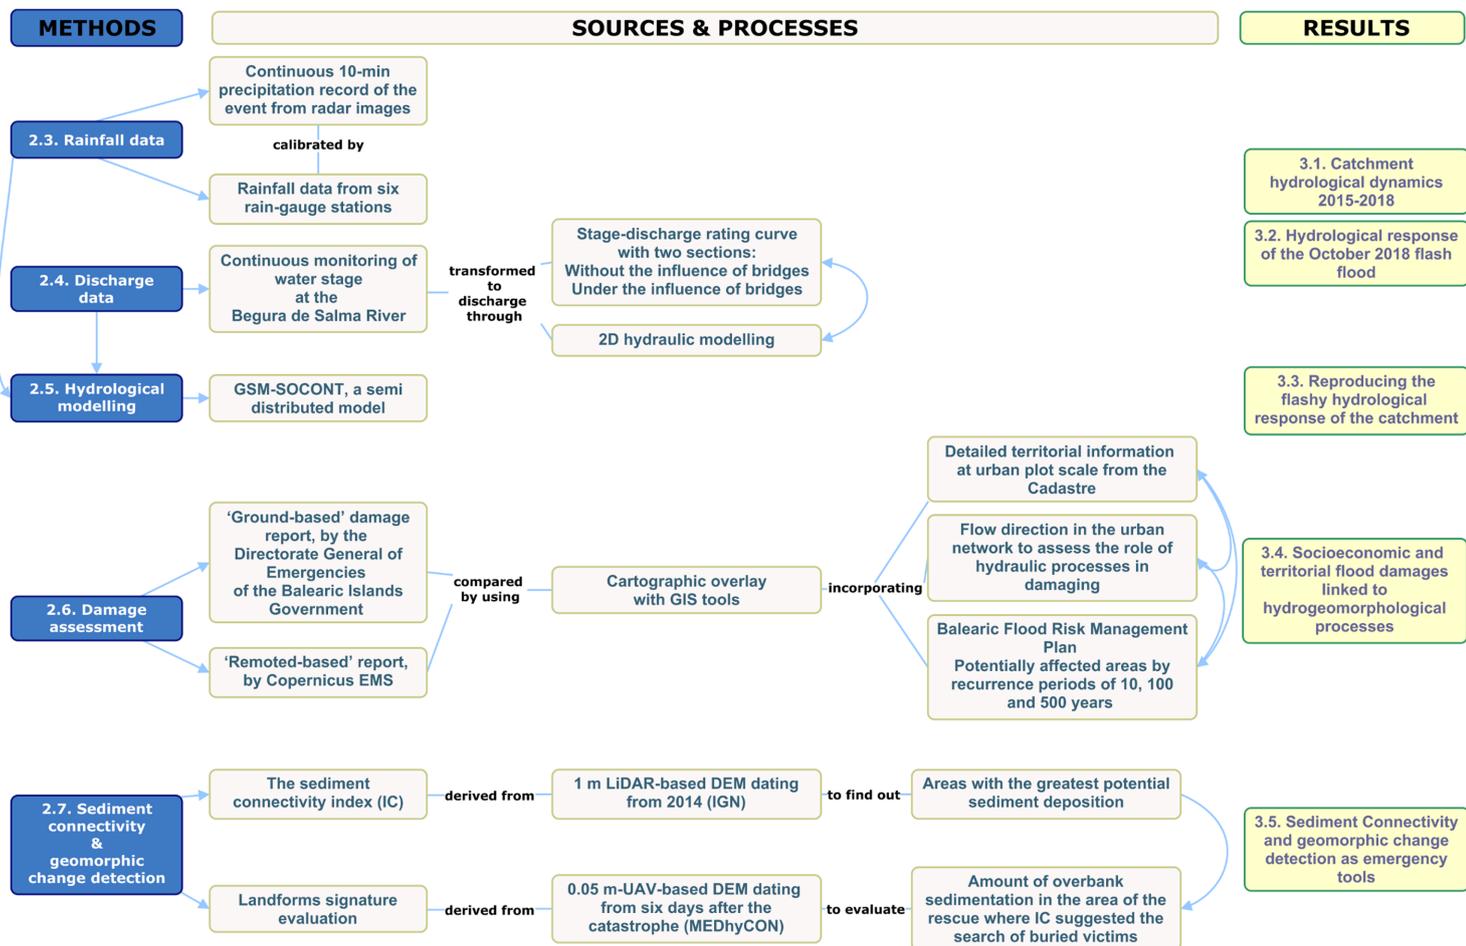
Figure 1 Workflow of the experimental design.

To obtain a better understanding of the flash flood and damage processes, a comprehensive and combined analysis of the meteorological synoptic situation, precipitation and discharge was developed through the analysis of the rainfall-runoff processes at a small spatial scale during this extreme event. Likewise, this analysis was linked to hydrological modelling to check the internal consistency of the information gathered by instruments and to flood damage and losses at Sant Llorenç des Cardassar village. Finally, high-resolution digital elevation models (HR-DEM) were generated by LiDAR 2014 data from the Spanish National Geographic Institute and by imagery captured through a low-cost UAV just six days after the catastrophe to calculate a sediment connectivity index (IC) and measure geomorphic changes (Fig. 1).

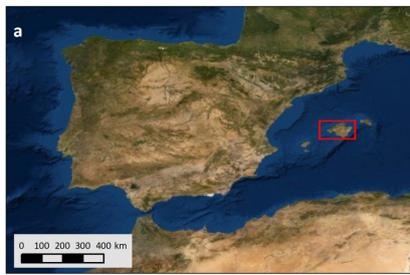
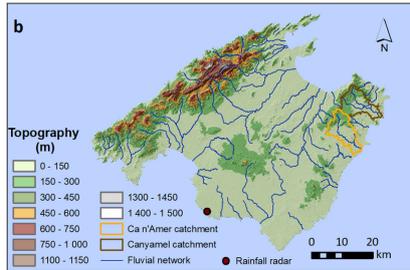
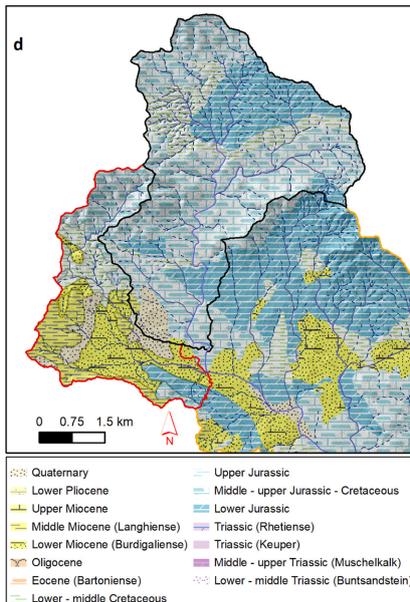
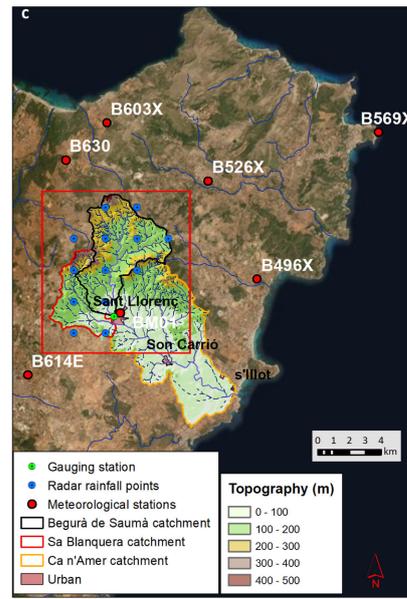
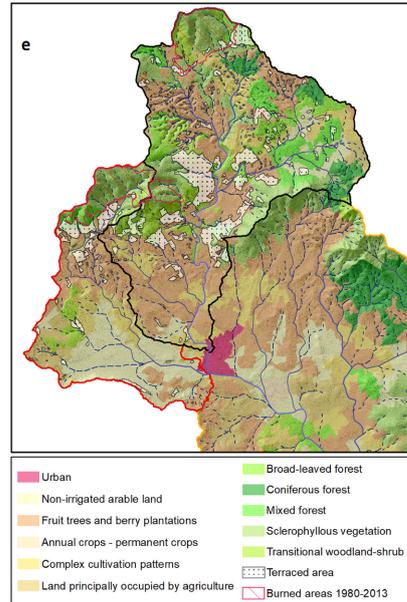
Figure 2 Main characteristics of affected basins during the 9th October 2018 flash-flood. (a) Location of Mallorca in the western Mediterranean. (b) Topography and fluvial network of Mallorca with the location of the main basins affected: Canyamel and Ca n'Amer rivers. (c) Blanquera and Begura de Salma headwater river catchments within the Ca n'Amer River, with locations of rainfall and hydrometric stations; and radar rainfall points derived from a regular mesh of 1x1 km. Source: <https://opendata.aemet.es>. Background: aerial photography and DEM data (PNOA, 2015). (d) Lithology of both Blanquera and Begura de Salma catchments. (e) Land uses and terraced areas for the same headwater catchments. Source: Corine Land Cover (2018).

headwaters. Terraced fields still occupied 10% of the catchment, although most of them were abandoned (Fig. 2e). In 1956, natural vegetation covered 21% of the catchment. This rose to 42% in 2012 due to an afforestation process of former agricultural land in the second half of the twentieth century. In
195 combination with other factors, afforestation triggered a higher fire risk: two wildfires burned an area of
1.7 km²: 17% in 1983 and 83% in 2011 (Balearic Forestry and Soil Conservation Service,
<http://xarxaforestal.caib.es>; Fig. 2e). The climate of the area is classified as Mediterranean temperate sub-
humid on the Emberger scale (Guijarro, 1986). Mean annual rainfall (1968-2018, B630 AEMET station,
see Fig. 2c) is 652 mm y⁻¹. A rainfall amount of 140 mm in 24 hours was estimated to have a recurrence
200 period of 25 years (YACU, 2003).

The 9th October storm affected the two northernmost catchments of ~~the~~ Llevant County; i.e., the Ca
n’Amer and Canyamel Rivers (Fig. 2) with 9 and 4 casualties respectively and significant damages. The
205 synoptic situation was ~~characteristic of like the situations generating~~ flash-flood events in the Western
Mediterranean (Fig. 3a). A cut-off low at mid-level was located in the eastern part of the Iberian Peninsula
and ~~a shallow low-level pressure was affect~~~~ed~~~~ing~~ the same region, driving warm and wet air from the
Mediterranean Sea to ~~the~~ Balearic Islands and the eastern part of the Iberian Peninsula. This occurred in
early October, when the sea surface temperature is close to its annual maximum in the Western
210 Mediterranean, providing high quantities of moisture. Moreover, the cut-off low showed a typical
divergence at mid-levels on its eastern flank, affecting the Balearic Islands and favouring the development

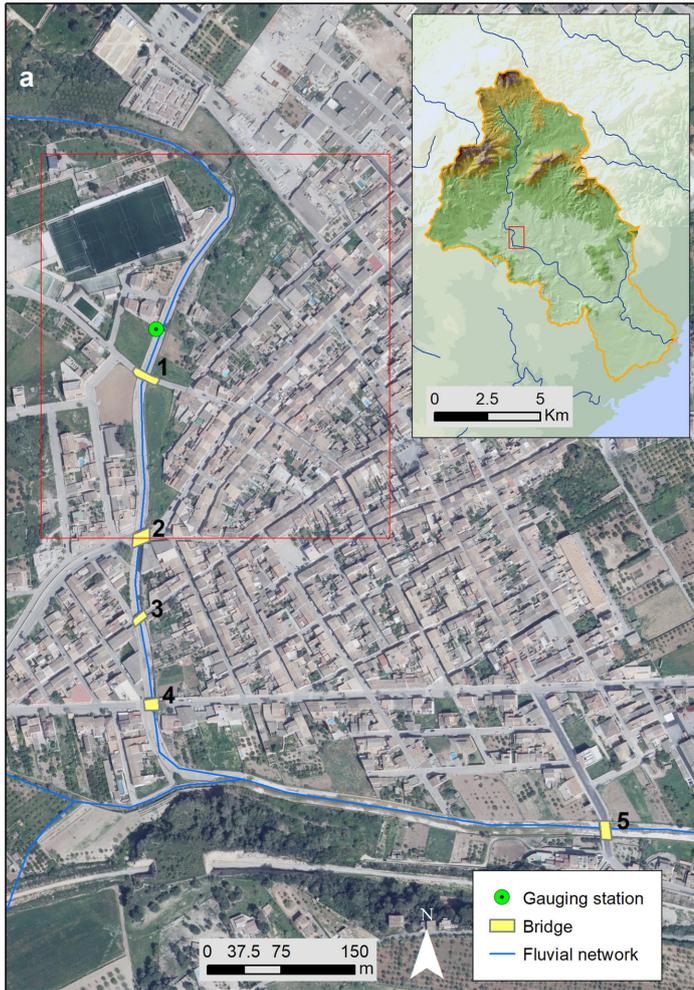
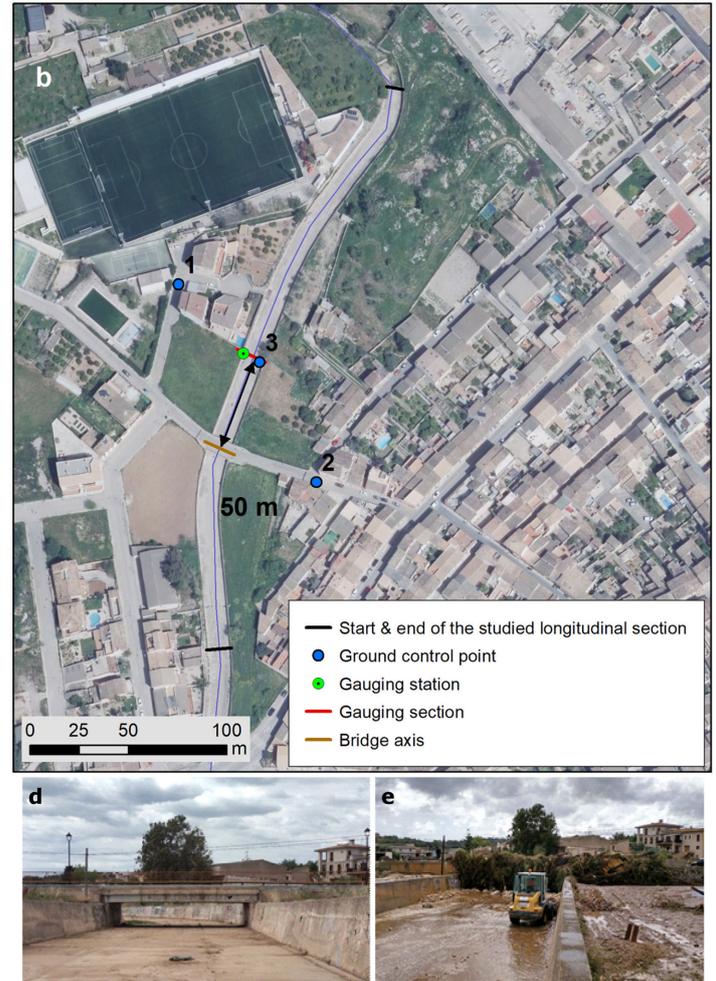
Figure 4 (a) Aerial view of the concrete channeling of the Begura de Salma River that crosses Sant Llorenç des Cardassar village and the location of bridges. (b) Detailed aerial view of the very beginning of this concrete channeling, where the hydrometric station is located. The photographs show a view of Bridge 1 from the hydrometric station when (d) the digital equipment was installed, on 10th June 2015 and (e) a few hours after the flash flood, on 10th October 2018. Background: aerial photography and DEM data (PNOA, 2015).

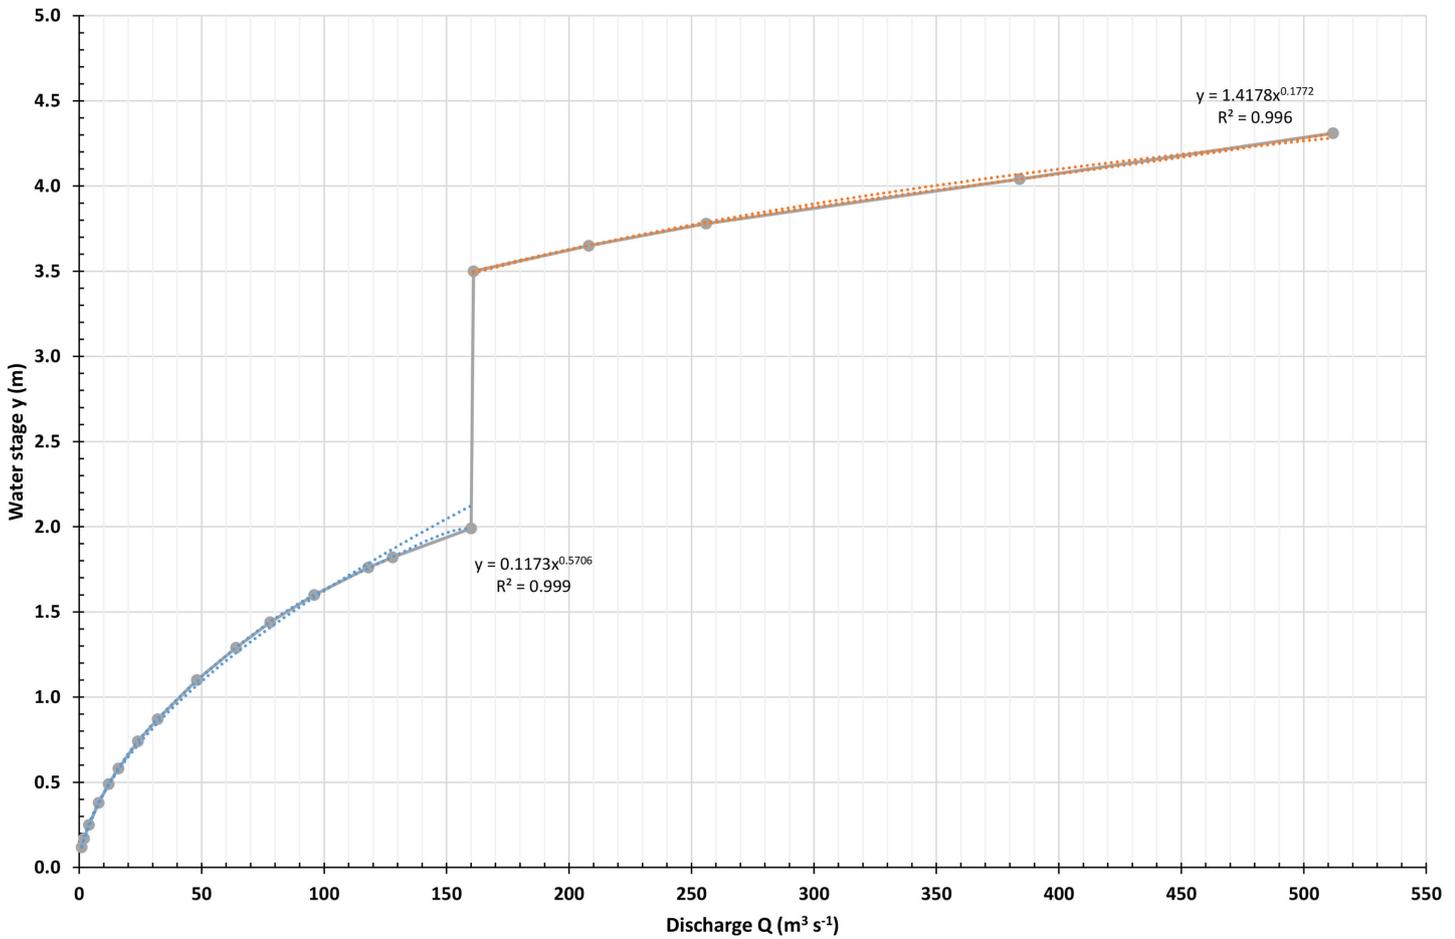
1270 **Figure 5** Stage-discharge rating curve performed by means of two-dimensional hydraulic modelling with two differentiated sections in accord with the influence of Bridge 1 (see Figure 3a) and its potential obstruction.

The SDRC was finally designed (see Fig. 5), showing clearly the two differentiated sections with a gap between them in WS of ca. 1.5 m because 1.4 m is the edge of Road Bridge 1 located just 50 m downstream from the hydrometric station. The SDRC is fitted to a power equation for both sections, obtaining high values of significance ($R^2 > 0.990$). Thus, in the case of the first section of the SDRC, the
360 adjustment was $R^2 0.999$, operating in open channel flows up to $160 \text{ m}^3 \text{ s}^{-1}$ in bankfull conditions or even overbanking the channeling, but always without the bridges' influence. The second section, with a $R^2 0.996$, defined for $Q > 160 \text{ m}^3 \text{ s}^{-1}$, was already influenced by the presence of the bridges, i.e. ~~That is~~ in open channel flows but conditioned by the backwater generated in the flow under pressure inside the span of Bridge 1 as well as over its concrete decks.

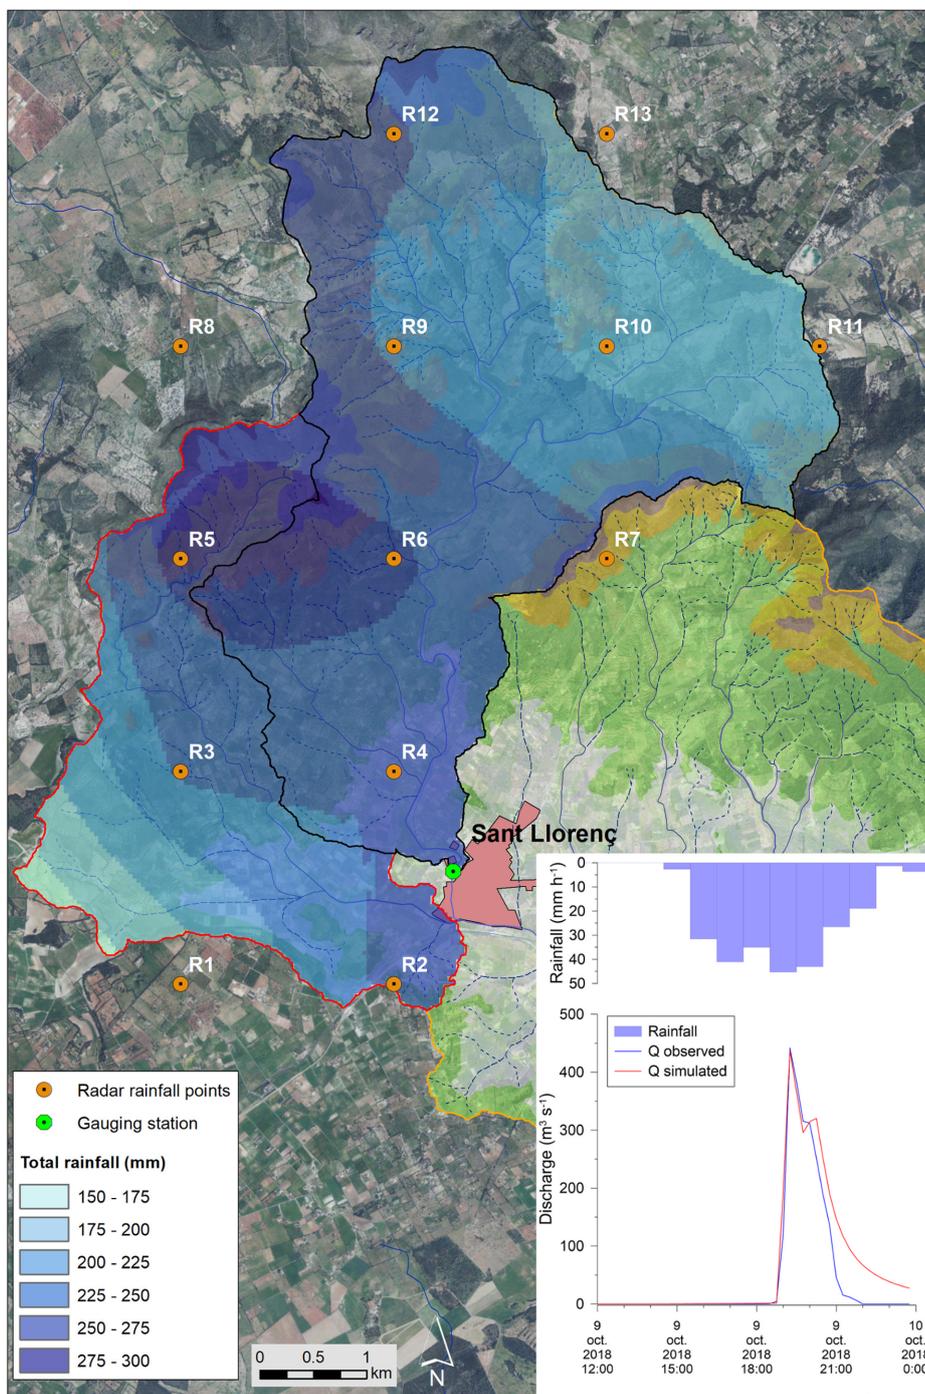
Figure 7 Map of isohyets of the rain storm of 9th October 2018 in the two headwater catchments of the Ca n'Amer River; i.e. the Blanquera and Begura de Salma rivers. Source: 10-minute radar images obtained from the web <https://opendata.aemet.es/>. The inset figure ~~illustrates~~ ~~shows~~ the ~~observed~~ discharge measured at the MEDhyCON hydrometric station, as well as the result of the rainfall-runoff simulation using a modified version of the GR3 model. Background: aerial photography and DEM data (PNOA, 2015).

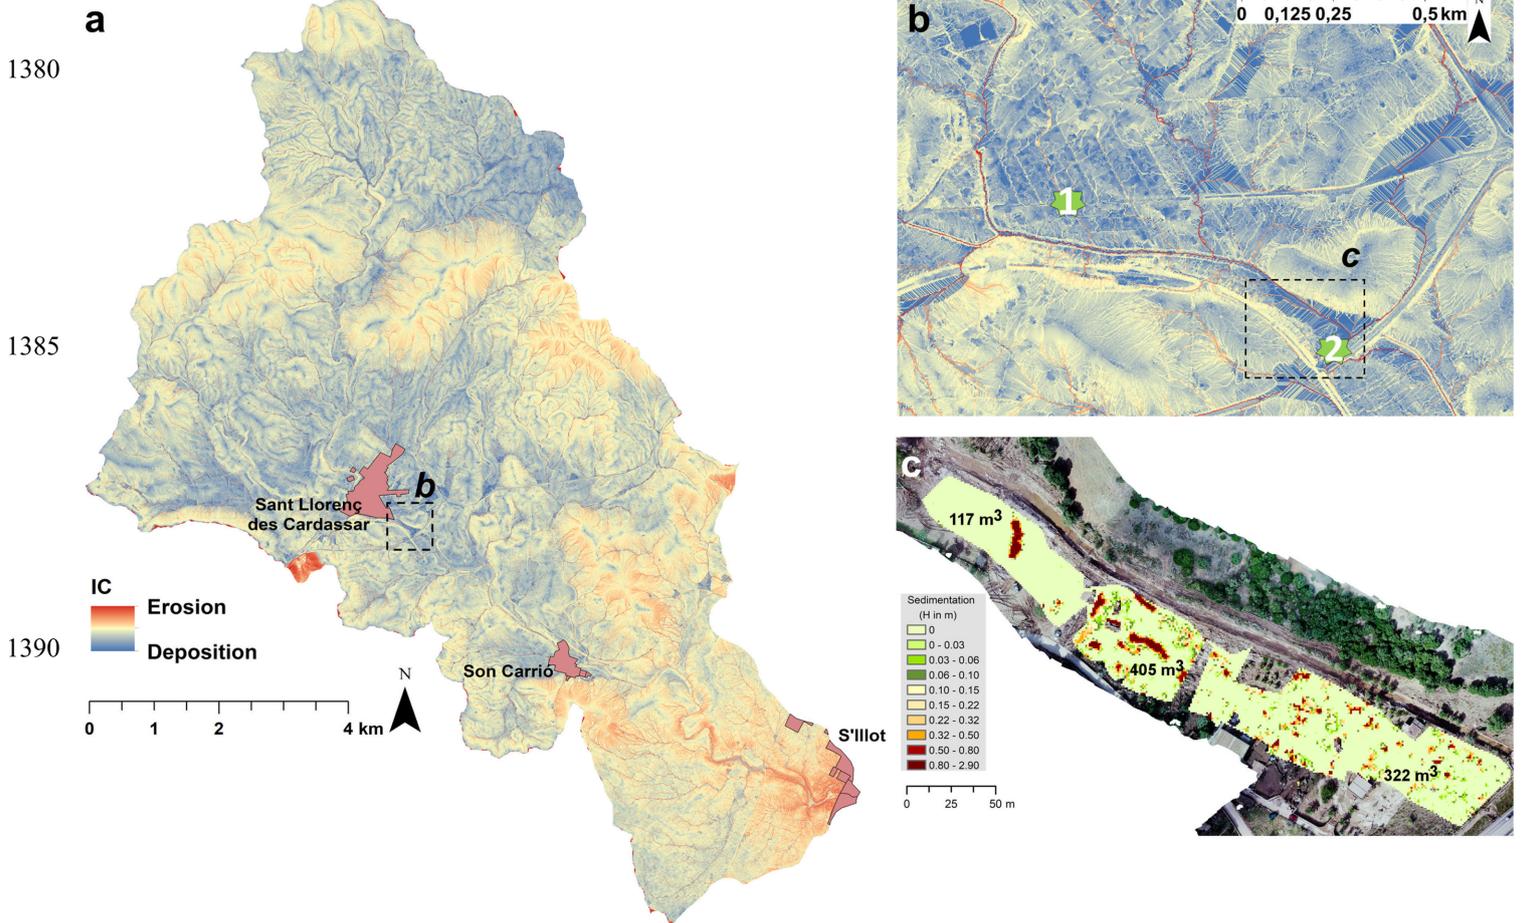
1395 **Figure 9** Spatial patterns of hydrological and sediment connectivity (deposition zones in blue colours)
 (a) in the Ca n'Amer River basin, (b) in the south-east part of Sant Llorenç des Cardassar with numbers
 indicating (1) the point where the missing person was last seen and (2) where this person was found by
 using this connectivity index from a 2-m resolution digital terrain model (MDT) ~~of 2-m resolution~~
 (Instituto Geográfico Nacional, 2014). (c) Overbank sedimentation estimated after the flash-flood from
 a DEM performed with SfM from a UAV flight (15th October 2018) in relation to the ground points of
 the 2014 LiDAR data. Back-ground aerial orthophotography of ca. 2 cm resolution also obtained ~~also~~
 from the drone images. Numbers indicate the total volume of deposited sediments in the three areas
 measured ~~areas~~.

n’Amer River basin but was only analysed from the point where the missing person was last seen (Fig. 9b, point 1). That was the exact point where the car in which he was [drive](#)~~circulating~~
645 [the](#) flood wave. Therefore, the preferential water and sediment paths most likely to be followed by the flood flows were identified, as well as the most important deposition areas downstream from the last point
[the](#) person was seen. The most likely deposition zone was identified and immediately communicated to

the Emergency Authorities, upstream from the bridge of the road Ma-15 which crosses the Ca n'Amer River about 1 km below Sant Llorenç des Cardassar. The search activities concentrated on that area, which is where the last victim was found (Fig. 9b, point 2) when the Emergency Authorities had decided to move their search activities to the mouth of the Ca n'Amer River and beyond into the Mediterranean. In addition to the ability of HR-DEMs to ~~the~~-improve sediment connectivity as a powerful tool to determine ~~the~~-preferential flow-paths and deposition areas, the present study evaluated the landforms signatures of the event by using UAVs as a ~~tool for a rapid~~-response ~~tool for~~ post-catastrophe search and rescue tasks along the whole downstream section of the Ca n'Amer River from the village of Sant Llorenç des Cardassar, in order to measure effectively the sediment deposits generated by the flash flood and to locate and quantify the most important deposition areas downstream from where the person was last seen. As the last missing person was found by using the connectivity index, in the end the sediment deposition ~~measurement~~~~quantification~~ was not needed during the Emergency operation. However, this study checked its validity by assessing the floodplain area where the last person was found. Accordingly, ~~for the elevations of~~ each of the 7103 LiDAR points on the right bank of the Ca n'Amer River ~~were~~~~the elevation was~~ compared. From the differences interpolated (TIN), an elevations raster for a total volume of 844.28 m³ was calculated, for an area of 12,254 m². The irregular distribution of the sediments in Fig. 9c responds to the rescue mobilisation. In the gaps visible in the sedimentation area of Fig. 9c, vehicles and search machinery were removed and not included in the volumes.
