Authors Response

Runup, Inundation, and Sediment Characteristics of December 22 2018 Indonesia Sunda Strait Tsunami

Abstract. A tsunami caused by a flank collapse of the southwest part of the Anak Krakatau volcano occurred on December 22, 2018. The affected area of the tsunami included a coastal area located at the edge of Sunda Strait, Indonesia. To gain an understanding of the tsunami event, field surveys were conducted a month after the incident. The surveys included measurements of runup height, inundation distance, tsunami direction, and sediment characteristics at 20 selected sites. The survey results revealed that the runup height and inundation distance reached 7.8 m and 292.2 m, both was found at Site Cagar Alam, part of Ujung Kulon National Park. Tsunami propagated radially from its source and arrived in coastal zone with direction was between 25° and 350° from North. Sediment samples were collected at 27 points in tsunami deposits with a sediment thickness of 1.5-12 cm. The distance of the sediment deposit area from the coast was 40%-90% of the distance of the inundation caused by the tsunami. The highest elevation of deposits was 60%-90% of the highest runup. Sand she

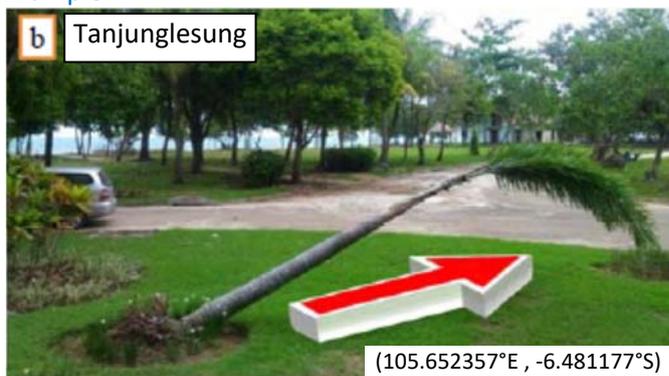
Example

Figure 4 and Page-4, Lines 27-35: Can you please indicate the survey point IDs of the arrows shown in Figure 4 as well as the ones stated in these lines such as “Tanjung Lesung (sites 7-13)” or, for example, where is this Tanggamus area? Then, the statements in these lines on Page 4 will make sense while reading and looking at the figure.

Yes, we can put the point IDs for each arrows in Fig 4. Also add the position of location mentioned in Page 4 but not shown in Fig 4 such as Tanggamus, Sertung island and Indian Ocean. Thanks for kind recommendation.

Figure 4 revised.

Figure 4: Direction of tsunami propagation, the tsunami spread radially from its source. Numbers shown are survey site numbers.

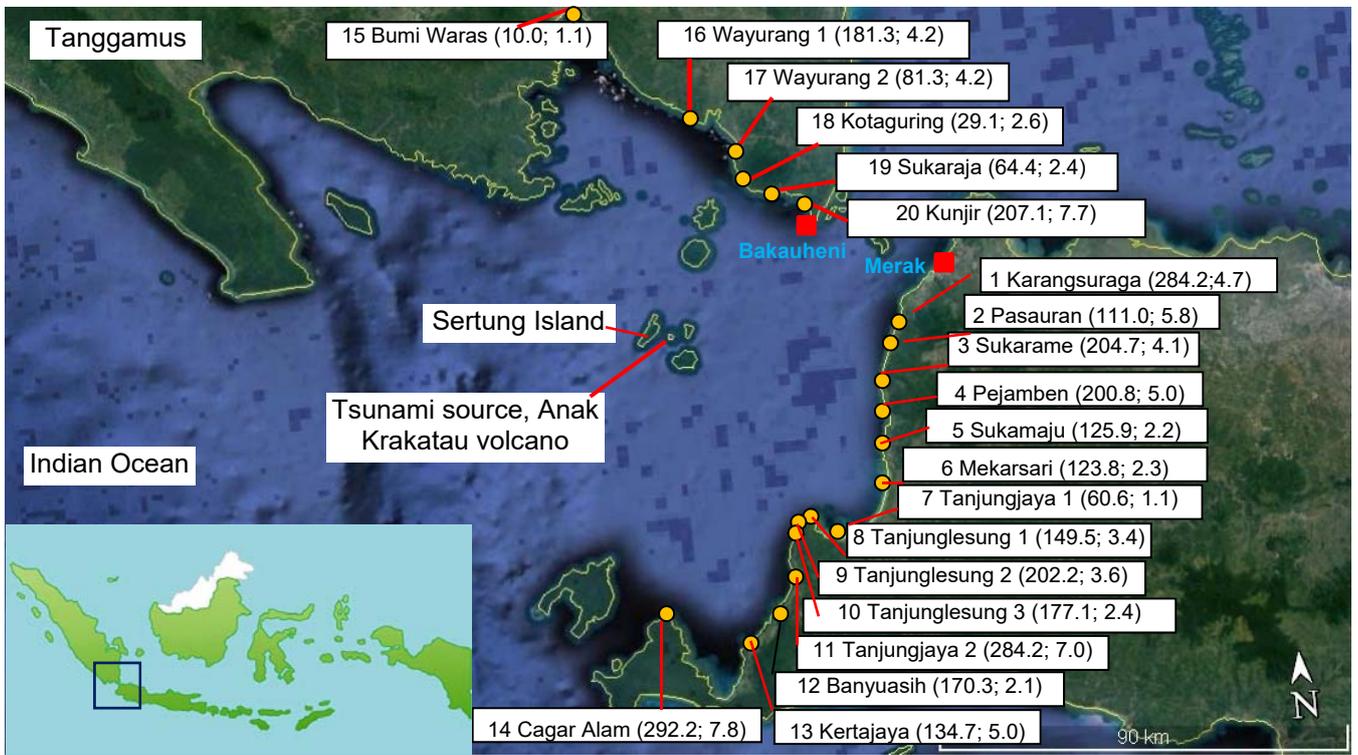
Figure1: Locations of field surveys. Sunda Strait lies between Java Island and Sumatra Island in Indonesia. Site numbers are followed by site names. Numbers in brackets indicate inundation distances and run-up heights in meters, respectively.

Page 2, Line 13: please show two locations “Merak” and “Bakahueni” in Figure 1.

Thanks for suggestion. Merak and Bakahueni are ferry ports with crowded traffic. They are important place to show. We add legends in Figure 1 in mark-up manuscript to show the two locations.

The measurement results from our field surveys show that run-up ranged from 1 to 9 m (Table 1 and Fig. 1). A runup height of about 1 m was found in many locations, at which no damage was found. The highest runup was found at the Tanjung Jaya 2, Cagar Alam, and Kunjir sites, with heights of 9.0, 7.8, and 7.7 m respectively. Site Tanjungjaya 2 is located in Cipenyu Beach. Muhari et al. (2019) reported maximum runup height of 13 m in area around Tanjungjaya/Cipenyu Beach as well. This value is significant different with our maximum run-up since we measure in flat valley part of Cipenyu Beach while Muhari et al. measured in hilly coast of Cipenyu Beach.

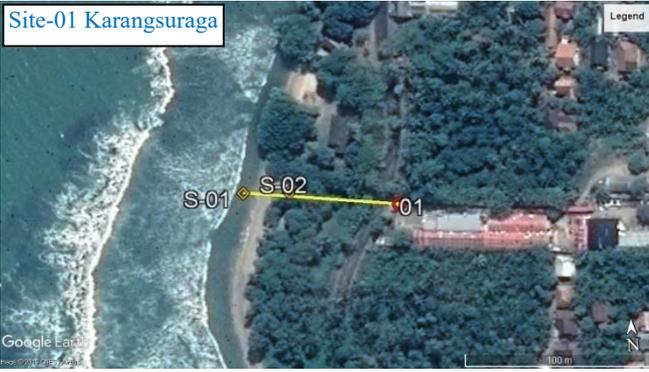
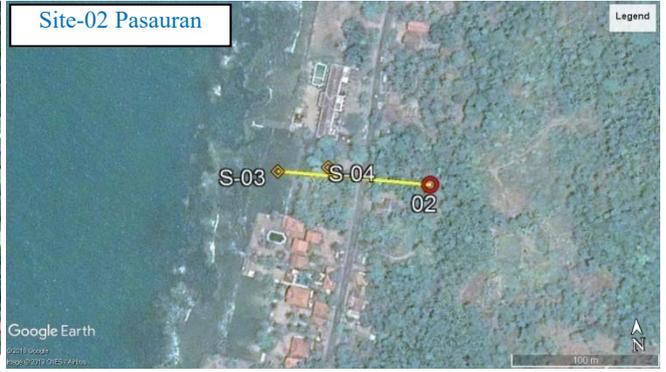
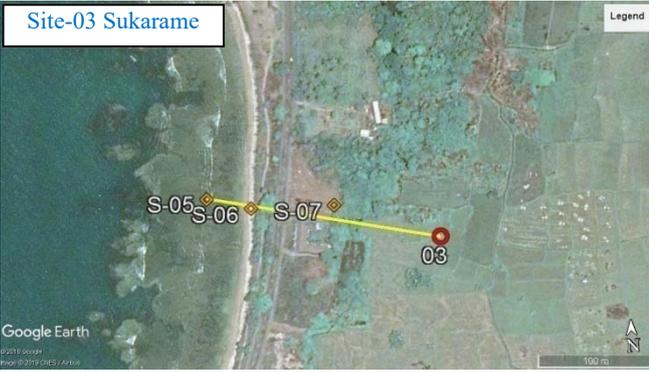
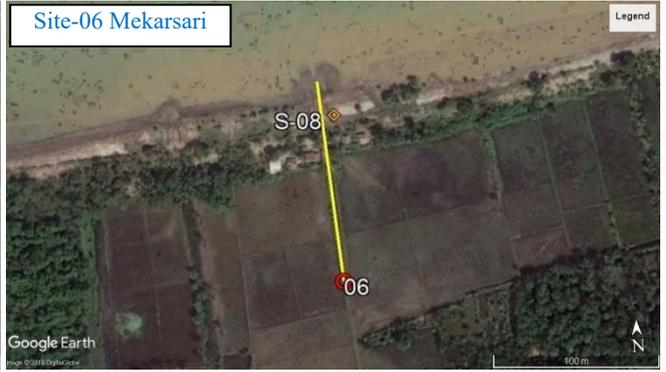
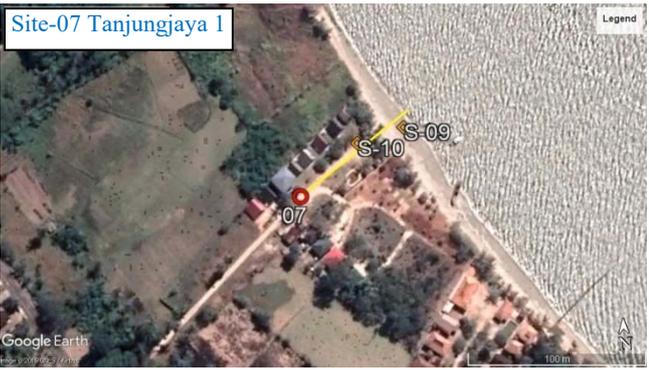
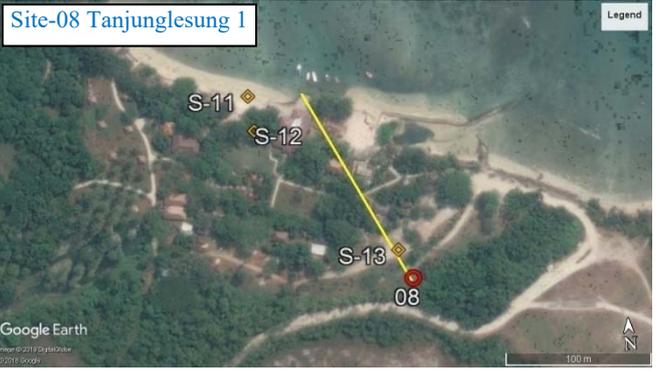
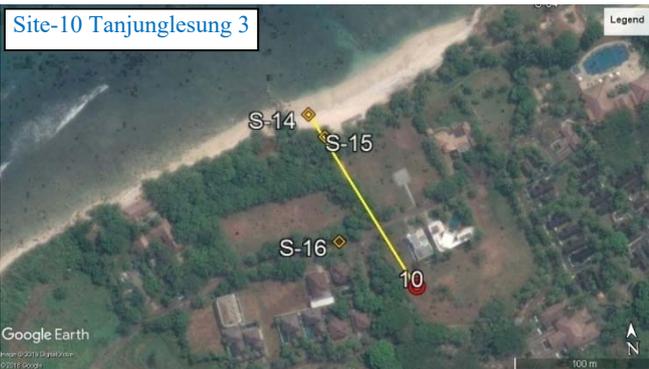
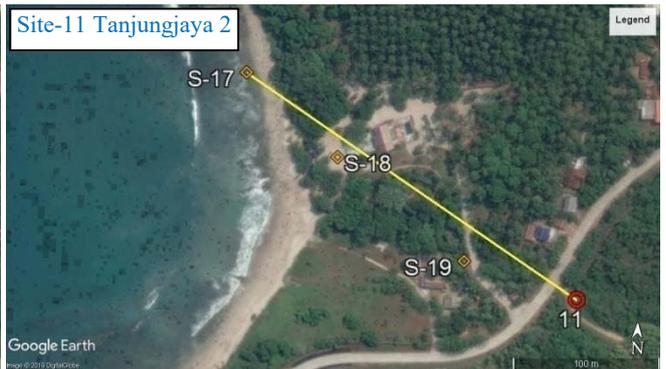
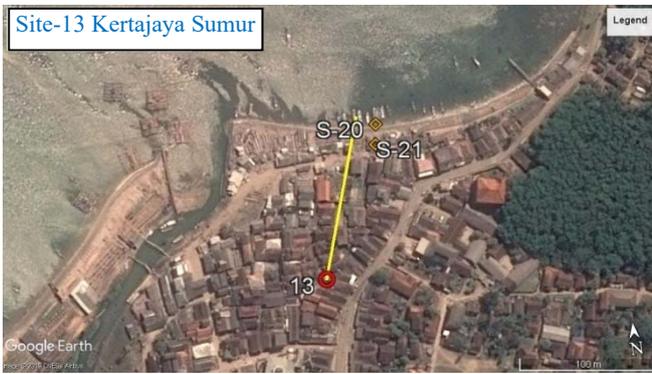
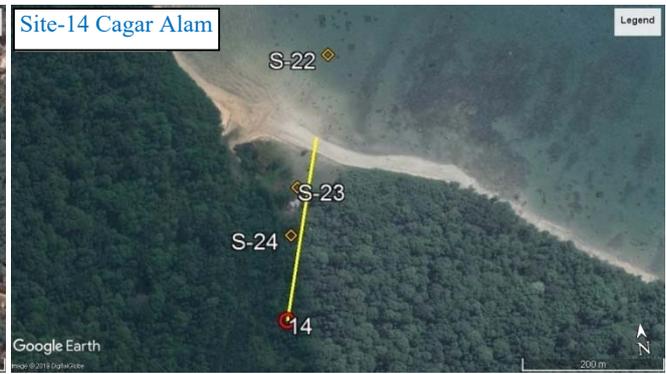
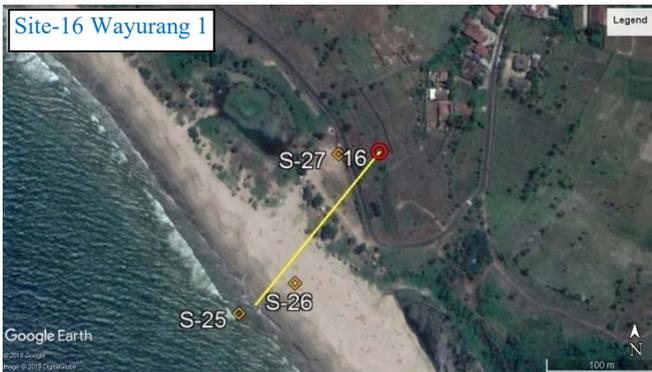
Highest point of run-up, Nearby number is survey site numbers
	Sediment test pit
S-xx	Sediment sample number
	transect

5 Figure 2: Aerial photographs from Google Earth of transects including highest run-up point and deposit pit.

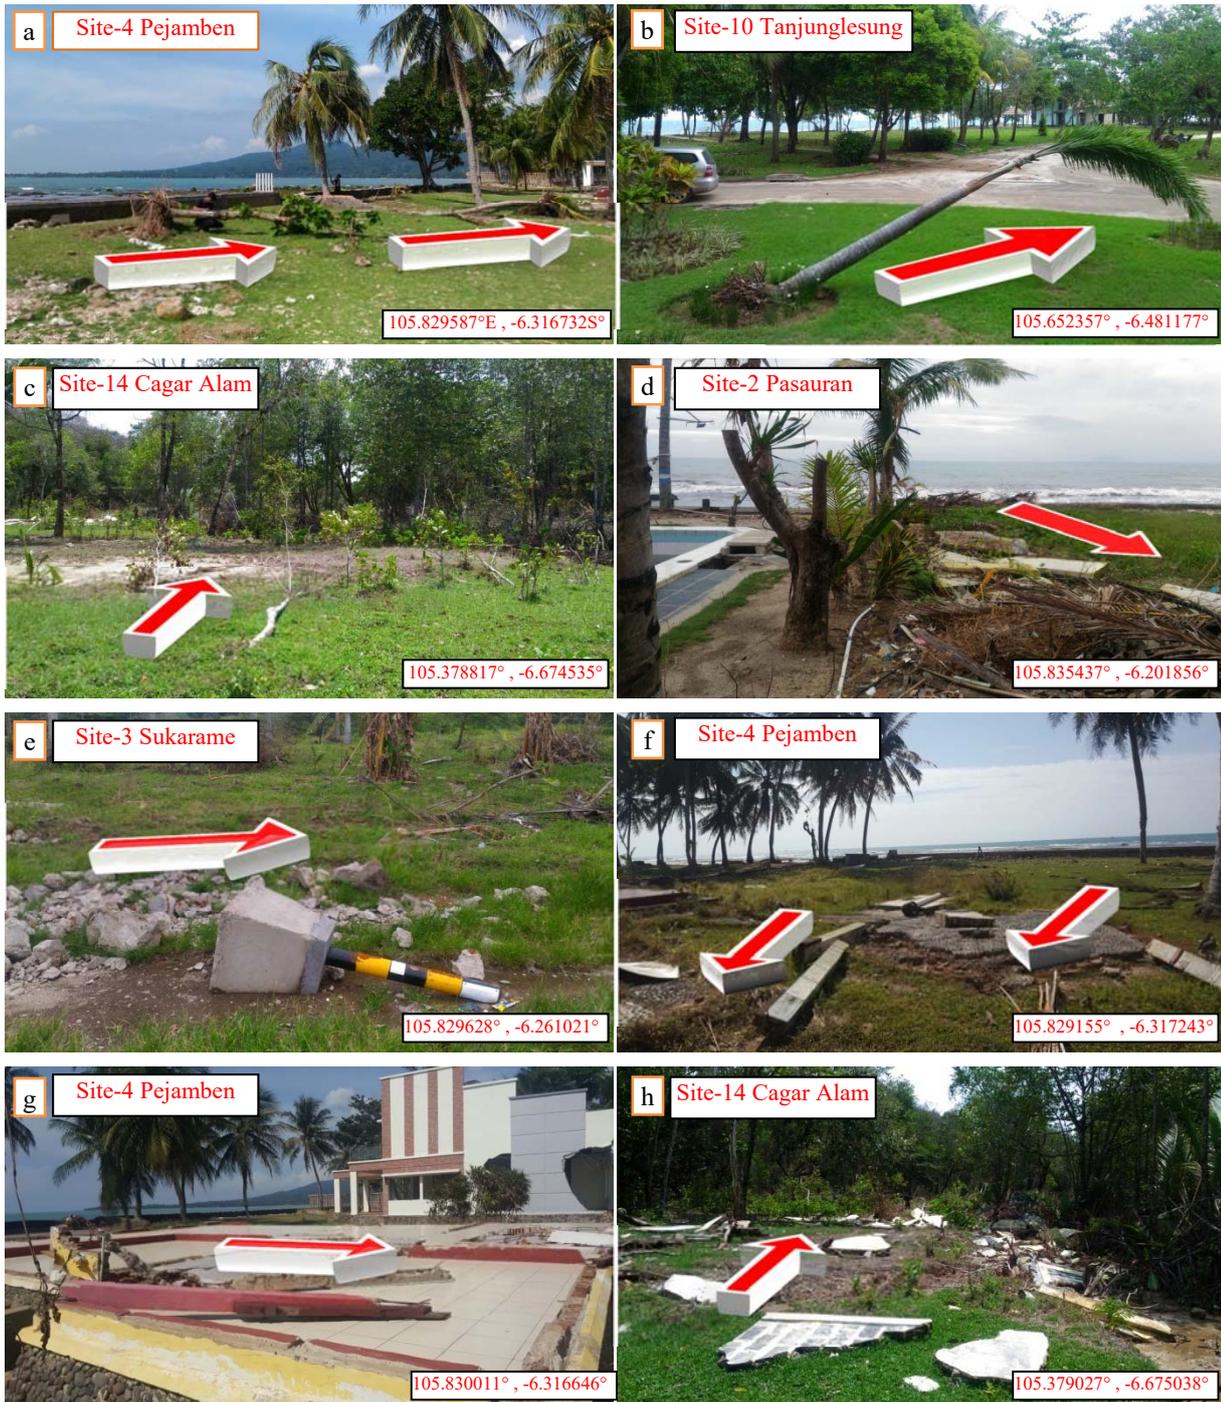
10 Figure 3: Evidence of tsunami direction. Arrows show the direction of tsunami flow on the ground surfaces.

Thanks for comment and recommendation. We add the site names and coordinates. Fortunately, we recorded coordinates for each locations, for instance shown by Fig. 3a, a man was recording a coordinates on a fallen tree.

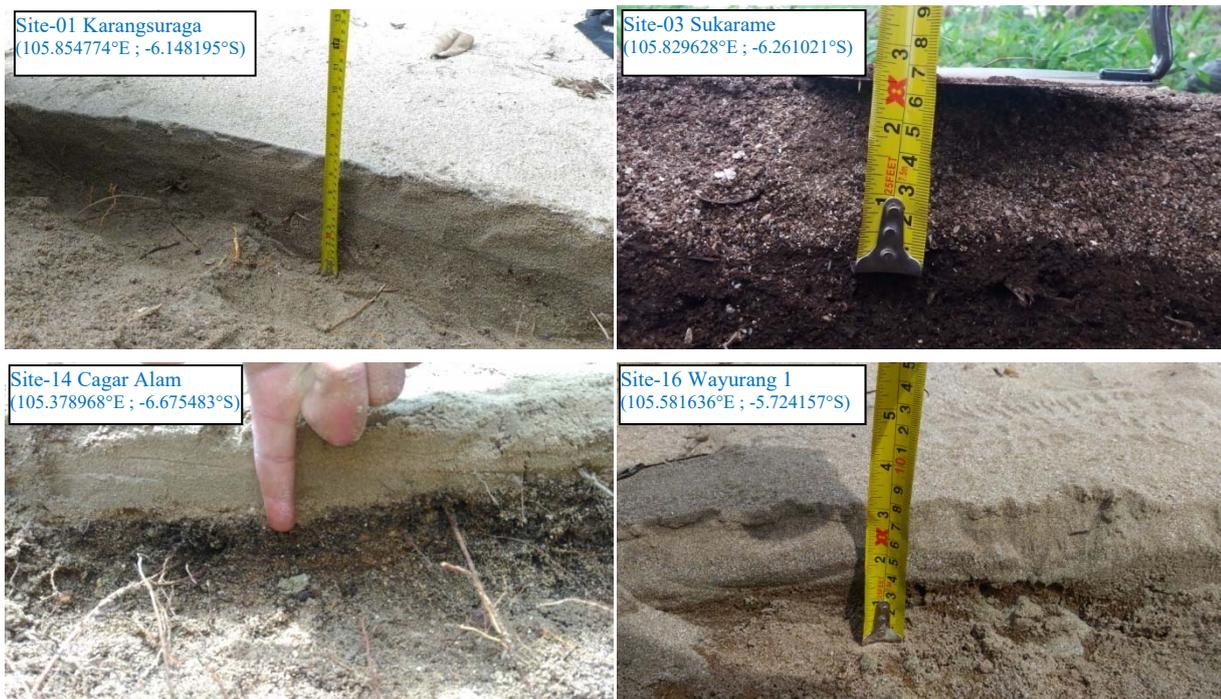
Figure 5: Tsunami sediment deposit, test pits were made to measure the deposit thickness.

The tsunami spread out from its source on the Anak Krakatau volcano to the beaches at the edge of Sunda Strait. To determine the direction of the tsunami that arrived at the beach, we obtained information from eyewitnesses. The tsunami hit at night and thus its arrival was difficult to see. Fortunately, it hit during a full moon period, so that there was some light. In addition to eyewitness accounts, we obtained evidence in the field related to the direction of the tsunami propagation. The evidence was in the form of fallen tree trunks, sloping vegetation and shrubs, damaged buildings, and building components carried away by the flow (Fig. 5).

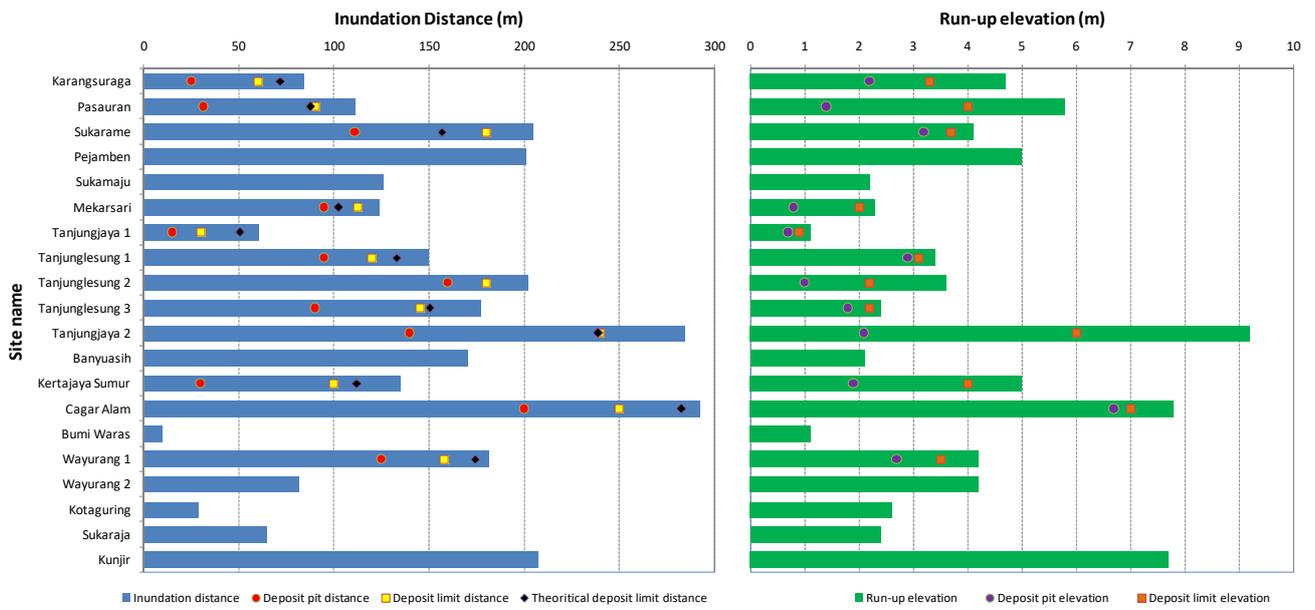
Figure 6: Positions of deposit pits and deposit limit compared to inundation distance and run-up elevation. Theoretical approach for tsunami deposit only available for distance not for elevation.

Fig. 7 shows the distance of measured sediment deposition and water runup compared to the distance of theoretical sediment deposition calculated using Eq. 1 and Eq. 2, the results are in good agreement. However, Sukarame, Tanjungjaya 1 and Cagar Alam do not fit well. The three location have morphological conditions may not ideal for applying the theoretical approach. Sukarame has beach scarp and tsunami flows across a stream around 90 m from coastline. Tanjungjaya 1 has also beach scarp and there is a sea wall, although not so high, that may block the sediment movement. Eventhough Tanjungjaya 1 has abundant material, low amplitude tsunami caused a few sand transport. Cagar Alam has a relative bigger stream than Sukarame. In addition, Cagar Alam has dense vegetation since it is a national park. The distance of area with significant sediment deposits caused

15 where w_s is the settling velocity, T is a period from the time of first wetting to final drying of inundated ground, and H is the tsunami height. Fig. 7 shows the distance of measured sediment deposition and water run-up compared to the distance of theoretical sediment deposition calculated using Eq. 1 and Eq. 2, the results are in good agreement. However, Sukarame, Tanjungjaya 1 and Cagar Alam do not fit well. The three location have morphological conditions may not ideal for applying the theoretical approach. Sukarame has beach scarp and tsunami flows across a stream around 90 m from coastline. Tanjungjaya 1 has also beach scarp and there is a sea wall, although not so high, that may block the sediment movement. Eventhough
20 Tanjungjaya 1 has abundant material, low amplitude tsunami caused a few sand transport. Cagar Alam has a relative bigger stream than Sukarame. In addition, Cagar Alam has dense vegetation since it is a national park. The distance of area with significant sediment deposits caused by the tsunami from the coast varied in the range of 15-200 m (average: 93 m) from the shoreline or 40%-90% (average: 67%) of the inundation distance.

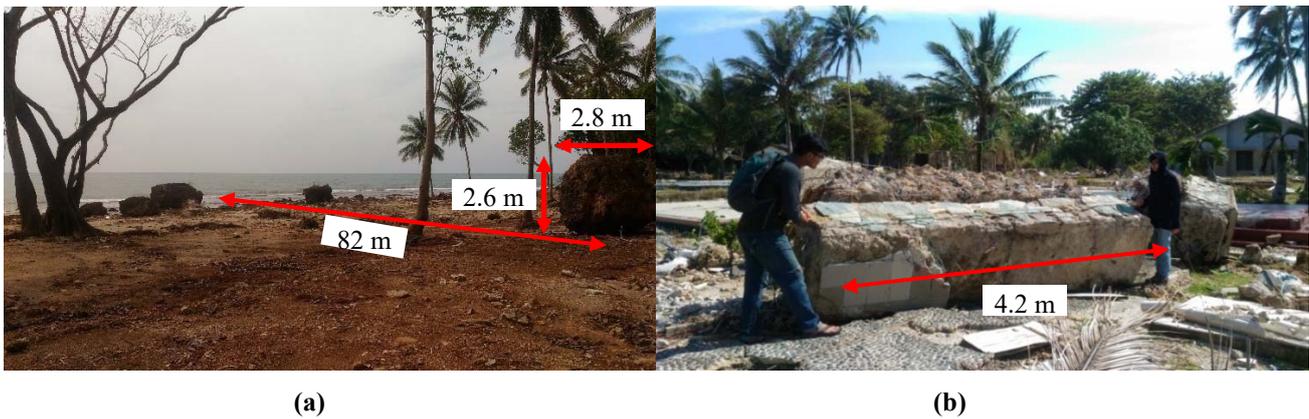
Figure 7: (a) Boulder that moved around 82 m inland in **Tanjungjaya 2** and (b) an element of seawall that moved around 30 m inland in **Pejamben**.

Page 6, Lines 33-34: "and ρ_w is the density of sea water." Unit is missing. "The velocities were calculated **from Equation 3** to be $u \geq 4.5$ m/s and $u \geq 4.0$ m/s for the 10.4-ton (Fig. 8a) and 9.4-ton (Fig. 8b) boulders, respectively." If so, please add the highlighted words.

The largest boulder, measuring 2.7 m in diameter (10.4 tons), was found at site 11 (Tanjungjaya 2), as shown in Fig. 7a. This boulder moved from its original point in the swash zone to 81 m inland. Other smaller stones were scattered around it. In Tanjunglesung (sites 8, 9, and 10), pebbles, cobbles, and small boulders (25-50 cm) were scattered up to 40 m from the coastline. At site 4, the seawall built to protect a hotel and villas was partly destroyed and moved ashore. A seawall chunk, measuring 1 m \times 1 m \times 4.2 m (9.5 tons), made from rubble mound and mortar moved as far as 30 m from its place of origin (Fig. 7b). Other smaller chunks were also moved.

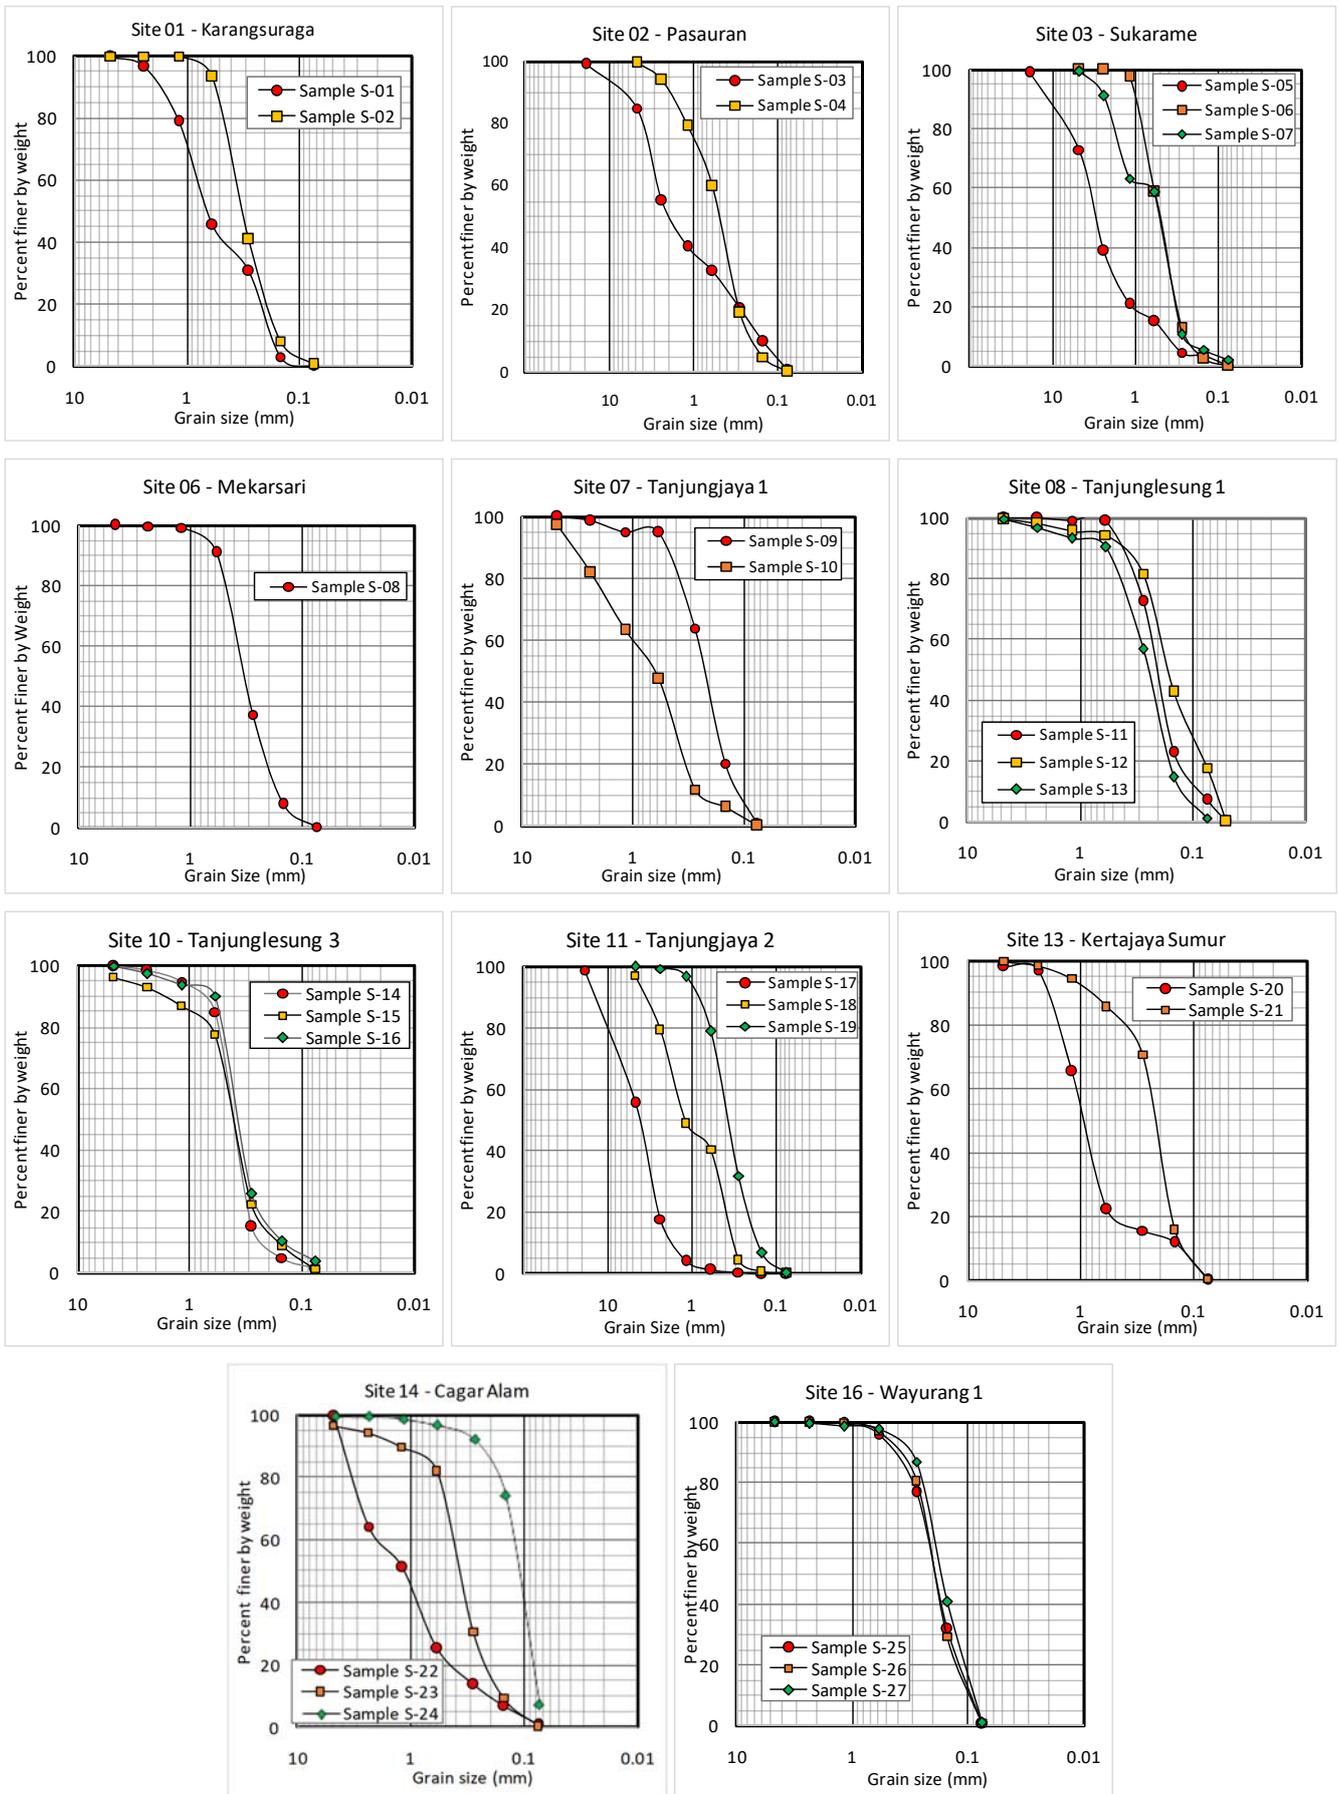
5 Figure 8: Sediment grain size results from sieve analysis for various sites.

40 From our results, the mean values show that medium and coarse were the dominant types of sand in the sample. Very coarse sand, granular sand, and pebbles were found at the Tanjungjaya 2 and Sukarame sites. Fine and very fine sand was also identified at several sites. The range of grain sizes found in the study area depends on the available source material. Wentworth

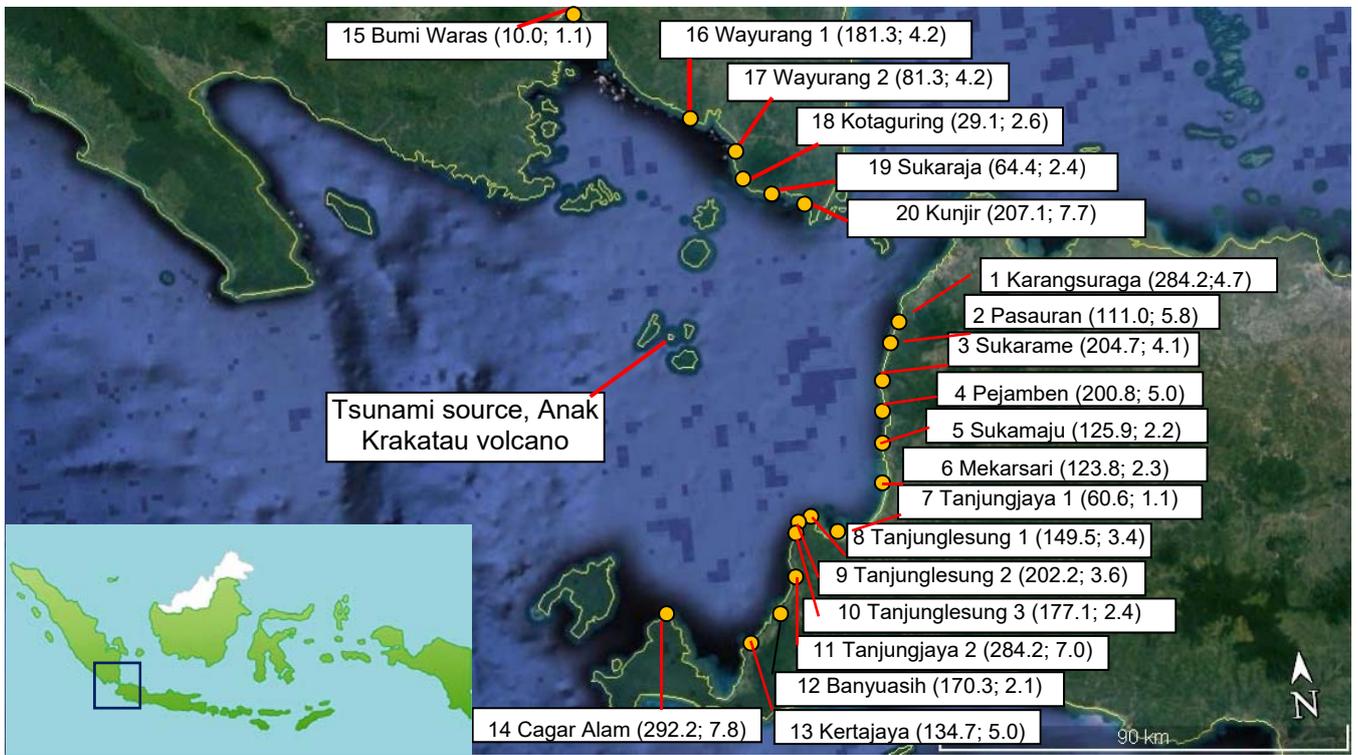
Figure 1: Locations of field surveys. Sunda Strait lies between Java Island and Sumatra Island in Indonesia. Site numbers are followed by site names. Numbers in brackets indicate inundation distances and runup heights in meters, respectively.

The runup was measured by determining the height difference between the highest point of sea water rise onto land and the coastline. Runup is influenced by the characteristics of the ground surface and slope. The measurement results from our field surveys show that runup ranged from 1 to 8 m (Table 1 and Fig. 1). A runup height of about 1 m was found in many locations, at which no damage was found. The highest runup was found at the Cagar Alam, Kunjir, and Tanjung Jaya 2 sites, with heights 40 of 7.8, 7.7, and 7.0 m respectively. The Cagar Alam (sanctuary) site is part of the Ujung Kulon National Park. This site has a

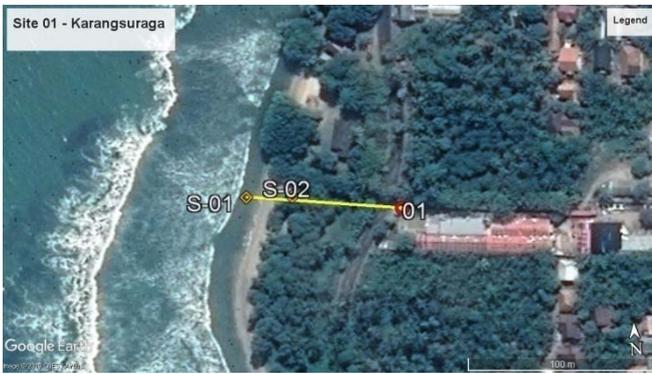
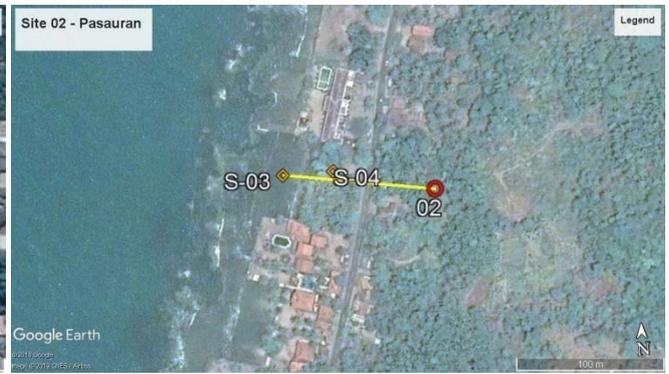
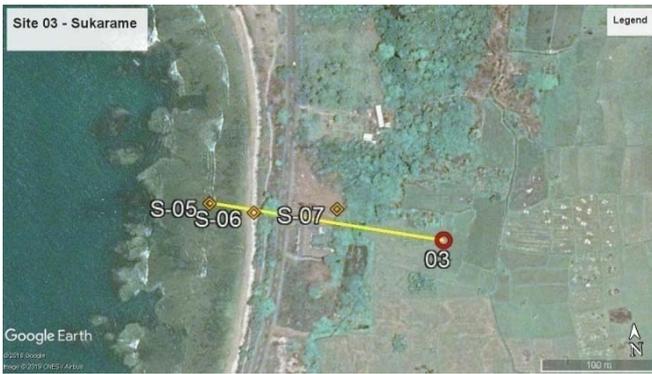
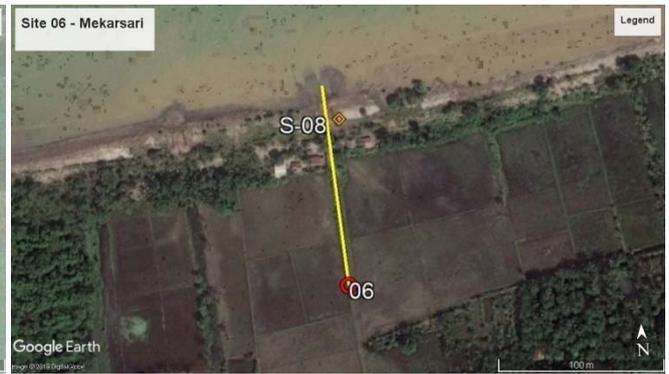
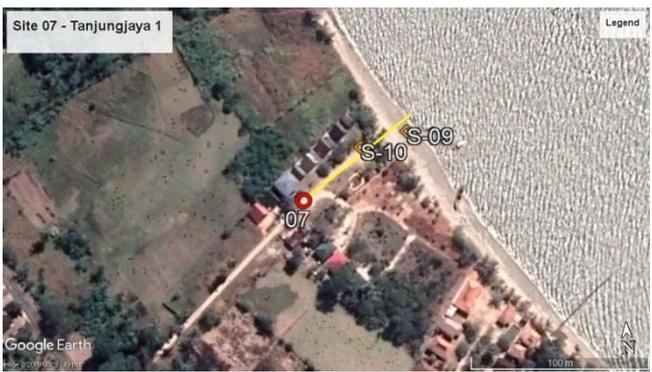
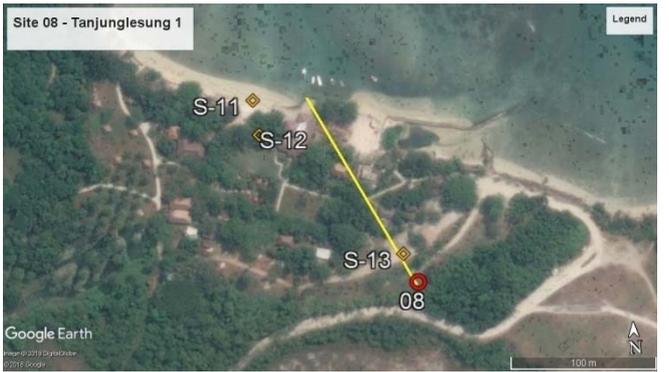
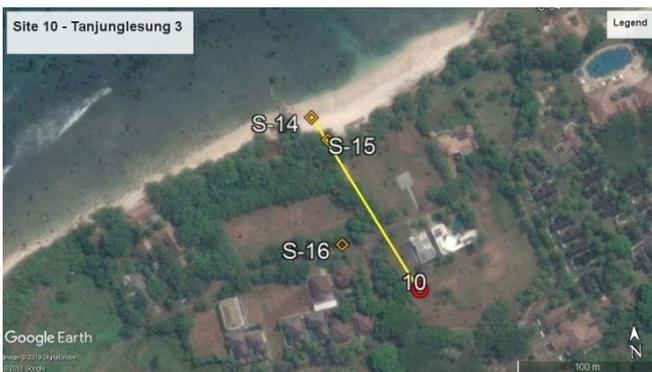
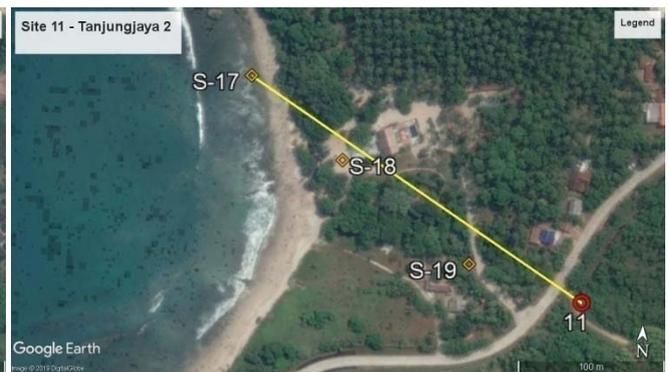
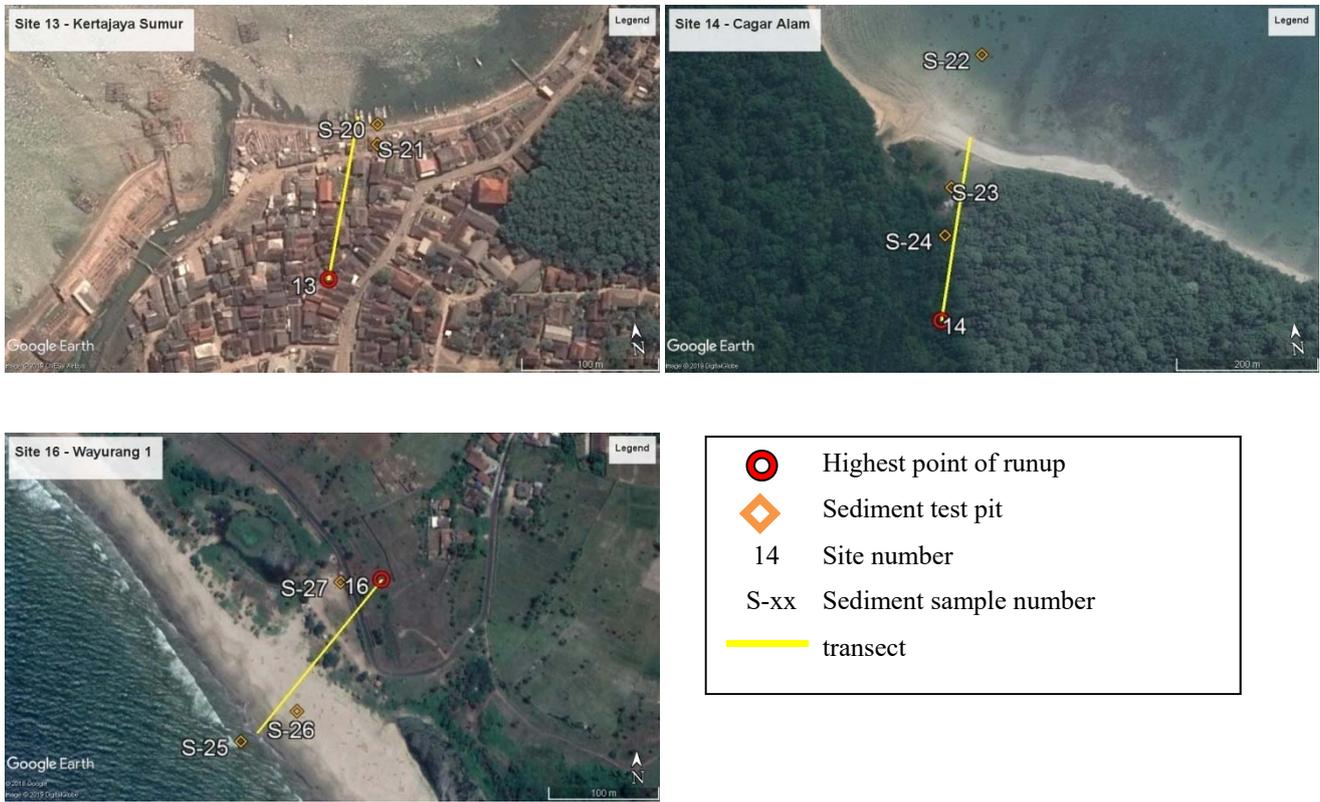
5 Figure 2: Aerial photographs from Google Earth of transects including highest runup point and deposit pit.

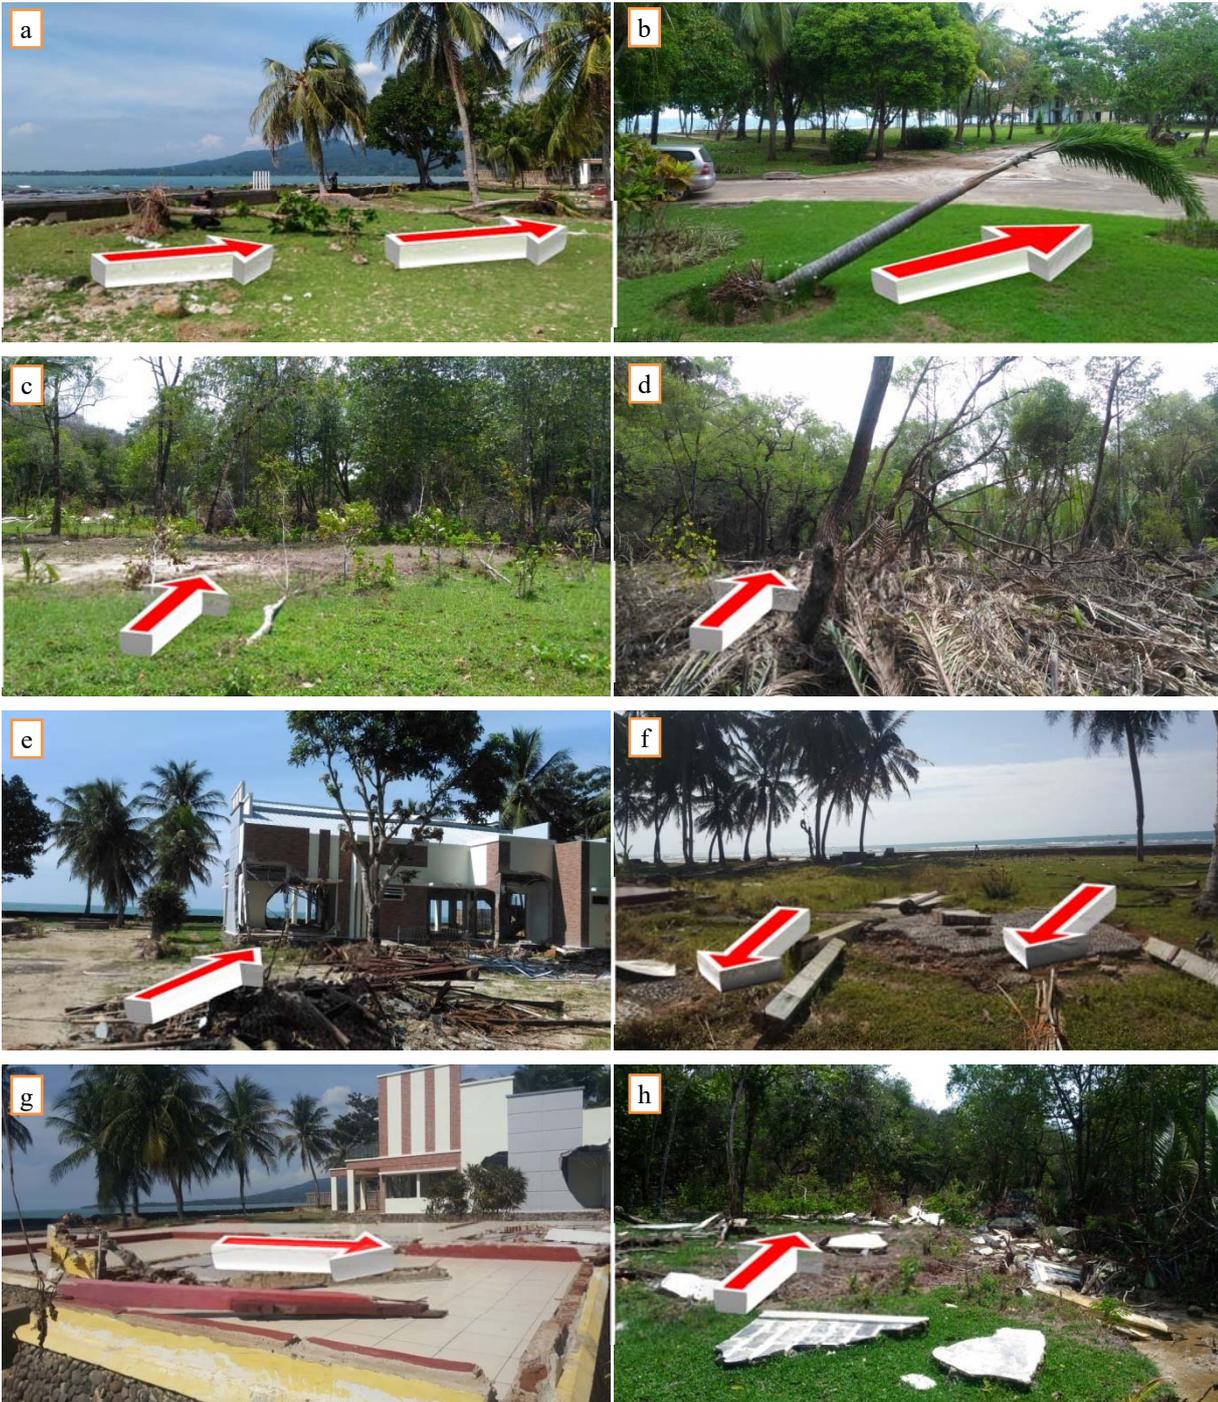
Figure 3: Evidence of tsunami direction. Arrows show the direction of tsunami flow on the ground surfaces.

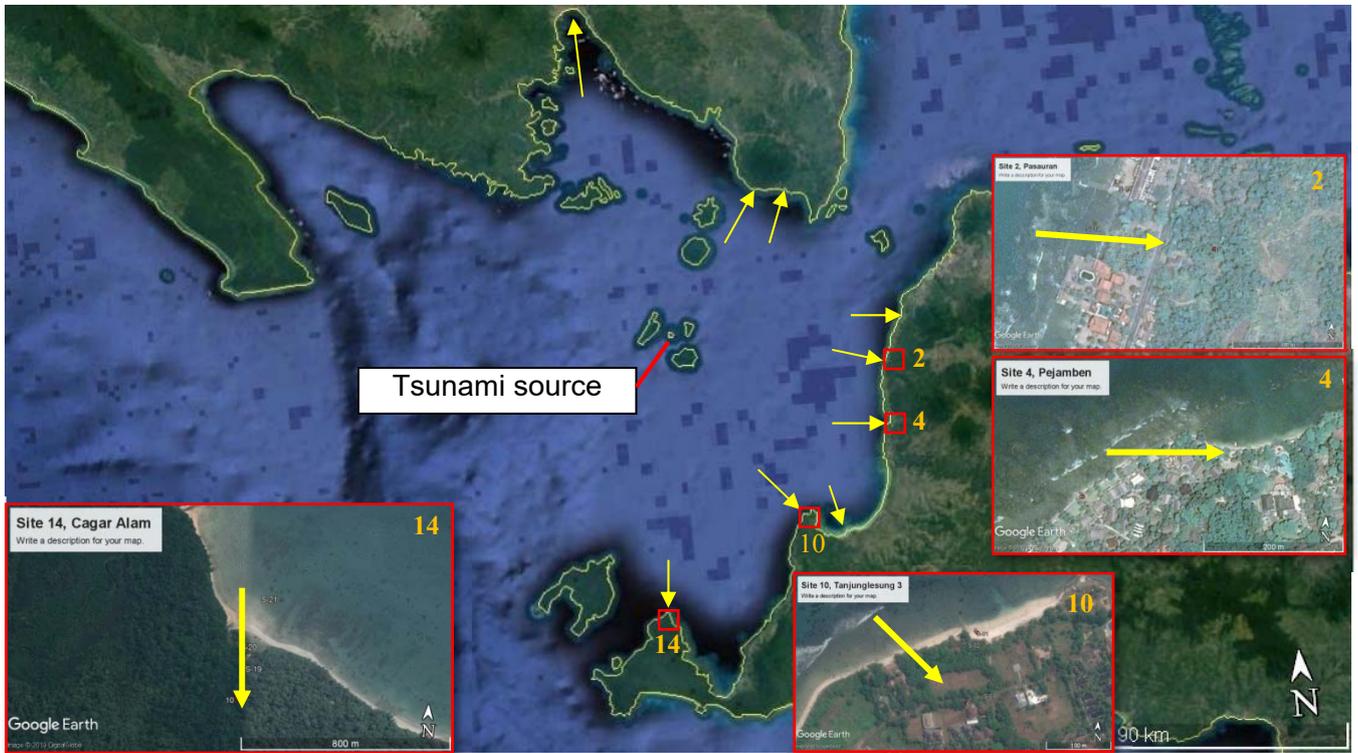
Figure 4: Direction of tsunami propagation, the tsunami spread radially from its source.

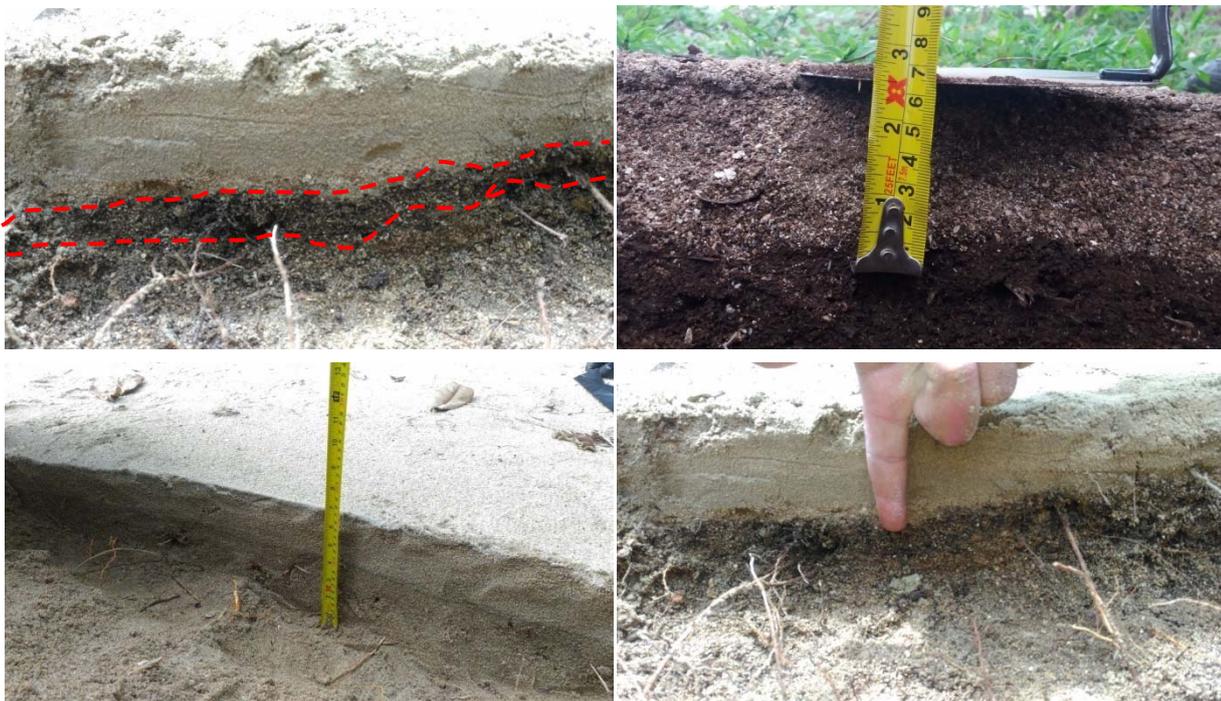
Figure 5: Tsunami sediment deposit, test pits were made to measure the deposit thickness.

The tsunami spread out from its source on the Anak Krakatau volcano to the beaches at the edge of Sunda Strait. To determine the direction of the tsunami that arrived at the beach, we obtained information from eyewitnesses. The tsunami hit at night and thus its arrival was difficult to see. Fortunately, it hit during a full moon period, so that there was some light. In addition to eyewitness accounts, we obtained evidence in the field related to the direction of the tsunami propagation. The evidence was in the form of fallen tree trunks, sloping vegetation and shrubs, damaged buildings, and building components carried away by the flow (Fig. 5).

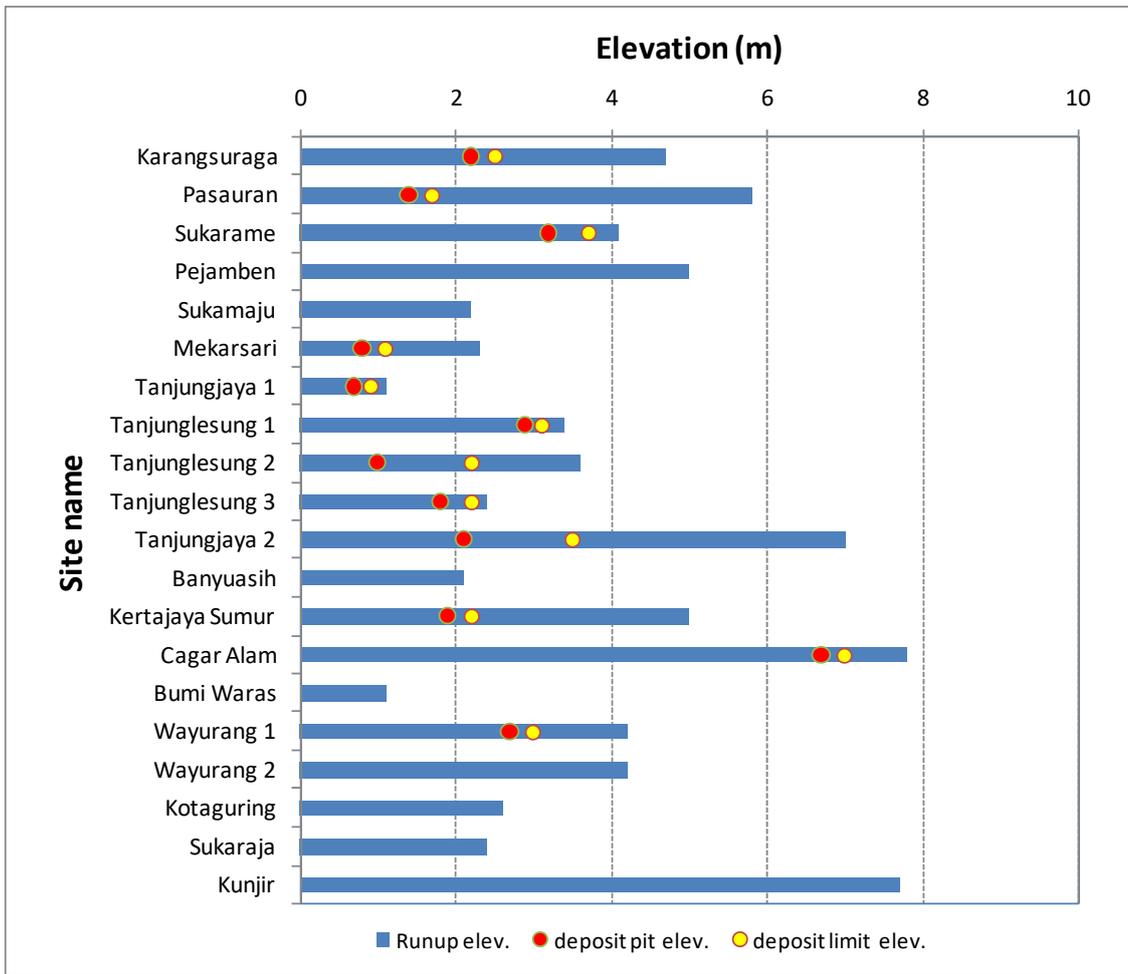
Figure 6: Positions of deposit pits and deposit limit compared to runup elevation

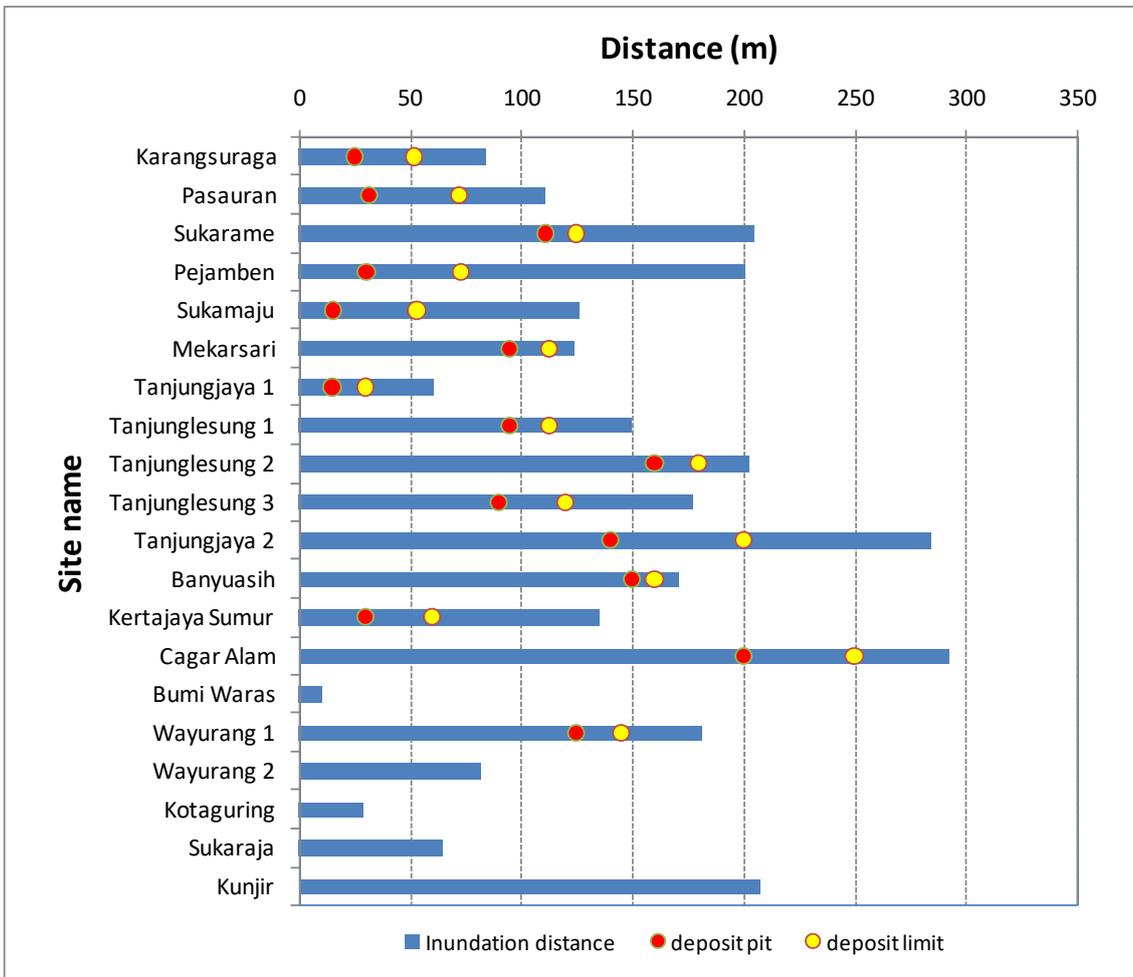
Figure 7: Positions of deposit pits and deposit limit compared to inundation distance.
