Authors Response

Runup, Inundation, and Sediment Characteristics of December 22 2018 Indonesia Sunda Strait Tsunami

Abstract. A tsunami caused by a flank collapse of the southwest part of the Anak Krakatau volcano occurred on December 22, 2018. The affected area of the tsunami included a coastal area located at the edge of Sunda Strait, Indonesia. To gain an understanding of the tsunami event, field surveys were conducted a month after the incident. The surveys included measurements of runup height, inundation distance, tsunami direction, and sediment characteristics at 20 selected sites. The survey results revealed that the runup height and inundation distance reached 7.8 m and 292.2 m, both was found at Site Cagar Alam, part of Ujung Kulon National Park. Tsunami propagated radially from its source and arrived in coastal zone with direction was between 25° and 350° from North. Sediment samples were collected at 27 points in tsunami deposits with a sediment thickness of 1.5-12 cm. The distance of the sediment deposit area from the coast was 40%-90% of the distance of the inundation caused by the tsunami. The highest elevation of deposits was 60%-90% of the highest runup. Sand she

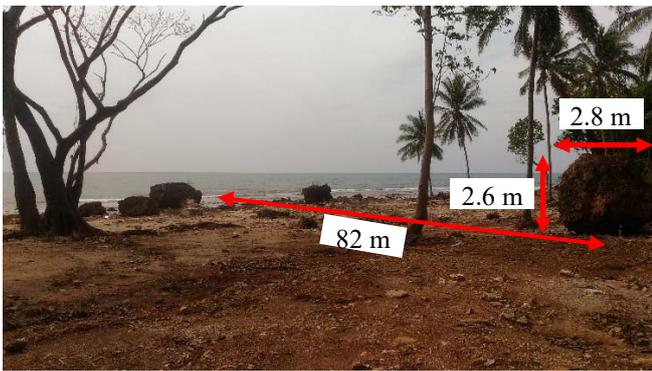
Figure 8: (a) Boulder that moved around 82 m inland and (b) an element of seawall that moved around 30 m inland.

The largest boulder, measuring 2.7 m in diameter (10.4 tons), was found at site 11 (Tanjungjaya 2), as shown in Fig. 8a. This boulder moved from its original point in the swash zone to 81 m inland. Other smaller stones were scattered around it. In Tanjunglesung (sites 8, 9, and 10), pebbles, cobbles, and small boulders (25-50 cm) were scattered up to 40 m from the coastline. At site 4, the seawall built to protect a hotel and villas was partly destroyed and moved ashore. A seawall chunk, measuring 1 m × 1 m × 4.2 m (9.5 tons), made from rubble mound and mortar moved as far as 30 m from its place of origin (Fig. 8b). Other smaller chunks also moved.

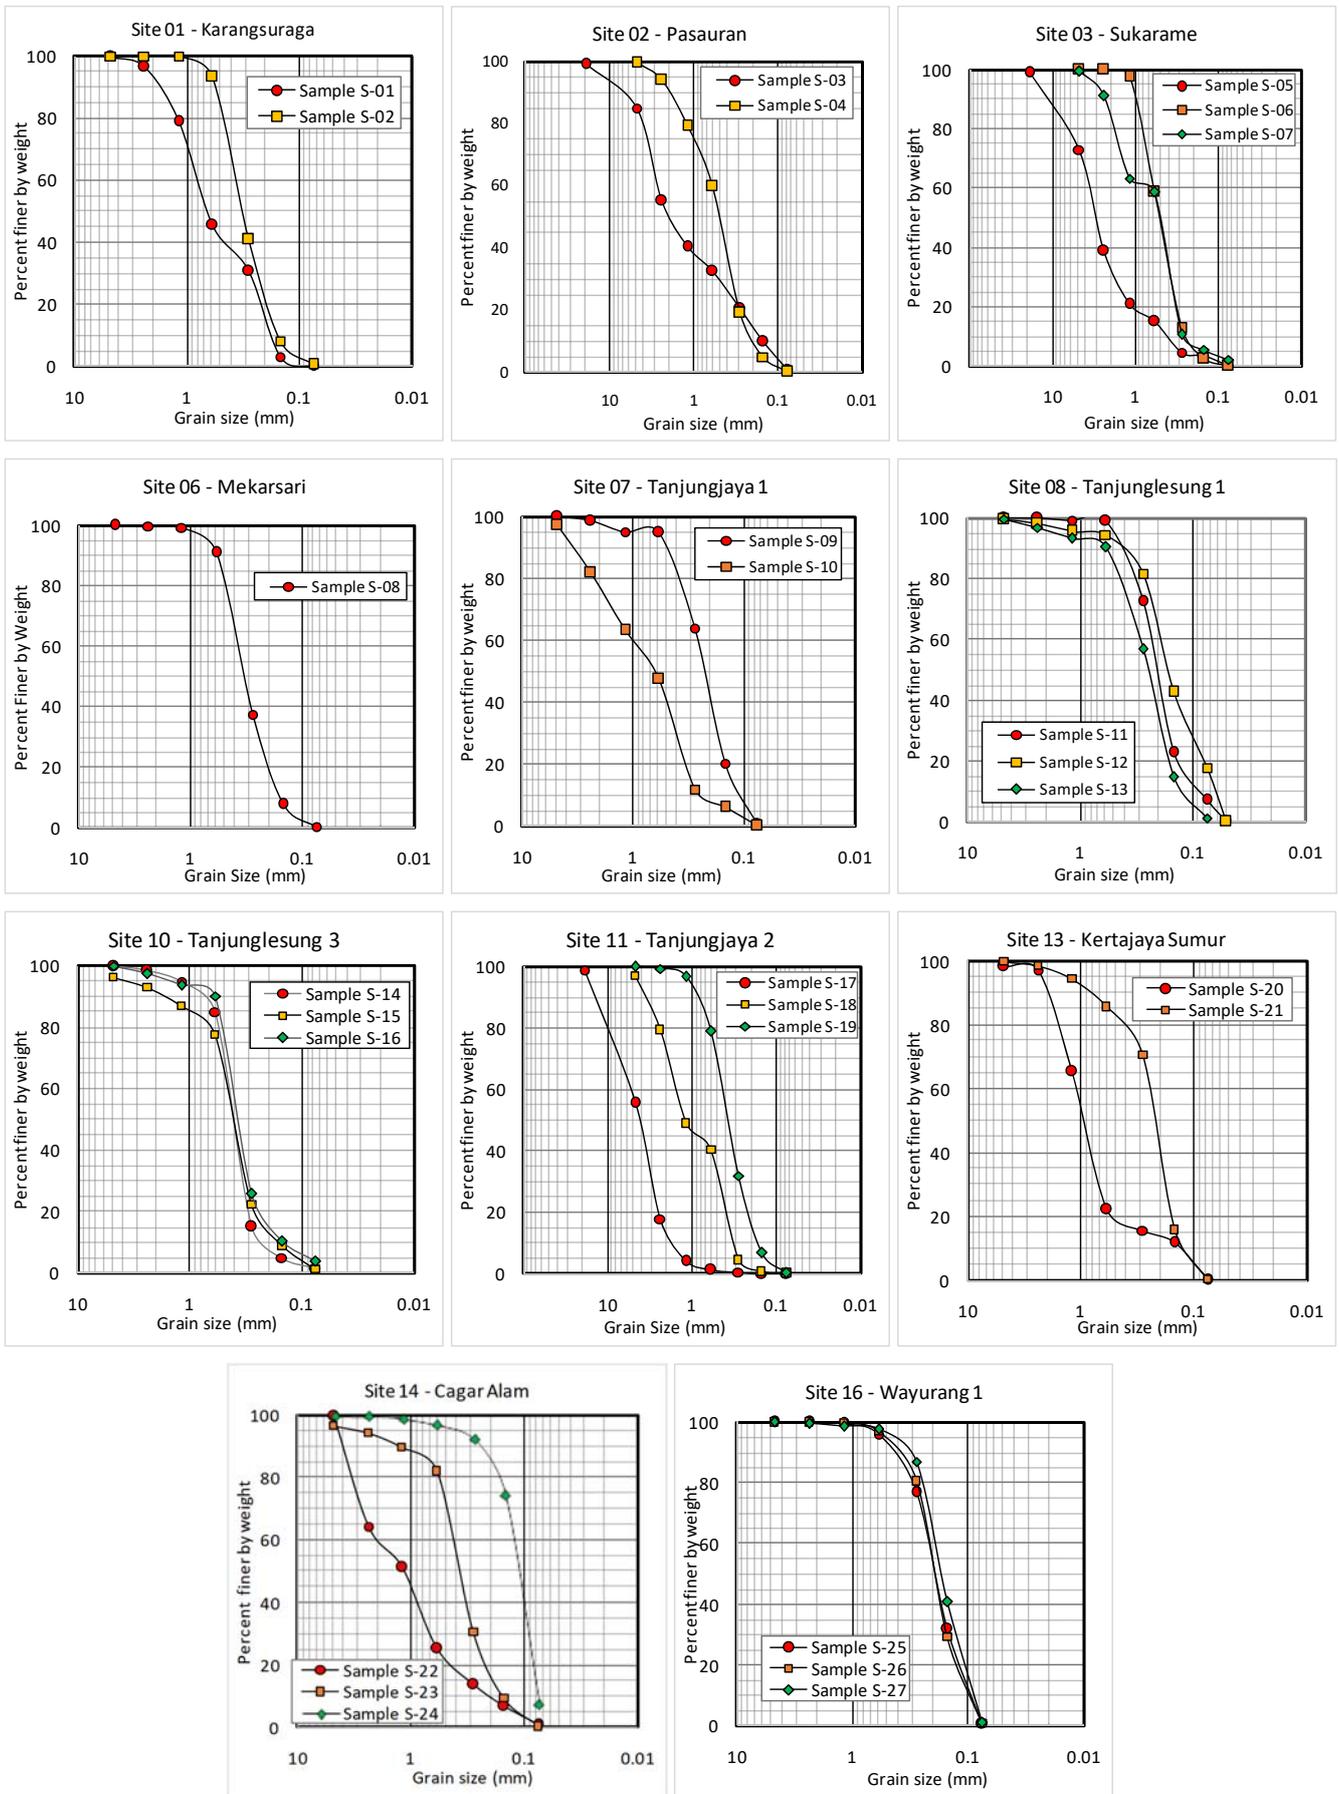
5 Figure 9: Sediment grain size results from sieve analysis for various sites.

From our results, the mean values show that medium and coarse were the dominant types of sand in the sample. Very coarse sand, granular sand, and pebbles were found at the Tanjungjaya 2 and Sukarame sites. Fine and very fine sand was also identified at several sites. The range of grain sizes found in the study area depended on the available source material.
