Run-up, Inundation, and Sediment Characteristics of December 22 2018 Indonesia Sunda Strait Tsunami

10 **Abstract.** A tsunami caused by a flank collapse of the southwest part of the Anak Krakatau volcano occurred on December 22, 2018. The tsunami affected the coastal areas located at the edge of Sunda Strait, Indonesia. To gain an understanding of the tsunami event, field surveys were conducted a month after the incident. The surveys included measurements of run-up height, inundation distance, tsunami direction, and sediment characteristics at 20 selected sites. The survey results revealed that the run-up height reached 9.2 m in Tanjungjaya and inundation distance 286.8 m was found at Cagar Alam, part of Ujung
15 Kulon National Park. The tsunamis propagated radially from Anak Krakatau and reached the coastal zone with direction between 25° and 350° from North. Sediment samples were collected at 27 points in tsunami deposits with a sediment thickness of 1.5-12.7 cm. The average distance of area with significant sediment deposits and deposit limit from the coast are 45% and

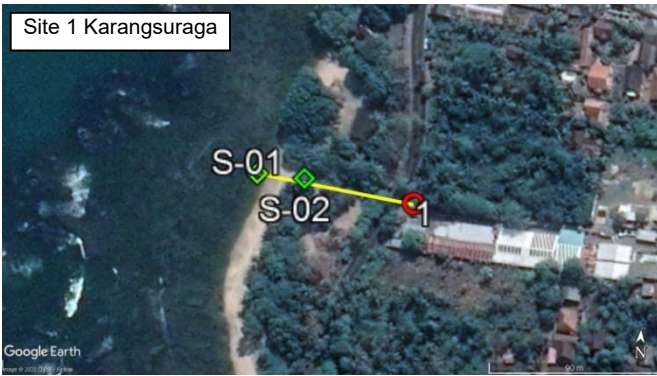
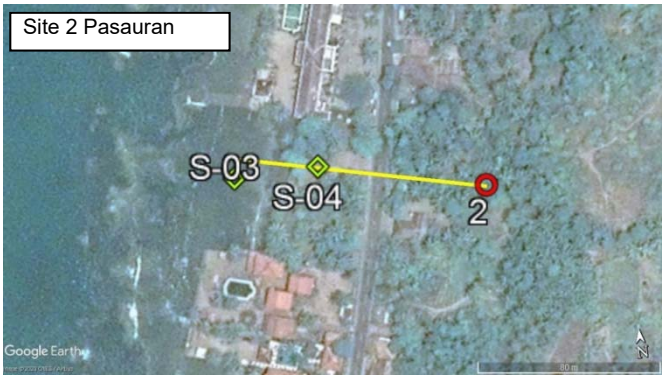
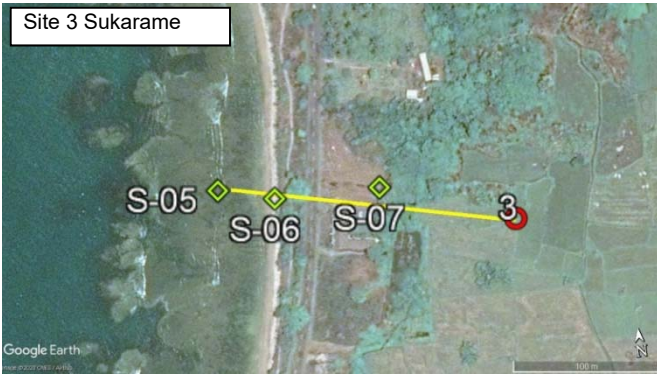
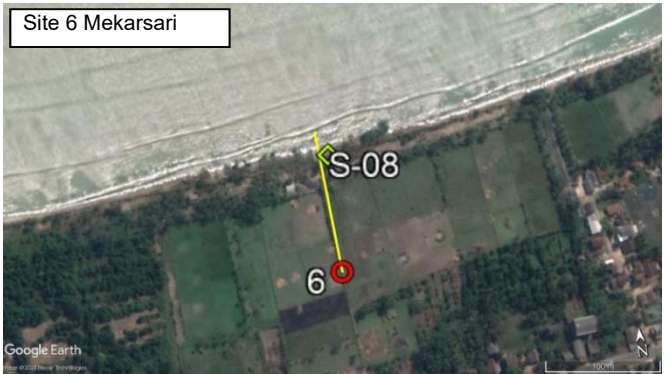
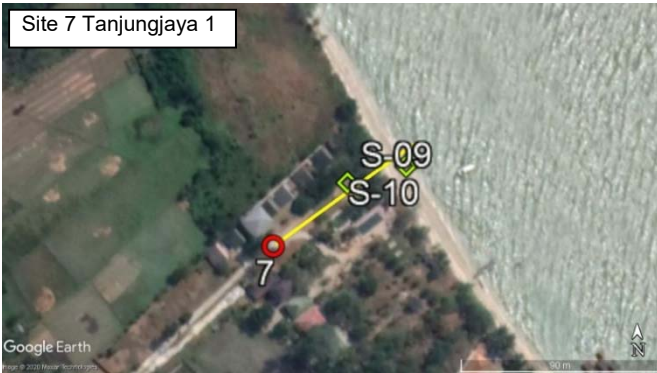
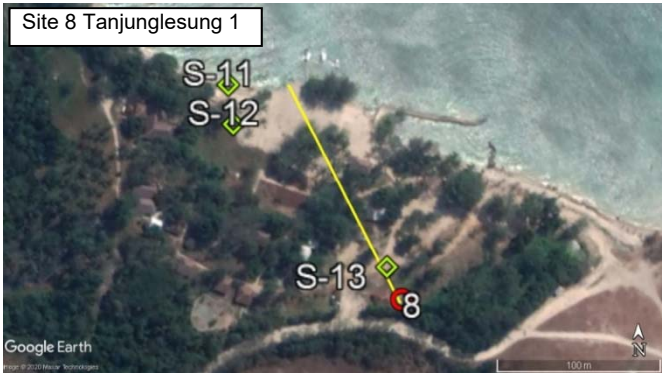
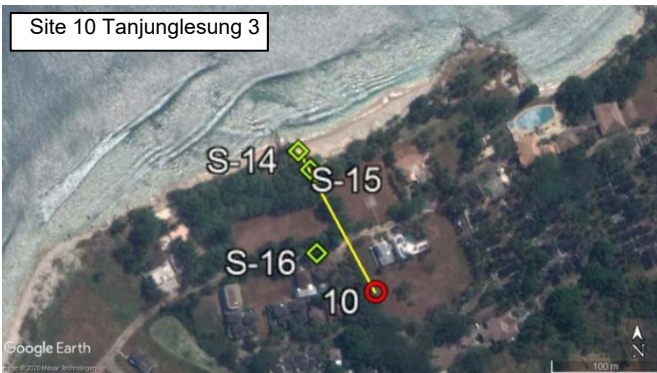
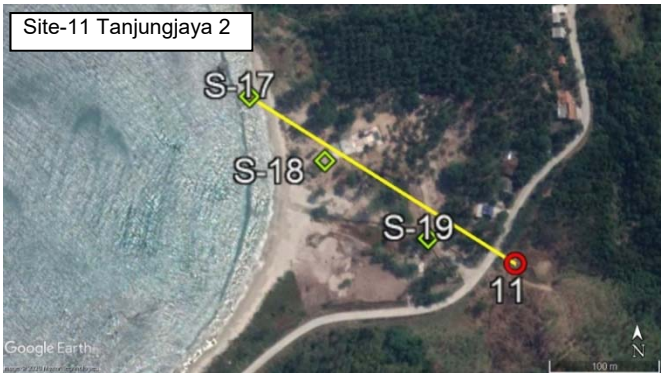
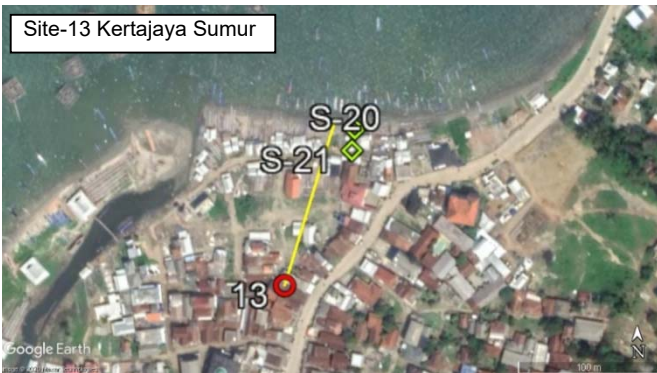
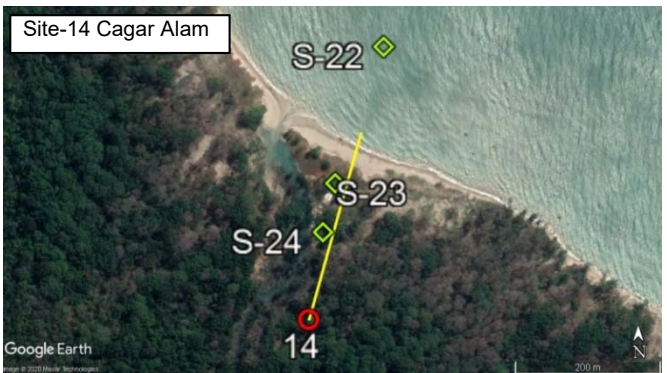
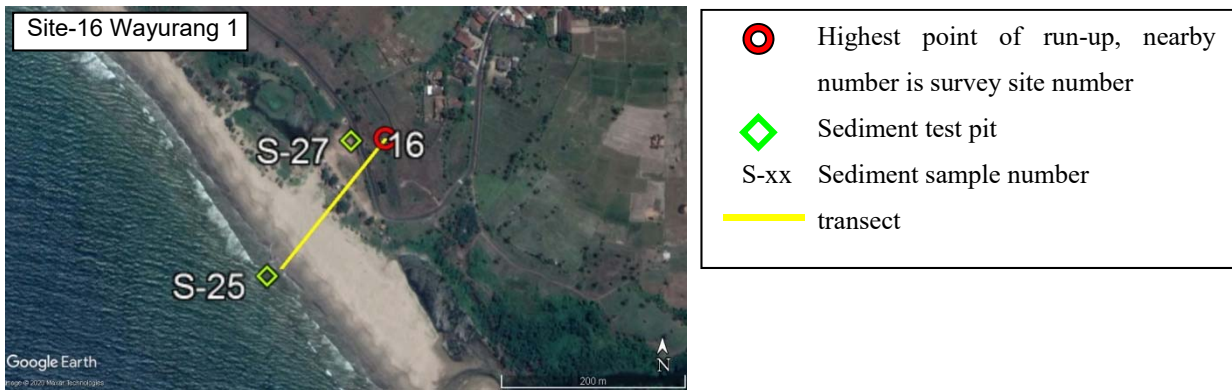
Figure 2. Aerial photographs from Google Earth of transects including highest run-up point and deposit pit.

25 Sediment samples were collected from selected points at measurement locations that could be in the swash zone, nearshore, berm, or deposit areas (Table 2 and Fig. 2). The measurement of deposit thickness in sandy sheets was carried out by digging a number of shallow holes. The measured thickness was considered to be near the maximum thickness. This method was qualitative and subjective because tsunami deposits are discontinuous, sporadic, and scattered over a flooded area. Sand sheets deposited on land vary greatly due to the influence of sedimentary sources and topography. A pit was made at each selected point to observe layers suspected to have been produced by the tsunami. We took only one sample at each pit for laboratory testing and did not take vertical samples at intervals of 1 cm, as done by some researchers (Gelfenbaum and Jaffe 2003; Hawkes *et al.* 2007; Srinivasalu *et al.* 2007; Srisutam and Wagner 2010), because a detailed analysis was not our focus, particularly the number of tsunami waves and the vertical variation of sediment. The grain size of the samples obtained from the field was tested using ASTM standard sieve analysis. In addition, we investigated boulder movement at four sites.

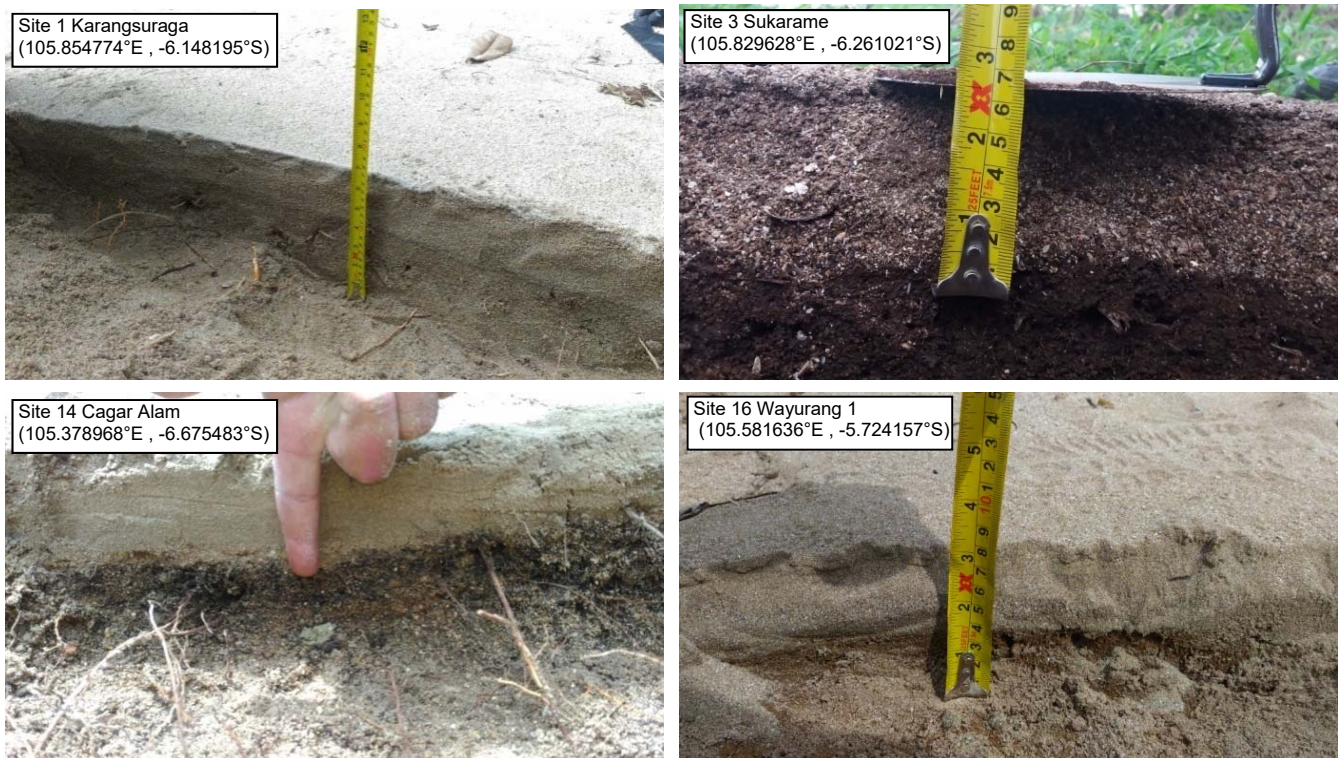
Figure 5. Tsunami sediment deposit, test pits were made to measure the deposit thickness.

The best location for the observation of tsunami sediment is about 50-200 m inland from the coastline (Srisutam and Wagner, 2010) or about 50-400 m inland (Moore *et al.*, 2006), as used for the 2004 Sumatra-Andaman tsunami. In this study, the 12 deposit pits were 9-195 m from the shoreline. Four deposit pits were less than 50 m from the shoreline (Fig. 6). Three of them were at sites 1, 2, and 7, respectively, due to the short inundation and beach scarp. Another was at site 13 (Kertajaya Sumur), where high-density housing blocked the sediment transport and created a deposit at short distance from the shoreline.

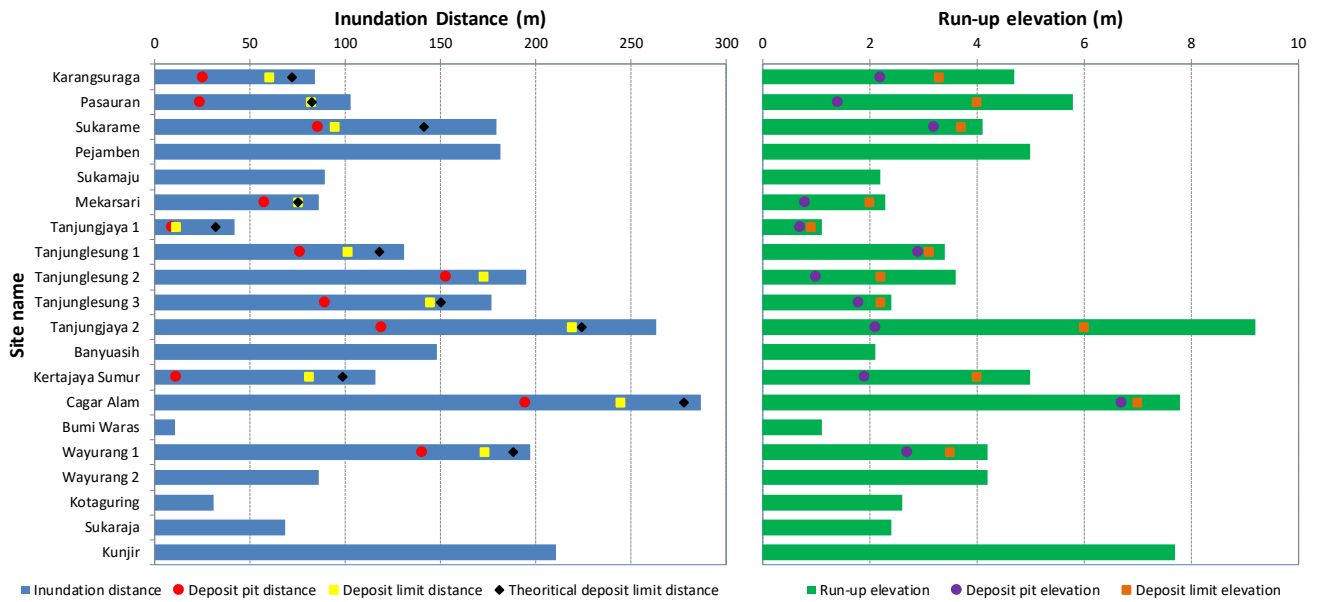
Figure 6. Positions of deposit pits and deposit limit compared to inundation distance and run-up elevation. Theoretical approach for tsunami deposit only available for distance not for elevation.

5 where w_s is the settling velocity, T is a period from the time of first wetting to final drying of inundated ground, and H is the tsunami height. Fig. 6 shows the distance of measured sediment deposition and water run-up compared to the distance of theoretical sediment deposition calculated using Eq. 1 and Eq. 2, the results are in good agreement. However, Sukarame, Tanjungjaya 1 and Cagar Alam do not fit well. The three location have morphological conditions may not ideal for applying the theoretical approach. Sukarame has beach scarp and tsunami flows across a stream around 90 m from coastline. Tanjungjaya
10 1 has also beach scarp and there is a sea wall, although not so high, that may block the sediment movement. Eventhough Tanjungjaya 1 has abundant material, low amplitude tsunami caused a few sand transport. Cagar Alam has a relative larger stream than Sukarame. In addition, Cagar Alam has dense vegetation since it is a national park.

As it can be seen in Fig. 6, the distance of area with significant sediment deposits caused by the tsunami from the coast (deposit pit distance) varied in the range of 9-195 m (average: 82 m) from the shoreline or 10%-70% (average: 45%) of the inundation
15 distance. Moreover, the limits where tsunami sediments were found that can still be seen with the naked eye (deposit limit distance) are around 11-244 m (average 122 m) from the coastline or 30%-90% (73% on average) of the inundation distance. Fig. 6 also presents the elevation of the deposit pit and deposit limit to the runup elevation. The average elevation of deposit pit and deposit limit are 43% and 72% of the runup elevation respectively.

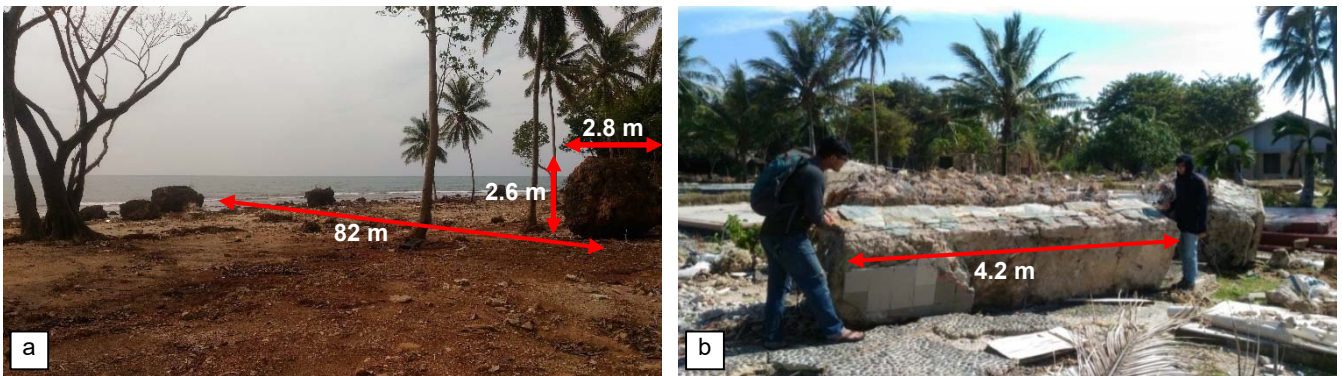
Figure 7. (a) Boulder that moved around 82 m inland in Tanjungjaya 2 and (b) an element of seawall that moved around 30 m inland in Pejamben.

The largest boulder, measuring 2.7 m in diameter (10.4 tons), was found at site 11 (Tanjungjaya 2), as shown in Fig. 7a. This boulder moved from its original point in the swash zone to 82 m inland. Other smaller stones were scattered around it. In Tanjunglesung (sites 8, 9, and 10), pebbles, cobbles, and small boulders (25-50 cm) were scattered up to 40 m from the coastline. At site 4, the seawall built to protect a hotel and villas was partly destroyed and moved ashore. A seawall chunk, measuring 1 m × 1 m × 4.2 m (9.5 tons), made from rubble mound and mortar moved as far as 30 m from its place of origin (Fig. 7b). Other smaller chunks were also moved.

where μ is the friction coefficient, m is the boulder mass (kg), g is the gravitational acceleration, C_d is the drag coefficient, A_n is the area of the boulder projected normal to the flow (m^2), and ρ_w is the density of sea water (kgm^{-3}). The velocities were calculated from Equation 3 to be $u \geq 4.5 \text{ ms}^{-1}$ and $u \geq 4.0 \text{ ms}^{-1}$ for the 10.4-ton (Fig. 7a) and 9.4-ton (Fig. 7b) boulders, respectively.
