Runup, Inundation, and Sediment Characteristics of December 22 2018 Indonesia Sunda Strait Tsunami

Abstract. A tsunami caused by a flank collapse of the southwest part of the Anak Krakatau volcano occurred on December 22, 2018. The affected area of the tsunami included a coastal area located at the edge of Sunda Strait, Indonesia. To gain an
10 understanding of the tsunami event, field surveys were conducted a month after the incident. The surveys included measurements of runup height, inundation distance, tsunami direction, and sediment characteristics at 20 selected sites. The survey results revealed that the runup height and inundation distance reached 7.8 m and 292.2 m, both was found at Site Cagar Alam, part of Ujung Kulon National Park. Tsunami propagated radially from its source and arrived in coastal zone with direction was between 25° and 350° from North. Sediment samples were collected at 27 points in tsunami deposits with a
15 sediment thickness of 1.5-12 cm. The distance of the sediment deposit area from the coast was 40%-90% of the distance of the inundation caused by the tsunami. The highest elevation of deposits was 60%-90% of the highest runup. Sand sheets were spo

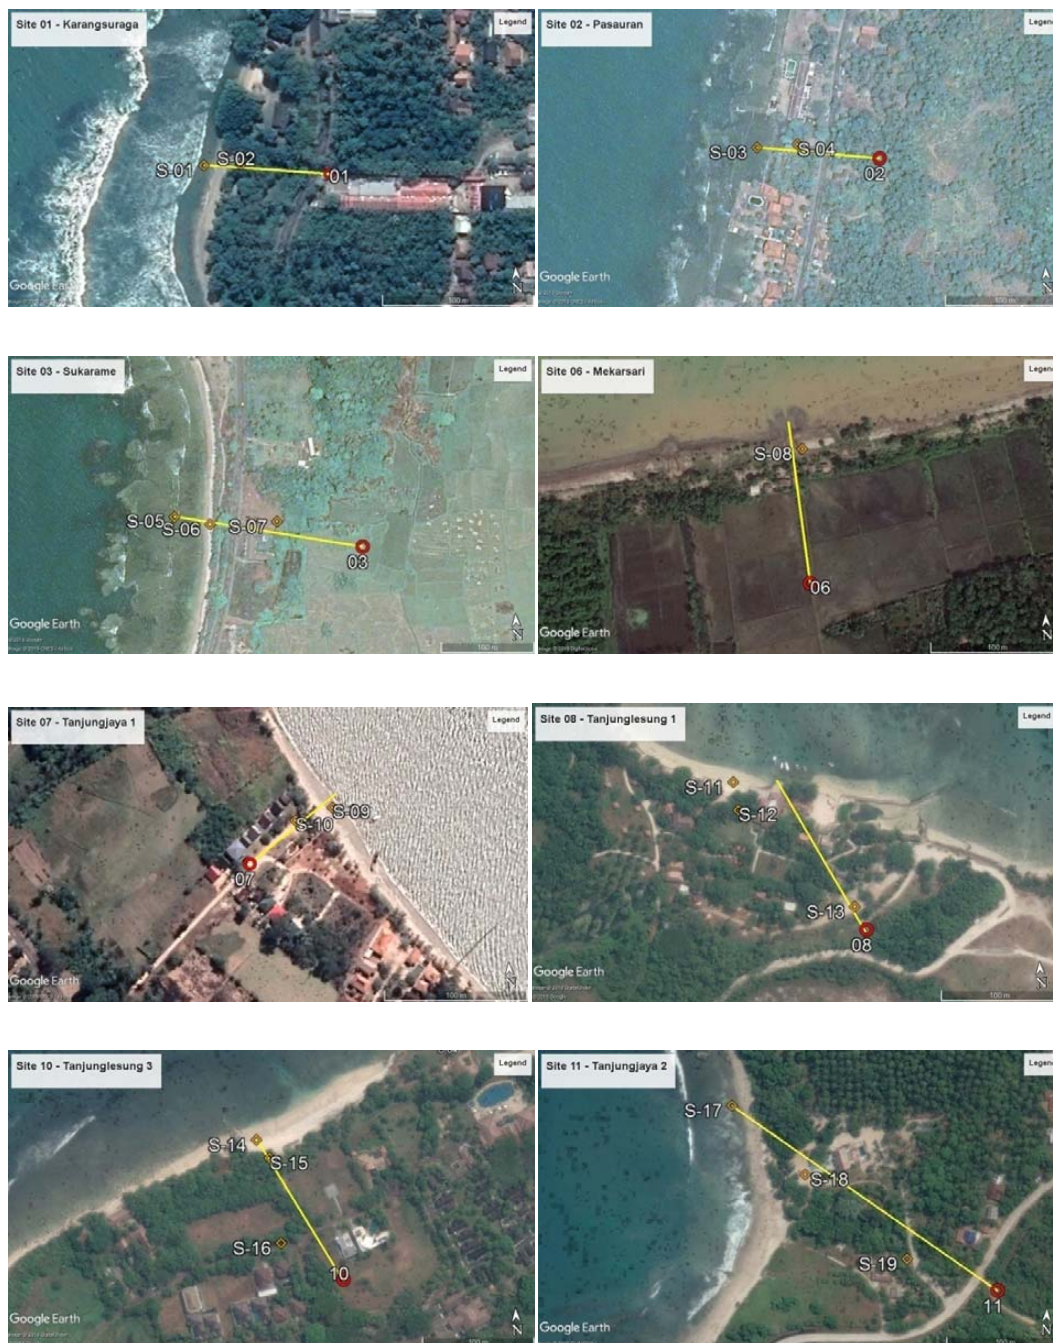
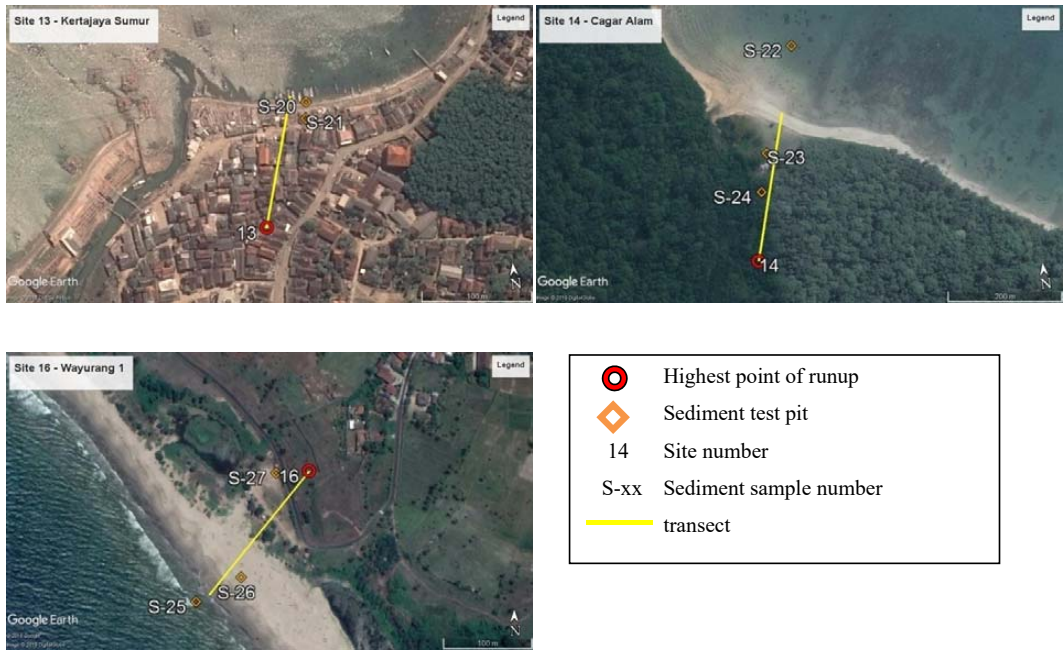
5 **Figure 2:** Aerial photographs from Google Earth of transects including highest runup point and deposit pit. © Google Earth.

Sediment samples were collected from selected points at measurement locations that could be in the swash zone, nearshore, berm, or deposit areas (Table 2 and Fig. 2). The measurement of deposit thickness in sandy sheets was carried out by digging a number of shallow holes. The measured thickness was considered to be near the maximum thickness. This method was qualitative and subjective because tsunami deposits are discontinuous, sporadic, and scattered over a flooded area. Sand sheets deposited on land vary greatly due to the influence of sedimentary sources and topography. A pit was made at each selected point to observe layers suspected to have been produced by the tsunami. We took only one sample at each pit for laboratory testing and did not take vertical samples at intervals of 1 cm, as done by some researchers (Gelfenbaum and Jaffe 2003; Hawkes et al. 2007; Srinivasalu et al. 2007; Srisutam and Wagner 2010), because a detailed analysis was not our focus, particularly the number of tsunami waves and the vertical variation of sediment. The grain size of the samples obtained from the field was tested using ASTM standard sieve analysis. In addition, we investigated boulder movement at four sites.

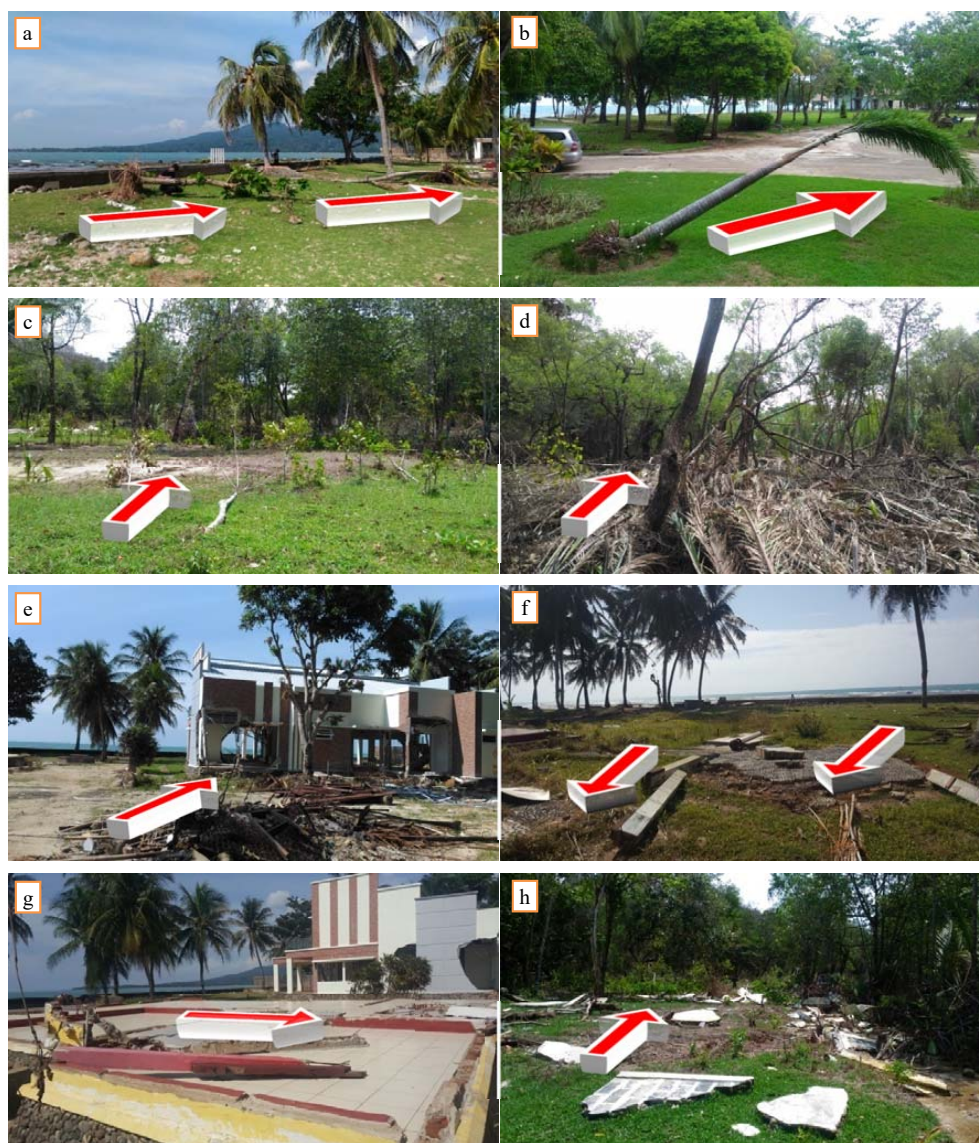
Figure 3: Evidence of tsunami direction. Arrows show the direction of tsunami flow on the ground surfaces.

20 thus its arrival was difficult to see. Fortunately, it hit during a full moon period, so that there was some light. In addition to eyewitness accounts, we obtained evidence in the field related to the direction of the tsunami propagation. The evidence was in the form of fallen tree trunks, sloping vegetation and shrubs, damaged buildings, and building components carried away by the flow (Fig. 3).

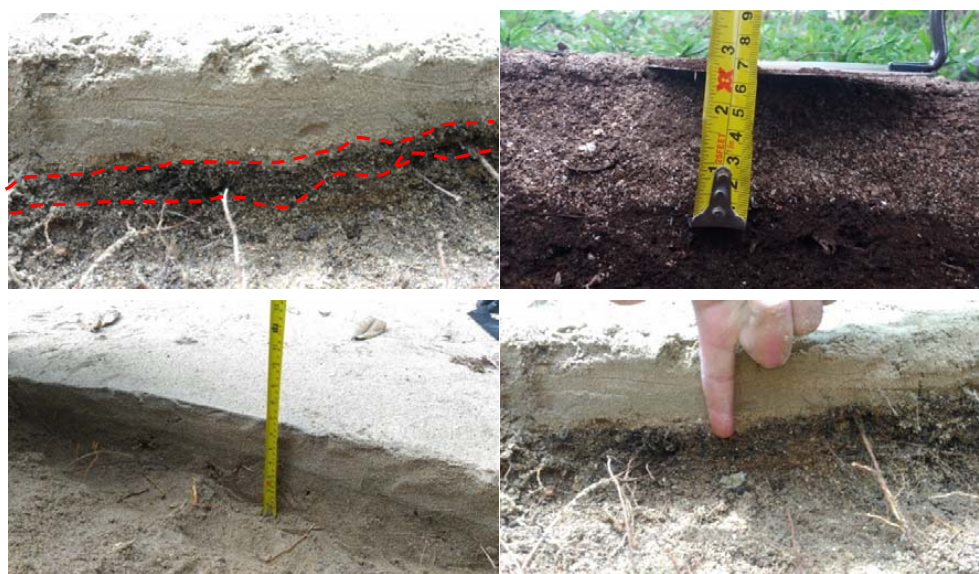
Figure 5: Tsunami sediment deposit, test pits were made to measure the deposit thickness.

Prehistoric (paleo-) tsunamis have been identified from sediment deposits (Atwater 1992; Dawson and Shi 2000; Peters, Jaffe and Gelfenbaum 2007). Sediment deposits can be used to explain and reconstruct significant tsunami events (Dawson *et al.* 1995; Van Den Bergh *et al.* 2003). The present study attempts to describe the impact of a recent tsunami on sediment movement around the coastal area. The tsunami carried sediment from the coast inland. However, not all sites that we measured had significant sediment deposits. Only places with a sufficient source of material had clearly observable sediment deposits (Fig. 5). The survey sites used for sediment samples are shown in Fig. 2. Sediment deposits generally do not spread evenly and continuously but are separated at certain locations, which allow it to settle. Topography controls sediment deposits; for instance, there are more sediment deposits at ground surface depressions.

The best location for the observation of tsunami sediment is about 50-200 m inland from the coastline (Srisutam and Wagner, 2010) or about 50-400 m inland (Moore *et al.*, 2006), as used for the 2004 Sumatra-Andaman tsunami. In this study, the 12 deposit pits were 15-200 m (average: 93 m) from the shoreline. Four deposit pits were less than 50 m from the shoreline (11). Three of them were at sites 1, 2, and 7, respectively, due to the short inundation and beach scarp. Another was at site 13 (Kertajaya Sumur), where high-density housing blocked the sediment transport and created a deposit a short distance from the shoreline.

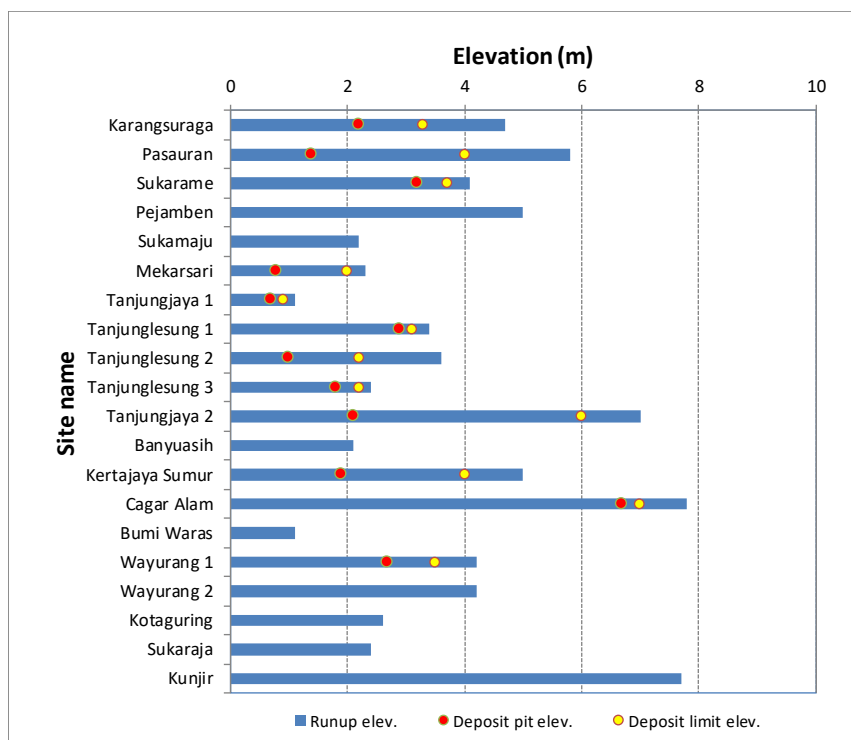
Figure 6: Positions of deposit pits and deposit limit compared to runup elevation

where w_s is the settling velocity, T is a period from the time of first wetting to final drying of inundated ground, and H is the tsunami height. Fig. 6 depicts comparison among deposit pits, deposit limit and runup elevation. Deposit pits were location of sediment sample taken where significant thickness of sediment deposit were available. Deposit limit were end location of sediment deposit. From the figure, the elevations of the significant sediment deposits lie between 25% to 85% (average 54%), and the elevation of deposit limit reached 60%-90% (average: 81%) of the runup elevation. Fig. 7 shows the distance of measured sediment deposition and water runup compared to the distance of theoretical sediment deposition calculated using Eq. 1 and Eq. 2; the results are in good agreement. The distance of area with significant sediment deposits caused by the tsunami from the coast varied in the range of 15-200 m (average: 93 m) from the shoreline or 40%-90% (average: 67%) of the inundation distance.

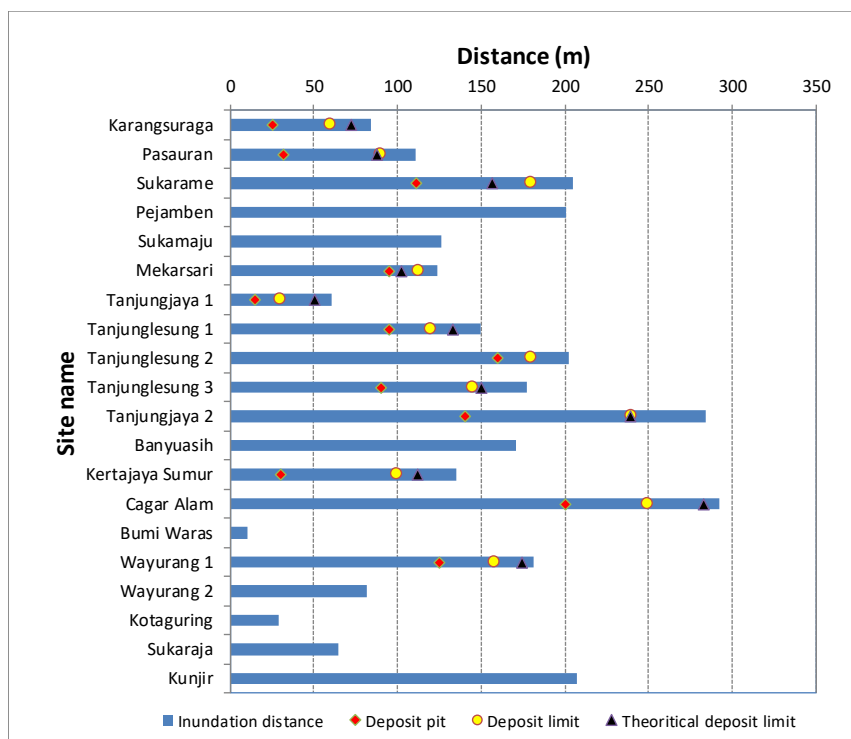
Figure 7: Positions of deposit pits and deposit limit (measured and theoretical) compared to inundation distance.

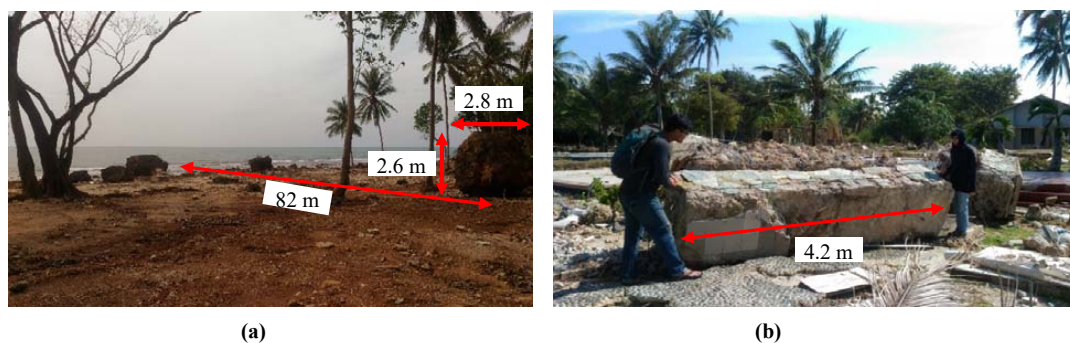
Figure 8: (a) Boulder that moved around 82 m inland and (b) an element of seawall that moved around 30 m inland.

The largest boulder, measuring 2.7 m in diameter (10.4 tons), was found at site 11 (Tanjungjaya 2), as shown in Fig. 8a. This boulder moved from its original point in the swash zone to 82 m inland. Other smaller stones were scattered around it. In Tanjunglesung (sites 8, 9, and 10), pebbles, cobbles, and small boulders (25-50 cm) were scattered up to 40 m from the coastline. At site 4, the seawall built to protect a hotel and villas was partly destroyed and moved ashore. A seawall chunk, measuring 1 m × 1 m × 4.2 m (9.5 tons), made from rubble mound and mortar moved as far as 30 m from its place of origin (Fig. 8b). Other smaller chunks also moved.

where μ is the friction coefficient, m is the boulder mass (kg), g is the gravitational acceleration, C_d is the drag coefficient, A_n is the area of the boulder projected normal to the flow (m^2), and ρ_w is the density of sea water. The velocities were calculated to be $u \geq 4.5$ m/s and $u \geq 4.0$ m/s for the 10.4-ton (Fig. 8a) and 9.4-ton (Fig. 8b) boulders, respectively.
