Authors response to Professor Don Forbes review – Reviewer 1

Arctic tsunamis threaten coastal communities and landscapes - survey of Karrat fjord 2017 tsunami effects in Nuugaatsiaq, western Greenland.

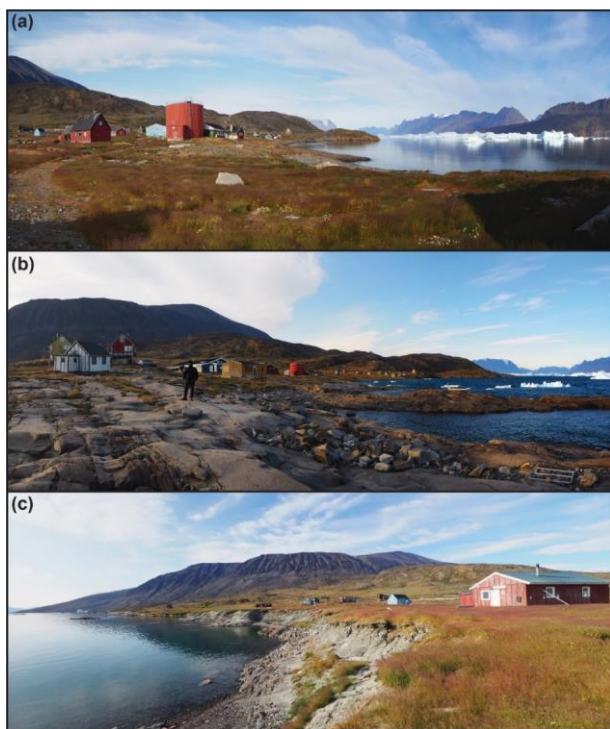
60 **Figure 2.** Coastal landscapes in Nuggatsiaq. (a) Densely vegetated (grasses and shrubs) coastal lowland with ragged shoreline dissected by rocky capes and coves with narrow beaches; (b) Main headland with exposed glacially scoured bare rock surfaces, note accumulations of boulders in rocky hollows; (c) Cliffed coast in Nuugaatsiaq harbour. Tops of the cliff were eroded and gullied by tsunami.

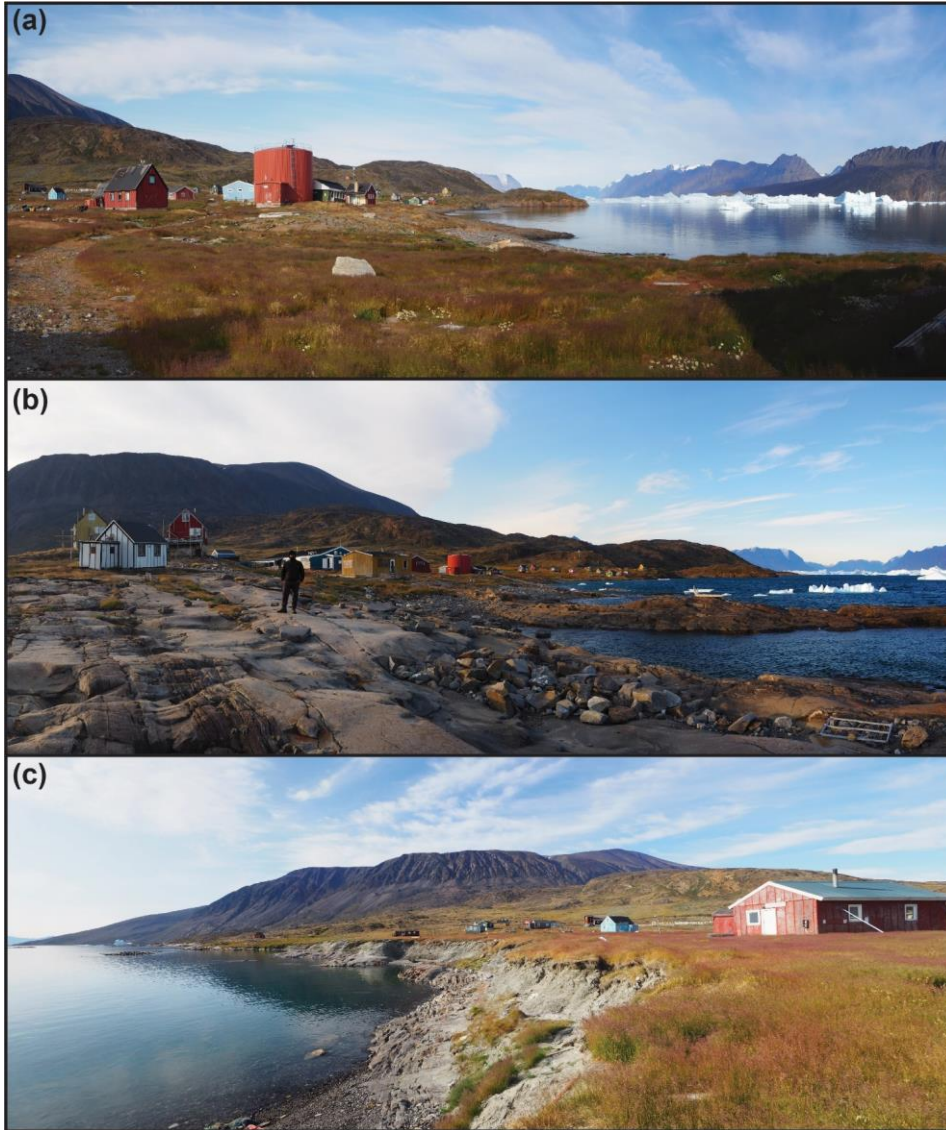
Figure 2. Coastal landscapes in Nuggatsiaq. (a) Densely vegetated (grasses and shrubs) coastal lowland with ragged shoreline dissected by rocky capes and coves with narrow beaches; (b) Main headland with exposed glacially scoured bare rock surfaces, note accumulations of boulders in rocky hollows; (c) Clifed coast in Nuugaatsiaq harbour. Tops of the cliff were eroded and gullied by tsunami.

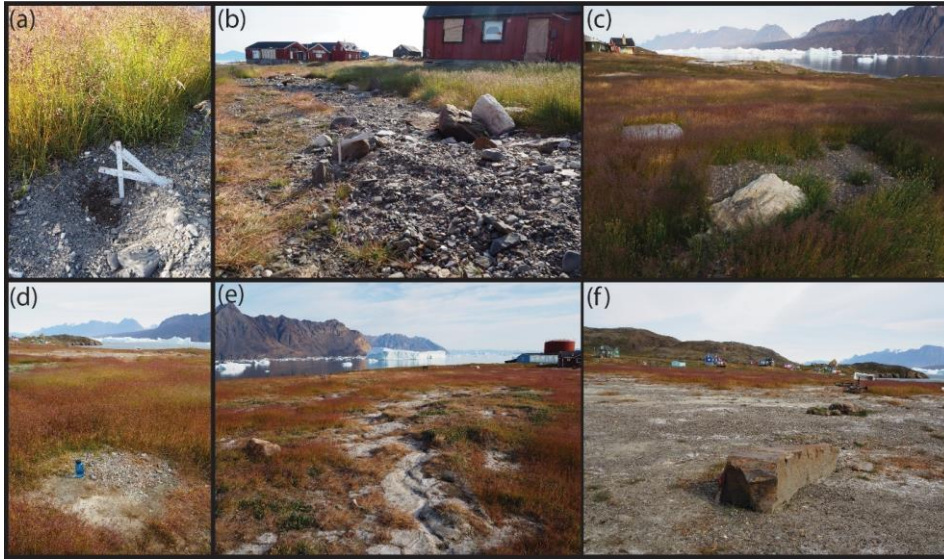
Figure 5. Examples of tsunami deposits preserved in Nuugaatsiaq two years after the event. (a) Ca. 4-6 cm thick cover of marine gravels covering grass vegetation; (b) Up to 10 cm thick layer of tsunami deposits eroded from local beach and deposited on road and grass vegetation; (c) Melt-out material from iceberg (gravels and mud) and ca. 100 cm long boulder thrown onshore by tsunami; (d) Deposits melted-out from iceberg washed on shore by waves; (e) rills eroded in soil and tsunami deposits by returning wave; (f) Over 100 cm long boulder moved by wave on the thin layer of gravels and eroded soil deposits. Note salty surfaces and eroded tundra rafts in the background.

Figure 3. Examples of tsunami deposits preserved in Nuugaatsiaq two years after the event. (a) Ca. 4-6 cm thick cover of marine gravels covering grass vegetation; (b) Up to 10 cm thick layer of tsunami deposits eroded from local beach and deposited on road and grass vegetation; (c) Melt-out material from iceberg (gravels and mud) and ca. 100 cm long boulder thrown onshore by tsunami; (d) Deposits melted-out from iceberg washed on shore by waves; (e) rills eroded in soil and tsunami deposits by returning wave; (f) Over 100 cm long boulder moved by wave on the thin layer of gravels and eroded soil deposits. Note salty surfaces and eroded tundra rafts in the background.

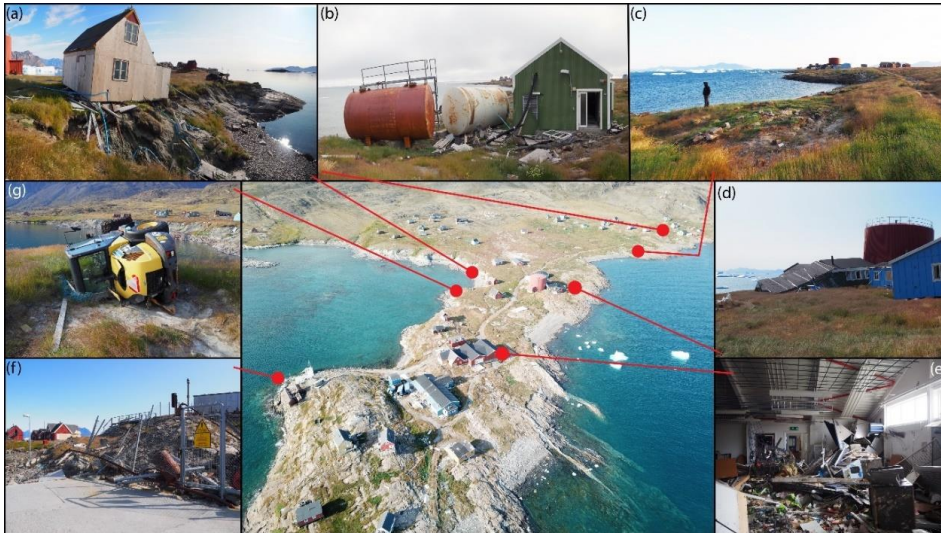
755 infrastructure) within: 22 buildings were fully swept away from land, 23 buildings were partly broken and 11 of them
were moved between 2 m to over 100 m from original location (Fig. 6). Most of the buildings were constructed on a
wooden frame, covered with wooden boards and settled on pier foundations. Only a few of the settlement buildings were
built on a metal frame coated with corrugated metal sheet settled on a concrete frame foundation. The first type of building
(with pier foundations) were not strong enough to resist the wave impact and were pushed by the tsunami or in some
760 cases washed away to the fjord (Fig. 7 a,c).

In those buildings which were not moved but still affected by the wave, we observed some damage of their wooden lining,
as well as a deposition of marine sediments and litter in the ground floor area. The typical damages observed in buildings
which were pushed by the tsunami but remained on land were: broken windows and doors, devastated interior. In contrast
to buildings with pier foundations, much smaller damages were observed in buildings with concrete frame foundations.
765 These, due to a more stable anchoring in the ground, gave a much higher resistance to the wave impact. The most common
damages included broken walls, bowed and twisted metal construction frames (Fig. 7 b, d). It should be considered
extremely fortunate that the fuel tanks situated at the power plant (which were one of the first parts of infrastructure hit
by tsunami) were not destroyed and no leakage of petrol was reported (Fig. 7b).

Figure 7. Examples of infrastructure damages caused by 2017 tsunami in Nuugaatsiaq. (a) Wooden house removed by wave from point foundation transported several dozen of meters; (b) Fuel tanks washed away from concrete frames and pushed towards power plant. Note large accumulation of litter and tsunami deposits around and inside the buildings; (c) site of former building position, which was destroyed and swept away by tsunami. Note broken wooden point foundations, media connections and erosional gullies; (d) Smashed and collapsed wooden school building moved towards major water tank; (e) Interior of local shopping centre passed by tsunami. Note large amounts of litter and rotting food supplies and twisted and bowed metal frame construction; (f) Partly-torn metal fence around fuel storage site which acted as a trap for litter transported by tsunami; (g) example of heavy machine knocked over by waves.

Figure 5. Examples of infrastructure damages caused by 2017 tsunami in Nuugaatsiaq. (a) Wooden house removed by wave from point foundation transported several dozen of meters; (b) Fuel tanks washed away from concrete frames and pushed towards power plant. Note large accumulation of litter and tsunami deposits around and inside the buildings; (c) site of former building position, which was destroyed and swept away by tsunami. Note broken wooden point foundations, media connections and erosional gullies; (d) Smashed and collapsed wooden school building moved towards major water tank; (e) Interior of local shopping centre passed by tsunami. Note large amounts of litter and rotting food supplies and twisted and bowed metal frame construction; (f) Partly-torn metal fence around fuel storage site which acted as a trap for litter transported by tsunami; (g) example of heavy machine knocked over by waves.
