Author's Response to the second round of reviews

Title: Arctic tsunamis threaten coastal landscapes and communities – survey of Karrat Isford 2017 tsunami effects in Nuugaatsiaq, western Greenland. Thank you to the authors for revising their paper. It is improved, but I remain underwhelmed. The authors state that the lack of detail in their observation is at least partly related to having only spent 2.5 days on site. But this, in my opinion, does not negate the fact that the observations are pretty sparse. I cannot recommend publication in its current state.

MANUSCRIPT COMPLETE NO TRACKED CHANGES

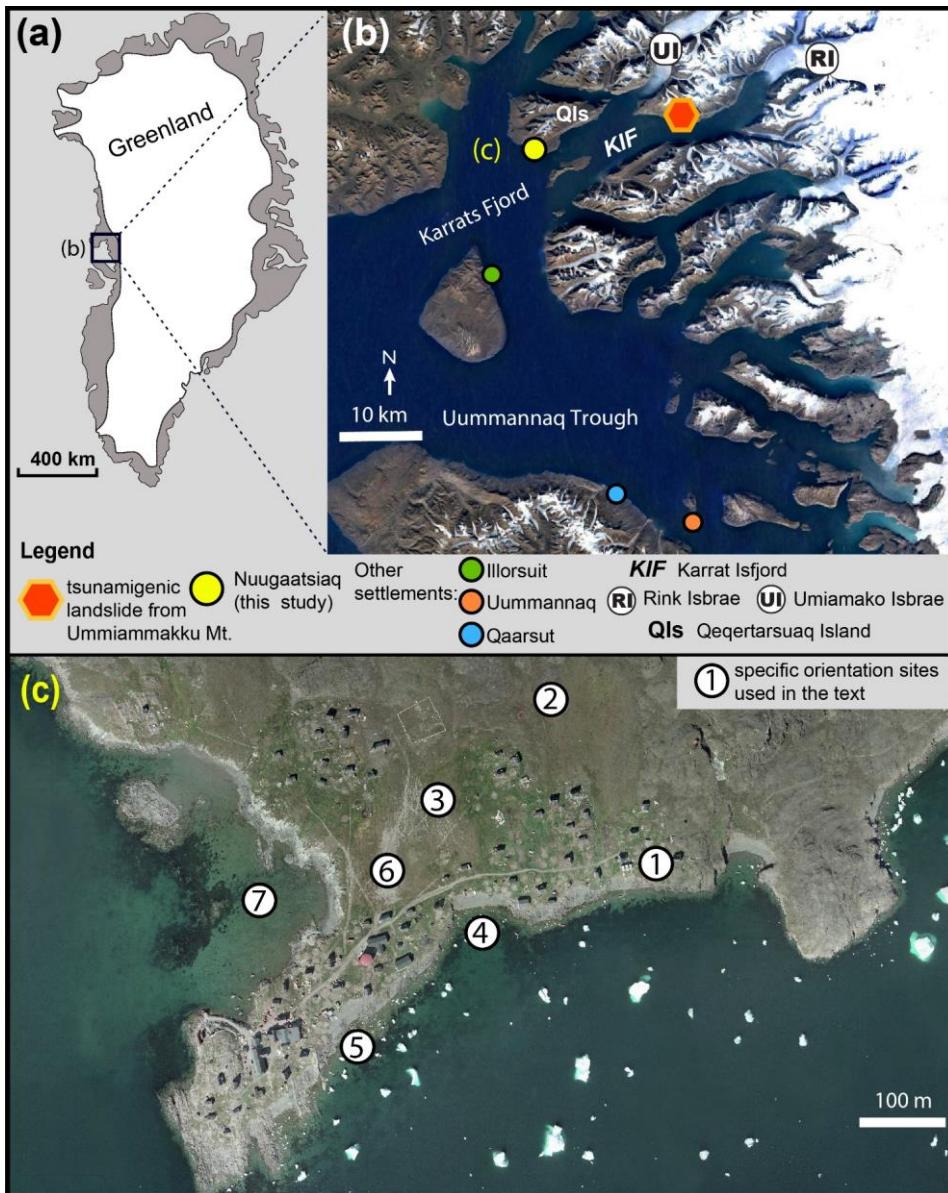
565 **Figure 1.** Location of study area. a) General position of Karrat Fjord in western Greenland (Source: Google Earth); b)
 566 Karrat Fjord area, where tsunamigenic landslide occurred on 17 June 2017 and inundated settlement of Nuugaatsiaq; c)
 567 Aerial image of Nuugaatsiaq before the event (nunuagis.gl). Number in circles mark orientation sites used in the text 1 –
 568 area with first line of buildings destructed by tsunami, 2 – heliport above the tsunami inundation limit, 3 – playground
 569 area, partly flooded by tsunami, 4 – first beach eroded by tsunami; 5 – second beach eroded by tsunami; 6 – saddle
 570 between beach(4) and harbour; 7 – local harbour.

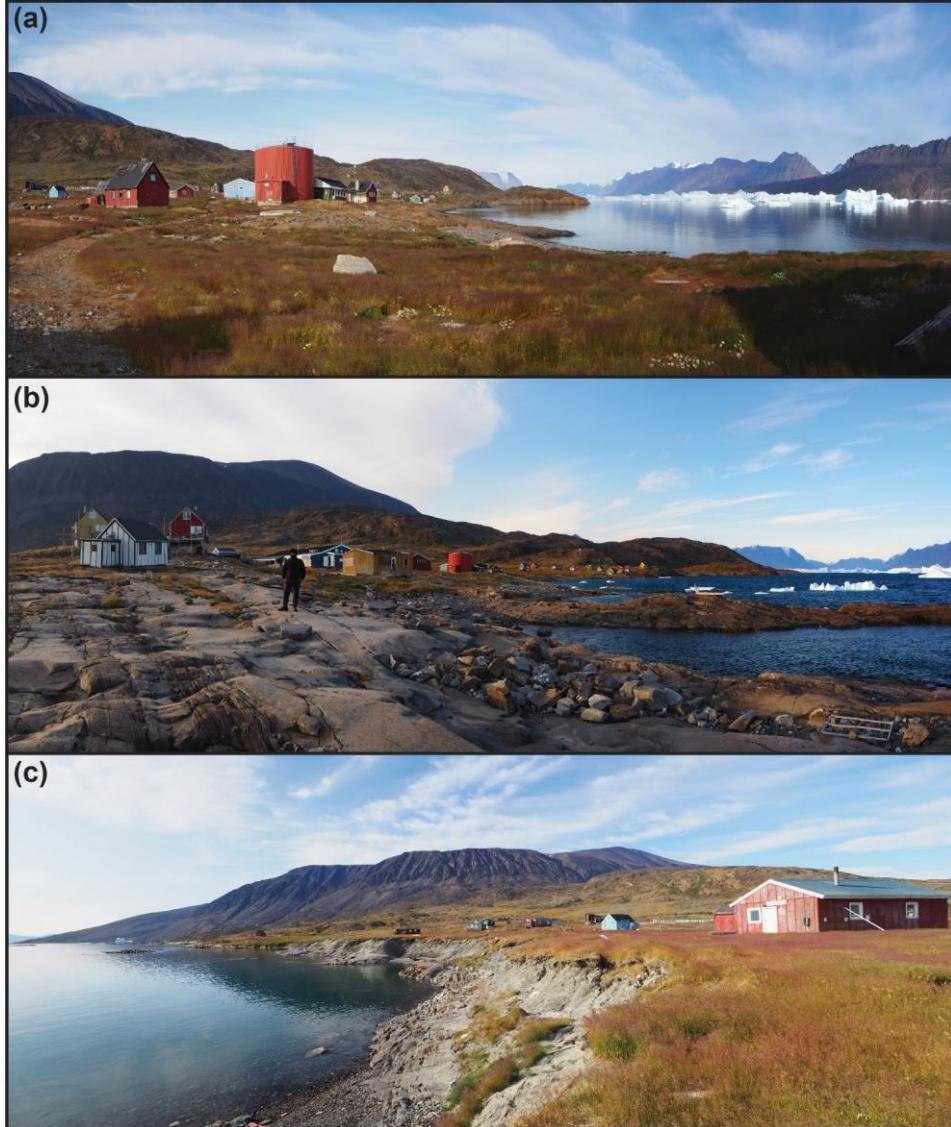
Figure 2. Coastal landscapes in [Nuugaatsiaq](#). (a) Densely vegetated (grasses and shrubs) coastal lowland with ragged shoreline dissected by rocky capes and coves with narrow beaches; (b) Main headland with exposed glacially scoured bare rock surfaces, note accumulations of boulders in rocky hollows; (c) Clifftop in Nuugaatsiaq harbour. Tops of the cliff were eroded and gullied by tsunami.

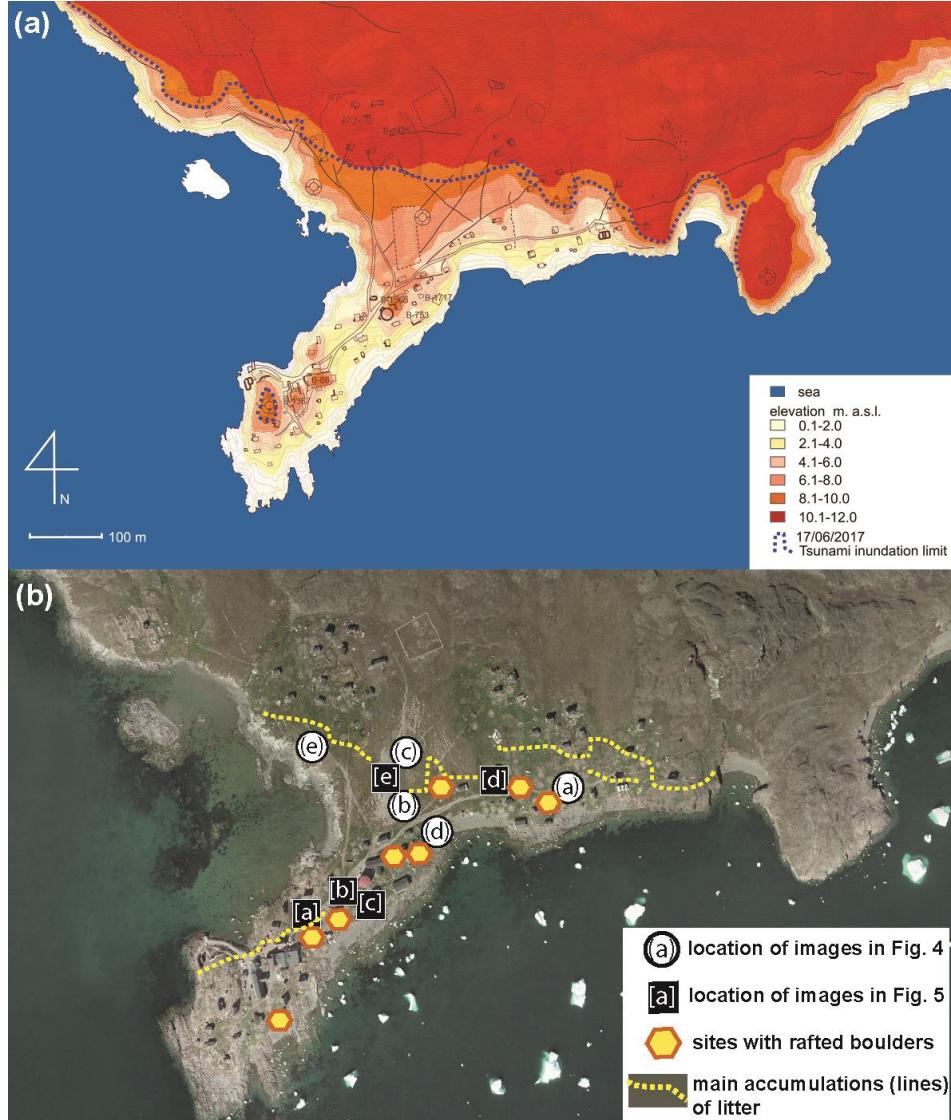
580 **Figure 3.** (a) Digital elevation model (2-m DEM, <https://www.pgc.umn.edu/data/arcticdem/>) of Nuugaatsiaq with
581 marked tsunami inundation limit (wave flooded the terrain up to 8 m a.s.l.). (b) Overview map of the settlement with
582 marked location of images from Fig. 4 and 5. Lines of litter visible in the landscape 2 years after the event and sites where
583 large boulders rafted by tsunami were marked too. Background: technical map of settlement from nunagis.gl

185 A field survey carried out by a group of researchers led by Professor Fritz from the Georgia Institute of Technology (Schiermeier, 2017; <https://ce.gatech.edu/news/after-recon-trip-researchers-say-greenland-tsunami-june-reached-300-feet-high>) found evidence that the wave runup height was ca. 90 m at the landslide site, and up to 50 m on the opposite side of the Karrat Fjord. Numerical modelling of the landslide and wave performed by Paris et al. (2019) indicates that 190 ~~the~~ Nuugaatsiaq located ca. 32 km from the landslide was hit by three 1 – 1.5 m high waves, inundating the settlement over a period of ca. 3 minutes. The wave inundated terrain up to 8 m a.s.l. (Fig. 3 a)

195 Inspection of satellite images and photographs taken in Nuugaatsiaq before the event suggest that grassy-tundra covers dominated the top of coastal bluffs and the strip of coastal lowlands between the predominantly rocky shore and main coastal road passing the settlement from west to east. During our fieldwork we noticed very dense and relatively high (0.4 – 0.6 m) grassy meadows covering coastal lowlands, and recolonizing abandoned playgrounds, roads, backyards (Fig. 2a). The observed post-event vegetation cover in study area was significantly denser and higher than in other settlements visited in the region in the same season. The striking feature of the Nuugaatsiaq post-tsunami landscape is a dense and high (0.4–0.6 m) grass that covers a significant part of the settlement (Fig. 2a). Two years after the event most of the blocks of eroded soil, rafts of tundra, boulders, or litter that were found were almost entirely hidden in a high grass cover (Fig. 4a). The wave has torn blocks of tundra (shrubs, mosses, grass) off the coastal slope and deposited them on land (Fig. 4 b, c). We ~~have noticed that noted~~ a significant removal of tundra cover, soil erosion, and associated formation of rills or small gullies (0.2–0.6 m deep) concentrated on surfaces exposed after the washing away of buildings. Tundra and soil were also eroded along the cliffted coast of the harbour (Fig. 4 d, e). At a few places along the main road and in the 200 ~~surroundings vicinity~~ of the playground the vegetation cover (grasses) was covered by a thin layer of tsunami deposits (3 – 7 cm) composed mainly of marine gravels mixed with coarser sands. Salty patches with dead-vegetation were observed mainly across the saddle between southern coast and ~~leal western~~ harbour (site 6 in Fig. 1c). After analyzing the video coverage of the event and post-event images (~~please check see~~ list of online resources in references), we assume that some parts of the grass cover were compressed by the fragments of icebergs or ice-floes washed on shore by tsunami. In sites where ice-bergs~~s~~ or ice-floes~~s~~ were deposited and melted away grasses were weighted down and melt-out sediments (gravel, sand, mud) was observed between grass blades. Such spots were surrounded by lush grassy tundra. Tundra was compressed also by tsunami-derived boulders both eroded from beaches and melted out of icebergs (Fig. 3bb).

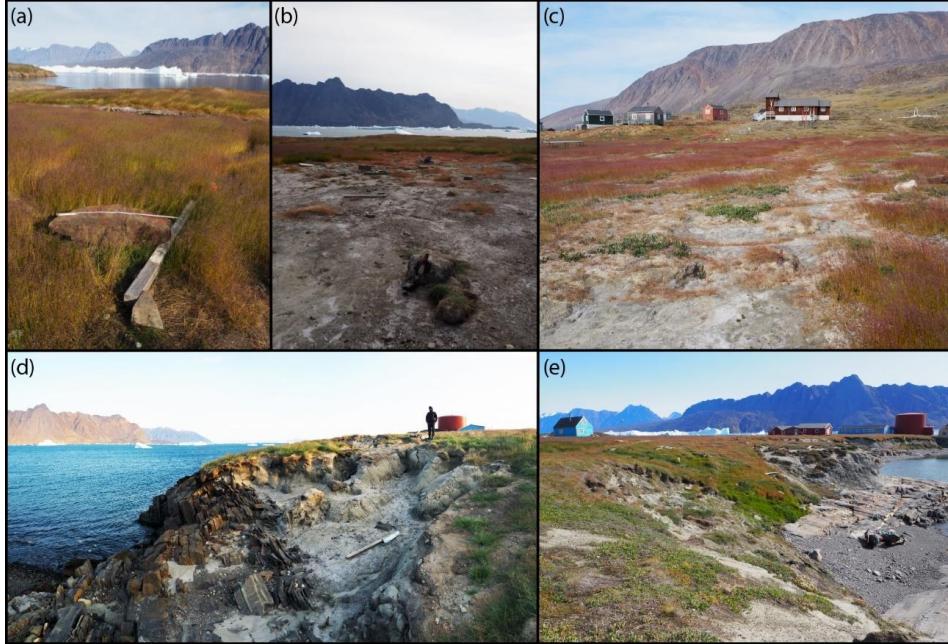
Figure 4. Examples of tsunami effects on tundra and soil covers in Nuugaatsiaq two years after the event. (a) High grass covers eroded tundra blocks, boulders and litter deposited by tsunami; (b) eroded tundra block/raft deposited on the coastal lowland inundated by tsunami with thin layer of redistributed marine sediments and salt covers; (c) deposited tundra and soil blocks and gullied ground surface by wave which backwash to the fjord; (d) eroded edges of low bluffs above the small beach (site 4 in Fig. 1c); (e) cliffed coast heavily dissected by tsunami which overwashed the saddle (site 6 in Fig. 1c) between beach (site 4 in Fig. 1c) and drained to local harbour (site 7 in Fig. 1c).

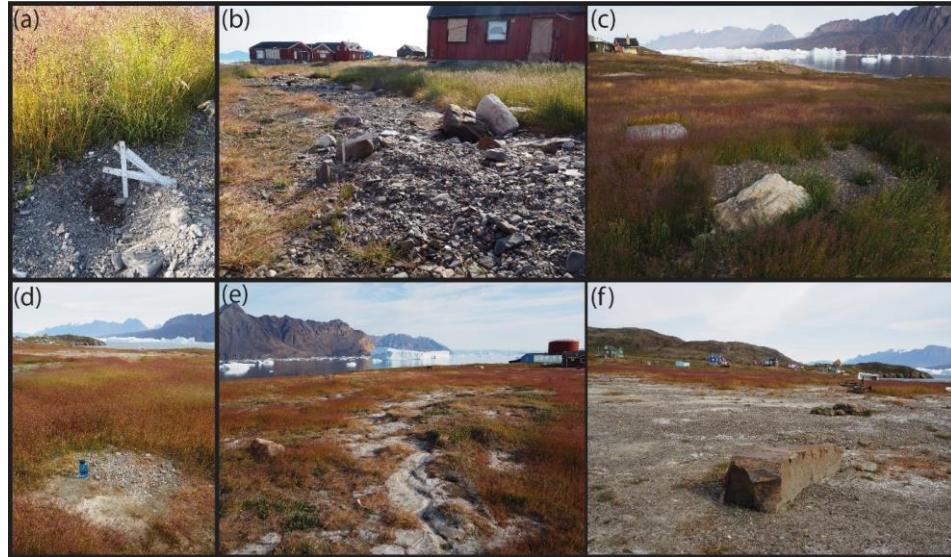
595 **Figure 5.** Examples of tsunami deposits preserved in Nuugaatsiaq two years after the event. (a) Ca. 4-6 cm thick cover
of marine gravels covering grass vegetation; (b) Up to 10 cm thick layer of tsunami deposits eroded from local beach and
deposited on road and grass vegetation; (c) Melt-out material from iceberg (gravels and mud) and ca. 100 cm long boulder
thrown onshore by tsunami; (d) Deposits melted-out from iceberg washed on shore by waves; (e) rills eroded in soil and
tsunami deposits by returning wave; (f) Over 100 cm long boulder moved by wave on the thin layer of gravels and eroded
soil deposits. Note salty surfaces and eroded tundra rafts in the background.
600

During the field survey the tsunami deposits were found in two areas located in the direct proximity to small beaches in the central part of the settlement (between sites 4 and 5 in Fig. 1c). Sand and gravel washed from narrow and thin beaches was deposited along the main road (ca. 30 - 50 m from the shore), where the thickness of deposits exceeds 8-10 cm (Fig. 5 a,b). Thin layerss of tsunami deposits (3 – 5 cm), most probably reworked by snow-melt flow (Fig. 5 e, f) were found in 235 the saddle (playground area) between site 4 and 7 (see Fig. 1c). The general scarcity of tsunami deposits can be explained by the geomorphology of the local coastal zone, dominated by sediment-free rocky capes and coves with narrow (7-20 m wide), gravel-dominated beaches (Fig 2a). Apart from gravel deposits washed from local beaches, waves transported boulders which were found in the inundated terrain in 2 main types: groups of smaller boulders (a-axis ca. 0.2-0.4 m) deposited on marine gravels along the local road, and separated-individual larger boulders (a-axis over 1.0 m), washed up 240 to 100 - 120 m inland between beach and local harbour (Fig. 5 b,f). In a few places we found pads of marine gravels and boulders deposited up to 100 m from the shore and surrounded by dense grass cover (Fig. 5 c,d). Based on the inspection of videos taken during the event we correlated their location with the deposition of icebergs. In comparison with other Greenlandic coastal sites zone-transformed by a tsunami i.e. Paatut 2000 tsunami (Buchwal et al., 2015) the thickness, extent, and diversity of tsunami deposits found in Nuugaatsiaq was much smaller, , what we associated with We attributed 245 this to the- sediment-poor beach source and predominantly rocky coastal relief with sediment-free and glacially scoured surfaces. We detected at the recognizable difference in tsunami landscape modification between the areas of wave overflow covering most of the saddle in central part of settlement (site 6, Fig. 1c) and area of wave uprush and drainage covering eastern part of the settlement (terrain between sites 1 and 2, Fig. 1c). In the first zone, the tsunami waves eroded material (sand, gravel, boulders) from the largest beach in the settlement and fragments of sedimentary and tundra bluffs covering 250 rocky coastal slopes (site 4– Fig. 1c) and transported this mixed load of deposits through the settlement to the harbour (site 7, Fig. 1c). This explains the larger number of sites and zones with accumulations of tsunami deposits, signs of tsunami erosion and infrastructure destruction concentrated in this zone. In the second area, tsunami waves approached the rocky coastal zone, almost sediment free, and inundated the grassy lowland carrying mainly community litter and only small amount of sediments, which was difficult to detect in the trace-in-lushy tundra vegetation inspected 2 years 255 after the event.

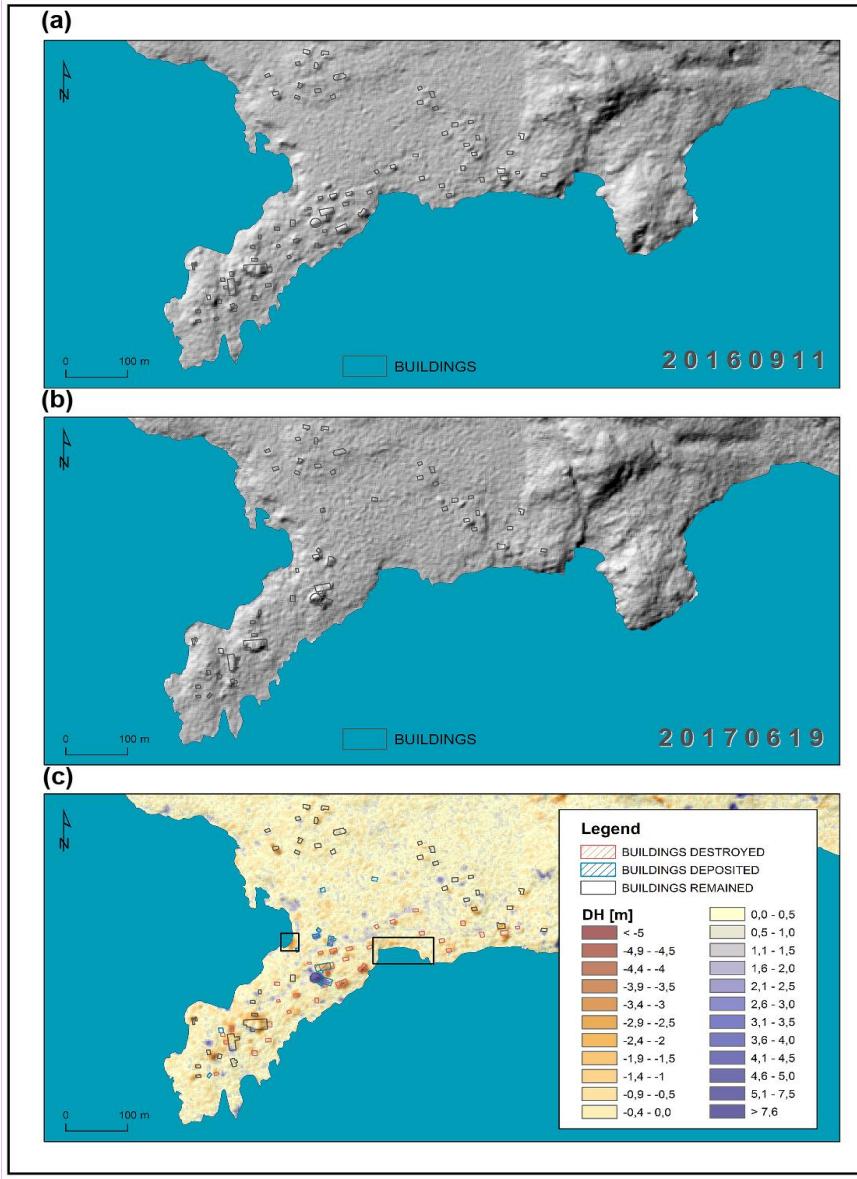
Figure 6. Post-tsunami terrain change in the Nuugaatsiaq area. (a) DTM of study site on the 11th September 2016 – pre-tsunami conditions; (b) DTM of study site on the 19th September 2017 – post-tsunami conditions.; (c) Terrain change calculated from two digital terrain model (DTM) data. The colour scale illustrates values of terrain change (DH), where warm colours stand for an elevation decrease due to erosion, and cold colours represent an elevation increase led by the effects of deposition. Please notice that major changes in the terrain are associated with construction, destruction or relocation of buildings. The resolution of model (2 m) precluded detection of small-scale landscape modifications observed during the fieldwork. Two sites were both field observations and remote sensing analyses detected significant change (erosion) was beach (site 4 in Fig. 1) and cliff edge in the harbour (site 7 in Fig.1) on the opposite sites of the saddle (marked by red rectangles).

Commented [A3]: Here we present the results of our GIS analyses (DTM subtraction). The key finding is that GIS analyses support our field observations and two sites where tsunami erosion was detectable – where beach and clifffed coast on both sides of the saddle in the middle of the settlement.

As you will notice, we have processed two scenes from ArcticDEM in ArcGIS and calculated terrain changes between pre- and post-wave landscapes. The GIS algebra confirmed our field observations and proved that the erosion was concentrated on the ‘saddle area’ between beach and harbour.

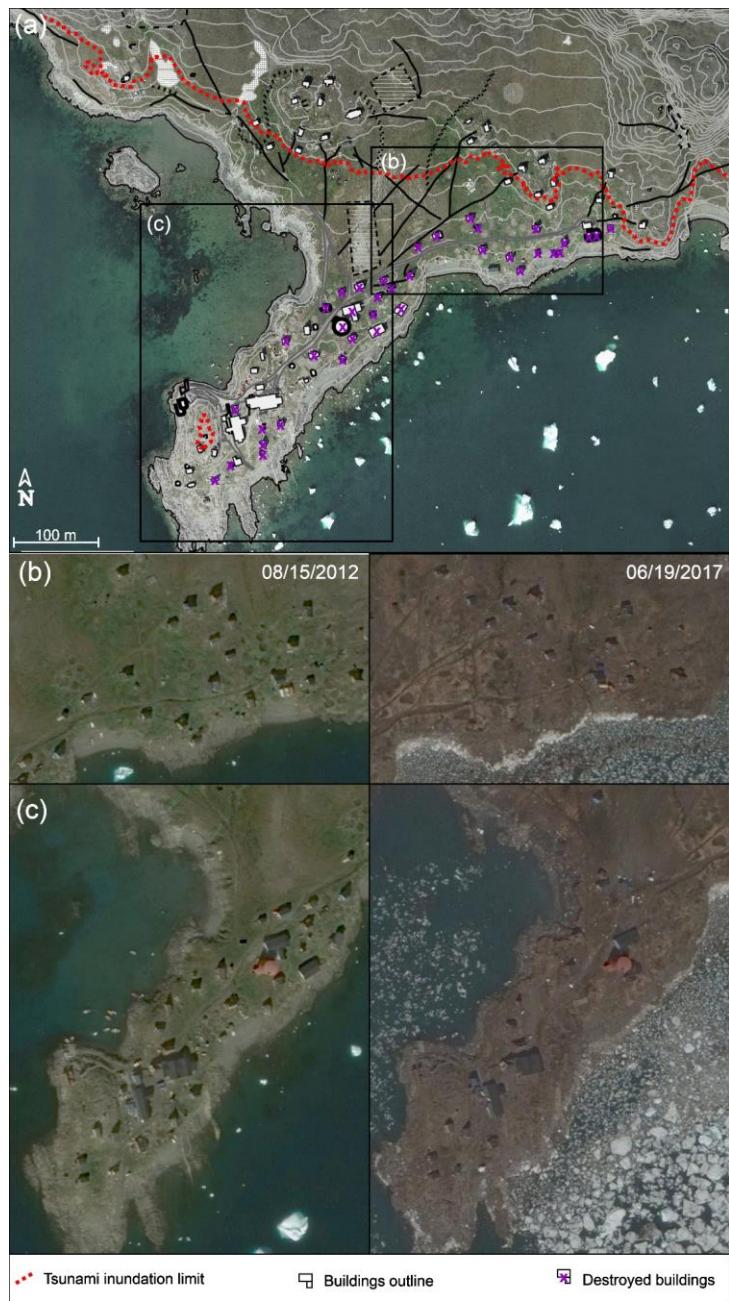
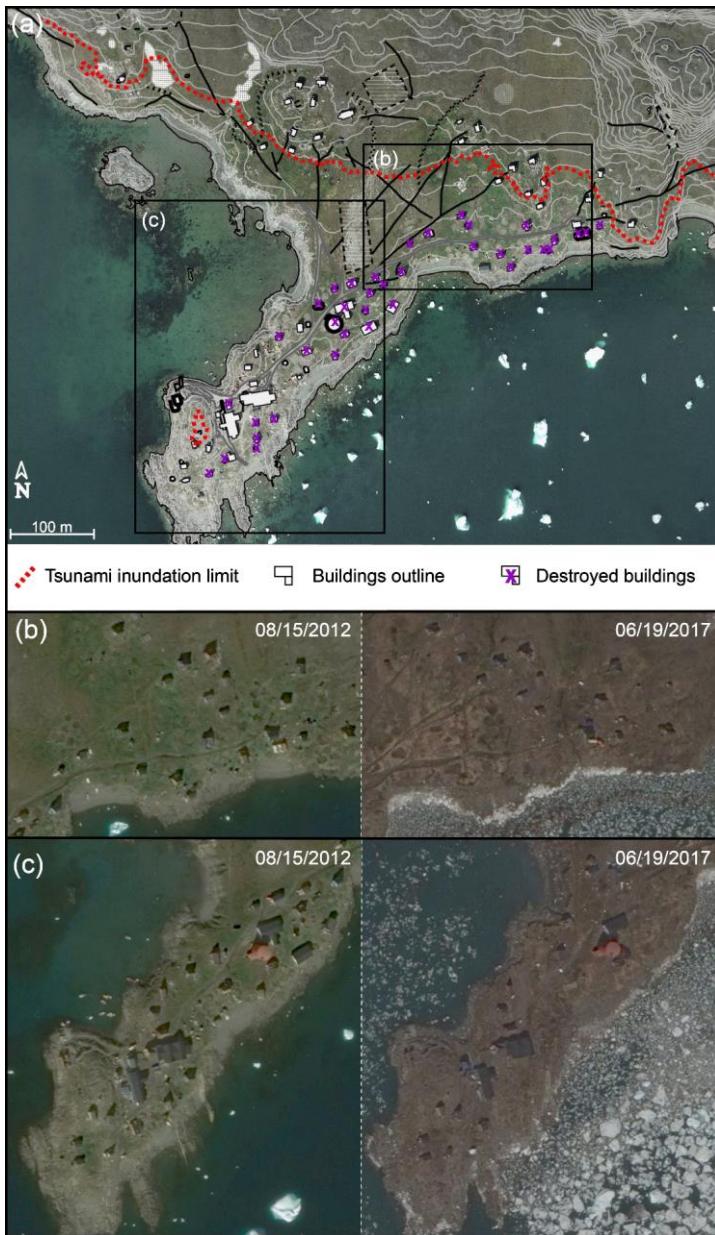
Figure 6**Figure 7.** Scale of destruction in settlement infrastructure. (a) General overview of area inundated by tsunami with location of damaged buildings. The inventory of tsunami-induced changes of settlement infrastructure are based on interception of aerial images, local spatial plans and field surveying. Background orthophoto [and topographic map& technicalmap](#): nunagis.gl.; (b) Satellite image of settlement before the tsunami impact (15th August 2012) and; (c) Satellite image of settlement after the tsunami impact illustrate the scale of destruction and dislocation of buildings (19th June 2017) Background Google Earth Image © 2020 Maxar Technologies.

Before the tsunami event the Nuugaatsiaq community infrastructure was composed of 94 buildings (houses, services and 265 administration buildings, dog kennels, technical facilities etc.). The wave destroyed 45 buildings (48% of the original infrastructure) within:viz. 22 buildings were fully swept away from land, 23 buildings were partly broken damaged, and 11 of them were moved between 2 m to over 100 m from original location (Fig. 6Fig. 7). Most of the buildings were

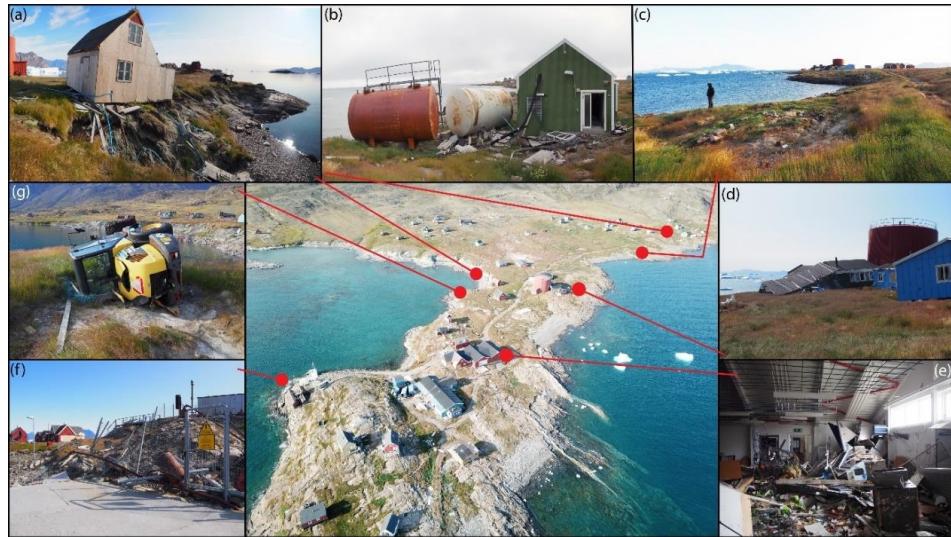
Figure 7Figure 8. Examples of infrastructure damages caused by 2017 tsunami in Nuugaatsiaq. (a) Wooden house removed by wave from point foundation transported several dozen of meters; (b) Fuel tanks washed away from concrete frames and pushed towards power plant. Note large accumulation of litter and tsunami deposits around and inside the buildings; (c) site of former building position, which was destroyed and swept away by tsunami. Note broken wooden point foundations, media connections and erosional gullies; (d) Smashed and collapsed wooden school building moved towards major water tank; (e) Interior of local shopping centre passed by tsunami. Note large amounts of litter and rotting food supplies and twisted and bowed metal frame construction; (f) Partly-torn metal fence around fuel storage site which acted as a trap for litter transported by tsunami; (g) example of heavy machine knocked over by waves.

constructed on a wooden frame, covered with wooden boards and settled on pier foundations. Only a few of the settlement buildings were built on a metal frame coated with corrugated metal sheet settled on a concrete frame foundation. The first type of building (with pier foundations) ~~were~~ not strong enough to resist the wave impact and these structures were pushed by the tsunami or in some cases washed away to the fjord (Fig. 7Fig. 8 a,c).

In those buildings which were not moved but still affected by the wave, we observed some damage of their wooden ~~lining~~cladding, as well as a deposition of marine sediments and litter in the ground floor area. The typical damages observed in buildings which were pushed by the tsunami but remained on land were: *broken windows and doors*, *devastated interior*. In contrast to buildings with pier foundations, much smaller damages were observed in buildings with concrete frame foundations. These, due to a more stable anchoring in the ground, gave a much higher resistance to the wave impact. The most common damages included broken walls, bowed and twisted metal construction frames (Fig. 7Fig. 8 b, d). It should be considered extremely fortunate that the fuel tanks situated at the power plant (which were one of the first parts of infrastructure hit by tsunami) were not destroyed and no leakage of petrol was reported (Fig. 7Fig. 8b).

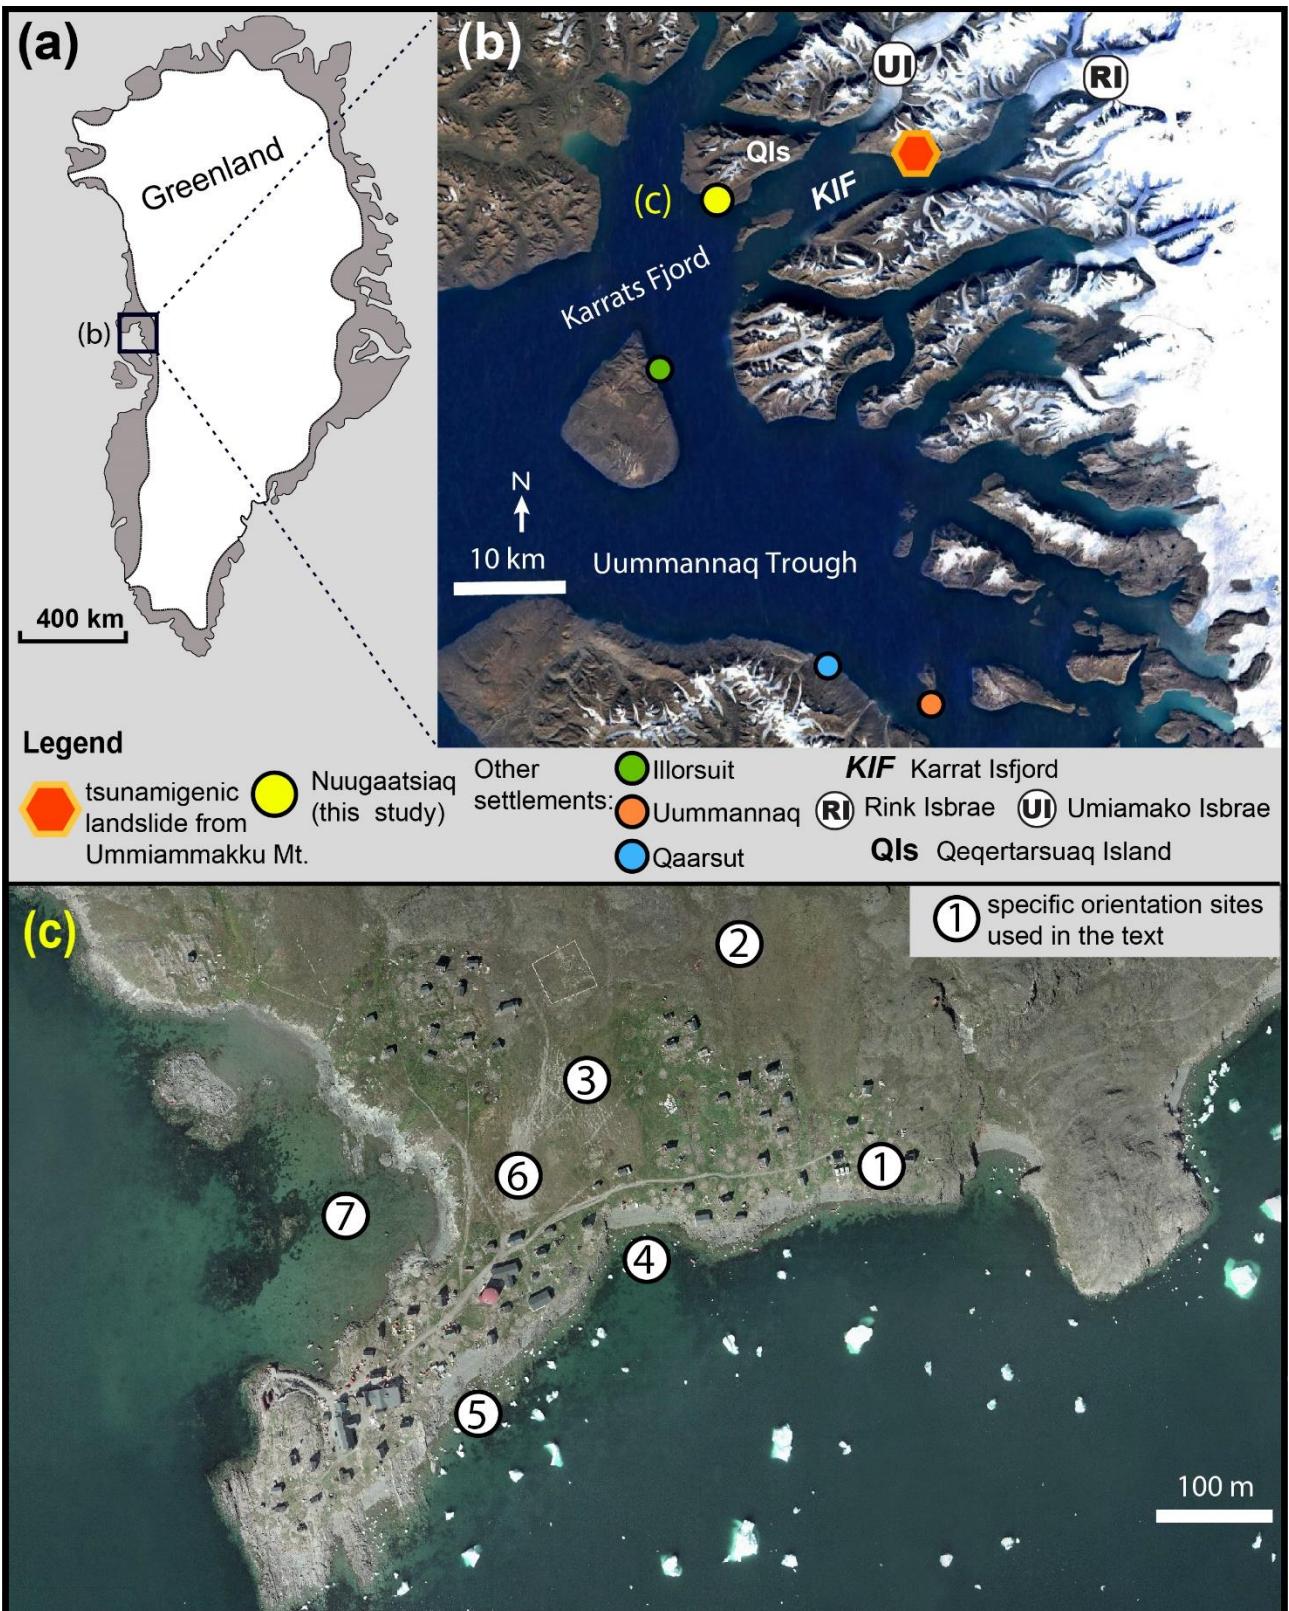
Figure 1. Location of study area. a) General position of Karrat Fjord in western Greenland (Source: Google Earth); b) Karrat Fjord area, where tsunamigenic landslide occurred on 17 June 2017 and inundated settlement of Nuugaatsiaq; c) Aerial image of Nuugaatsiaq before the event (nunuagis.gl). Number in circles mark orientation sites used in the text 1 – area with first line of buildings destructed by tsunami, 2 – heliport above the tsunami inundation limit, 3 – playground area, partly flooded by tsunami, 4 – first beach eroded by tsunami; 5 – second beach eroded by tsunami; 6 – saddle between beach(4) and harbour; 7 – local harbour.

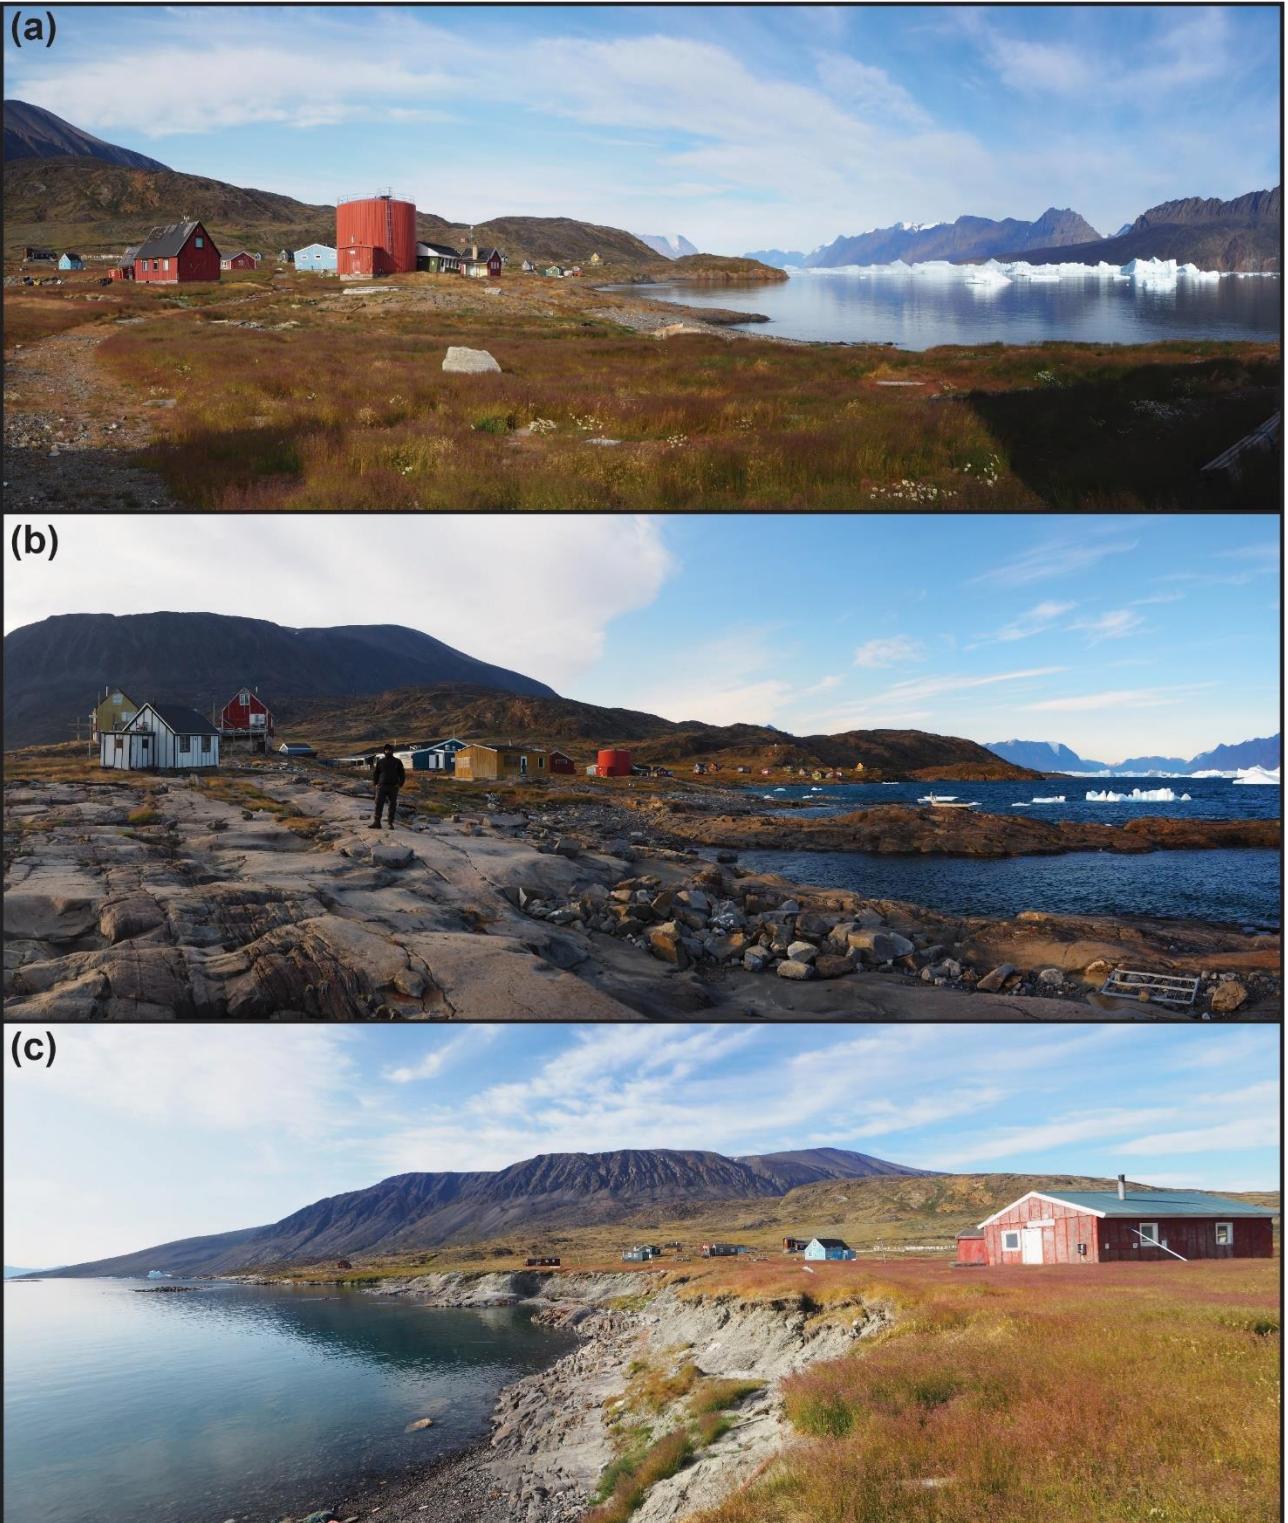
Figure 2. Coastal landscapes in Nuugaatsiaq. (a) Densely vegetated (grasses and shrubs) coastal lowland with ragged shoreline dissected by rocky capes and coves with narrow beaches; (b) Main headland with exposed glacially scoured bare rock surfaces, note accumulations of boulders in rocky hollows; (c) Cliffted coast in Nuugaatsiaq harbour. Tops of the cliff were eroded and gullied by tsunami.

We recognized two main effects on coastal geomorphology induced by tsunami impact. The tsunami erosion was concentrated on the low bluffs of tundra along the coast between narrow beaches (section of the coast between sites 1-4-5 in Fig. 1c, Fig 2a). Eroded blocks of tundra cover were deposited on land (Fig. 4b). The returning wave caused additional 210 erosion of bluffs edges and dissected them by a series of rills/gullies (Fig. 4d). The direction of the wave flow recorded in the orientation of deposited litter, buildings, marine deposits, boulders, and tundra blocks suggest that the wave overwashed the section of settlement through a saddle (site 6 in Fig. 1c) between the middle beach (site 4 in Fig. 1c) and local harbour (site 7 in Fig. 1c), and modified the relief of cliffs in the harbour. The edges of the sedimentary cliffs were gullied, and the steep cliff slopes were spread with eroded blocks of tundra and litter (Fig. 4e). Two years after the event, 215 normal coastal processes (wave and tidal action) had not yet removed or redistributed the eroded blocks of tundra and litter from the slopes and bases of the cliffs (Fig. 2c).

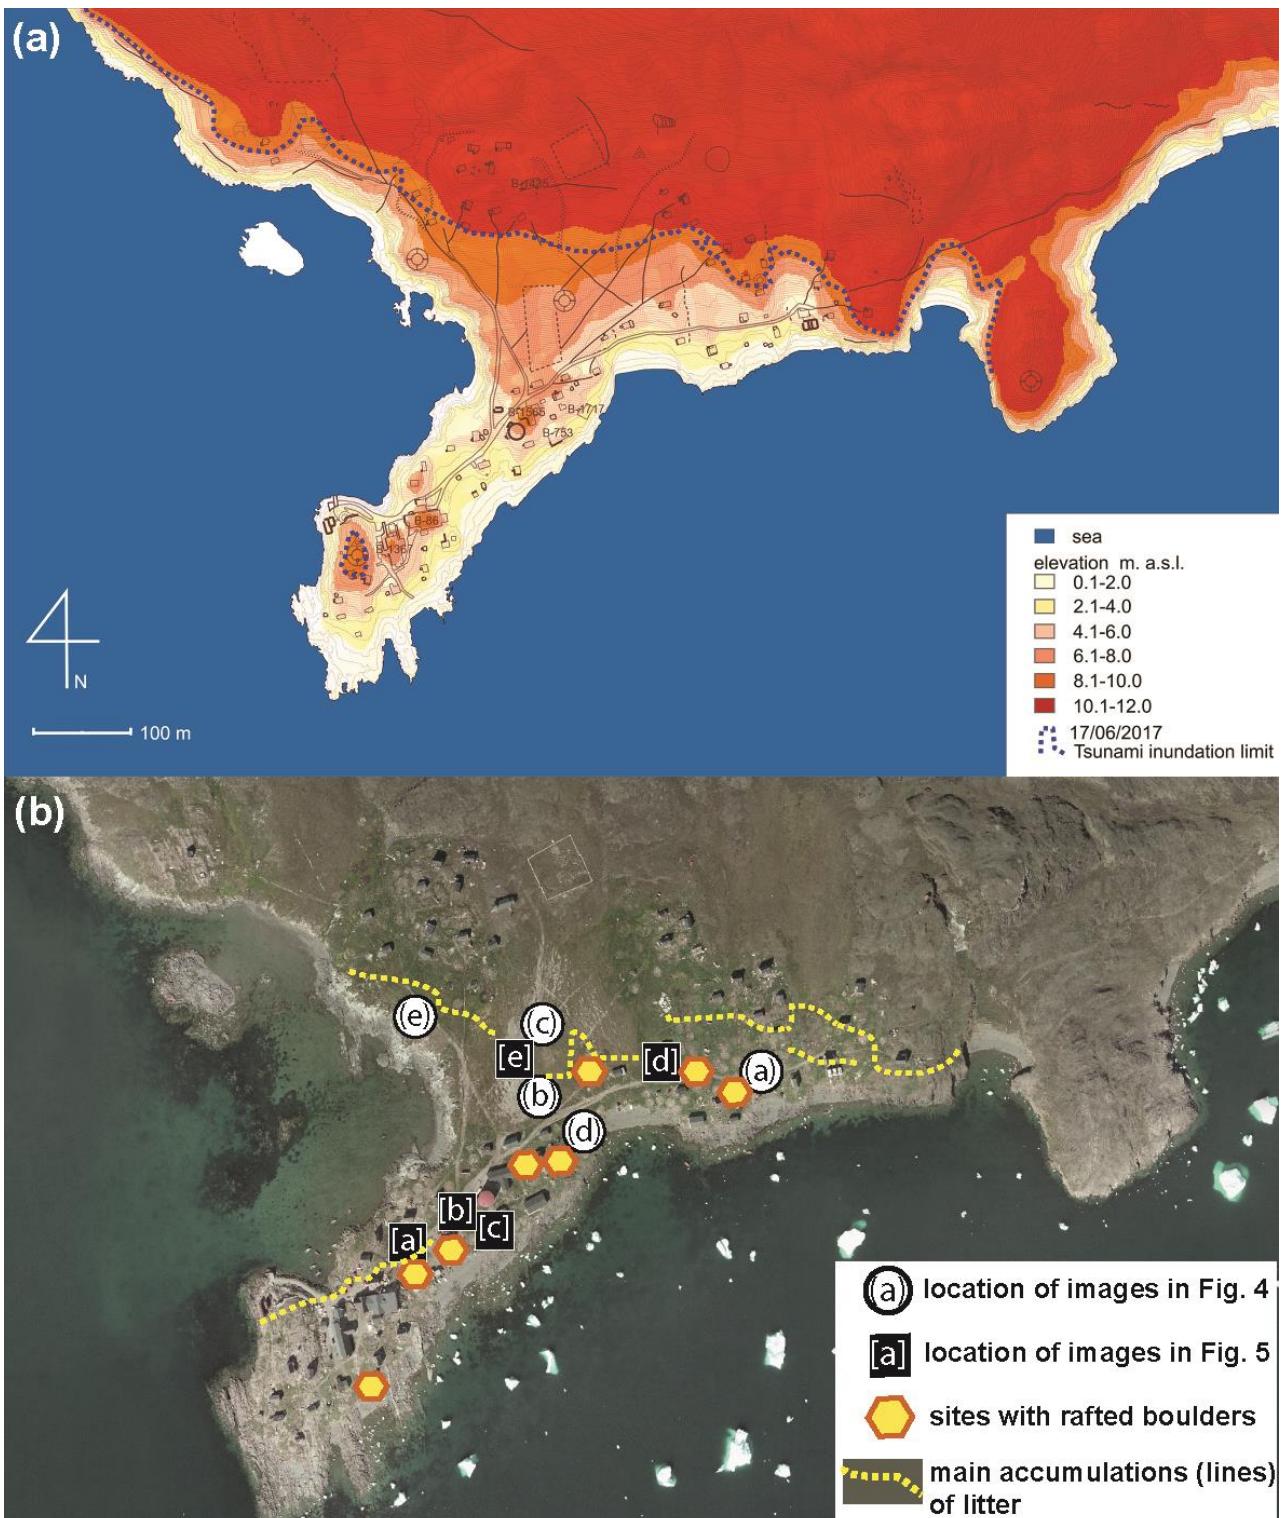
Figure 3. (a) Digital elevation model (2-m DEM, <https://www.pgc.umn.edu/data/arcticdem/>) of Nuugaatsiaq with marked tsunami inundation limit (wave flooded the terrain up to 8 m a.s.l.). (b) Overview map of the settlement with marked location of images from Fig. 4 and 5. Lines of litter visible in the landscape 2 years after the event and sites were 560 large boulders rafted by tsunami were marked too. Background: technical map of settlement from nunagis.gl

Inspection of satellite images and photographs taken in Nuugaatsiaq before the event suggest that grassy-tundra covers dominated the top of coastal bluffs and the strip of coastal lowlands between the predominantly rocky shore and main coastal road passing the settlement from west to east. During our fieldwork we noticed very dense and relatively high (0.4 – 0.6 m) grassy meadows covering coastal lowlands, and recolonizing abandoned playgrounds, roads, backyards (Fig. 190 2a). The observed post-event vegetation cover in study area was significantly denser and higher than in other settlements visited in the region in the same season. Two years after the event most of the blocks of eroded soil, rafts of tundra, boulders, or litter that were found were almost entirely hidden in a high grass cover (Fig. 4a). The wave has torn blocks of tundra (shrubs, mosses, grass) off the coastal slope and deposited them on land (Fig. 4 b, c). We noted a significant removal of tundra cover, soil erosion, and associated formation of rills or small gullies (0.2-0.6 m deep) concentrated on 195 surfaces exposed after the washing away of buildings. Tundra and soil were also eroded along the cliffted coast of the harbour (Fig. 4 d, e). At a few places along the main road and in the vicinity of the playground the vegetation cover (grasses) was covered by a thin layer of tsunami deposits (3 – 7 cm) composed mainly of marine gravels mixed with coarser sands. Salty patches with dead-vegetation were observed mainly across the saddle between southern coast and western harbour (site 6 in Fig. 1c). After analyzing the video coverage of the event and post-event images (see list of 200 online resources in references), we assume that some parts of the grass cover were compressed by the fragments of icebergs or ice-floes washed on shore by tsunami. In sites where ice-bergs or ice-floes were deposited and melted away grasses were weighted down and melt-out sediments (gravel, sand, mud) was observed between grass blades. Such spots were surrounded by lush grassy tundra. Tundra was compressed also by tsunami-derived boulders both eroded from beaches and melted out of icebergs (Fig. 3b).

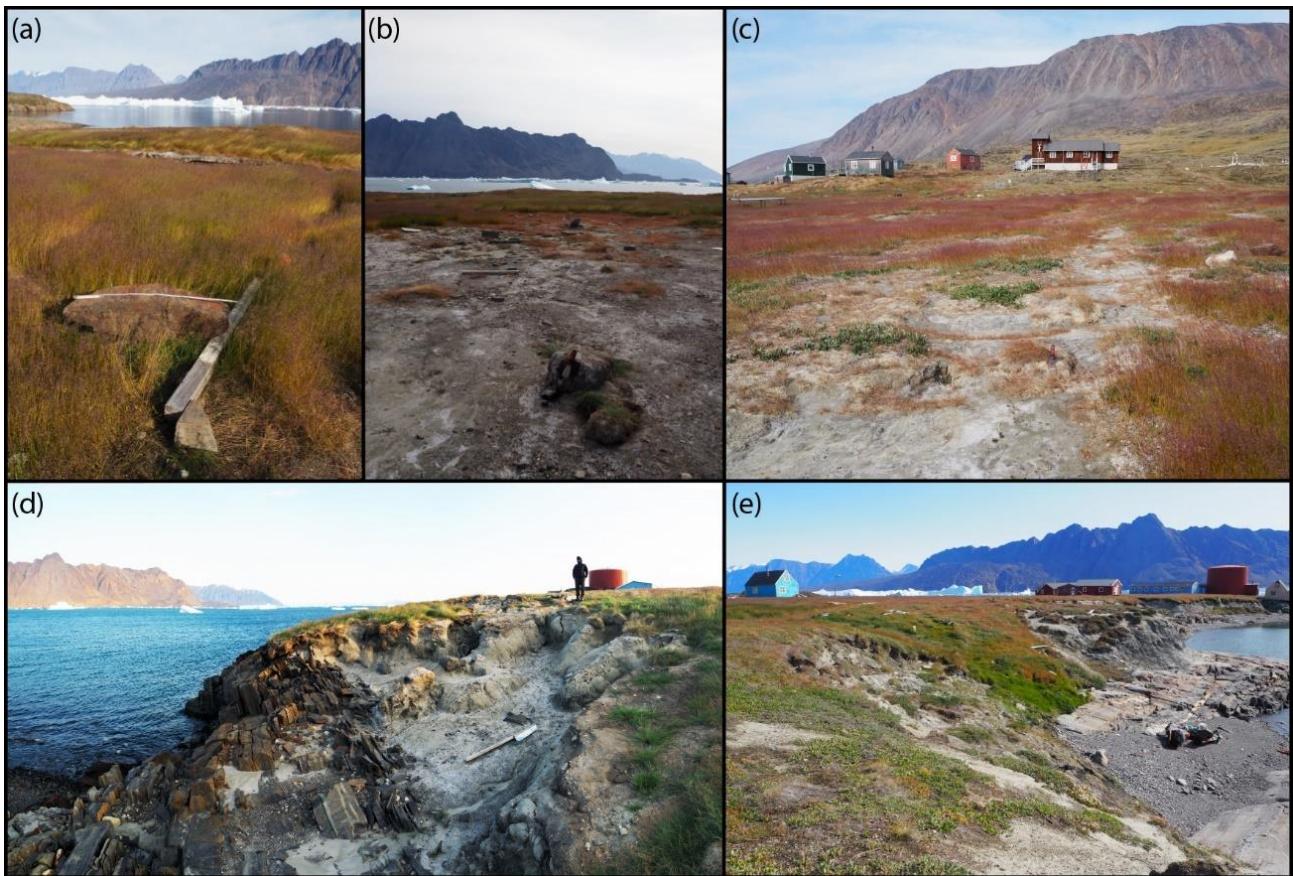
Figure 4. Examples of tsunami effects on tundra and soil covers in Nuugaatsiaq two years after the event. (a) High grass covers eroded tundra blocks, boulders and litter deposited by tsunami; (b) eroded tundra block/raft deposited on the coastal lowland inundated by tsunami with thin layer of redistributed marine sediments and salt covers; (c) deposited tundra and soil blocks and gullied ground surface by wave which backwash to the fjord; (d) eroded edges of low bluffs above the small beach (site 4 in Fig. 1c); (e) clifffed coast heavily dissected by tsunami which overwashed the saddle (site 6 in Fig. 1c) between beach (site 4 in Fig. 1c) and drained to local harbour (site 7 in Fig. 1c).

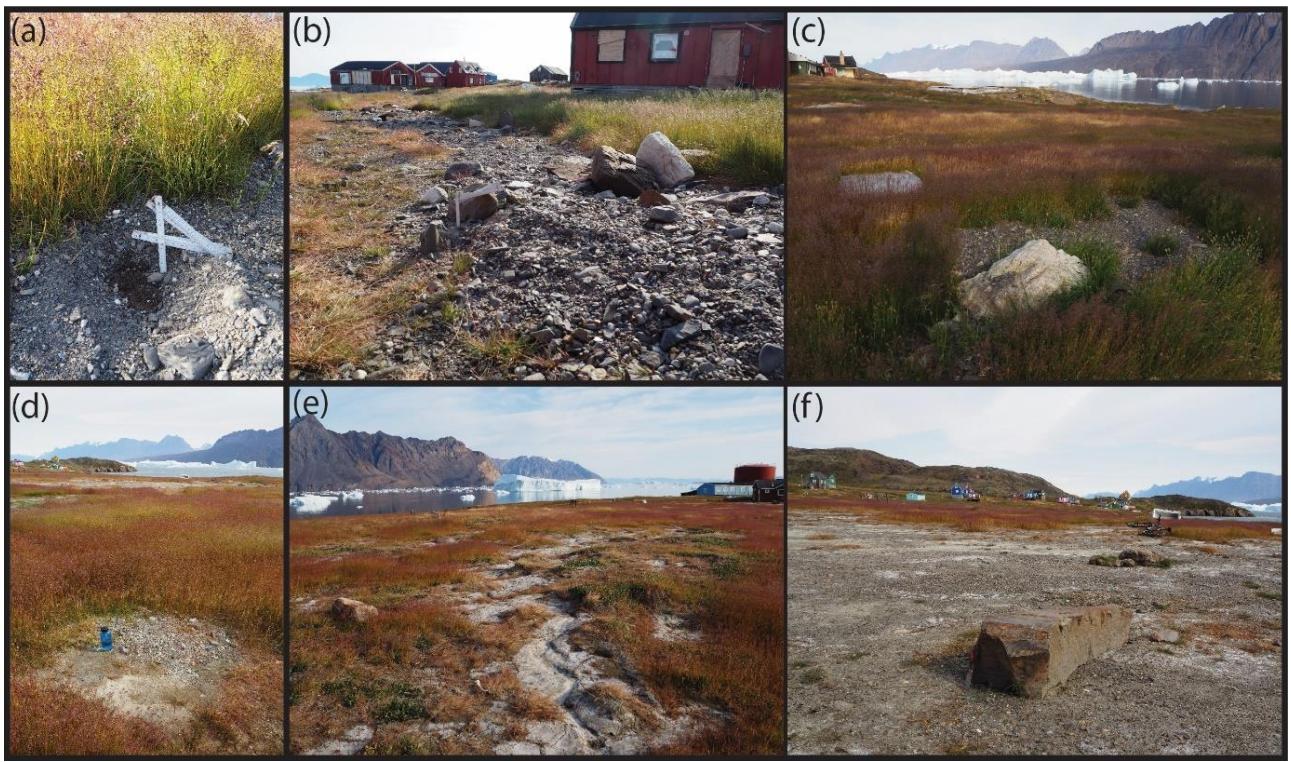
Figure 5. Examples of tsunami deposits preserved in Nuugaatsiaq two years after the event. (a) Ca. 4-6 cm thick cover of marine gravels covering grass vegetation; (b) Up to 10 cm thick layer of tsunami deposits eroded from local beach and deposited on road and grass vegetation; (c) Melt-out material from iceberg (gravels and mud) and ca. 100 cm long boulder thrown onshore by tsunami; (d) Deposits melted-out from iceberg washed on shore by waves; (e) rills eroded in soil and tsunami deposits by returning wave; (f) Over 100 cm long boulder moved by wave on the thin layer of gravels and eroded soil deposits. Note salty surfaces and eroded tundra rafts in the background.

During the field survey the tsunami deposits were found in two areas located in the direct proximity to small beaches in 220 the central part of the settlement (between sites 4 and 5 in Fig. 1c). Sand and gravel washed from narrow and thin beaches was deposited along the main road (ca. 30 - 50 m from the shore), where the thickness of deposits exceeds 8-10 cm (Fig. 5 a,b). Thin layers of tsunami deposits (3 – 5 cm), most probably reworked by snow-melt flow (Fig. 5 e, f) were found in the saddle (playground area) between site 4 and 7 (see Fig. 1c). The general scarcity of tsunami deposits can be explained by the geomorphology of the local coastal zone, dominated by sediment-free rocky capes and coves with narrow (7-20 m
